# SCOTTISH HOSPITALS INQUIRY

## **Bundle of documents for Oral hearings commencing from 19 August 2024 in relation to the Queen Elizabeth University Hospital and the Royal Hospital for Children, Glasgow**

### **Bundle 12 - Estates Communications**

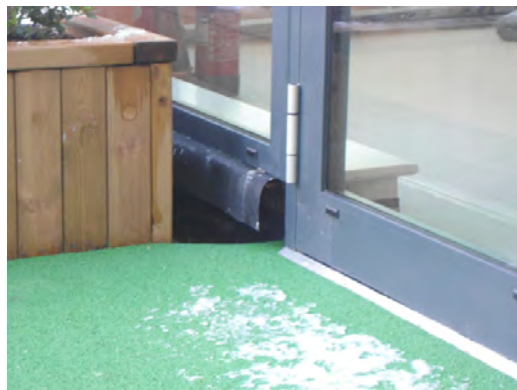
The drainage pipes from AHU's do not extended to the drainage outlet. We have asked Brookfield to confirm when the pipes have been extended towards the drain. If left as, is there is a risk that the falls in the floor will direct the water away from the drain. We asked Brookfield to confirm that step over's will be provided. They have confirmed that repair and stepover's will be provided. See Supervisor's Communication General Matters / Other Instructions (CI 13.1) No 241.

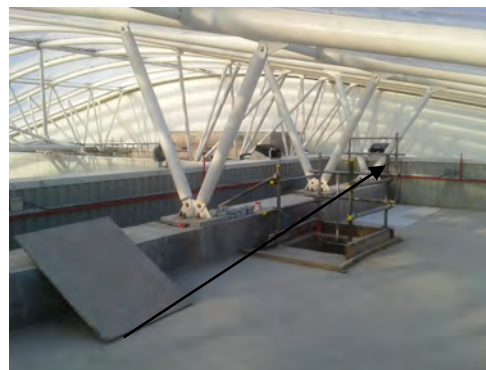
There is temporary scaffolding providing perimeter protection at concrete floor beams above the cores accessed from Level 12. We have asked Brookfield to confirm if permanent perimeter protection is to be fitted. See Supervisor's Communication General Matters / Other Instructions (CI 13.1) No 242.

Temporary scaffolding providing perimeter protection.

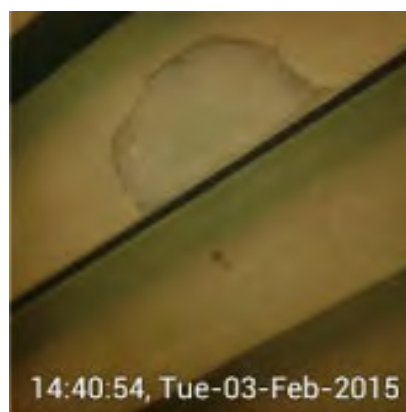
Damaged tread. There were other treads requiring repairs to lifting eyes.

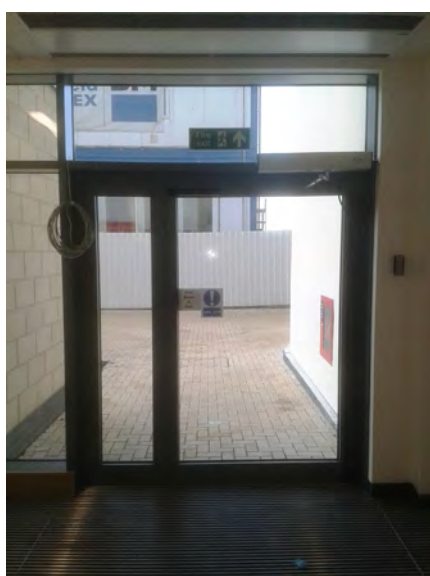
Push button not installed.

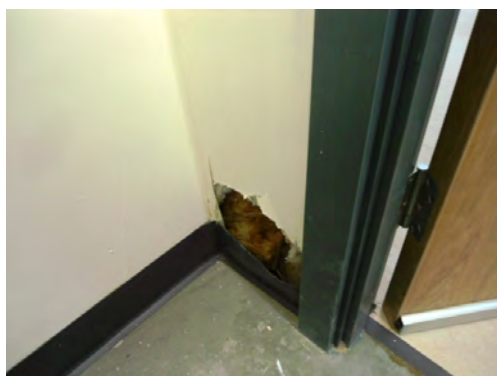
Plasterboard damaged in room GEN21-086

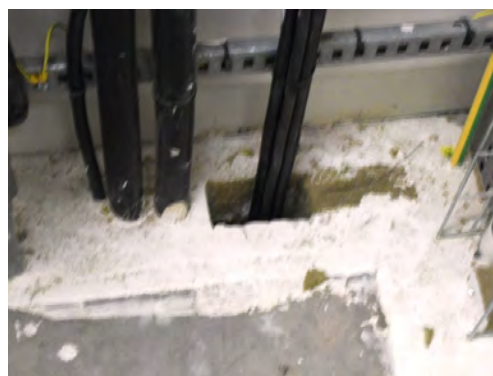
Gap in the fire bat in room GEN21-054

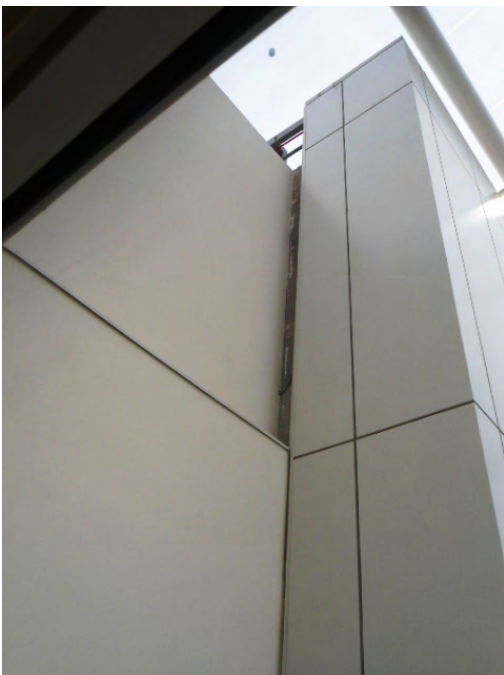
exposed concrete visible from Level 11 corridor.

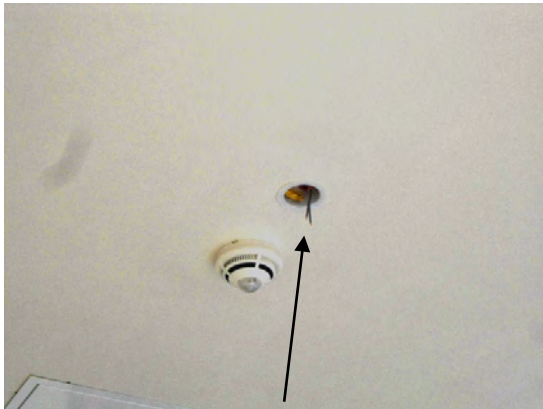
Remote LED to be completed

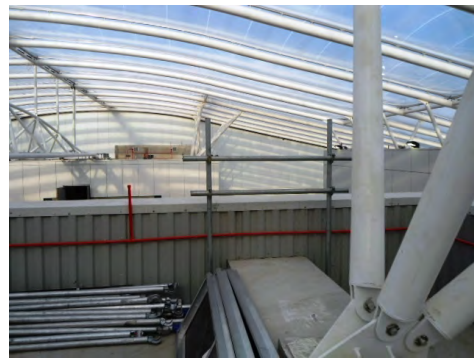
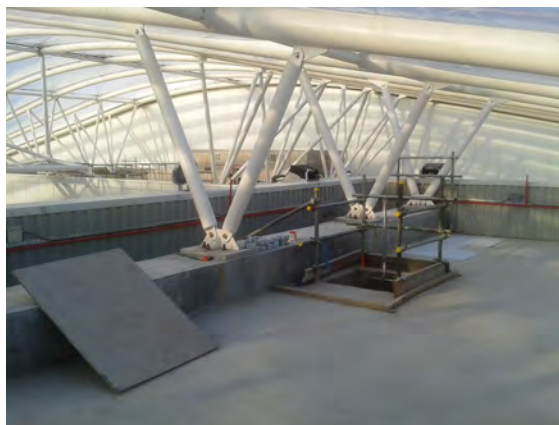
There is temporary scaffolding providing perimeter protection at concrete floor beams above the cores accessed from Level 12. We have asked Brookfield to confirm if permanent perimeter protection is to be fitted. See Supervisor's Communication General Matters / Other Instructions (CI 13.1) No 242.

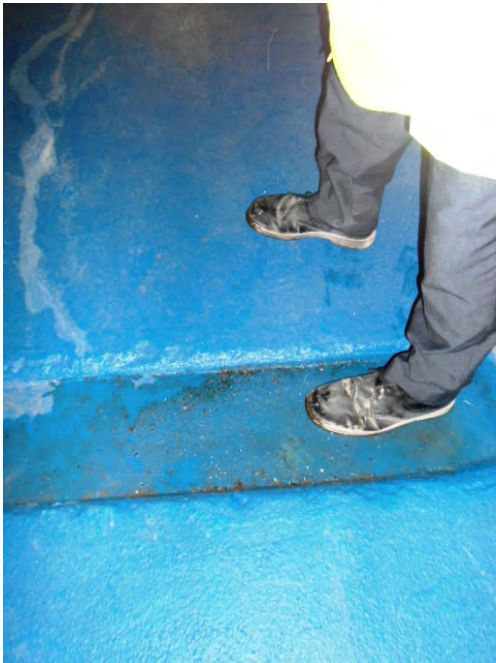
Level 5

The car park floors on levels 1, 2, 3, 4, and 5 adjacent to the stair on the east elevation have recessed channels which cross the pedestrian walkway similar to the potential trip hazards identified in Communication No 209. Brookfield has confirmed that IFT is to infill the channels with coloured screed on the walkways. They have intimated that these locations do not interfere with the water flow as they are the opposite end to the outlet gully. (See Supervisor's Communication General Matters / Other Instructions (CI 13.1) No 224).

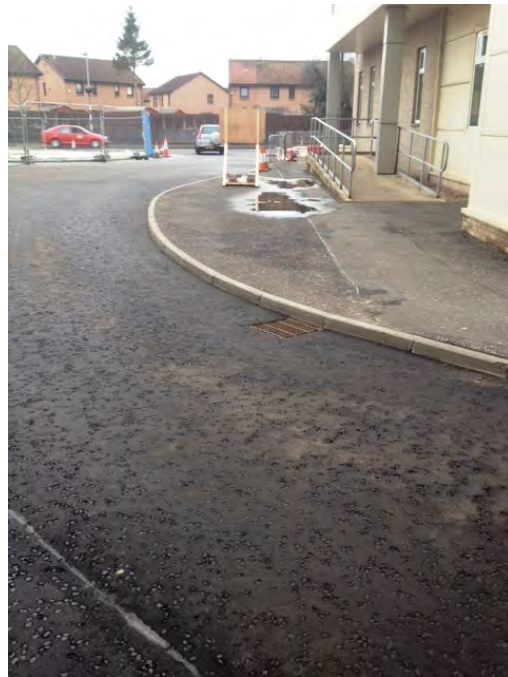
Ponding at the extended footpath area on the east side of the maternity unit, and potential specification non-compliance on sections of the footpath to the dual carriageway just north of the energy centre.

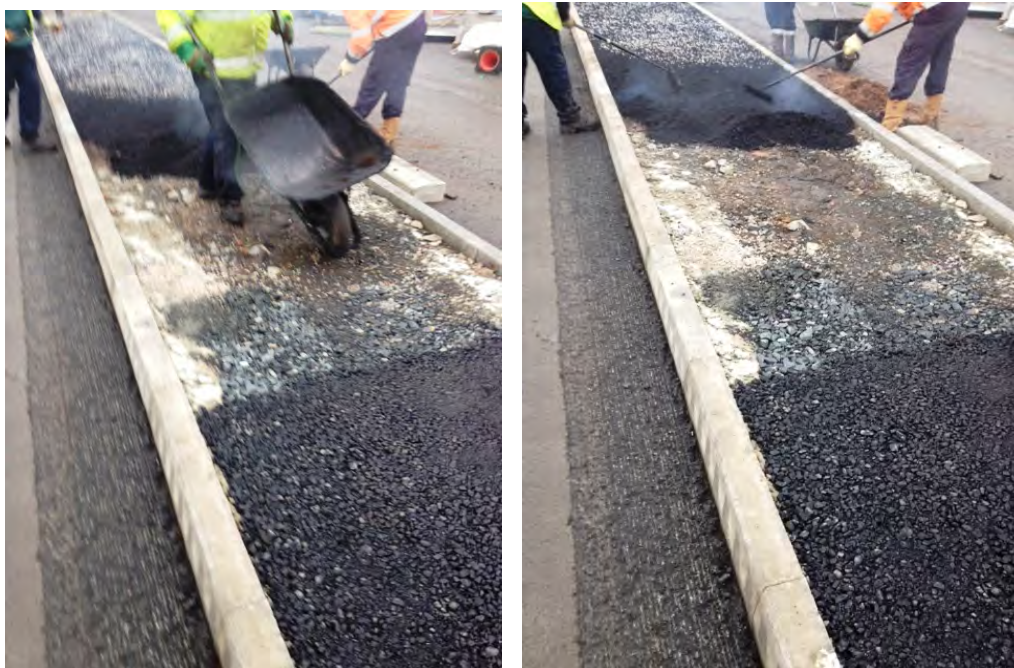
We asked Brookfield to confirm that the footpath make up to the dual carriageway just north of the energy centre complies with the specification (See photos below) Brookfield has confirmed that Land Engineering are to remove section of non complying asphalt and replace with specified material and layers. Land Engineering are to provide photo commentary showing removal and replacement in correct layers alongside delivery tickets evidencing material installed. Consequently Supervisor's Communication General Matters / Other Instructions (CI 13.1) No 236 is closed out.

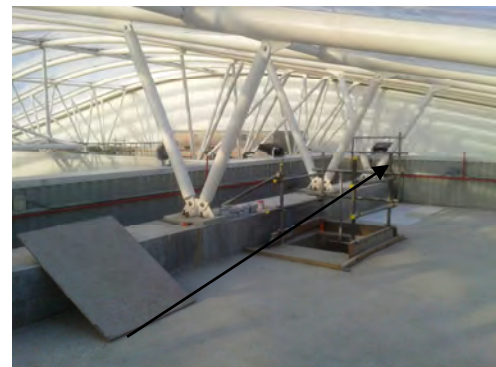
Temporary scaffolding providing perimeter protection.

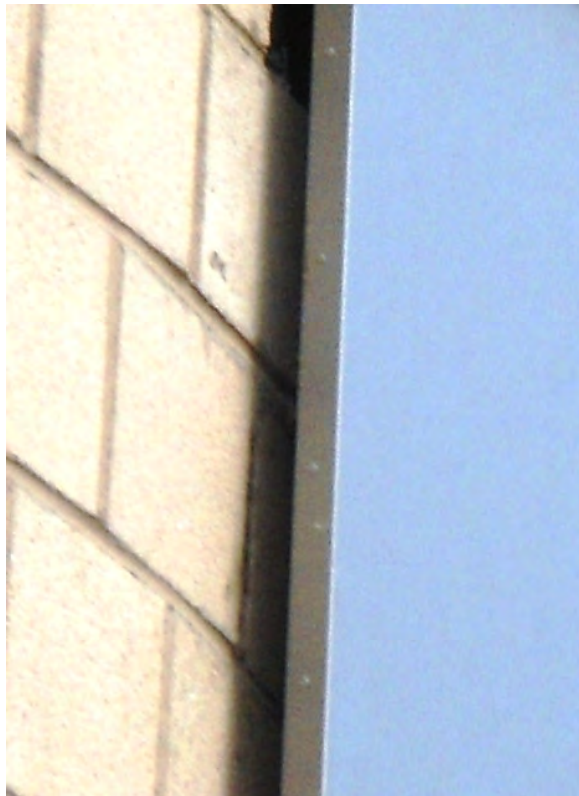
Gap between cladding and blockwork interface.

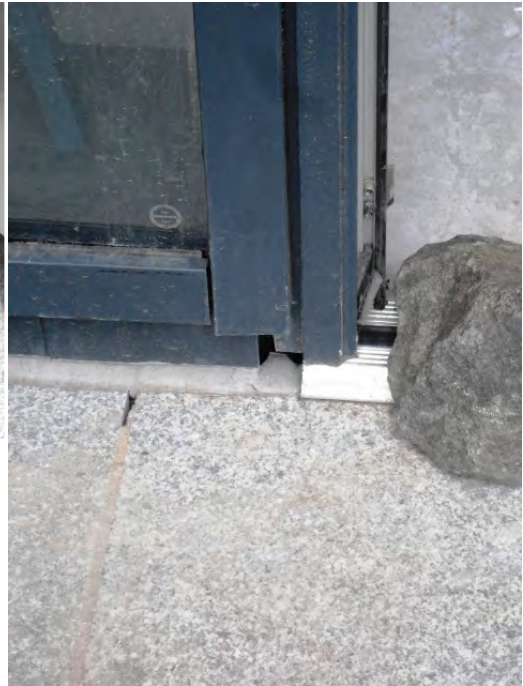
Excessive gap at the bottom of the door frame.

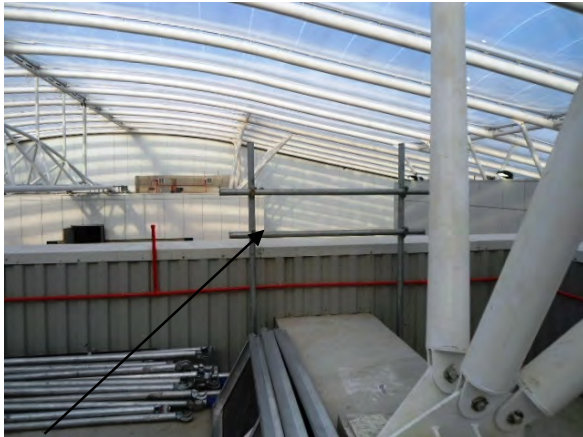
Temporary scaffolding providing perimeter protection.
