Legionella Risk Assessment & Water Hygiene Survey Report

Client Name:	Bouygues E&S FM UK
Site Name:	The Royal Hospital for Children & Young People
Site Address:	Little France Crescent, Edinburgh, EH16 4TJ
Survey Date:	18 th – 21 st February 2019
Surveyor Name:	[REDACTED]

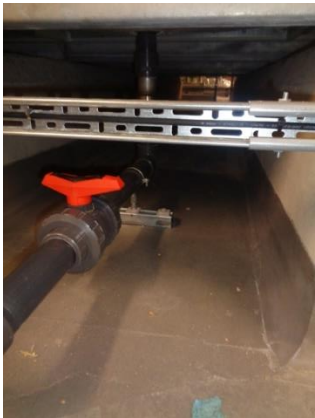
Risk Rating	Item 12 Recommended Action	Photo Ref.						
High	<p>The Drain points on all cold-water storage tanks are too long and acting as dead legs. It is recommended that these are shortened or that they are placed onto a twice weekly flushing regime to ensure that all stagnation products are removed.</p>	3.1						
	<table border="1"> <thead> <tr> <th>Rectified By</th> <th>Comments</th> <th>Date</th> </tr> </thead> <tbody> <tr> <td>Name: Signature:</td> <td></td> <td></td> </tr> </tbody> </table>	Rectified By	Comments	Date	Name: Signature:			
Rectified By	Comments	Date						
Name: Signature:

Photo Ref.	Location	Photo Ref.	Location
3.1	Roof Plant Room - Example of drain valve on all CWSTS's	3.2	Roof Plant Room – Glass Trap on CWST overflow

Rectified By	Recommendations	Rectified By	Recommendations
Name: Signature: Date:	These are acting as a dead leg & should be placed on the twice weekly flushing regime.	Name: Signature: Date:	Clean trap quarterly & top up added biocide when required, or install a screen on overflow pipe

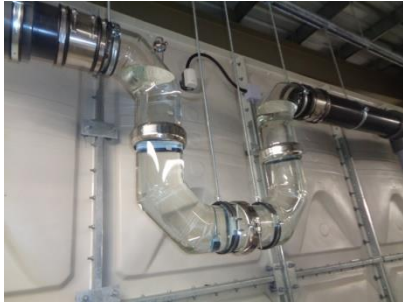
Risk Rating	Item 13 Recommended Action	Photo Ref.
High	<p>The glass overflows on CWST5, CWST06, CWST07 and CWST08, should be cleaned quarterly and kept topped up with added biocide, to ensure no biofilm is allowed to grow.</p>	3.2 3.3

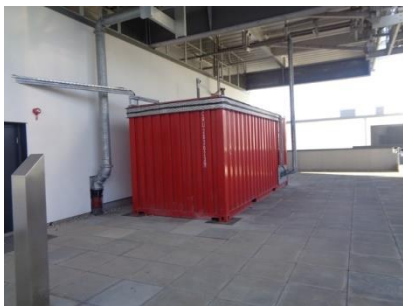
Photo Ref.	Location	Photo Ref.	Location
3.3	Roof Plant Room – CWST07 & CWSST08	3.4	Roof Top

Risk Rating	Item 13 Recommended Action	Photo Ref.						
	<table border="1"> <thead> <tr> <th>Rectified By</th> <th>Comments</th> <th>Date</th> </tr> </thead> <tbody> <tr> <td>Name: Signature:</td> <td></td> <td></td> </tr> </tbody> </table>	Rectified By	Comments	Date	Name: Signature:			
Rectified By	Comments	Date						
Name: Signature:								
Risk Rating	Item 14 Recommended Action	Photo Ref.						
High	<p>Fire Sprinkler Tank for the helipad. – The lack of flow in the tank and temperatures stored may be a Legionella risk, however, the risk from fire outweighs the risk from Legionella.</p> <p>When testing or flushing the system, there is a high risk from aerosols of contaminated water. The work has to be completed with minimum exposure to aerosols, preferably discharging water into a closed container or drain, perhaps at times when there is a minimum number of people on site, to be exposed to any aerosol produced.</p>	3.4

Rectified By	Recommendations	Rectified By	Recommendations
Name: Signature:	As the tanks are already fitted with an overflow screen the glass trap is not required & should be	Name: Signature:	When test / Flushing Fire Sprinkler Tank minimal exposure to aerosol should be created & exposure to

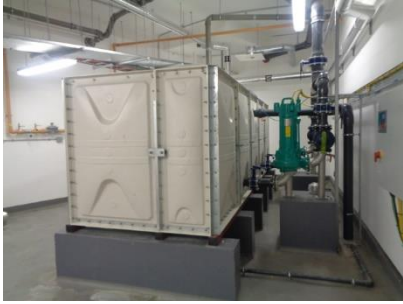
Photo Ref.	Location	Photo Ref.	Location
3.5	Plant Room 016	3.6	Roof Plant Room – CWST03 & CWST04

Risk Rating	Item 16 Recommended Action	Photo Ref.
Medium	<p>The Rain Water Harvesting Storage Tank located in Plant Room 016 is currently not feeding any outlets and is being drained via pumps. Ensure that the tank complies with BS8515:2009. The tank should be insulated to prevent heating and freezing of the collected water, water tight, avoid stagnation, resist microbial growth and be sited so as not to create an environment suitable to the growth of Legionella. The size of the tank should be suitable for use, not oversized to ensure regular turnover of stored water, with screened vents fitted to prevent the ingress of contaminants.</p> <p>When the system is used it is recommended that a six monthly check of condition (sediment, bio-film and temperatures etc.), clean and disinfect as per inspection results and consider the use of a biocide treatment.</p> <p>Consider water sampling to check condition of water (TVC's & Legionella).</p>	3.5

Rectified By	Recommendations	Rectified By	Recommendations
Name: Signature: Date:	Inspect Rain Water collection tank 6 monthly, consider water sampling from tank	Name: Signature: Date:	Maintain filters in filtration plant as per manufacturers instructions, record all action in site log book

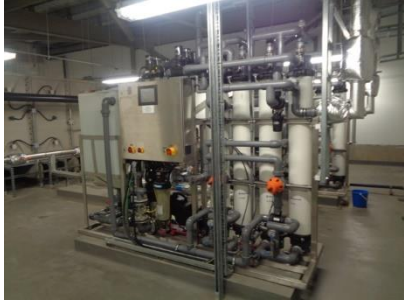
Risk Rating	Item 17 Recommended Action	Photo Ref.
Medium	Filters have been associated with the support of bacterial growth. Therefore, the filtration plant off CWST03 & CWST04 should be maintained as per the manufacturer's instructions	3.6
Rectified By	Comments	Date
Name: Signature:

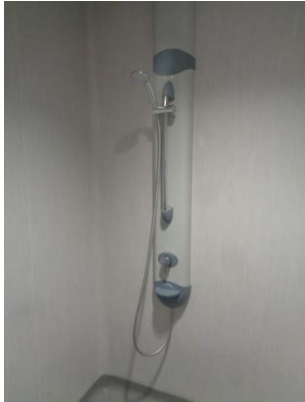
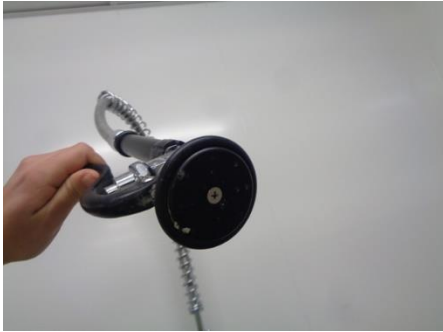
Photo Ref.	Location	Photo Ref.	Location
3.7	Typical shower throughout site	3.8	B-51-001 Kitchen

Risk Rating	Item 19 Recommended Action	Photo Ref.
High	<p>Showers / Combi Oven & Shower spray wash attachments - Aerosols of water are the means by which legionella bacteria are transmitted.</p> <p>It is recommended that all showerheads and spray wash attachments are de-scaled and disinfected every three months, as scale is a nutrient for bacterial growth. Those showers, which are not used on a weekly basis, should be flushed through with hot and cold water supplies for a minimum of 5 minutes at least twice weekly without the creation of an aerosol.</p> <p>Alternatively both the hot and cold water supplies could be permanently disconnected and pieced through at the main branch and actions recorded within the site log book.</p>	<p>3.7</p> <p>3.8</p>
Rectified By	Comments	Date
Name: Signature:

Rectified By	Recommendations	Rectified By	Recommendations
Name: Signature: Date:	Shower heads should be de-scaled & disinfected quarterly, flush twice weekly if not used	Name: Signature: Date:	Spray wash heads should be de-scaled & disinfected quarterly, flush twice weekly if not used

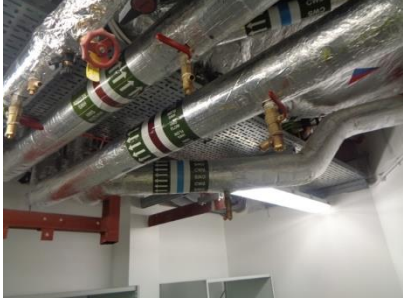
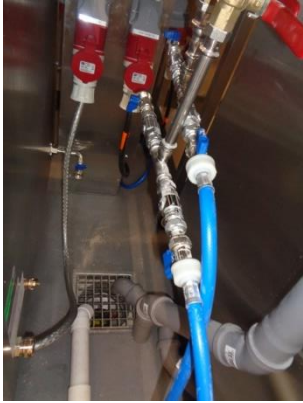
Photo Ref.	Location	Photo Ref.	Location
3.9	I2-006	3.10	B-51-001 Kitchen

Risk Rating	Item 20 Recommended Action	Photo Ref.
High	<p>Dead Legs/Dead Ends were seen in the following locations;</p> <ul style="list-style-type: none"> • I2-006 (Drain valve) 3.9 • B-51-001 (No appliances fitted yet) 3.10 • GF1-054 (Only one Washing Machine fitted) 3.11 • G-A1-101 (No appliance fitted) 3.12 • G-I1-006 (No appliance fitted) 3.13 • 3.C1.4-013 Dead Leg no appliance fitted yet 3.14 • 4 K2-068 dead Leg No appliance fitted yet 3.15 • G-Y-1-004 (bin wash connections) 3.16 • BS1-015 – waste station isolated 3.17 • IP1-016 Below sink 3.18 • Hot Water Return CAL01 & CAL02 3.19 • Drain points on expansion vessels 3.20 • Drain Too long acting as a dead leg on all CWS tanks • Supply Pipe to chillers on roof <p>All dead ends identified should be removed and all associated pipe cut back to its main source and isolated, to prevent stagnation within the water system. Dead ends / legs provide an environment for bacterial growth, due to the lack of water movement.</p> <p>Due to the period of time that the appliance outlets have not had equipment attached it is recommended that flushing points are created to allow the dead legs that are created to be placed on a twice weekly flushing regime.</p>	<p>3.9</p> <p>3.10</p> <p>3.11</p> <p>3.12</p> <p>3.13</p> <p>3.14</p> <p>3.15</p> <p>3.16</p> <p>3.17</p> <p>3.18</p> <p>3.19</p> <p>3.20</p>

Rectified By	Recommendations	Rectified By	Recommendations
Name: Signature: Date:	Remove identified dead ends	Name: Signature: Date:	Dead legs created where appliance outlets do not have appliances attached - flush twice weekly

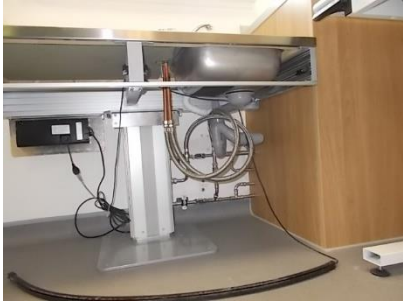
Photo Ref.	Location	Photo Ref.	Location
3.21	2-M2-009	3.22	Energy Centre

Risk Rating	Item 21 Recommended Action	Photo Ref.
High	<p>Flexible Link Hoses are fitted on the adjustable height sink in 2-M2-009. Evidence from scientific investigations have shown that some flexible hoses used to connect washbasin taps to plumbing systems were heavily infected with biofilm which included the Legionella bacteria. The rough inner surfaces and the pits provide ideal places for bacteria to attach and form biofilm and evade attempts at disinfection.</p> <p>Where flexi hoses must be used (e.g. on essential equipment such as hi – low sinks or where vibration occurs) they must be lined with a suitable alternative to EPDM, as well as being WRAS approved. Care should be taken to avoid kinking or distorting the pipes during installation.</p>	3.21
Rectified By		Comments
Name: Signature:		Date

Rectified By	Recommendations	Rectified By	Recommendations
Name: Signature: Date:	Ensure hoses used are not EPDM lined & are WRAS approved & do not allow pipe to become kinked	Name: Signature: Date:	A tight-fitting lid should be fitted to Pressurisation Tank. Further checks should be made to ensure a Biocide is being added to the unit

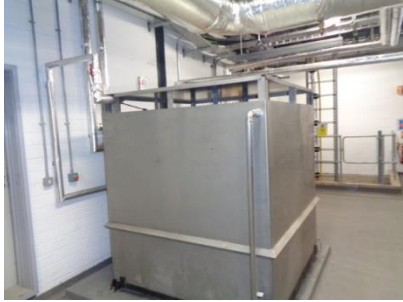
Risk Rating	Item 24 Recommended Action	Photo Ref.
High	The Pressurisation Unit Tank in the Energy Centre does not have a lid fitted, it is open around the top and has stagnant water in the tank. This runs the risk of creating aerosols from this water. The unit should have a tight-fitting lid fitted. At the time of survey, we were informed that a biocide was being added to the tank. However, the additive seen was a heating system inhibitor for scale & corrosion and did not appear to have a biocide added. Further investigation should be made to check if a biocide is added to the Unit.	3.22 3.23
Rectified By		Comments
Name:		Date
Signature:

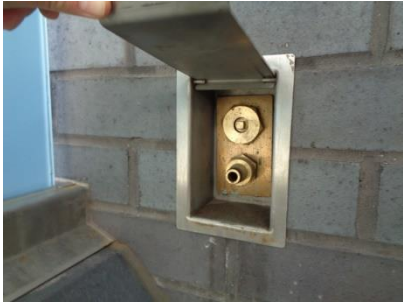
Photo Ref.	Location	Photo Ref.	Location
3.25	Typical outside tap (concealed)	3.26	Bin Wash Area

Risk Rating	Item 26 Recommended Action	Photo Ref.
High	If the hose union bib taps (HUBT) are considered to be infrequently used or unused, it is recommended that they are placed onto a weekly flushing regime and all information documented to prevent stagnation within the water system or remove the taps ensuring that all associated pipes are cut back to its original supply and isolated. Ensure that the HBUT's are fitted with backflow prevention. Also, it is recommended that the hose pipes are reeled back into their respective containers after each use and disconnected from the tap.	3.25
Rectified By		Comments
Name:		Date
Signature:

Rectified By	Recommendations	Rectified By	Recommendations
Name: Signature: Date:	Flush tap outlets weekly, ensure backflow prevention is in place & they are in log book to ensure they are on the twice weekly flushing regime	Name: Signature: Date:	Dismantle spray hose & clean quarterly, flush weekly if not used. Train staff on avoiding aerosols Take water samples.

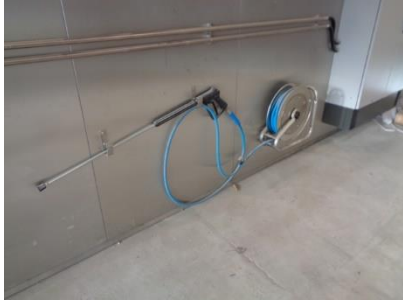
Risk Rating	Item 27 Recommended Action	Photo Ref.						
High	<p>It is recommended that the Bin wash equipment is monitored monthly. Check supply water temperatures and maintain below 20°C if possible. Check equipment is in a good clean condition, free from nutrients for bacterial growth e.g. oil, soil, grit etc.</p> <p>All actions should be recorded in the site log book including training staff on correct usage, to avoid exposure to aerosols if possible.</p> <p>It is recommended Legionella samples be taken quarterly, especially in summer months. The spray attachment should be cleaned and descaled quarterly. Ensure the correct back flow prevention device is fitted, as close as possible to the mains source. (CAT 4 double check valve)</p>	3.26						
	<table border="1" style="width: 100%;"> <thead> <tr> <th style="width: 30%;">Rectified By</th> <th style="width: 60%;">Comments</th> <th style="width: 10%;">Date</th> </tr> </thead> <tbody> <tr> <td>Name: Signature:</td> <td></td> <td></td> </tr> </tbody> </table>	Rectified By	Comments	Date	Name: Signature:			
Rectified By	Comments	Date						
Name: Signature:

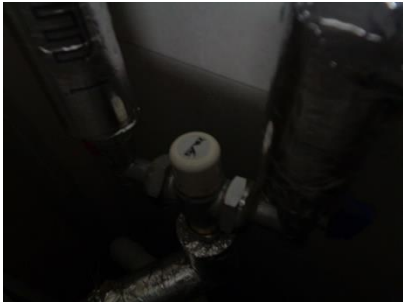
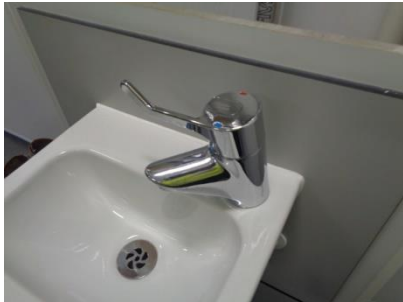
Photo Ref.	Location	Photo Ref.	Location
3.27	Typical TMV fitted throughout site	3.28	Typical TMV tap fitted throughout site

Risk Rating	Item 29 Recommended Action	Photo Ref.
High	<p>Thermostatic Mixing Valves (TMV's) and TMV taps produce water at a temperature that safeguards against the risk of scalding. The temperature range that these are set at, means that the downstream blended water may provide an environment where legionella & other bacterial growth can multiply. Therefore, they should be as close as possible to the outlet and the outlet used frequently.</p> <p>Where TMV's are employed to control hot water to outlets temperatures in order to prevent scalding, they should be set to give the following maximum temperatures.</p> <ul style="list-style-type: none"> • Wash hand basins /showers /sinks 41°C • Baths (None assisted) 44°C • Baths assisted 46°C <p>As part of statutory compliance all TMVs & TMV taps should be serviced regularly- minimum annually. All TMV's employed need to be temperature checked, condition inspected, including fail safe check.</p> <p>Also, inspect, clean, descale and disinfect any strainers or filters associated with TMVs.</p>	3.27 3.28

Rectified By	Recommendations	Rectified By	Recommendations
Name: Signature: Date:	TMVs should be condition & temperature checked regularly	Name: Signature: Date:	TMV taps should be condition & temperature checked regularly

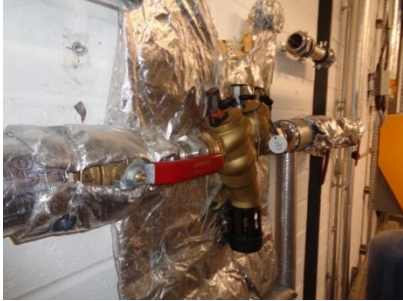
Photo Ref.	Location	Photo Ref.	Location
3.29	Energy Centre	3.30	Typical Dental Chair

Risk Rating	Item 30 Recommended Action	Photo Ref.
High	<p>RPZ valves. You will be required to give prior notification to your local Water Supplier if you are intending to install this type of device. There are a number of installation requirements that must be complied with, therefore you are advised to have the valve fitted and commissioned by a reputable company. The valve will require testing annually or more frequently if determined either by the local Water Supplier or the manufacturers of the device. Testing must be carried out by an Approved Tester, who on completion, must furnish the customer and the local Water Supplier with a current test report and certificate verifying that the valve is working correctly</p>	3.29
Rectified By	Comments	Date
Name: Signature:

Rectified By	Recommendations	Rectified By	Recommendations
Name: Signature: Date:	RPZ should be serviced annually by an approved tester	Name: Signature: Date:	Flush equipment at start & end of each day & between patients

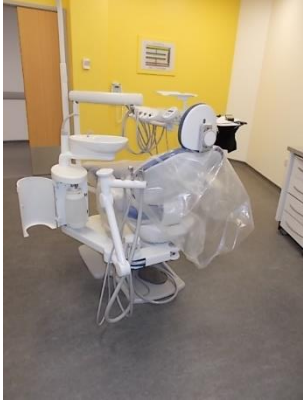
Risk Rating	Item 31 Recommended Action	Photo Ref.
High	<p>Dentistry Areas -Flush all system components and pipe work, twice daily for 2 to 4 minutes at the start and finish of each working day also, flush for at least 30 seconds between patients.</p> <p>Clean storage bottles daily and rinse with distilled or Reverse Osmosis (RO) water, drain, and leave inverted overnight. If mains water is used to fill bottles, then a disinfection agent e.g. Alpron or A-dec ICX should be used.</p> <p>Spittoons and aspirating units need to be washed through at the end of a session according to manufacturers' instructions.</p> <p>All sinks need to be labelled in surgeries, they should be labelled dirty or clean sink.</p> <p>Dental equipment requiring protection against backflow such as dental spittoons, three-in-one syringes, wet-line suction apparatus, and self-filling automatic radiographic processors should have anti-retraction valves incorporated on all handpieces, ultrasonic descalers and/or water lines.</p> <p>Responsible persons should ensure these are fitted where required. They must be regularly monitored and maintained.</p>	3.30

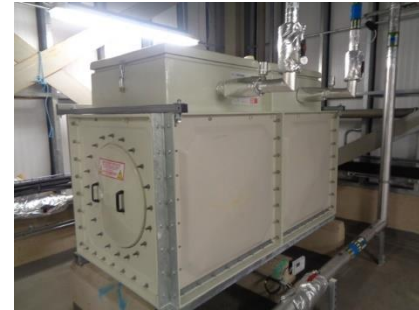
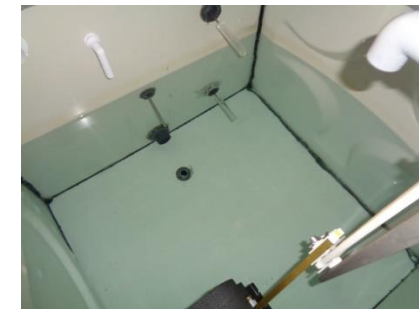
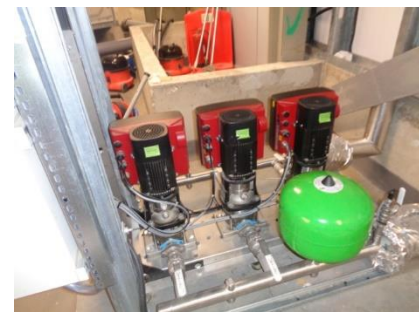
Cold water Storage Survey Section						
Check	Result		Further action?		External Image	
Safe working access?	Yes					
Asset Reference Number	CWST07 Cat 5					
Barcode/Tag number						
Location	Roof Plant Room					
Dimensions (L x W x H) (mm)	1000 x 1000 x 1000					
Volume (Litres)	1,000Litres					
Inlet Size (mm)	No Access insulation					
Outlet Size (mm)	No Access insulation					
Drain Size (mm)	No Access insulation					
Accessed via	Plant room					
Systems Supplied (inc CAL's)	Cat 5 supply					
Supplied By	CWST05 & CWST06					
Boosted Cold Water Supply from tank?	Yes					
Early warning pipe installed? (over 1000L only)	Yes					
Size of warning pipe (mm)	~					
Warning pipe screened?	~					
Size of overflow (mm)	~					
Overflow screened?	Glass traps					
BCWS Auto or Manually operated?	Auto					
Water Supply Temperature (°C)	~					
Water Storage Temperature(°C)	10.3					
Ambient Temperature (°C)	17.5					
Adequate Turnover Occurring?	Not at the time of this survey

Suitable Lighting	Yes					
Tight fitting Lid?	Yes					
Screened Lid Vent?	Yes					
Suitable Insulation to CWST?	Yes					
Suitable Insulation to Pipe Work?	Yes					
Vent terminating within CWST?	No					
Internal condition?	Clean					
Does it need cleaning?	No					
Tank material construction	GRP					
Lid material construction	GRP					
Is the cistern linked to approved standards?	Yes					
Inlet/outlet on opposite side?	Yes					
Drop Test Required?	No					
Ball cock present & operational?	Yes					
Is there conspicuous discharge from overflow or warning pipe?	No					
Clearance above cistern adequate?	Yes					
Any signs of corrosion?	No					
Length of ladder required for access	2m					
Risk Parameter (from score card)					Risk Rating	
1	2	3	4	5	6	Total
30	15	10	15	30	30	130
High
