## THE ROYAL HOSPITAL FOR CHILDREN AND YOUNG PEOPLE, EDINBURGH

### Key Issues Report No. 42 September 2018

<b>Site:</b>	Royal Hospital for Sick Children and Department of Clinical Neurosciences and Child and Adolescent Mental Health Services – Little France	
<b>Report:</b>	Independent Tester Key Issue Report No 42	
<b>Date:</b>	04/10/18	
<b>Present:</b>	<div style="background-color: black; width: 100px; height: 15px; margin-bottom: 5px;"></div> <div style="background-color: black; width: 100px; height: 15px; margin-bottom: 5px;"></div> <div style="background-color: black; width: 100px; height: 15px;"></div>	<b>Arcadis</b>  <b>Arcadis</b>  <b>Arcadis</b>

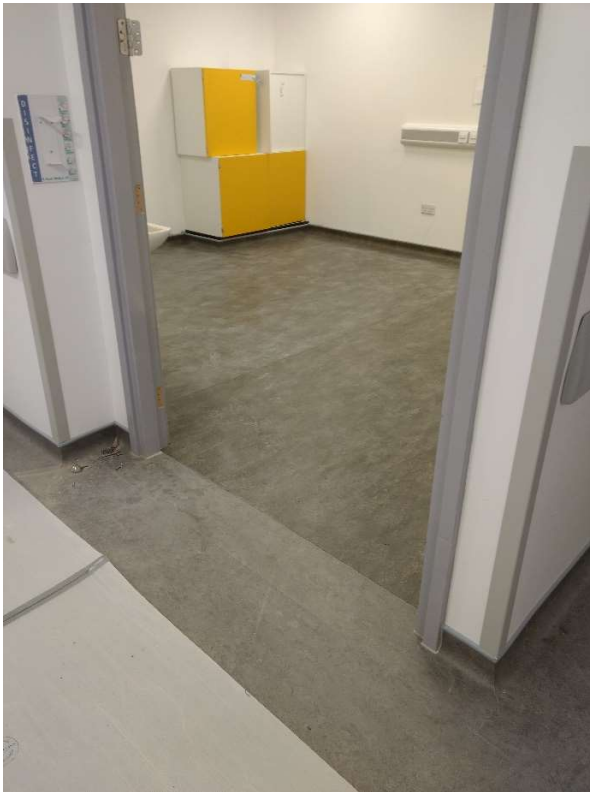
1.2.7	<p><b>Vinyl flooring</b></p> <ul style="list-style-type: none"> <li>▪ The IT noted during the initial review that the quality of the vinyl floor finishes in the PICU areas are particularly poor, with significant bubbling, uneven finishes, dirt particles below the vinyl, and generally poor weld finishes. The IT will review further as part of the final fabric review process.</li> <li>▪ As a result of the flooding circa 10,000m<sup>2</sup> of Marmolum will require complete replacement, and subsequent reinspection. A number of observations on general standard of workmanship have been raised in regard of the consistency of the Marmoleum fitting.</li> <li>▪ The IT has noted significant variations in the colour match of the vinyl flooring as demonstrated by photograph 01, MPX to advise on batch variations from their supplier.</li> </ul>	Multiplex

1 – Very noticeable batch variations between rooms – Dental room

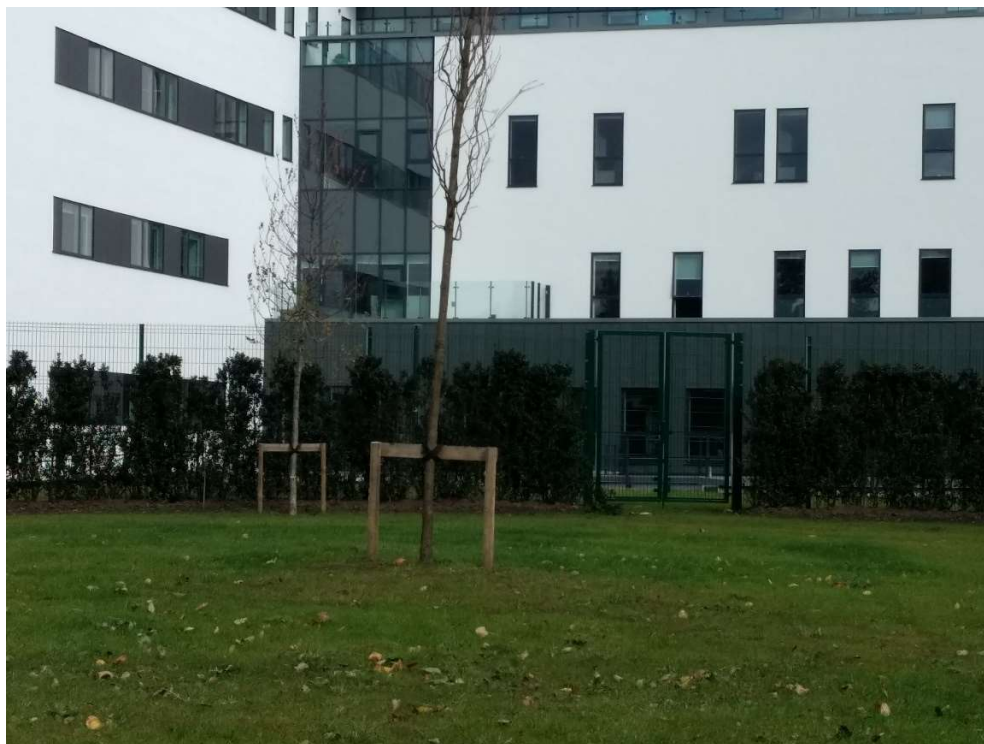
<p><b>1.2.16</b></p>	<p><b>External Works</b></p> <ul style="list-style-type: none"> <li>▪ External works are complete to all areas around the building.</li> <li>▪ The IT inspected the hard landscaping finishes to the area in front of the RIE link in the reporting period. A number of staining and contamination issues were noted, along with finishes and positioning of the motor cycle parking racks.</li> <li>▪ Cycle path works at the energy center are also complete along with the area between the Blue zone and the Anne Rowling Building.</li> <li>▪ The IT has noted that all soft landscaped areas have suffered some neglect in the absence of a ground works subcontractor following Crummock going into liquidation. The IT has been advised that MPX have engaged a replacement sub-contractor who have commenced on site.</li> <li>▪ The IT has been made aware that there is a requirement for an additional high fence to prevent access to the drop level areas of the CAHMS courtyards from ground level by the cycle path area.</li> <li>▪ In the reporting period the high mesh fence has been installed, and the mature hedging installed. However, the IT notes that the positioning of the full height gate allow unrestricted views to the 1<sup>st</sup> floor PICU windows.</li> </ul>	<p>Multiplex</p>

2 – Fence / hedge gate position allowing clear view to PICU

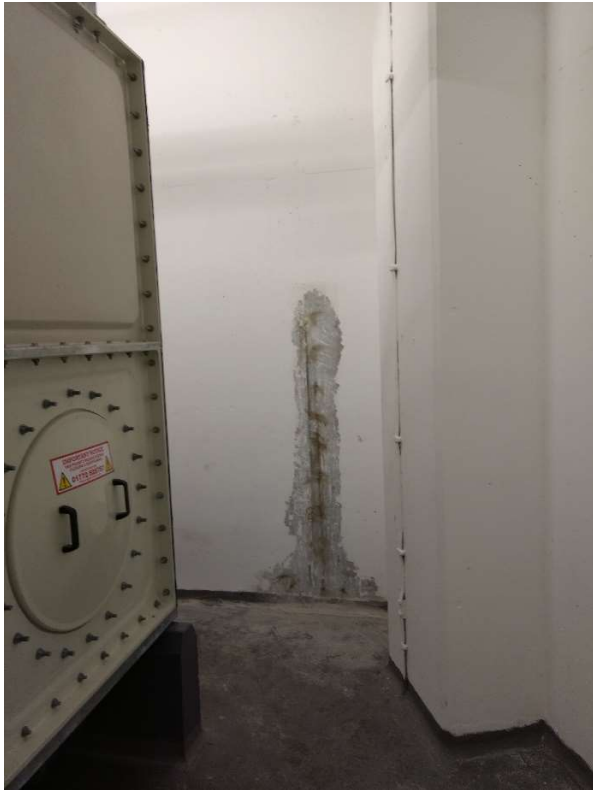
3 – Evidence of damp proofing requiring QA

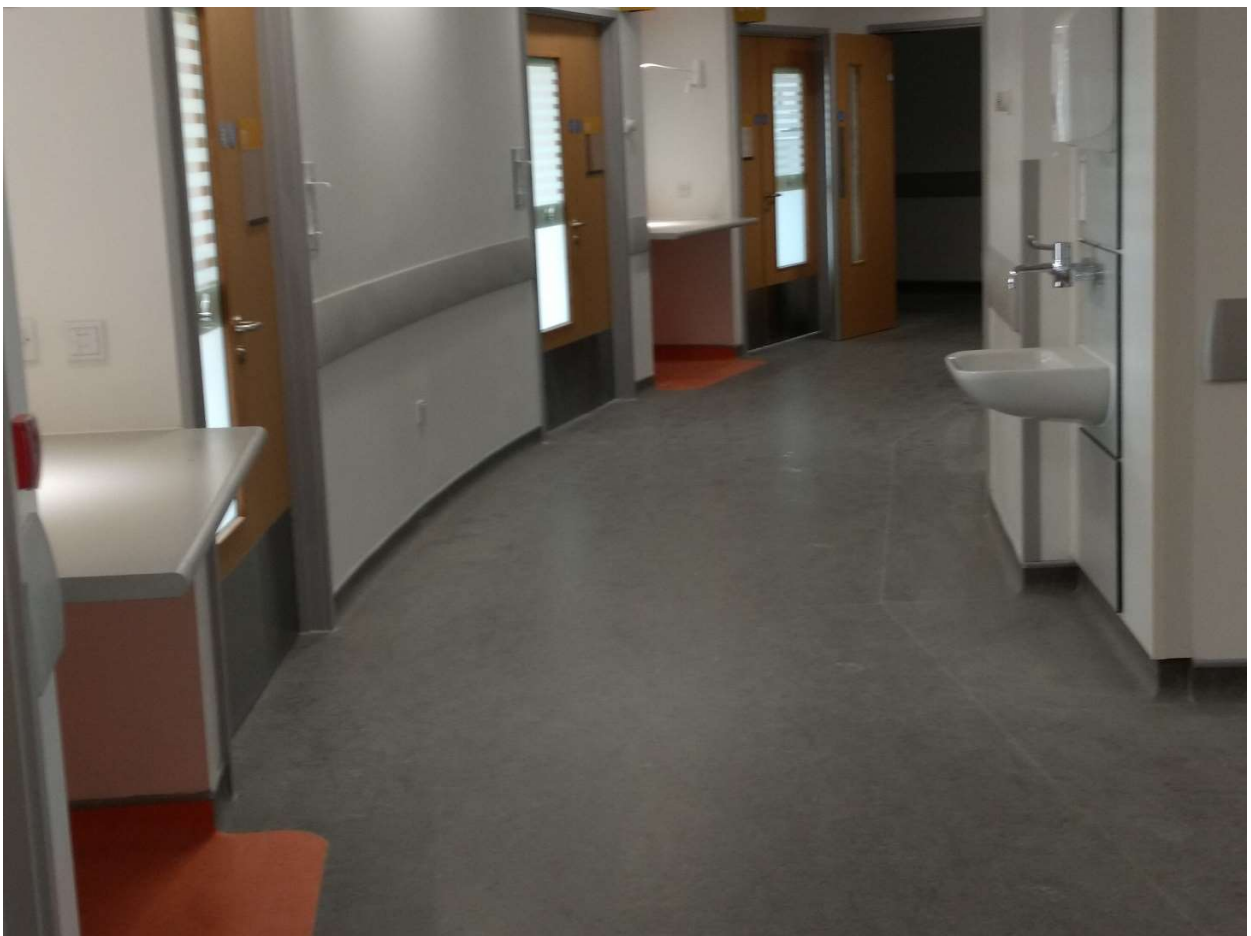
3 - Obstructions in corridors as CIT 229 and Zutec 19973

228			03/09/2018		<b>Lighting levels to Sample Processing room - 1-H2-016</b> Confirm lighting levels to all areas as compliant.	0	MULTIPLEX
229	19973		11/09/2018		<b>Corridor Obstructions</b> Two touch down bases on apex of curved corridor project 200 into circulation space. WHB on opposite side projects 300 in same area. Increased possibility of fixtures being damaged. This is contrary to BCR Clause 5.21 which states: "Project Co shall endeavour to minimise the extent of impact damage incurred by ensuring corridors are free of awkward corners / obstructions."	0	MULTIPLEX
230		KIR 42	05/10/2018		<b>Video access lighting levels</b> Following the demonstration of the video access system on 03/05/18 a number of areas were found to have insufficient lighting levels for the system to provide a suitable quality of image. MPX were to make alterations to add additional directional lighting to the areas in question and re-demonstrate. 27/09/18 - The video access was represented for demonstration - it was recorded that there was no improvement.	0	MULTIPLEX

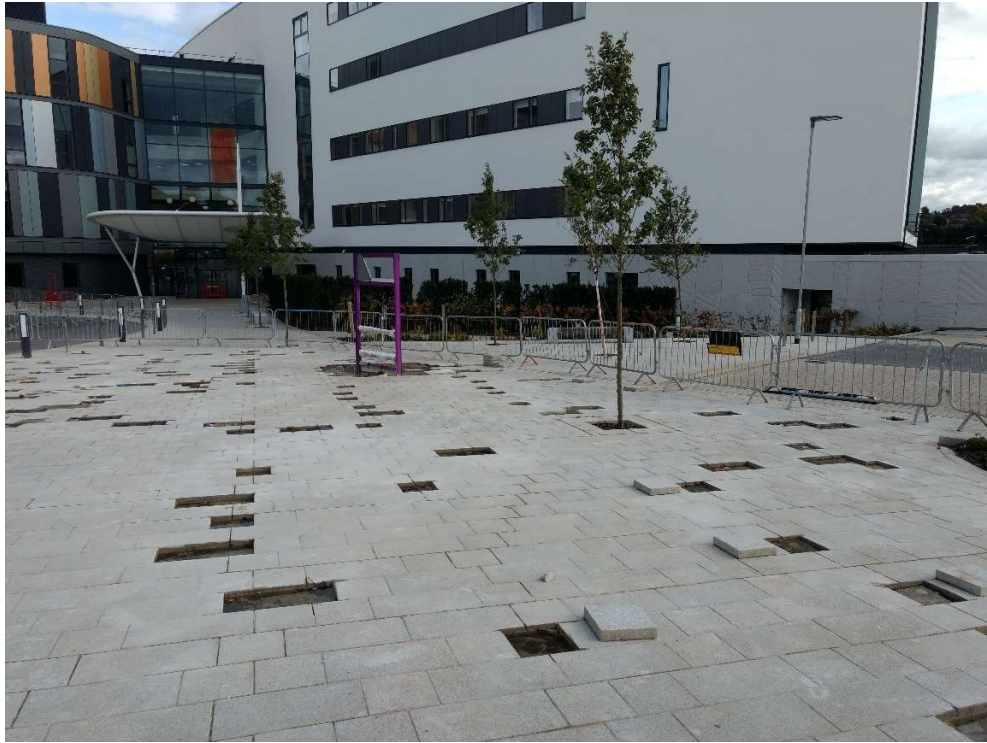
1.2.3	<p><b>General External Works</b></p> <ul style="list-style-type: none"> <li>▪ Final drainage, final attenuation, slabbing, kerbing, and hard landscaping finishes are fundamentally complete.</li> <li>▪ During heavy rain, a drainage issue was noted on the section of paving running parallel to the Anne Rowling building, where the run is to the planted bed, and not out to the permeable monoblocks in the taxi stand. (CIT 196) – (Further observation Tuesday 3<sup>rd</sup> April).</li> <li>▪ <b>19/09/18 The IT noted further areas of ponding following heavy rain to both sides of the main entrance. The water source was run off from the entrance canopy.</b></li> <li>▪ The IT has been made aware of a potential technicality issue regarding the Waterproofing and Gas Proofing Performance specifications, where comments on the specification (RBG-SZ-XX-SP-260-005_D) have not been fully addressed. The IT awaits confirmation that these comments are being addressed.</li> <li>▪ The IT noted that there are significant numbers of broken / cracked paving slabs in the main entrance area.</li> </ul>	Multiplex

4 – Extent of replacement slabs to main entrance

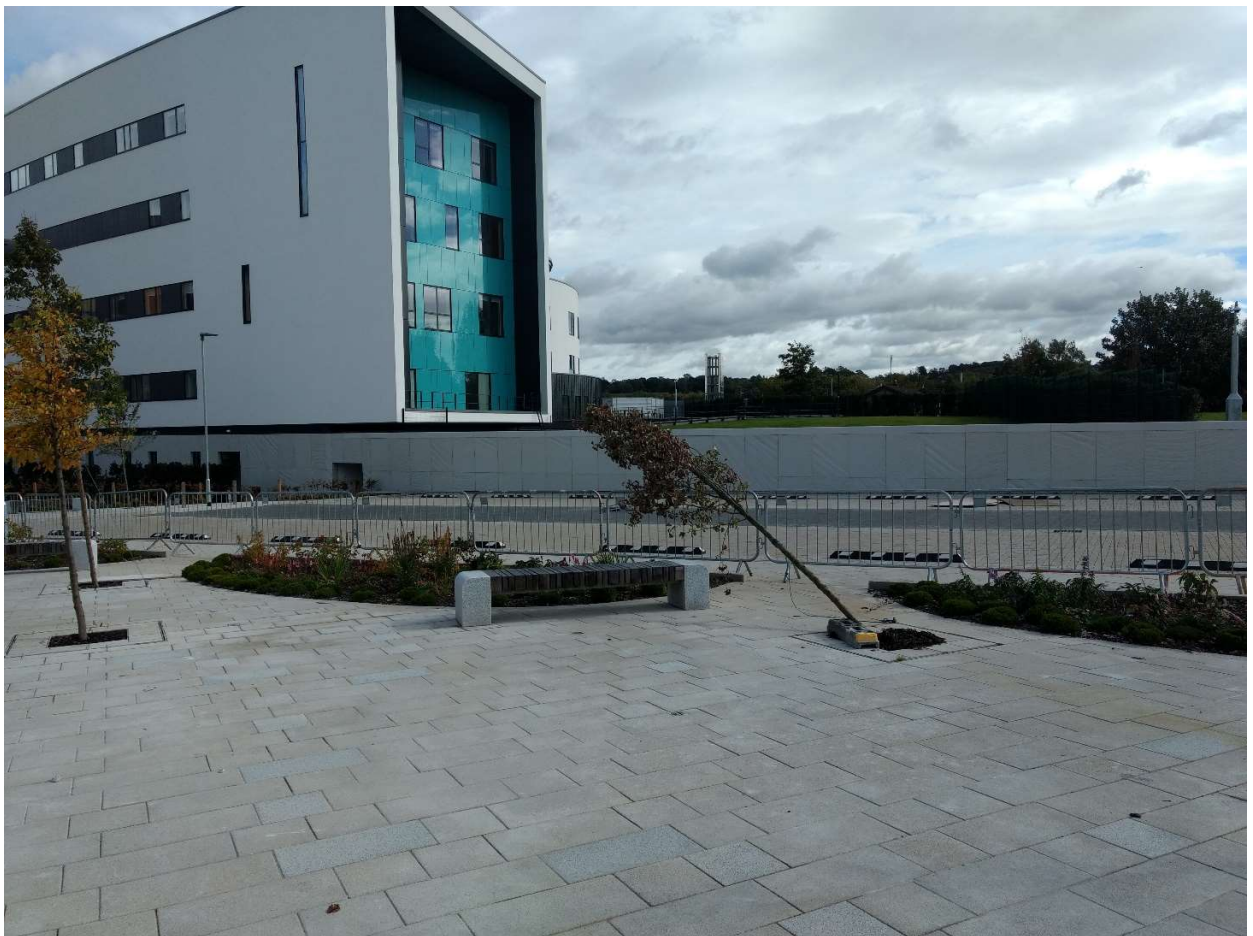
6 – Numerous trees have sustained wind damage

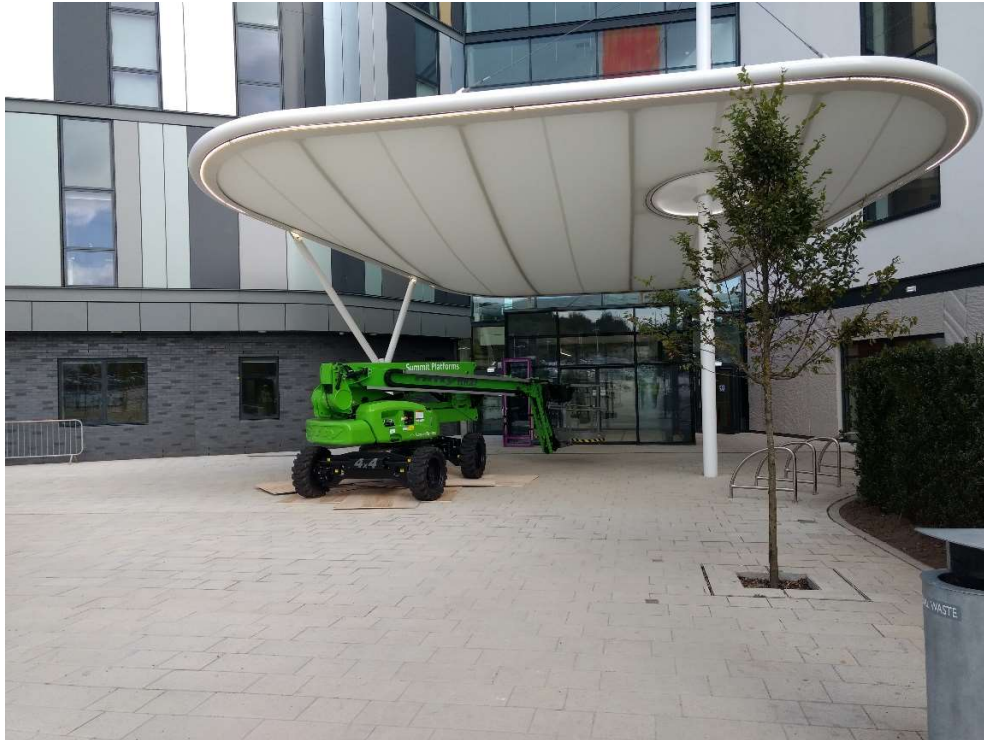
7 – Heavy machinery operating on paved areas without adequate weight spreaders

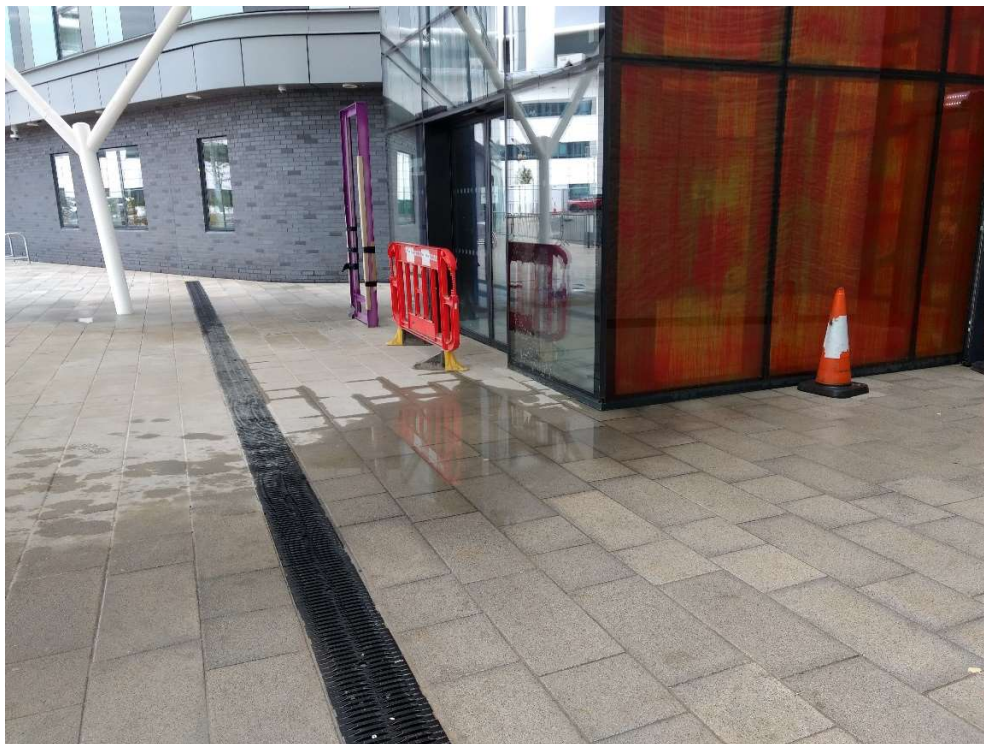
8 – Areas of ponding either side of main entrance – CIT196
