**Bundle of documents for Oral hearings
commencing from 13 May 2025 in relation
to the Queen Elizabeth University Hospital
and the Royal Hospital for Children,
Glasgow**

**Bundle 33
NEC3 Supervisor's Reports and Project
Supervisors Interface Action Notes**

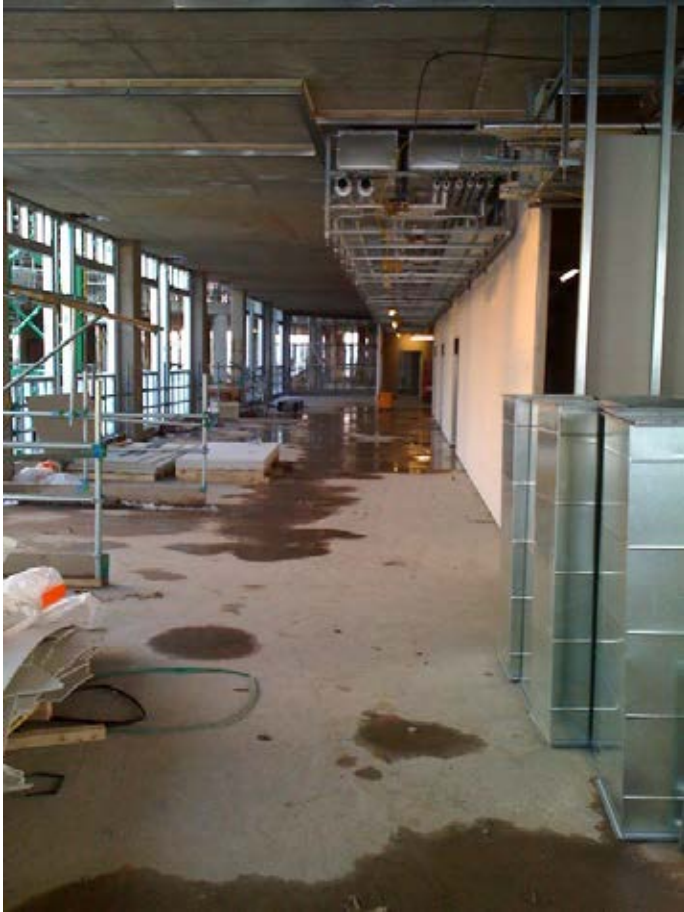
Brookfield has informed us that the boarding to the partition which has been exposed to water on Level 2 at the doors leading into the Genetic Freezer Store and the Block Slide Store will be replaced. Consequently we have requested confirmation when this will be completed for inspection. (See Supervisor's Communication General Matters / Other Instructions (CI 13.1) No 5)

5. Water stain to partition boarding 14th December 2010.

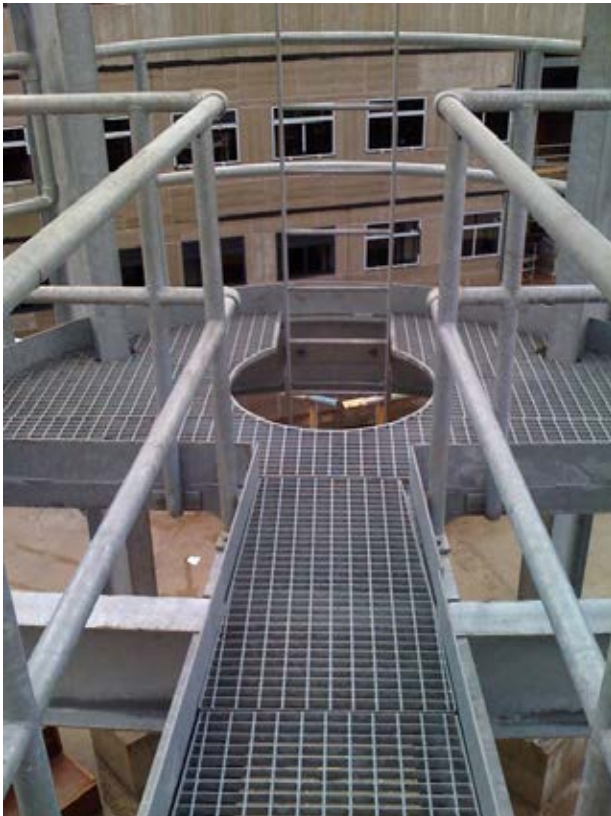
6. Damaged steel work 28th February 2011.

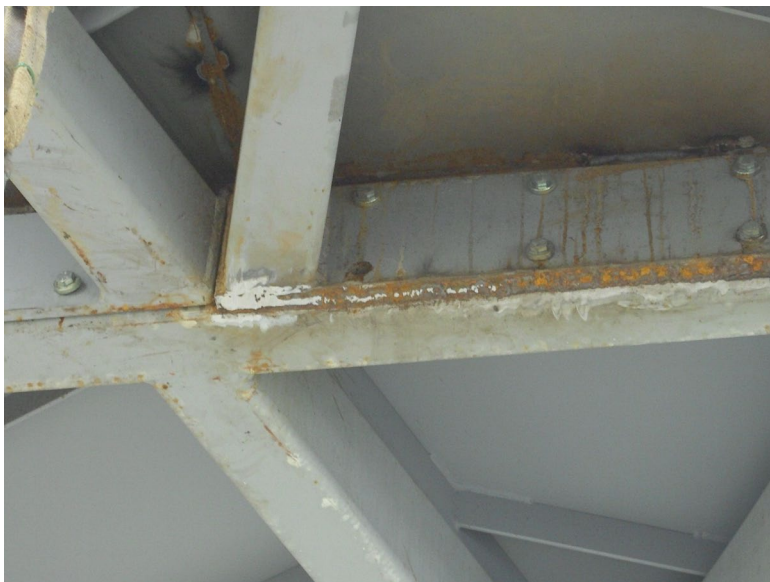
2. Rust on steel plate.

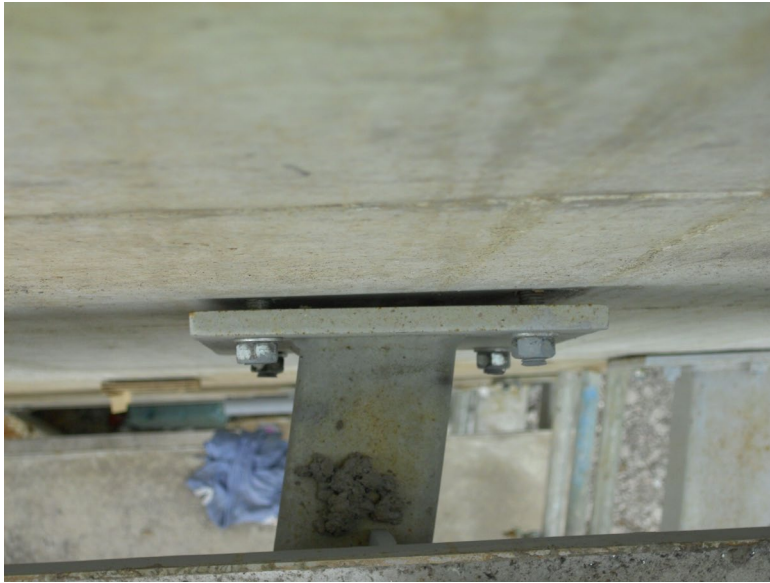
3. Missing bolt at Pod stair.

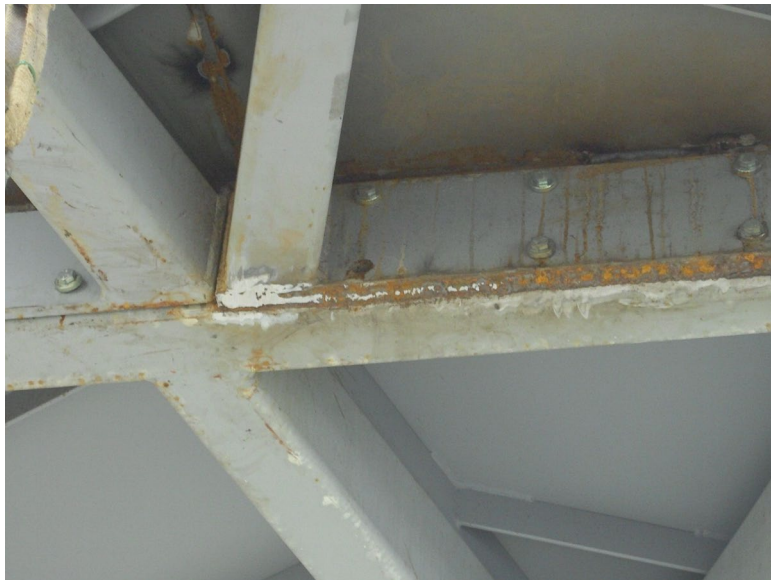
2. Rust on steel plate April 2011.

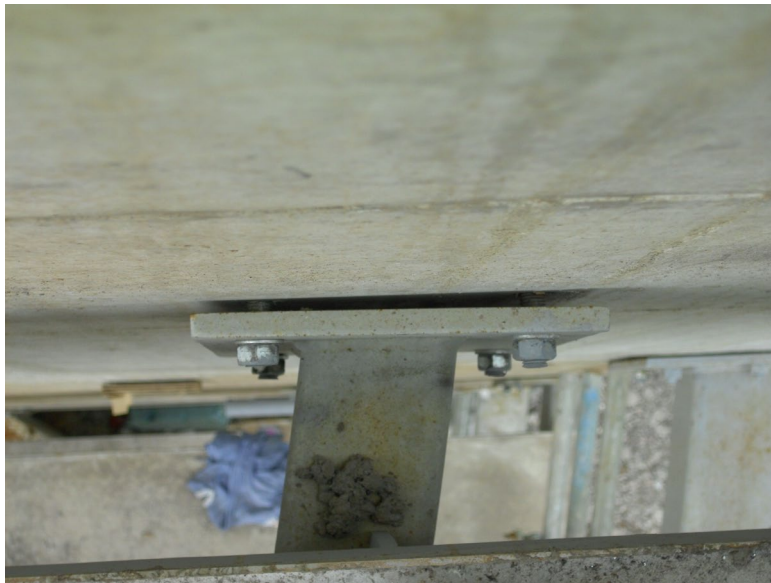
3. Missing bolt at Pod stair April 2011.

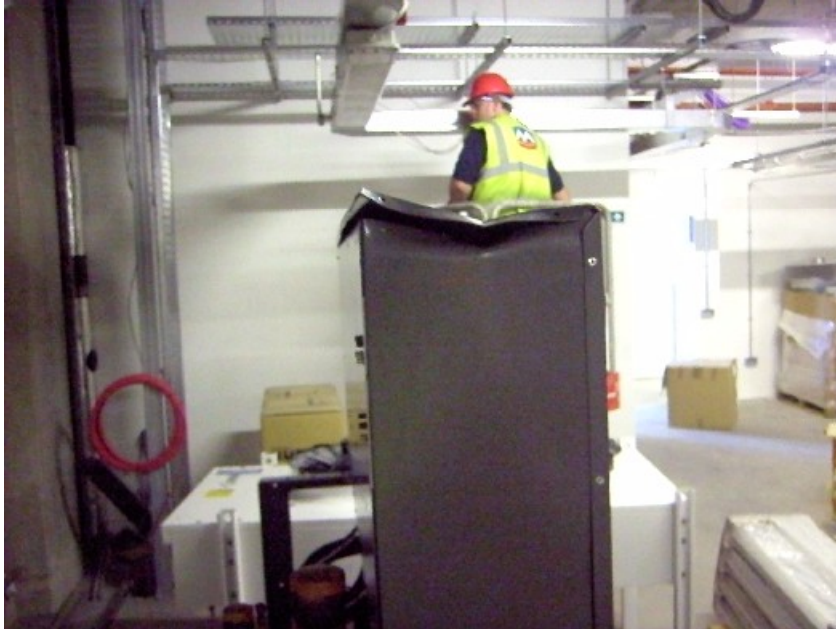
1. Damaged casing to the Scroll Compressor Pack

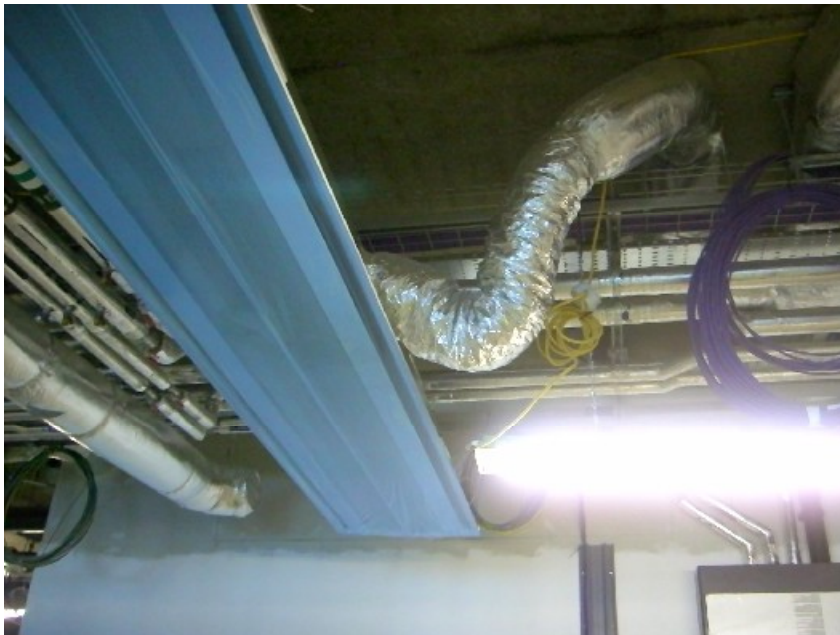
2. Ducting too long.

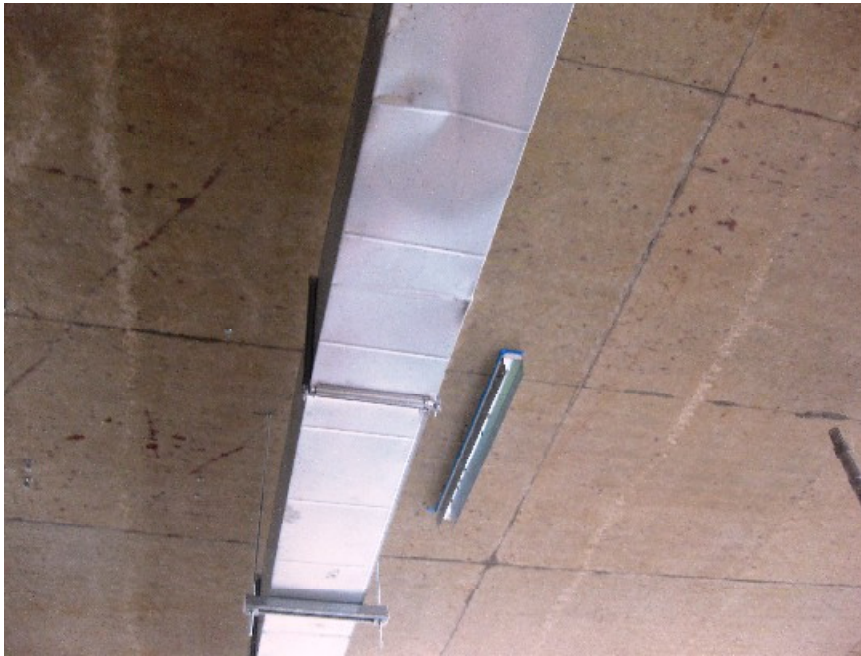
Photo No 1. Damaged trunking on Level 1.

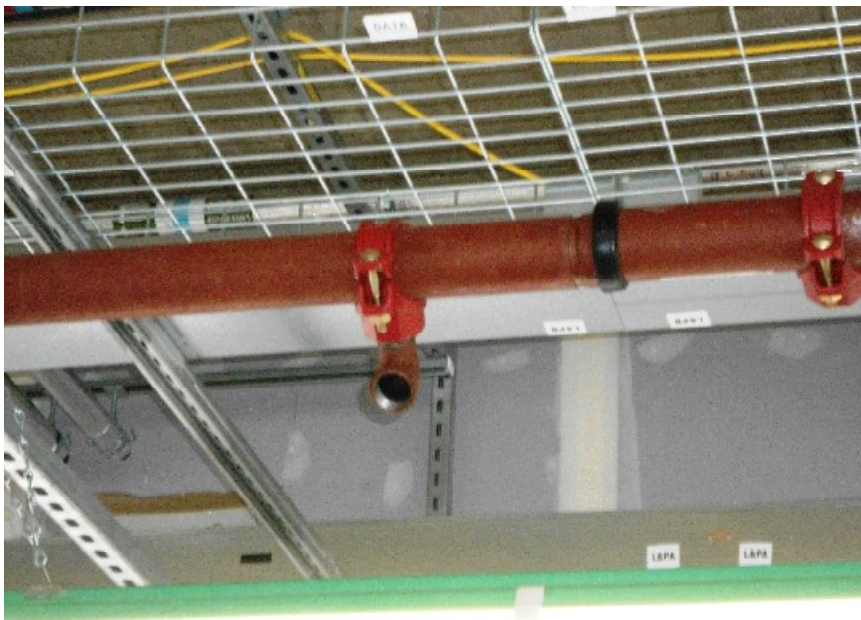
Photo No 2. Open ends of pipework

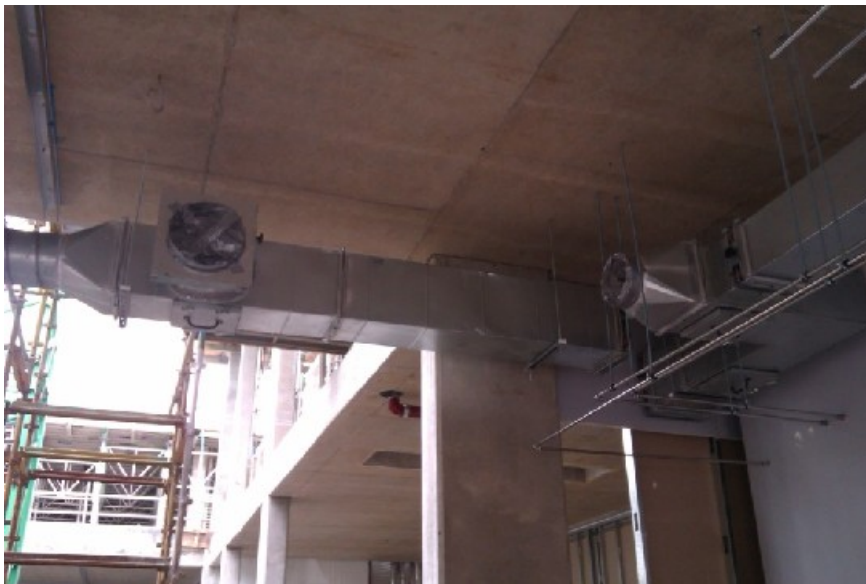
Photo No 4. Lightly damaged ductwork

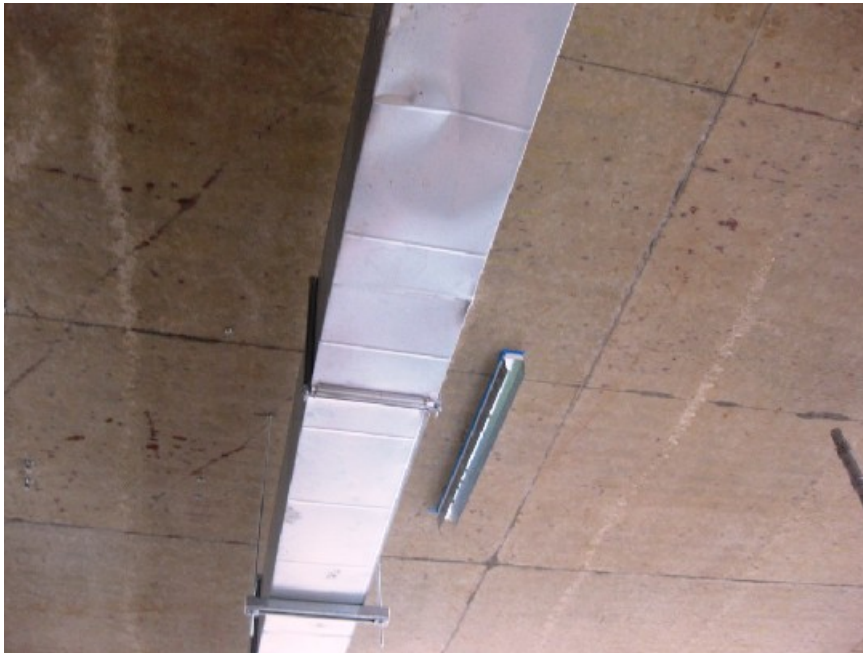
Photo No 1. Damaged trunking on Level 1.

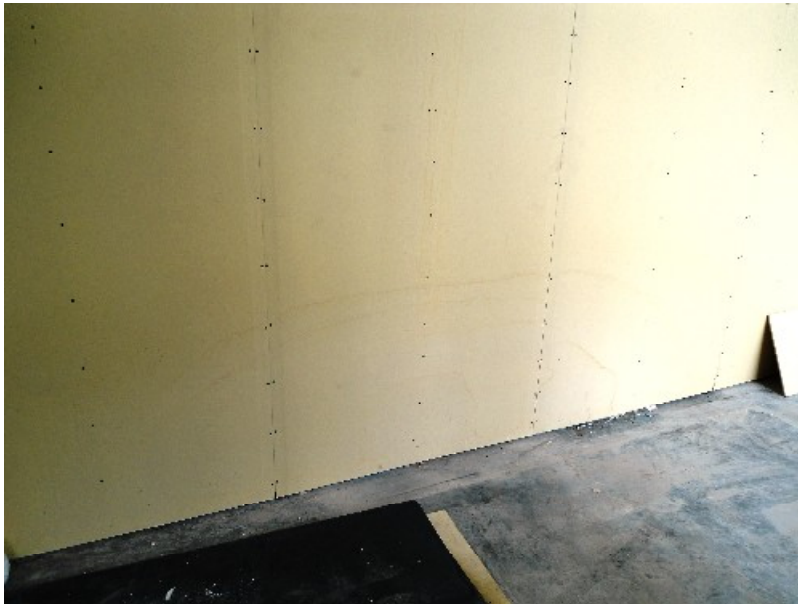
Photo 3 – Water stained boards Core E Stair Lobby Level 2

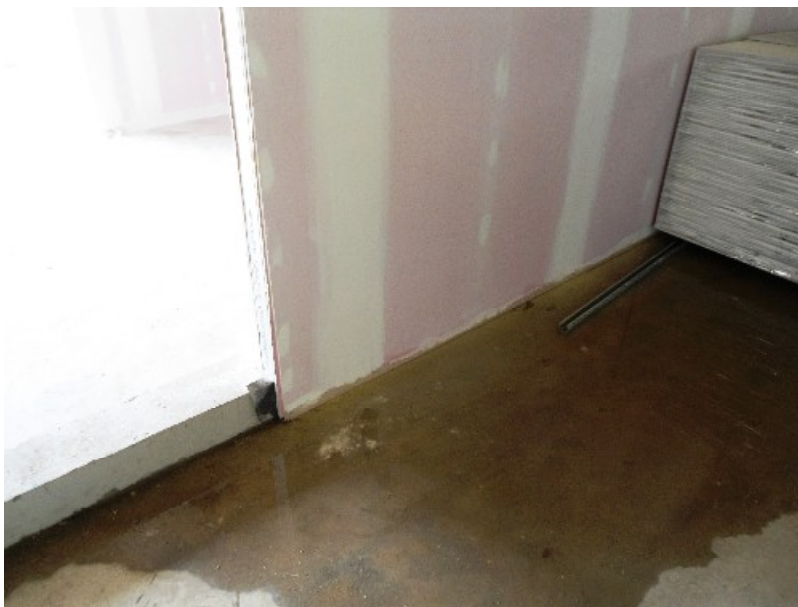
Photo 4 – Water Stained boards Plantroom 21 Level 2

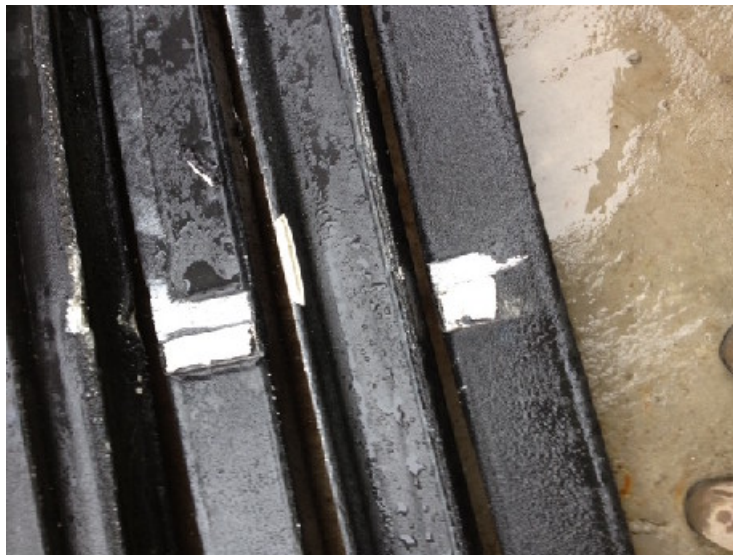
Photo 2 – Damaged intumescent cover.

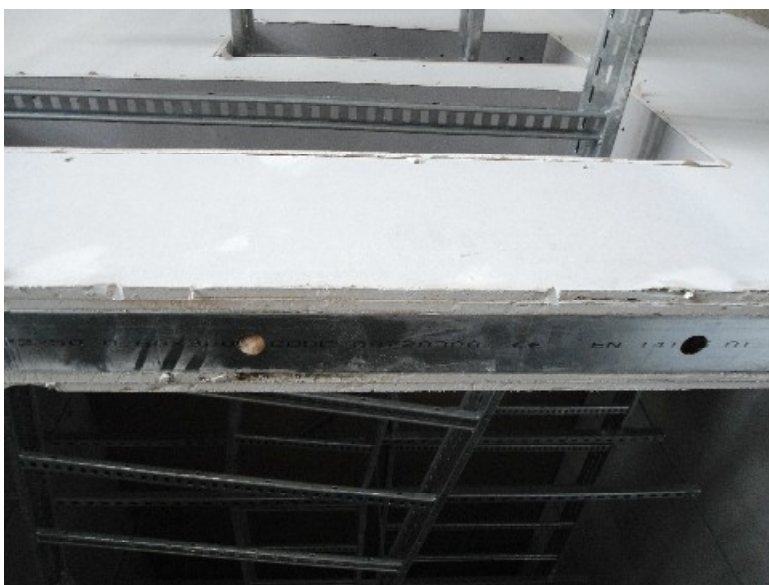
Photo 6 – Timber infill missing from lintel.

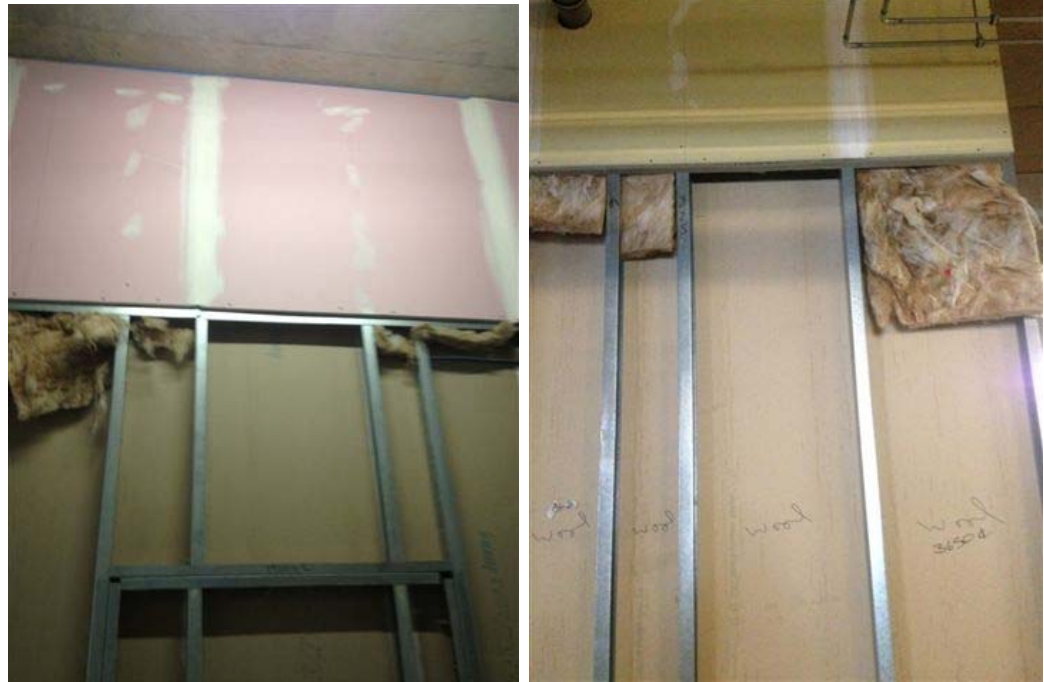
We noted that there was insulation missing from the upper sections of partitions in riser opposite Core B drawing area 528 and area 527. Brookfield is aware of these and will ensure that these are addressed prior to second boarding. See photos below.

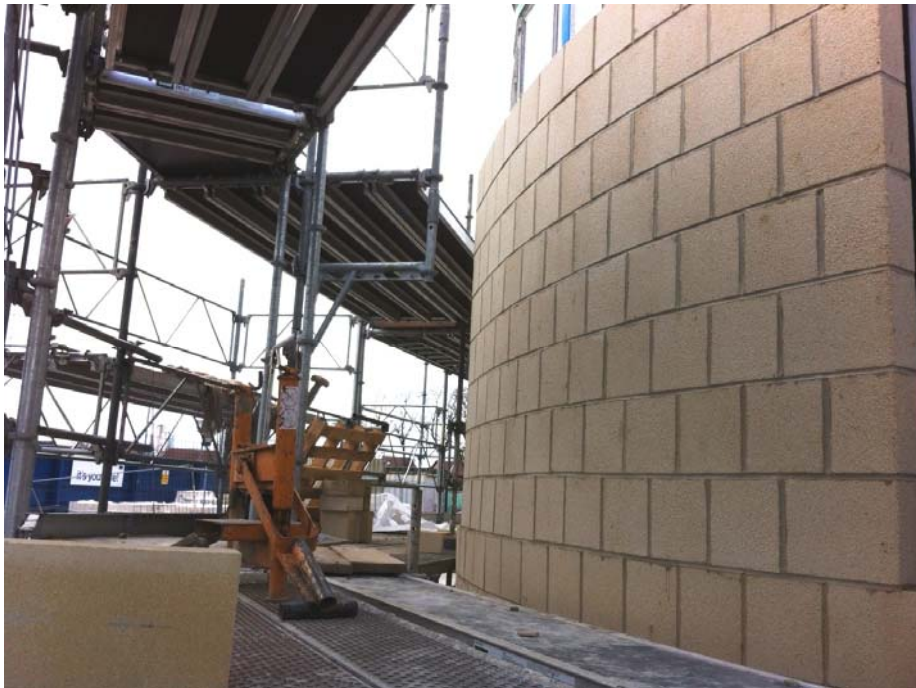
Poor quality blockwork with irregular beds and poor pointing

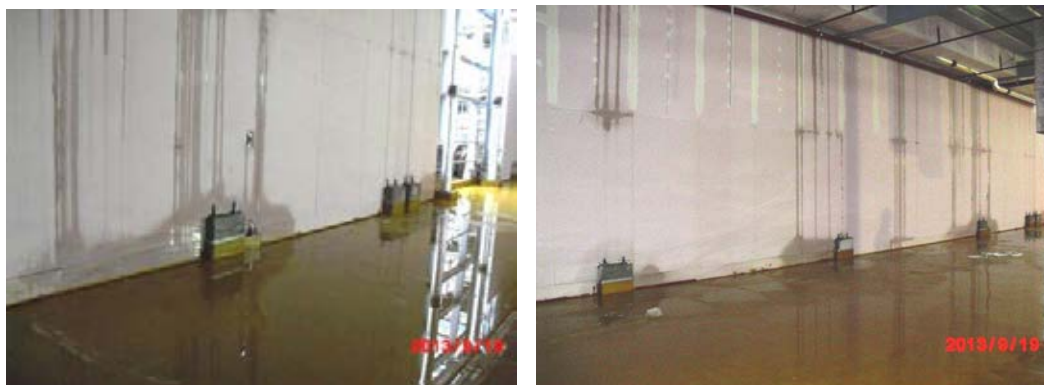
The partition between the east side of the atrium and plant room 41 has been damaged by water ingress. Brookfield to confirm they are aware there has been some damage, and will replace the boards after they have completed the resin flooring works. (See Supervisor's Communication General Matters / Other Instructions (CI 13.1) No 166).

Water damaged boards.

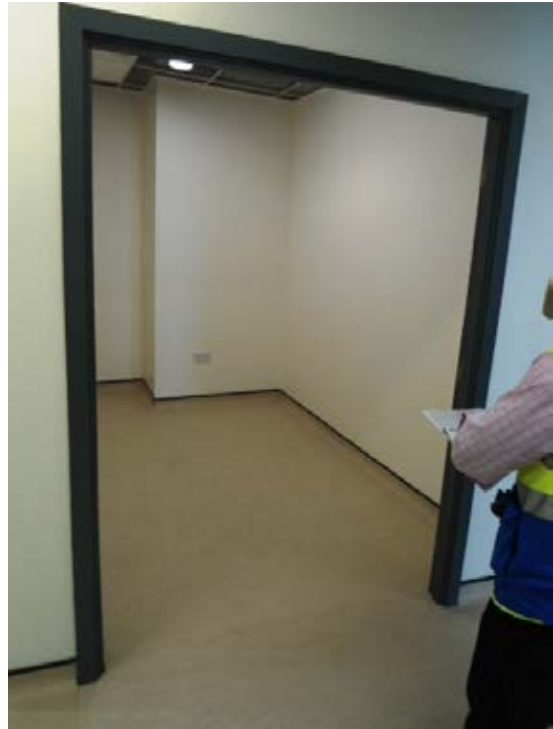
Vinyl becoming detached from the wall.

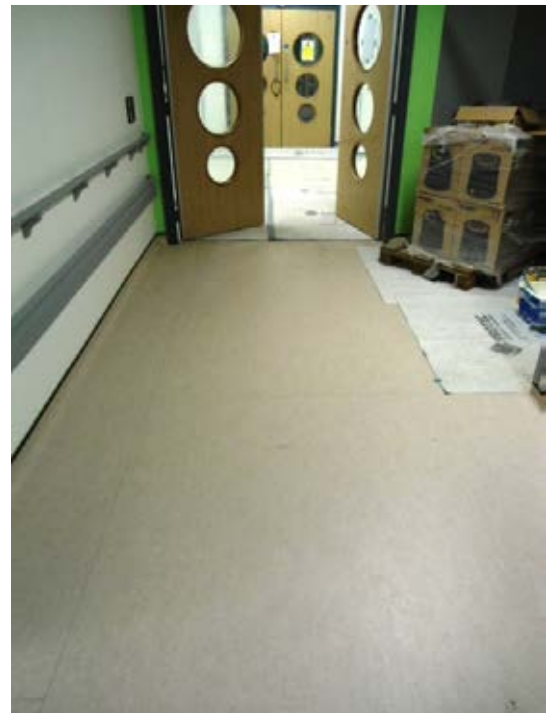
Shading on newly fitted vinyl.

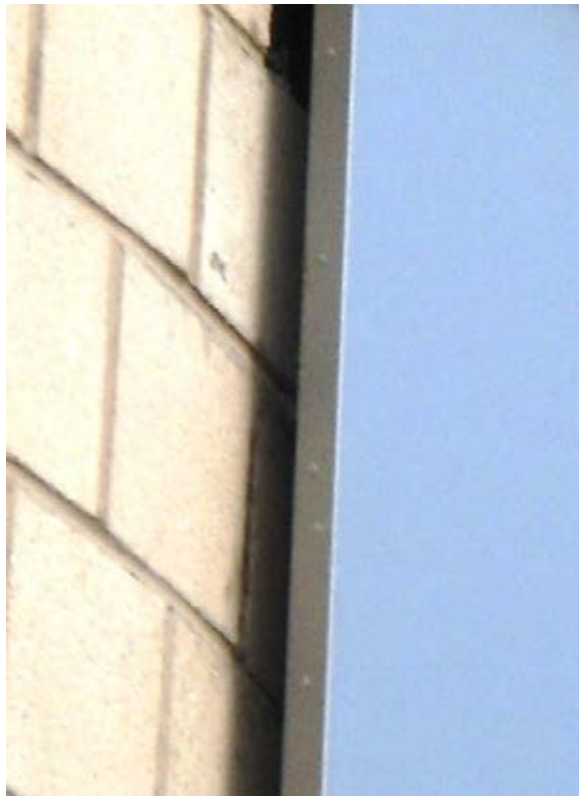
Gap between cladding and blockwork interface.
