SCOTTISH HOSPITALS INQUIRY

Bundle of documents for Oral hearings commencing from 19 August 2024 in relation to the Queen Elizabeth University Hospital and the Royal Hospital for Children, Glasgow

Bundle 15 - Water PPP

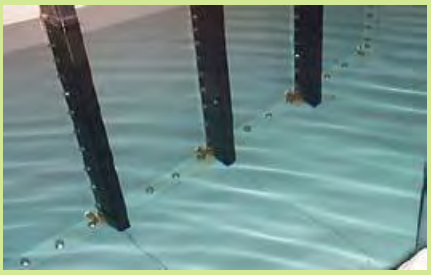
Light debris but corrosion to restraining bars

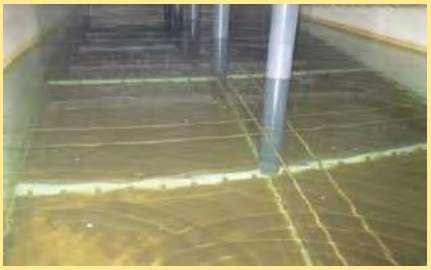
Moderate fouling suggesting cleaning should be conducted during the next 12 months

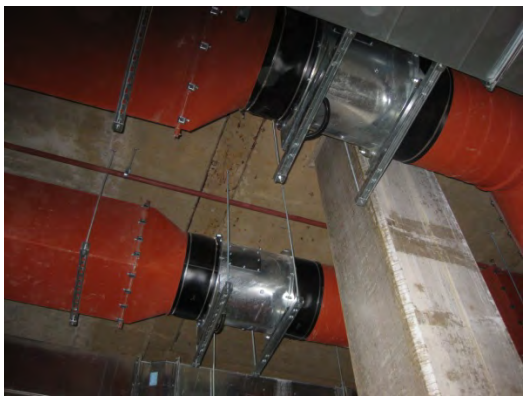
We noted that the air handling unit 21AHU16 supply duct transition does not appear to comply with HVAC DW144 clause 11.6 & 11.7 which could result in high pressure loss.

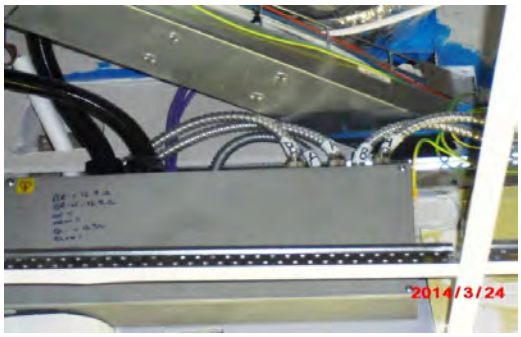
Room GENW 006 Cable plugged into Wago power outlet.

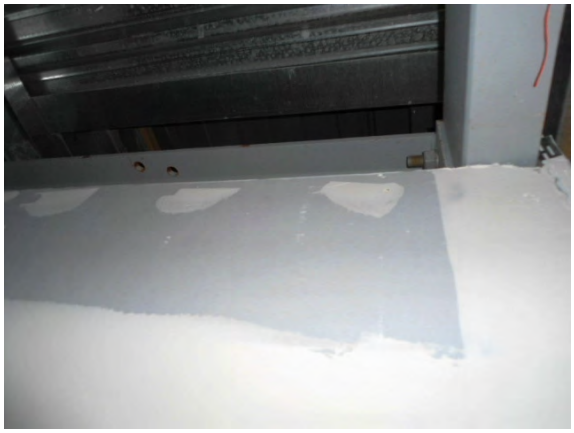
There is a gap between the underside of the roof and the top of the partitions and the steelwork has not been painted with intumescent paint. Brookfield has confirmed that the gap at roof level has been sealed. Consequently Supervisor's Communication General Matters / Other Instructions (CI 13.1) No 229 is closed out.

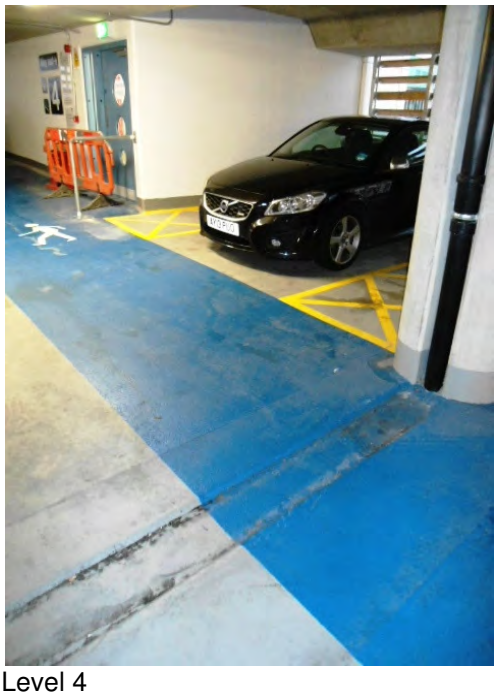
The car park floors on levels 1, 2, 3, 4, and 5 adjacent to the stair on the east elevation have recessed channels which cross the pedestrian walkway similar to the potential trip hazards identified in Communication No 209. Brookfield has confirmed that IFT is to infill the channels with coloured screed on the walkways. They have intimated that these locations do not interfere with the water flow as they are the opposite end to the outlet gulley. (See Supervisor's Communication General Matters / Other Instructions (CI 13.1) No 224).

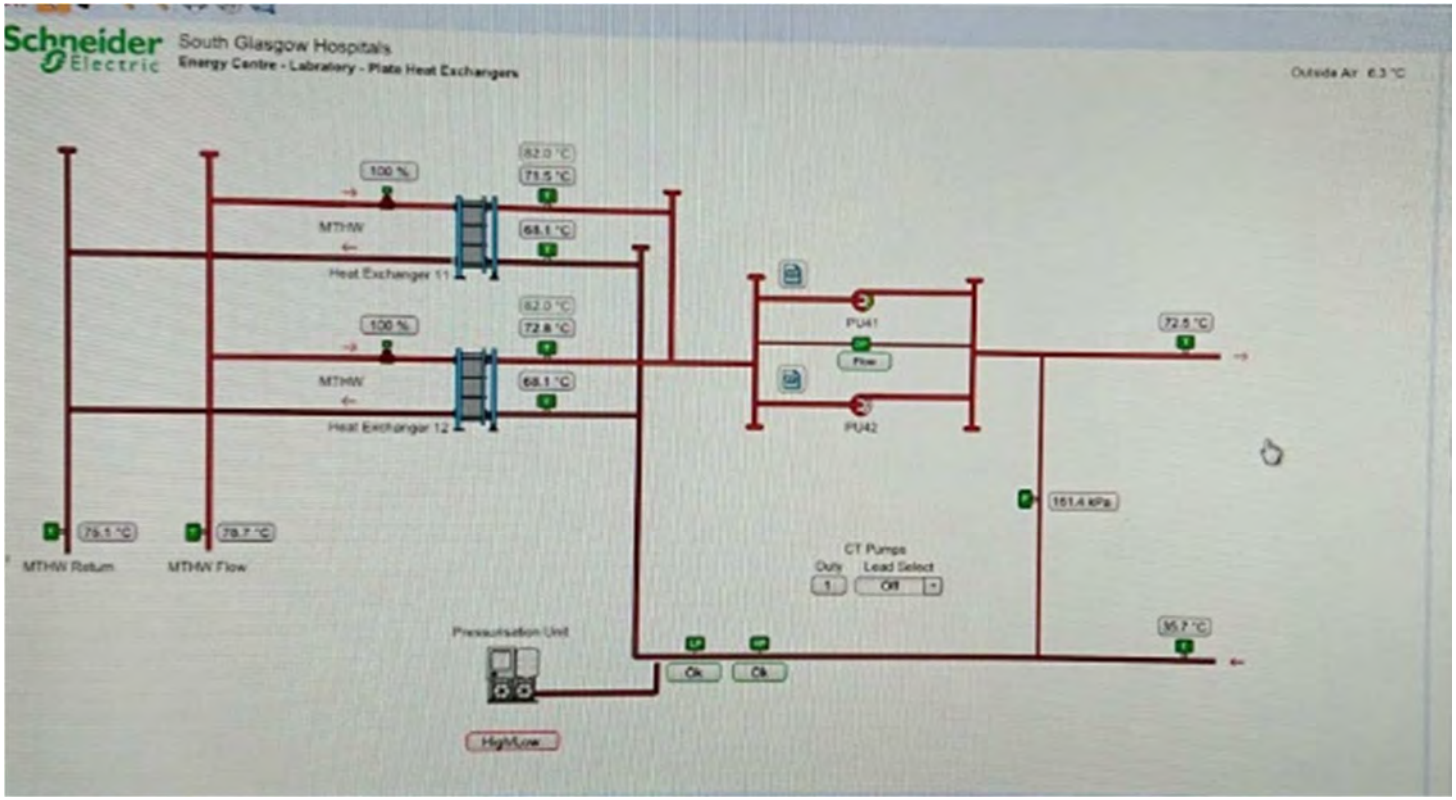
- Primary MTHW flow and return temperatures shown as 78.7°C and 75.1°C respectively.
- Both primary side PICV's at 100% (i.e. fully open).
- Secondary side LTHW flow set point temperature shown as 82°C, for both plate heat exchangers.
- Actual secondary side LTHW flow circuit temperatures indicated as being 71.5°C, and 72.8°C.

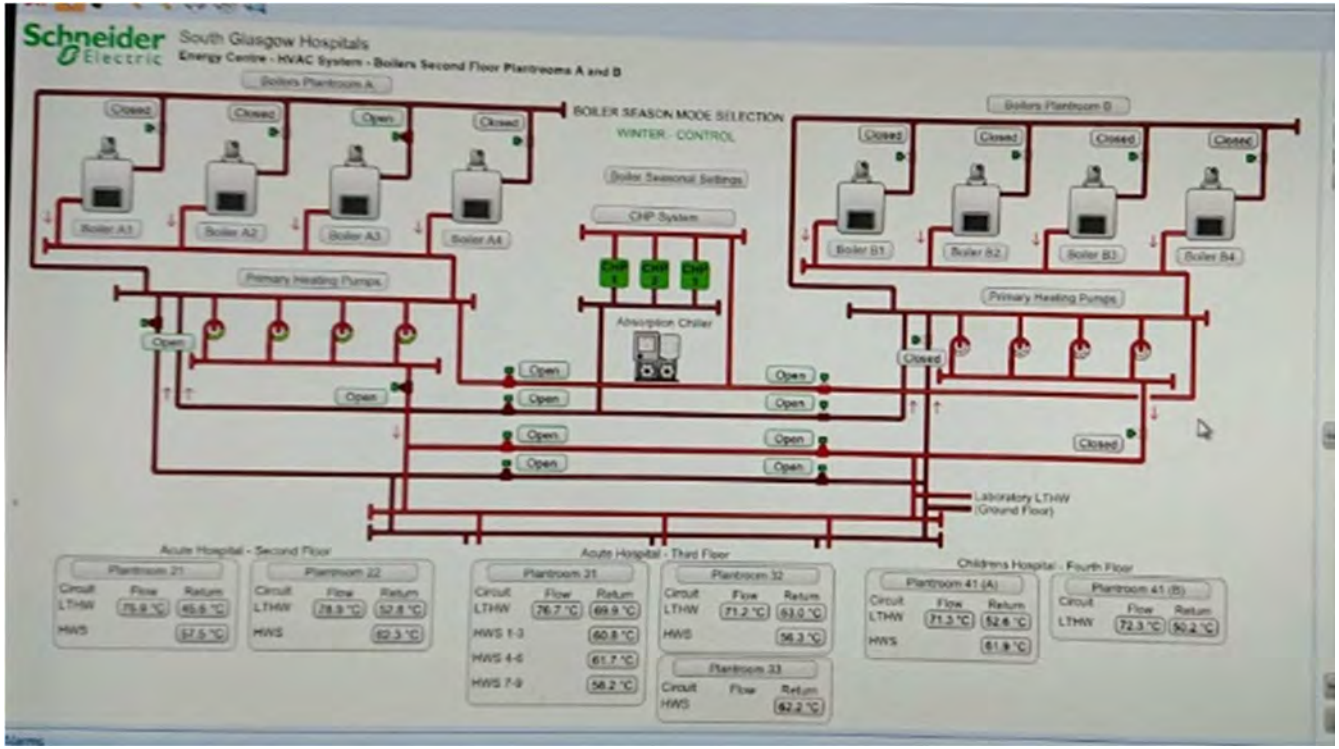
- Secondary side LTHW heating system distribution circuit temperatures shown are inconsistent.
- 1Nr 2-port motorised valve on primary MTHW return to boiler within Plant Room A is shown as open, although boiler is not operational.
- All 4Nr primary circulation pumps within Plant Room A are shown to be operational.
- 2-port motorised valves, on primary MTHW heating circuits from CHP system indicated as being open to both A and B side Plant Rooms.
- Motorised valves on 'cross-link' interconnecting circuit shown open, Plant Room B flow and return motorised valves closed.

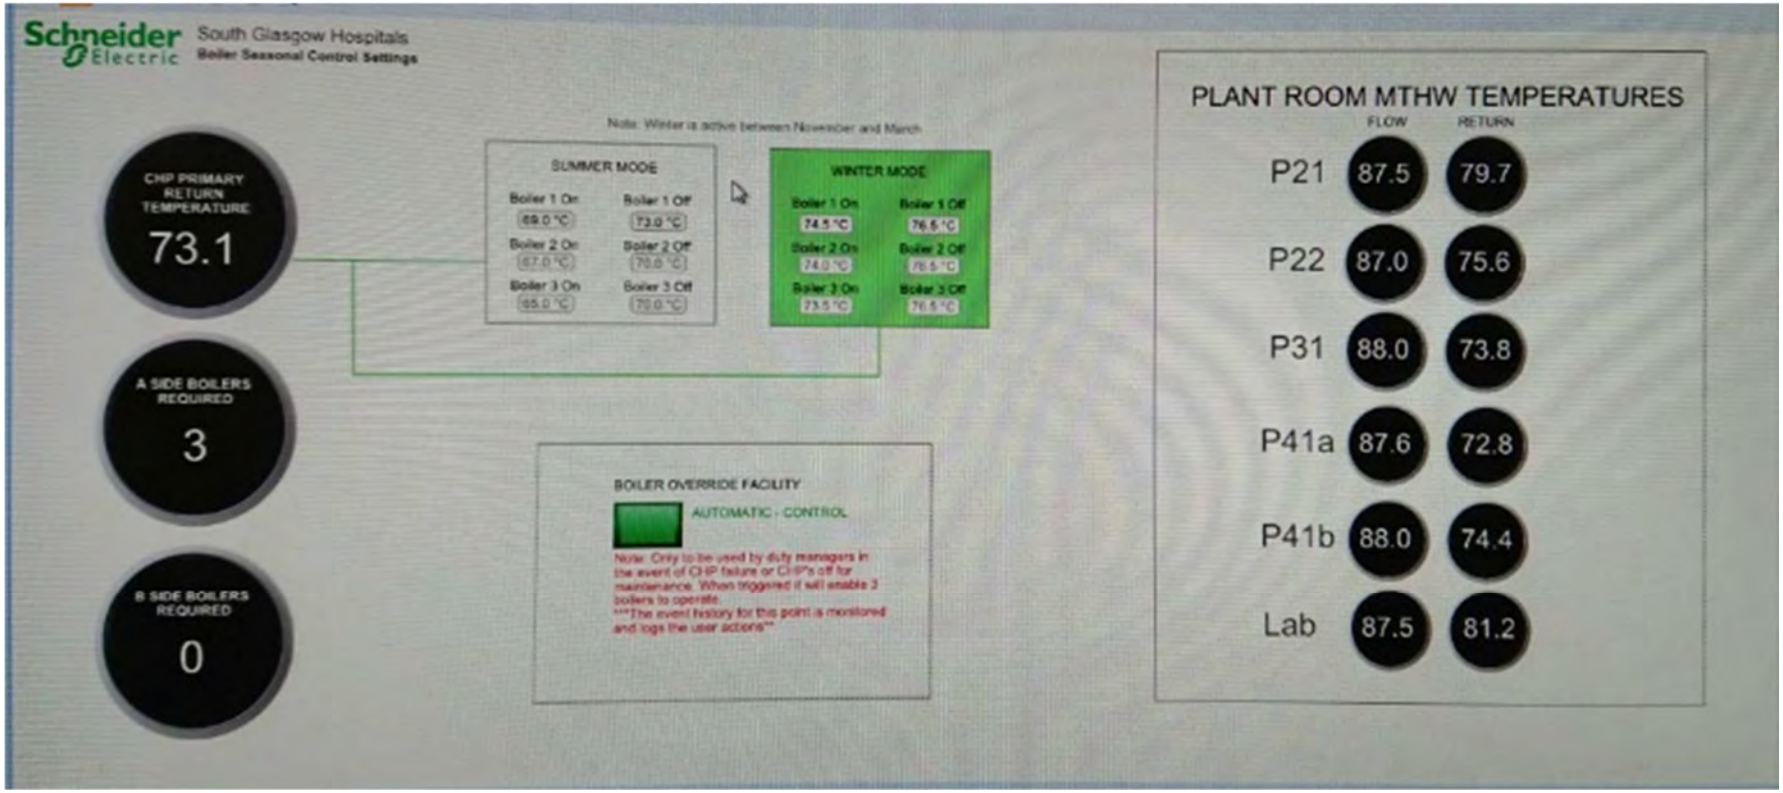
- Summer/winter mode selection added, which necessitates manual set point adjustment in event of a ‘cold snap during summer period’.
- Summer mode boiler 1, 2, and 3 ‘ON’ temperatures shown as 69°C, 67°C, and 65°C respectively.
- Summer mode boiler 1, 2, and 3 ‘OFF’ temperatures shown as 73°C, 70°C, and 70°C respectively.
- Winter mode boiler 1, 2, and 3 ‘ON’ temperatures shown as 74.5°C, 74°C, and 73.5°C respectively.
- Winter mode boiler 1, 2, and 3 ‘OFF’ temperatures shown as 76.5°C, 76.5°C, and 76.5°C respectively.
- ‘Automatic’ control override switch provided to enable 3Nr boilers in the event CHP’s being inoperative.
- Primary MTHW heating circuit temperatures indicated range between 88.0°C flow and 72.8°C return.
- CHP primary return temperature indicated as 73.1°C.
- 3Nr boilers within Plant Room A indicated as being required.

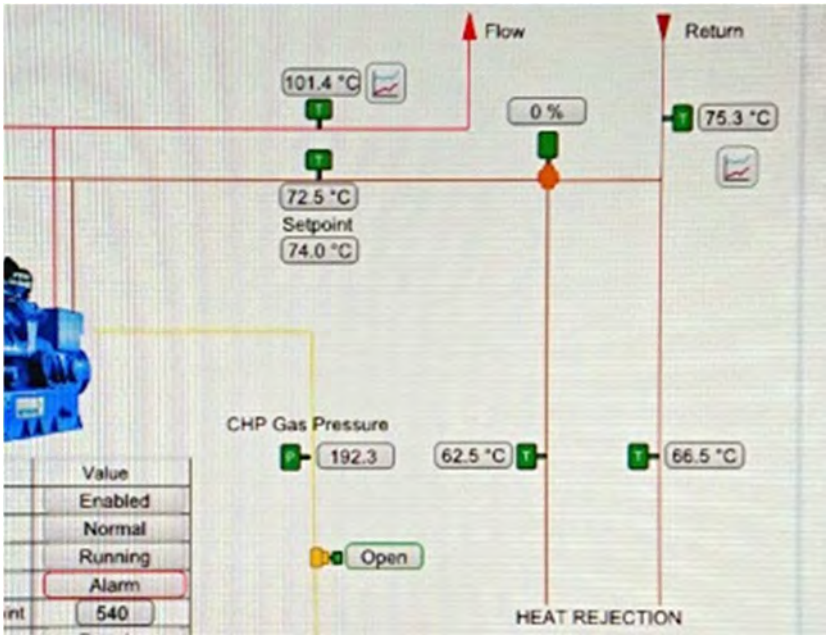
Below is an enlarged section of the CHP heat rejection circuit screenshot, as included within the User Manual.

The User Manual states that the CHP heat rejection valve set point was changed to 74°C in December 2017. This heat rejection facility should still operate in a similar manner to that originally intended, by opening the 3-port motorised valve and enabling circulation to roof mounted heat rejection emitters whenever the primary MTHW CHP common return water reached/exceeded set point temperature. However, we consider that the actual operation of the heat rejection cycle has changed by the implementation of subsequent control modifications (i.e. revised set point temperature), given that heat rejection to atmosphere would now appear to be prioritised over the originally intended automatic de-rating of CHP units. As such, this appears to be a significant deviation from the initial system design philosophy, and is not clearly clarified within the User Manual.

Analysis of the information contained within this screenshot indicates that a 0% heat rejection valve position signifies that the 3-port valve is open, thereby allowing circulation to the heat rejection emitters and heat dissipation to atmosphere. This corresponds correctly in terms of the revised 74°C heat rejection valve set point stated within the User Manual, and is in accordance with record documentation relating to initial valve operation, as noted below.

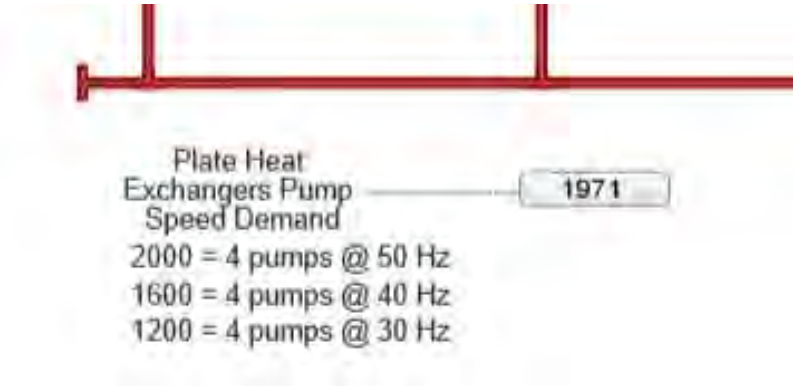
In terms of primary MTHW circulation pump control, the originally intended differential pressure method is no longer utilised as it was deemed problematic and caused too many errors within the system, as stated within the User Manual. Whilst primary circulation pumps were still intended to vary volume flow rate based on heat load demand, this was now intended to be achieved by speed modulation only, with the continued operation of all four pumps within either plant room.

The variation of speed from the 4Nr operational pumps was to be controlled based on the number of remote PICV's in the open, or closed, position. The User Manual describes this strategy based on 20Nr heat exchangers being installed, with all primary pumps reducing speed simultaneously in three fixed stages, as and when any 4Nr associated heat exchanger PICV's close. This proposed methodology of utilising 4Nr pumps in a fixed staged sequence is demonstrated within the image shown below.

As shown within this image, there would appear to be the requirement for all 4Nr primary pumps to operate at almost full speed, therefore delivering approximately 170l/s flow rate within the primary distribution circuit.

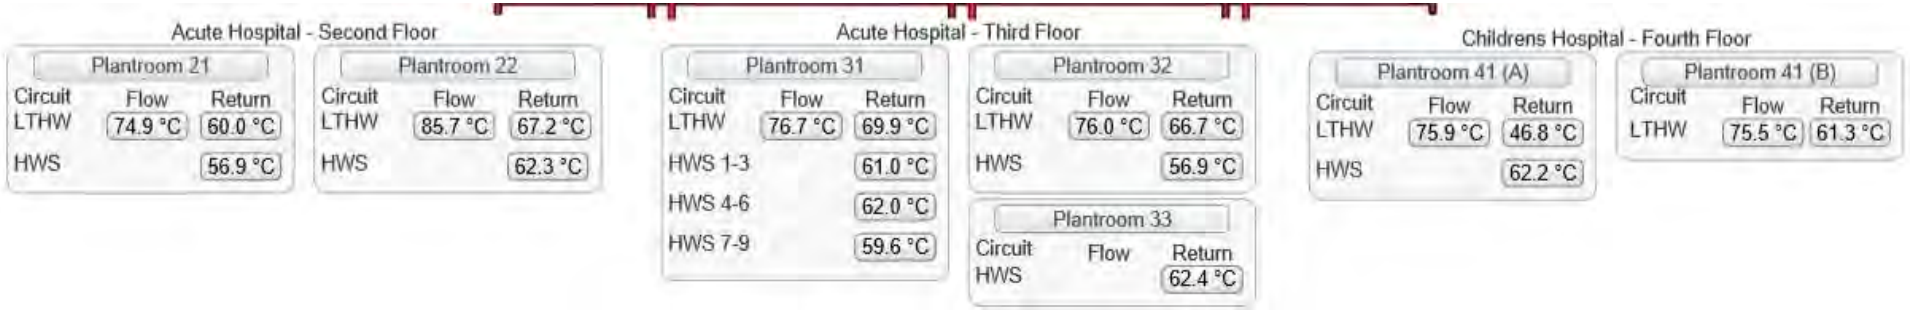
(21.03.18 @ 12:01pm)

As shown within these screenshots, secondary side LTHW temperatures are not in accordance with the original design temperatures of 75°C flow, and 60°C return. In addition to this, the User Manual states that all secondary side LTHW heating flow circuit set point temperatures were increased from 75°C to 82°C, and therefore, this was evidently not being achieved in the majority of remote plant rooms within the Adult & Children's Hospital at the time of our site visit.

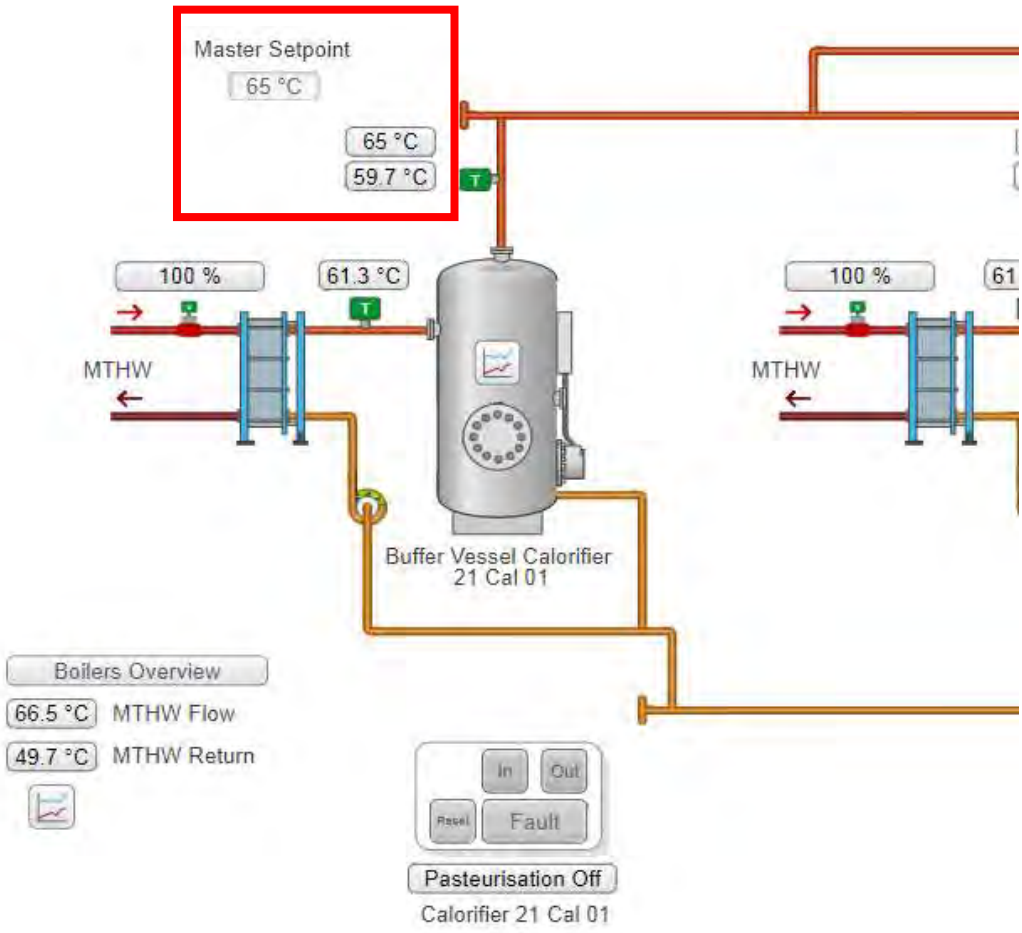
It would also appear that the domestic hot water service set point temperature has been raised from the originally intended temperature of 60°C to a higher set point of 65°C, as indicated below. This control adjustment is not identified within the User Manual, and as with the case of LTHW heating circuit temperatures, the secondary domestic hot water system would also not appear to be capable of achieving this revised set point.

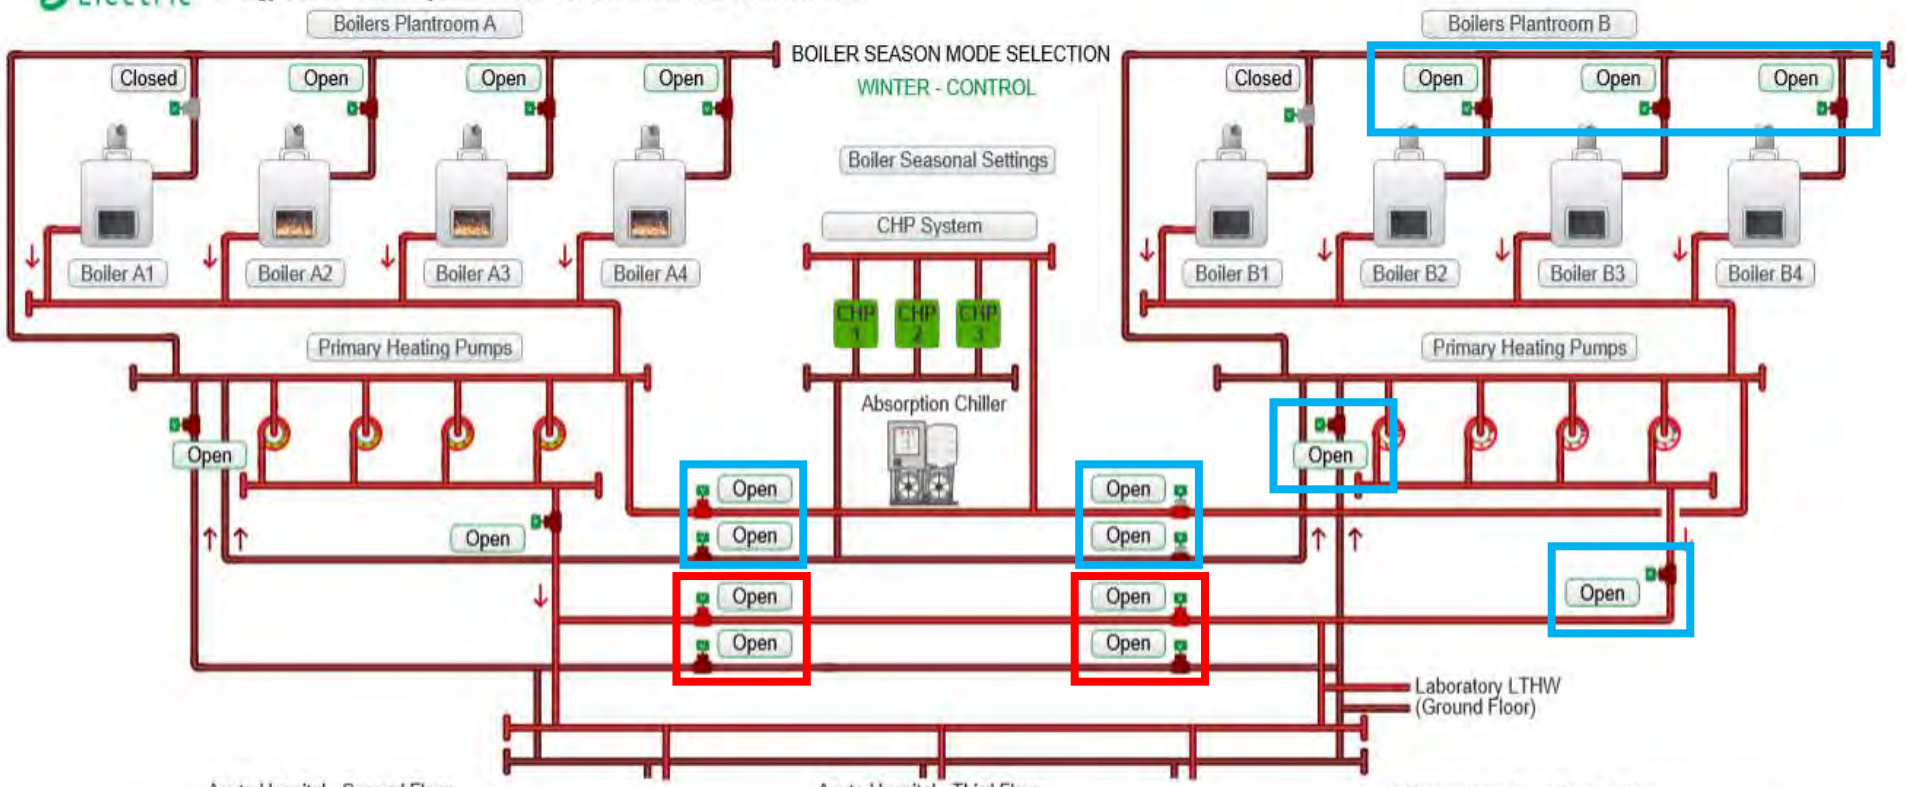
The apparent recommendation within the User Manual to rotate 'A' and 'B' plant rooms on a 3 month basis infers that the original automatic lead plant room switched control is no longer active/utilised. It also intimates that the revised strategy only allows one plant area to operate at any time, irrespective of heat load requirements.

This revised system strategy is apparent from the open position of 2-port motorised valves located on the 'cross-link' interconnecting circuit between plant rooms, as illustrated in Red on the screenshot shown on the following page (taken during site investigation works), particularly as there are 3Nr boilers operational (i.e. load > 15MW).

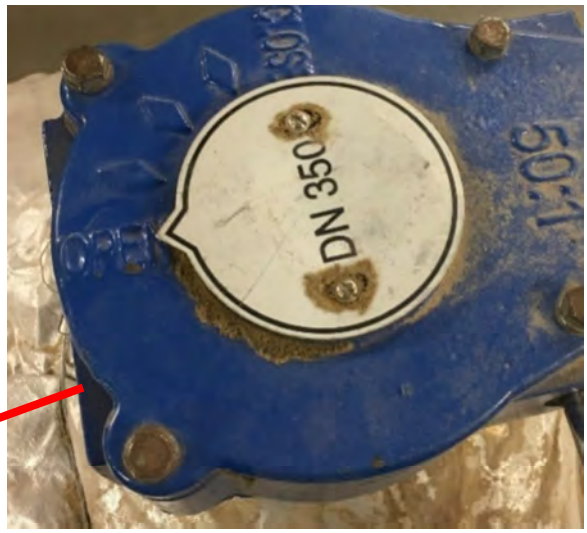
Furthermore, during our site investigation works we noted that the 'normally closed' isolation valves located on the primary MTHW heating circuit headers within the Adult & Children's Hospital were in the open position. Photographs taken during our site inspection works are shown below to demonstrate this.

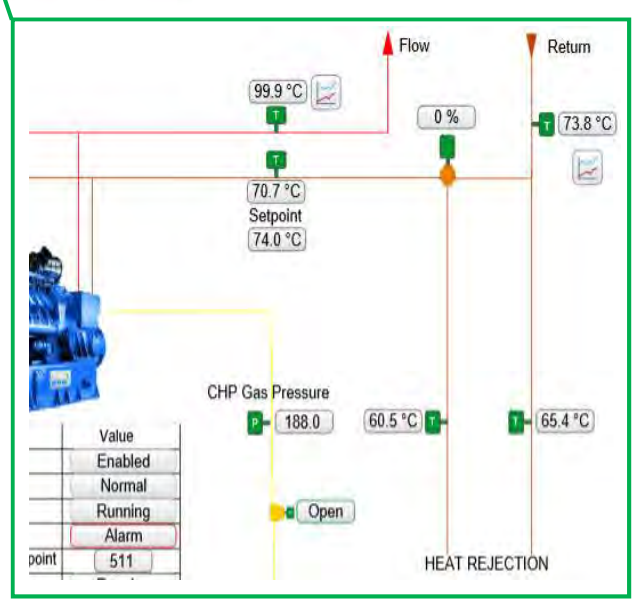
As shown within the enlarged Green image of the CHP diagrammatic screenshot, the heat rejection valve is shown in the open position (0%), the primary MTHW return circuit temperature is 73.8°C, and the temperature of common return circuit to CHP units is 70.7°C. Based on these parameters, and combined flow rate from CHP pumps, the extent of heat rejection at this particular point in time was calculated to be in the region of 376kW.

As shown within the screenshot, the primary MTHW return temperature of 73.8°C was below the revised heat rejection valve set point of 74°C, and therefore heat rejection should not have been occurring. In this instance, heat rejection unnecessarily lowered the common CHP return temperature to 70.7°C (i.e. 3.3°C below desired revised set point), plus in all probability enabled the operation of a third boiler under the dictates of the new winter mode set points

(73.5°C). As the return temperature received by the CHP units was lower than intended, the flow temperature from the units was consequently lowered accordingly.

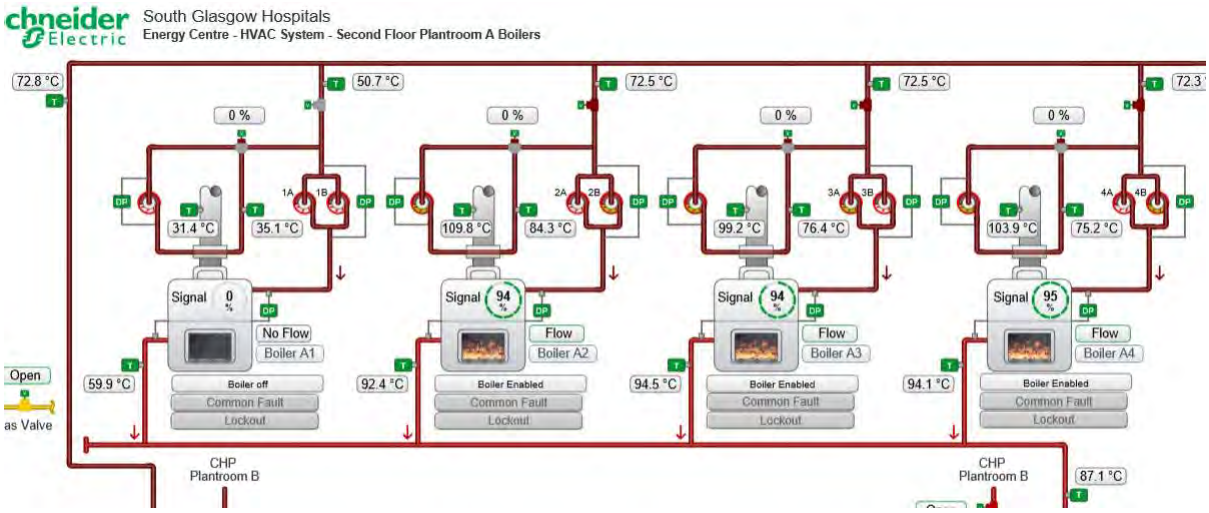
Furthermore, the table highlighted in Red within the CHP screenshot below indicates that 3Nr 'A' side plant room boilers were operation, whilst there was presumably 375kW being rejected to atmosphere. The screenshot below further serves to illustrate the actual boiler operation at this particular time, as both screenshots were taken at 12:52pm on 21st March 2018.

In addition to the foregoing, the revised heat rejection valve set point temperature, and winter control strategy maintaining boiler operation until a common CHP return temperature of 76.5°C is achieved, would suggest there to in all probability be constant heat rejection and continuous unnecessary cycling of boilers.

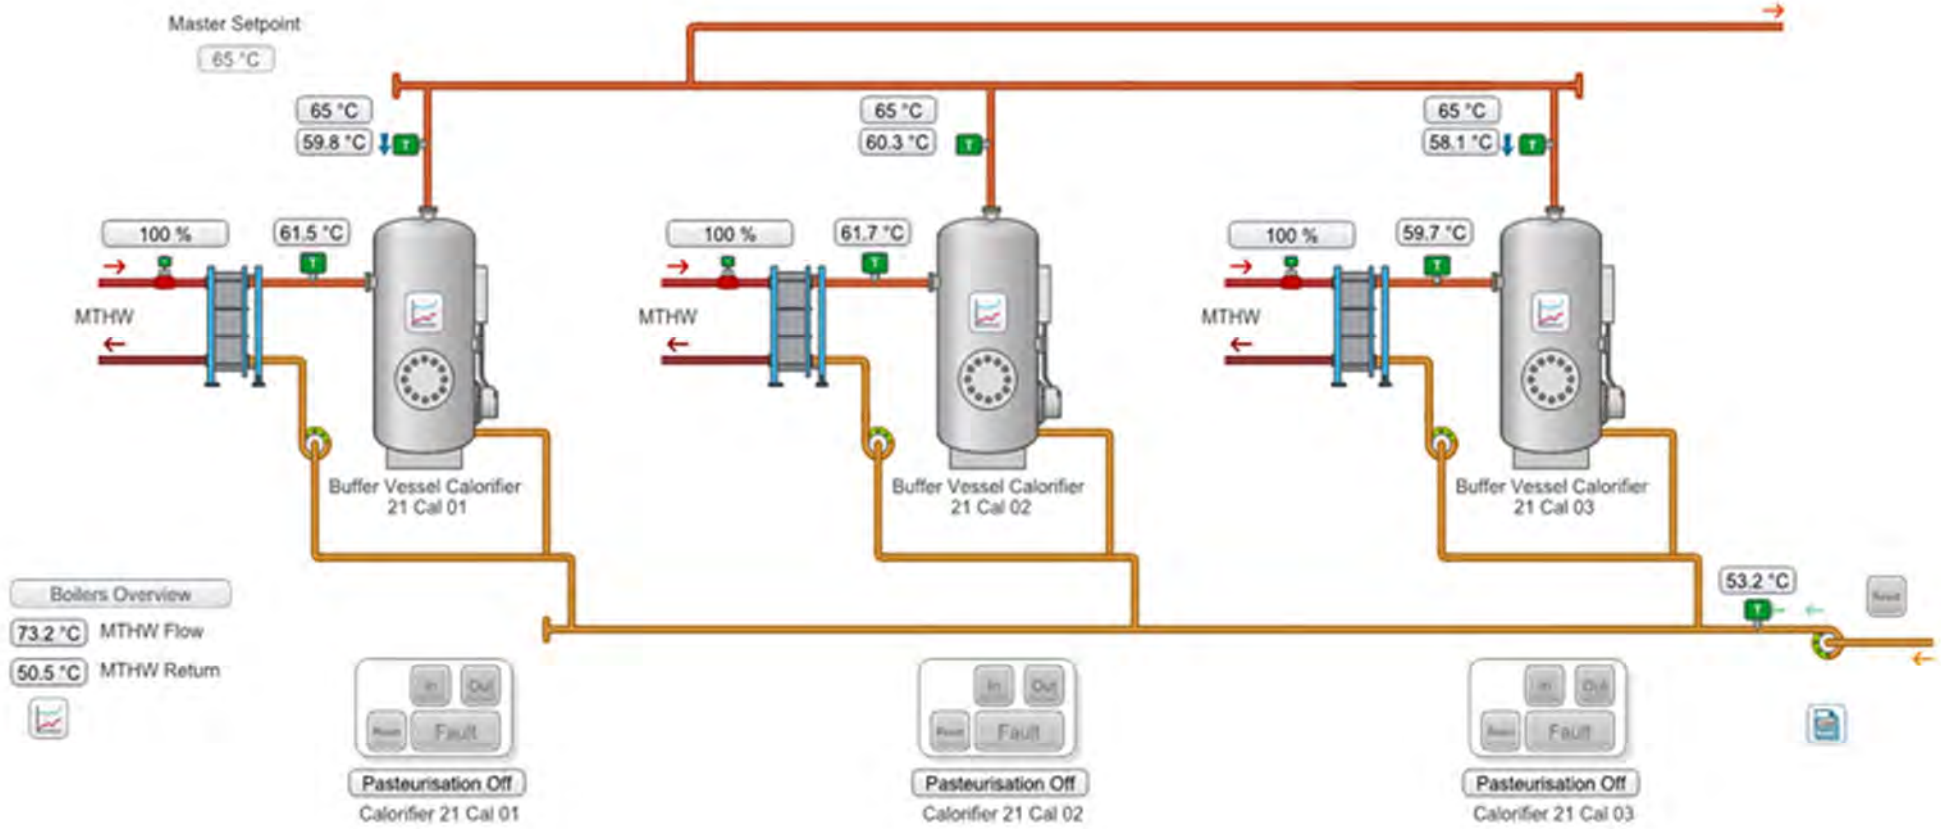
As shown on the above screenshot, the primary 'MTHW' circuit temperatures at this particular point in time are 73.2°C flow, and 50.5°C return. These low MTHW operational temperatures would result in heat exchanger mean water temperature in the region of 62°C, significantly lower than the original design intention of 90°C. In view of this, we expect that the heat output available from plate heat exchangers serving the secondary side facilities would be reduced, which in this instance are the domestic hot water calorifiers within Plant Room 21.

Also as indicated within the previous screenshot, the domestic hot water 'Master Setpoint' of 65°C contradicts the 60°C set point temperature defined within record documentation. This would typically suggest that either problems were identified in achieving the original set point temperature initially, or that difficulties achieving the original set point temperature transpired following the subsequent control modifications. Moreover, whilst the revised system control would appear to be programmed in order to achieve a domestic hot water flow temperature of 65°C, the system is clearly unable to satisfy this requirement as all three buffer/calorifier outlet temperatures are shown to be approximately 5 Deg C below the desired set point.

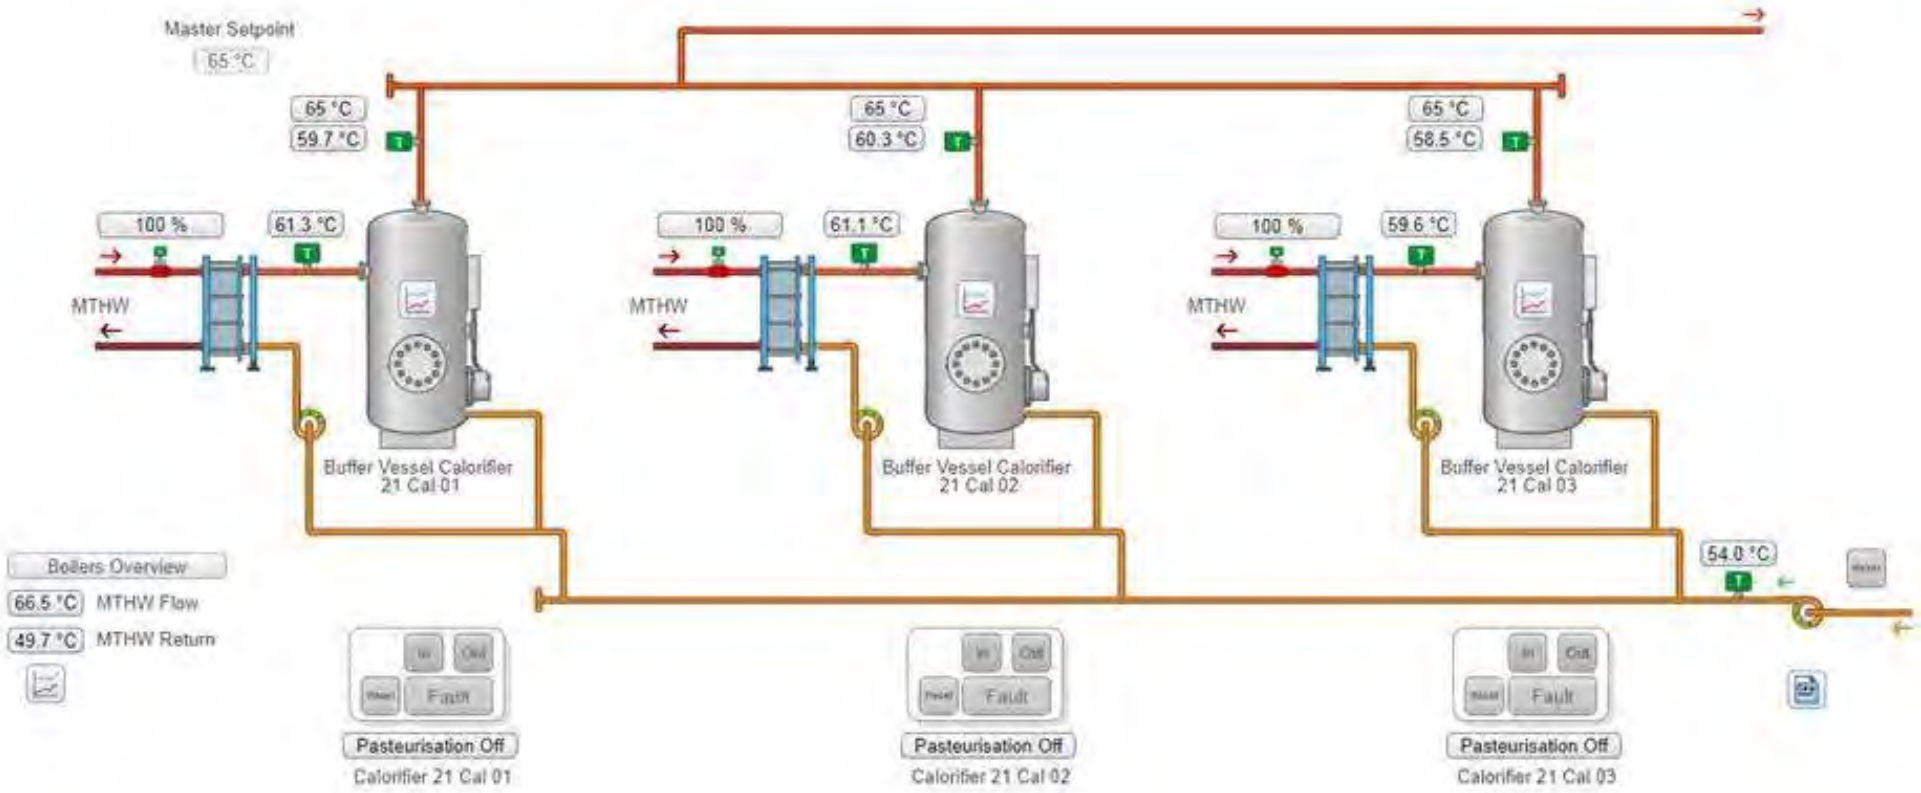
Whist the adjustment to the domestic hot water service 'Master Setpoint' temperature does not appear to be effectively increasing outlet temperatures above the original set point, this modification in control is not identified within the User Manual. This would appear to be abnormal given that any increase in the flow temperature would increase the risks associated with inadvertent scalding.

We expect the probable inability to achieve desired set point temperature is due to subdued primary 'MTHW' temperatures with heat exchangers unable to transfer sufficient heat energy to the domestic hot water service. This inability appears to have resulted in lower than programmed/controlled domestic hot water flow temperatures, and the domestic hot water recovery period would also appear to be adversely effected, given the return/circulation temperature shown in the screenshot. Furthermore, as both the domestic hot water flow

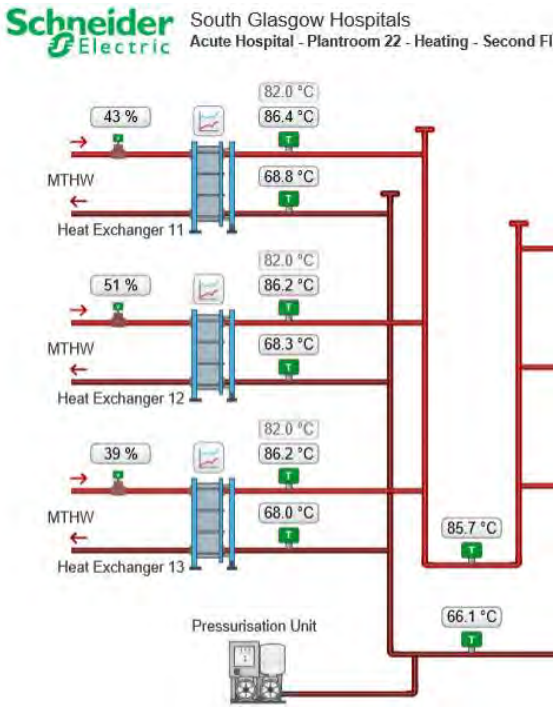
The foregoing descriptions identify that the current operation of the system is resulting in domestic hot water temperatures that are not in accordance with the Health and Safety Executive Guidelines, in respect of minimising the risks associated with legionella bacteria growth.

It should also be noted that screenshots only reveal probable temperature inadequacies within a particular plant room of the Hospital at two specific points in time, which could be during periods of low demand/draw-off. Therefore, temperatures could be lower during period of higher demand/draw-off, and be occurring in different plant rooms.

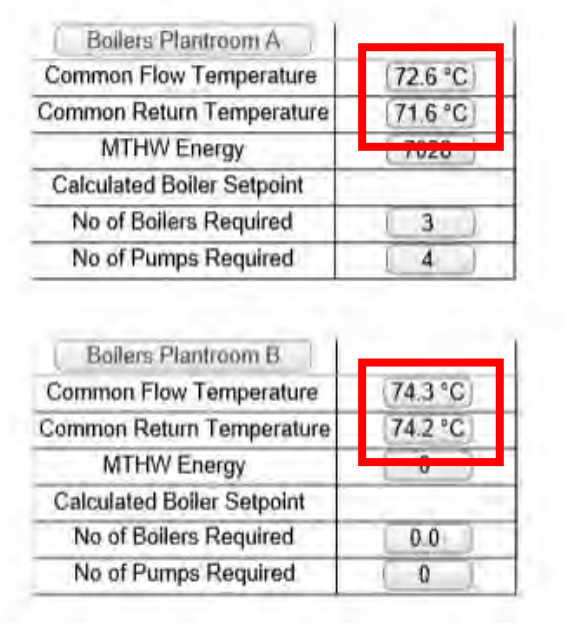
The screenshot shown below would also appear to indicate the incidence of a potential primary circulation short-circuit, given the temperatures as indicated.

As illustrated, plant room 'A' was operational with 3Nr boilers firing, whilst 'B' side plant room was inoperative. However, the common flow and return circuit temperatures recorded within the inoperative boiler plant room were notably higher than those registered within the operational plant room. At this particular point in time, the majority of 2-port motorised valves within both plant areas were found to be in the open position, as shown below.

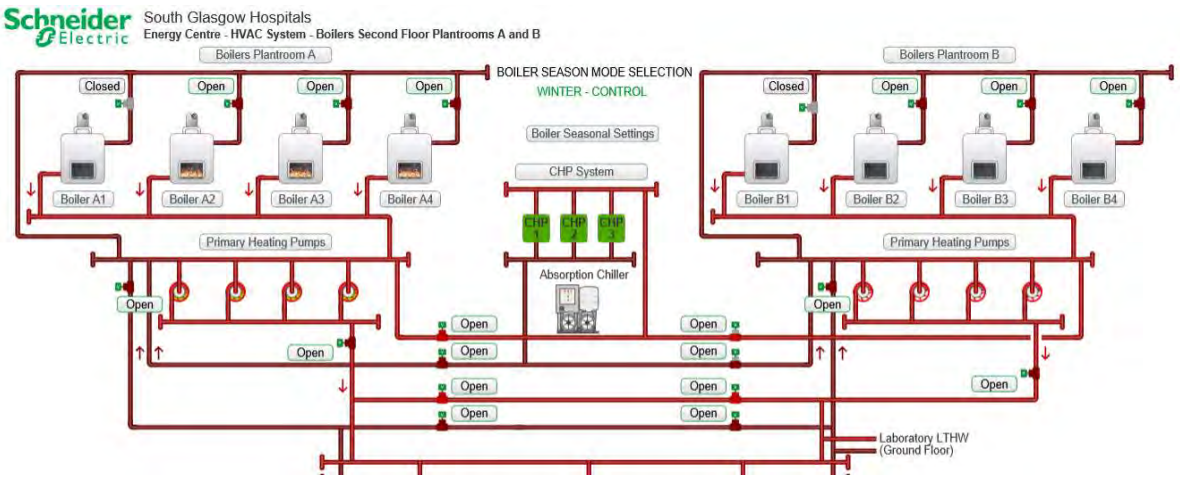
The revised control strategy intimates that only one plant room is intended to be operational at any particular time. If this is found to be the case, it would appear to completely disregard the presumed original design intention to facilitate the use of both plant rooms to satisfy higher heat loads (i.e. > 15MW). This could consequently result in insufficient simultaneous boiler heat generation to meet peak demands. Moreover, it would appear that the original automatic lead plant room changeover facility may now have been changed to a manual function, which would be more onerous for estates personnel, and likely increase the risk of human error (i.e. opposite of that defined within User Manual).

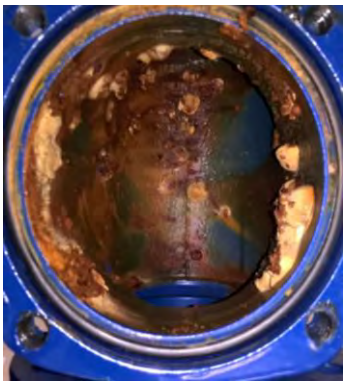
Asset Number 85079

A mains water inlet valve with water meter was received into the laboratory form Queen Elizabeth Hospital Glasgow. The laboratory was asked to investigate the deposits visible on the internal surface of the pipework.

Meter security seal intact (wired from meter housing to fixing bolt) seal broken by DH in the laboratory 03/12/2018.

The meter was removed from the pipe to gain access to all areas of the unit. When removing the meter further deposits were found on the internal surface of the pipe and on the casing of the meter fan.

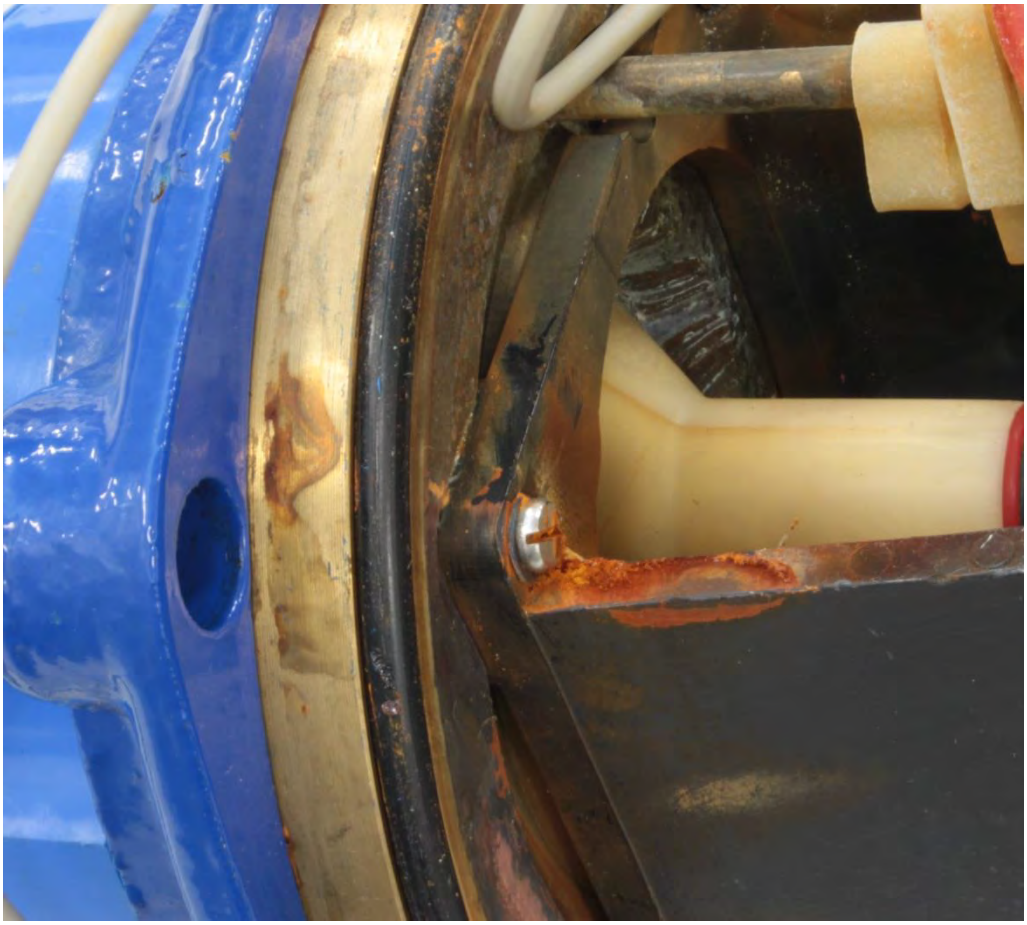
Figure 3: Transferred red/brown corrosion products with no evidence of corrosion on brass component.

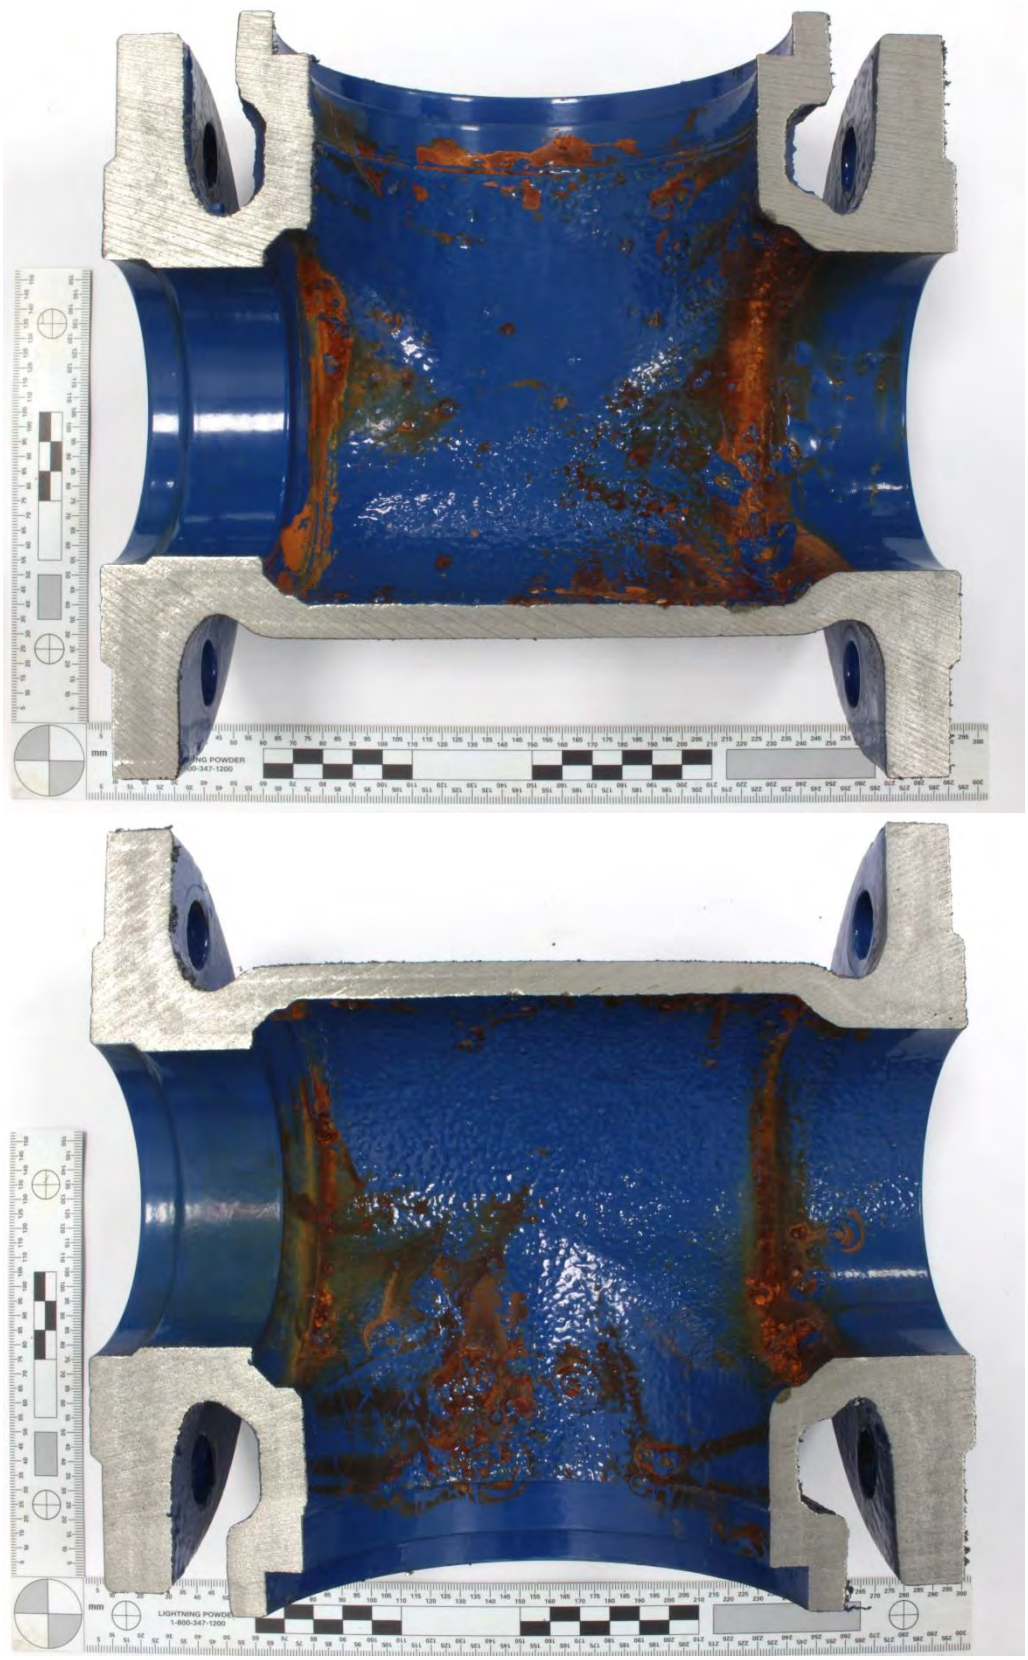
Figure 4: Overview of sectioned valve body showing corrosion products and paint blistering on internal surfaces. Note orange peel texture to paint layer.

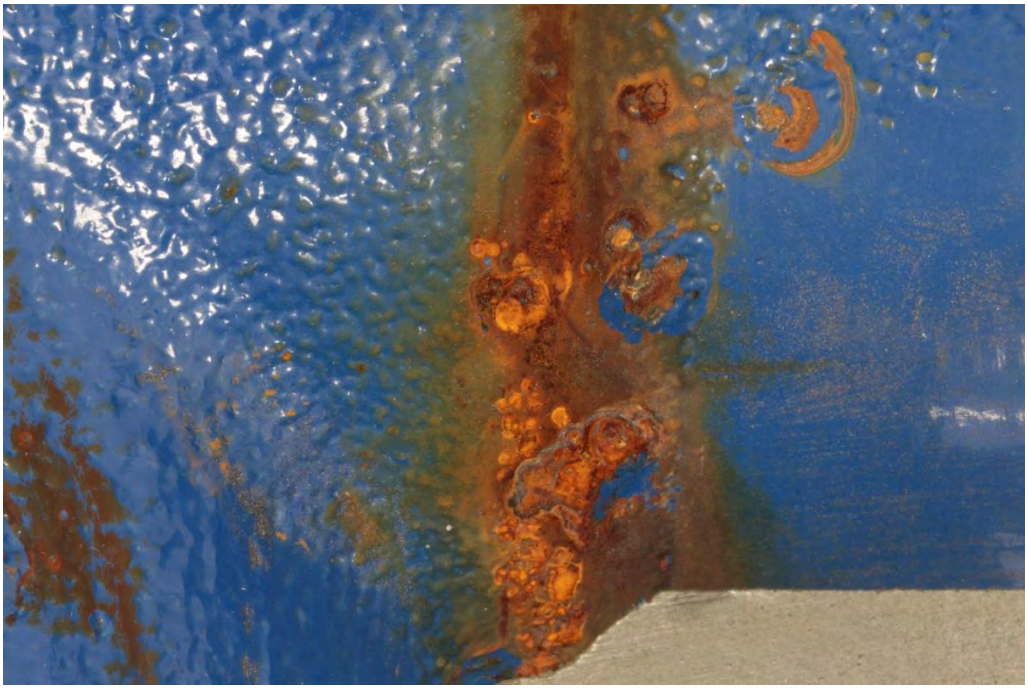
Figure 5: Corrosion at geometry change with red/brown corrosion product and orange peel finish.

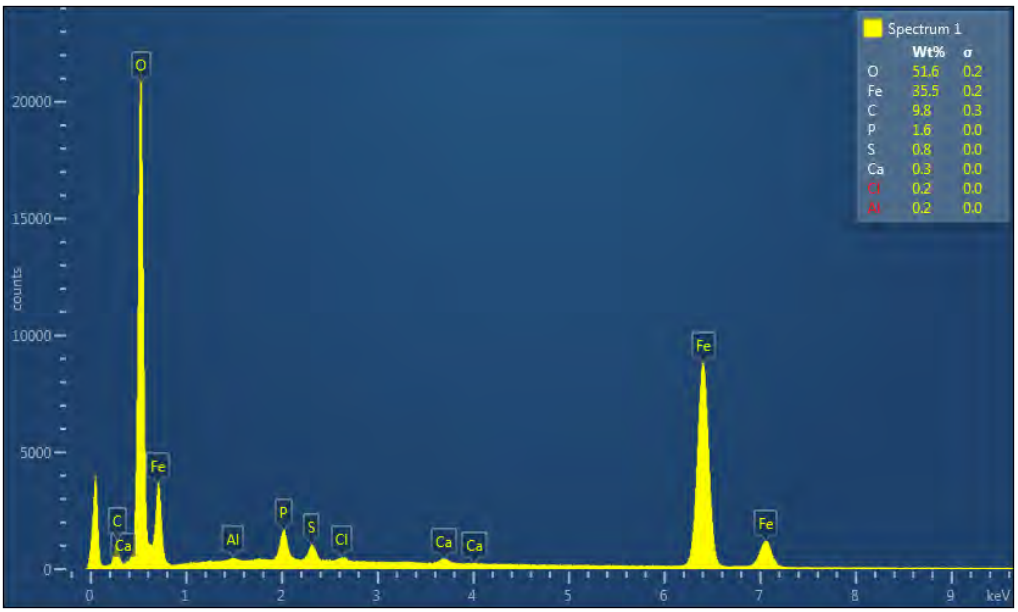
Figure 6: EDX Spectrum obtained from internal corrosion product.

The internal corrosion products were semi-quantitatively analysed using Energy Dispersive X-ray Analysis (EDX), the results are provided in Figure 6.
