SCOTTISH HOSPITALS INQUIRY

Bundle of documents for Oral hearings commencing from 19 August 2024 in relation to the Queen Elizabeth University Hospital and the Royal Hospital for Children, Glasgow

Bundle 15 - Water PPP

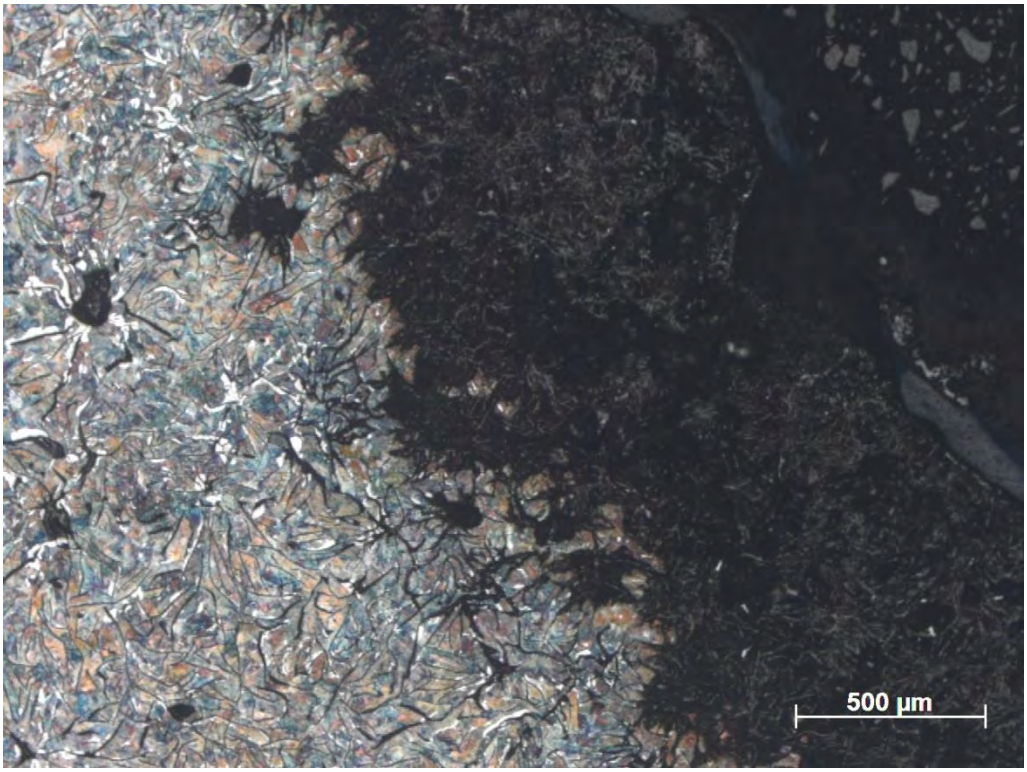
Figure 8: Detail of graphitic corrosion beneath paint layer.

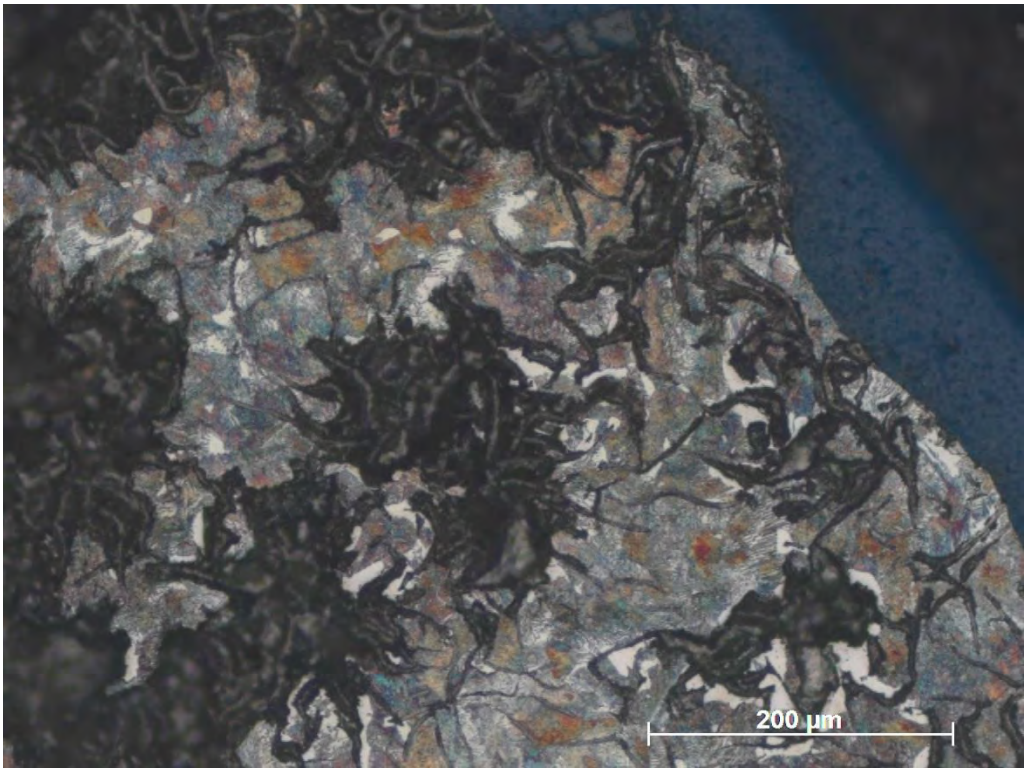
Figure 9: Corrosive attack around graphite flakes beneath paint layer. Note relatively thin paint layer.

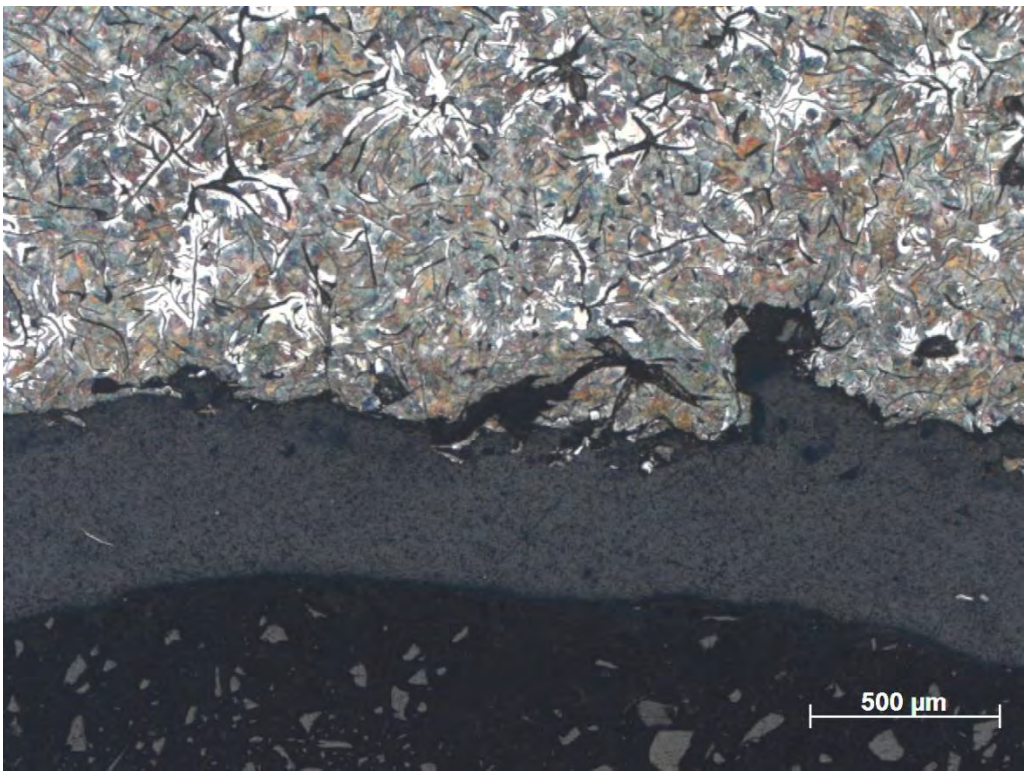
Figure 10: Painted external surface showing relatively coarse surface finish.
