# SCOTTISH HOSPITALS INQUIRY

## **Bundle of documents for Oral hearings commencing from 19 August 2024 in relation to the Queen Elizabeth University Hospital and the Royal Hospital for Children, Glasgow**

### **Bundle 12 - Estates Communications**

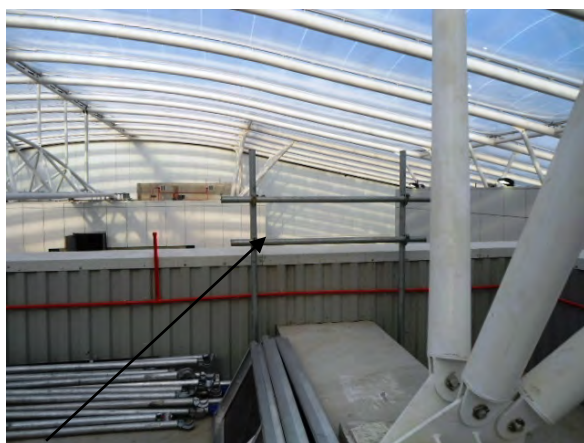
Temporary scaffolding providing perimeter

protection.

There is temporary scaffolding providing perimeter protection at concrete floor beams above the cores accessed from Level 12. We have asked Brookfield to confirm if permanent perimeter protection is to be fitted. See Supervisor's Communication General Matters / Other Instructions (CI 13.1) No 242.

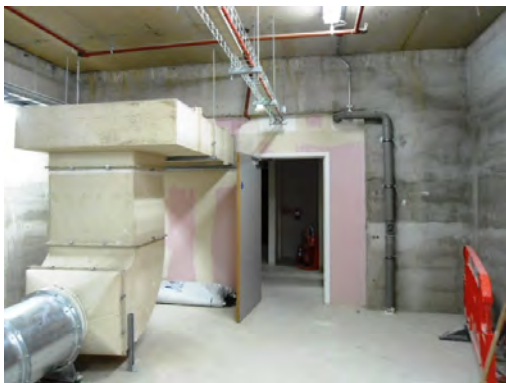
Level 12 Core A incomplete work.

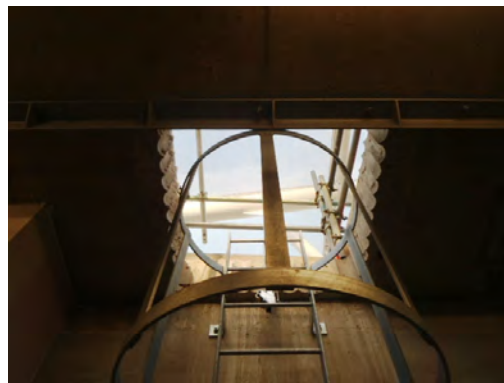
Hatch required to Cat ladder in room CA12-015.

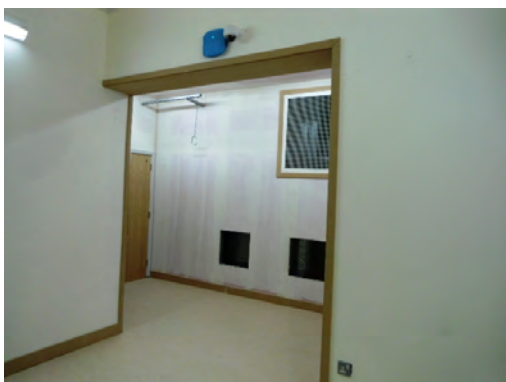
Some snagging work, painterwork and hatches required.

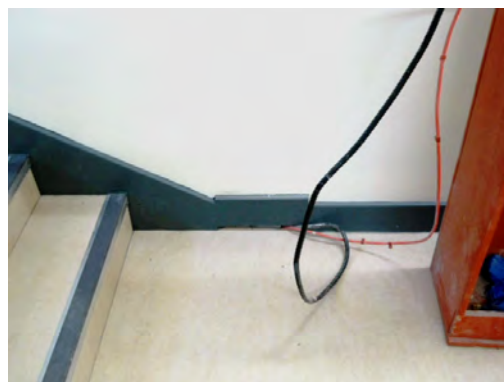
Site alarm system requires to be removed from some floors and skirting fitted.

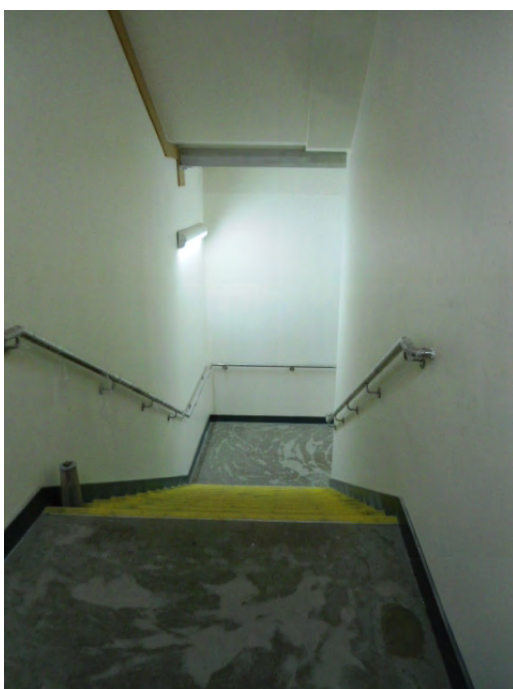
Cores A & B Level 1 to Level 0 incomplete work and snagging.

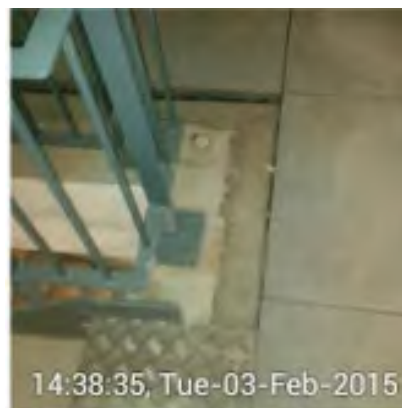
Edge of slab too high.

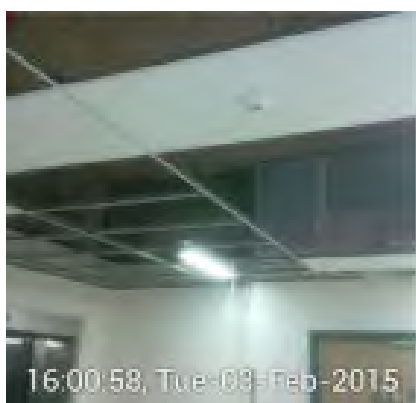
Incomplete ceilings

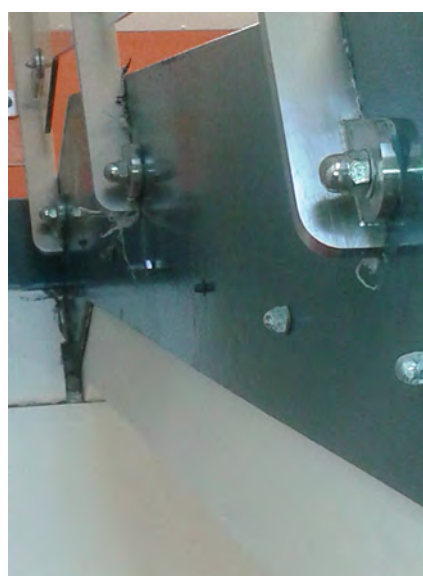
Nuts still to be cropped and fitted to steel stringer.

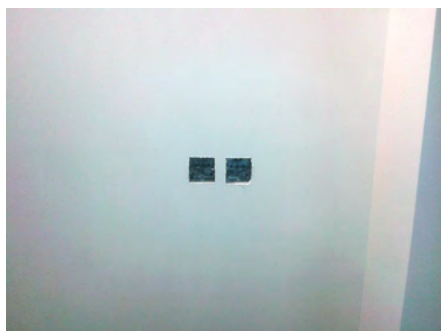
Redundant sockets.

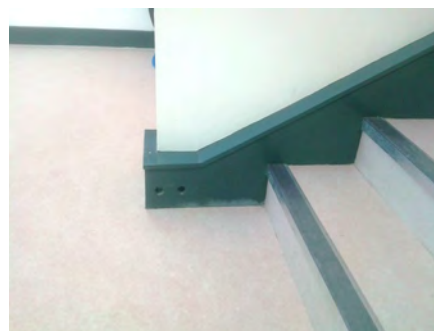
Holes to be filled in metal stringer.

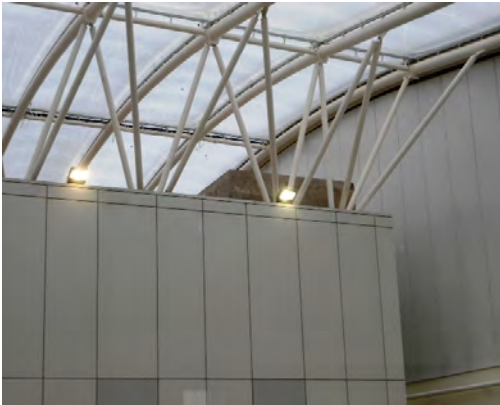
The concrete top of the lift enclosure in Core D is visible.

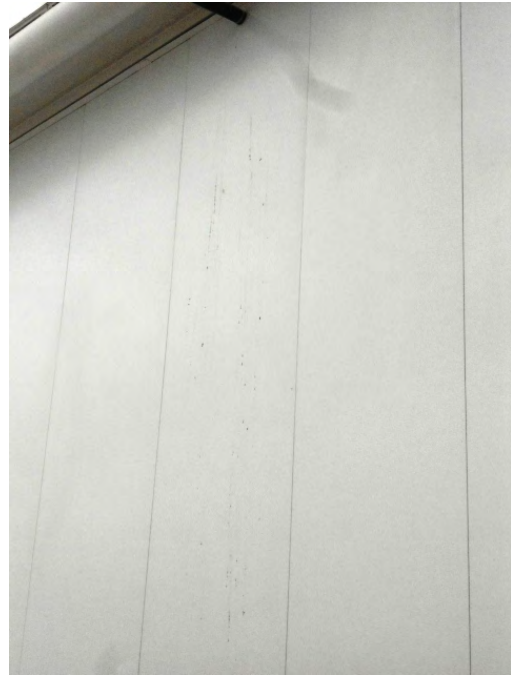
Pigeon droppings on cladding of Core B

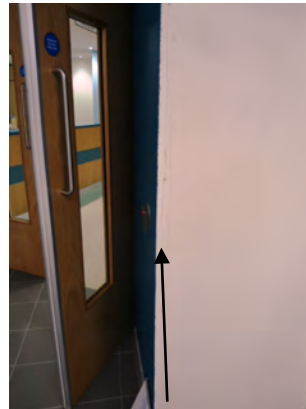
Damaged corner bead

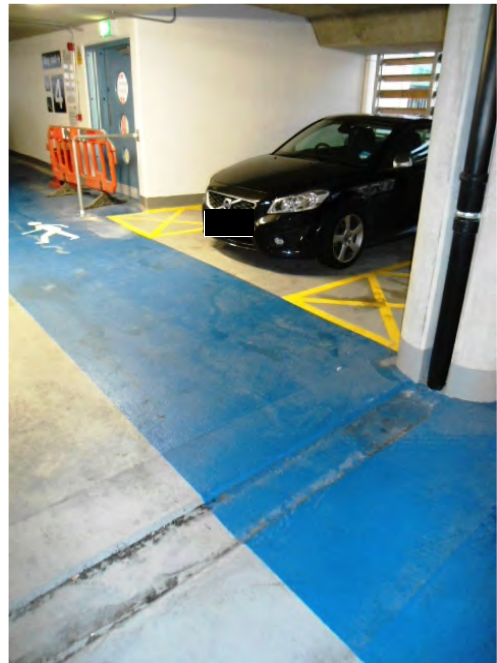
Level 4

The car park is now in use as the main project site car park. Some minor snagging remains outstanding and this together with items determined at a final inspection will be addressed towards the end of the project. This snagging will include some ponding issues on the top floor, and trip hazards at stairwell entrances.

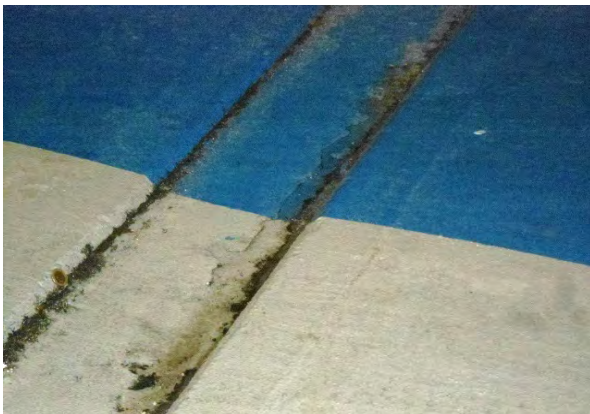
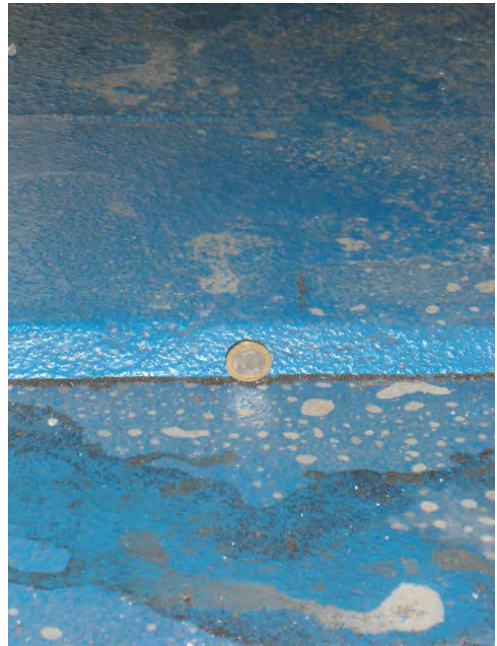
Level 3: Channel exceeds 30mm deep.

Some of the outlets taking the rainwater from the top level of the Car park are too high consequently water is ponding in the recessed channels.

We asked Brookfield to confirm what remedial work will be undertaken to resolve this issue and confirm when the work is complete. They have intimated that the recessed channels will be revised to give a fall to the outlets. See Supervisor's Notification of Defect (CI 42.2) No 83.

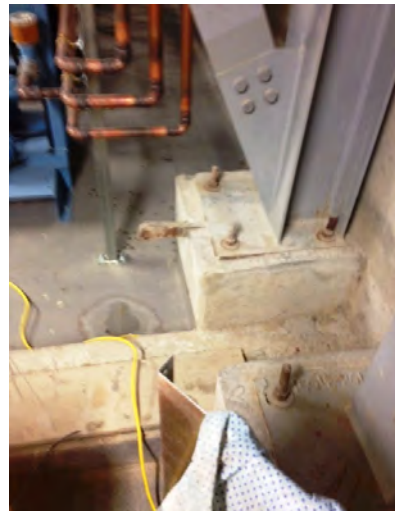
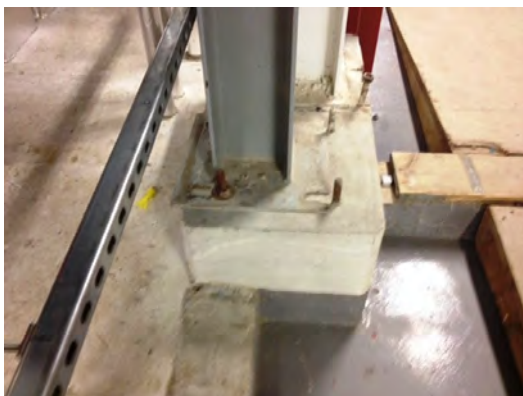
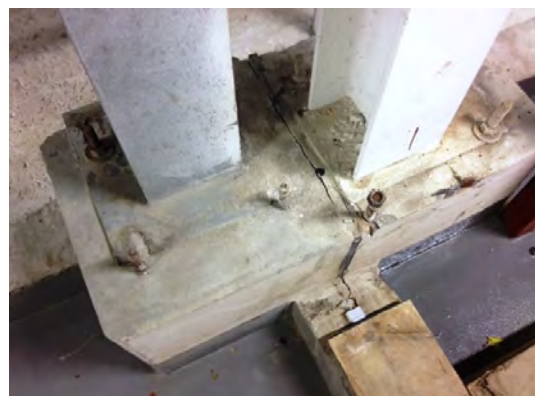
Clearing up in plant rooms has revealed some steel column base plate issues in the Children's area 4<sup>th</sup> floor – Brookfield are aware of this and are pursuing the matter.

We have asked Brookfield to confirm that the existing base detail as shown on the attached photographs in the Children's 4th floor plant room area is capable of safely resisting the loads which may be applied to it and that it conforms to the design intent. Brookfield confirmed that the steelwork installed by JD Pierce is adequate and capable of safely resisting the loads that have been applied to it and JD Pierce have issued a letter of conformity for all works. consequently. Supervisor's Communication General Matters / Other Instructions (CI 13.1) No 235 is closed out.

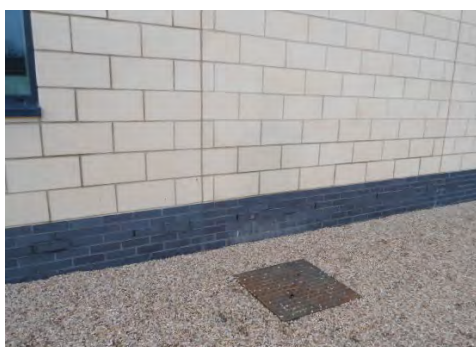
Although some work has been carried out to improve the quality the pointing on the external blockwork on the south and east elevations. Some of the blockwork does not reflect the quality of the pointing on the blockwork benchmark sample. Brookfield has informed us that all mortar tinting is now complete. Brookfield Manager F Shaw is to review the pointing with NHS (P Moir). See Supervisor's Notification of Defect (CI 42.2) No 81.

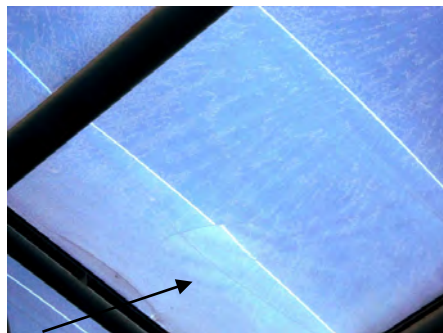
There is water trapped within the ETFE roof. Please confirm the cause and solution to this problem and confirm when resolved. See Supervisor's Notification of Defect (CI 42.2) No 101.

Water ponding on inner skin.

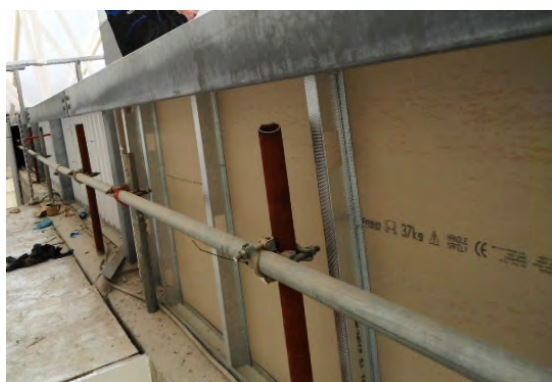
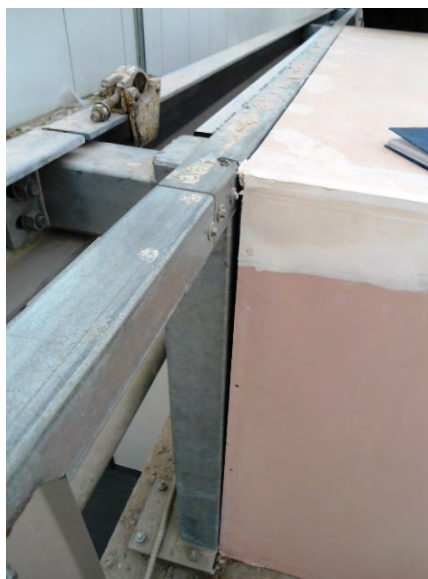
The fire stopping is incomplete to the Fire Enclosure in Core C above Level 12. We have asked Brookfield to confirm when this is complete. See Supervisor's Notification of Defect (CI 42.2) No 103.

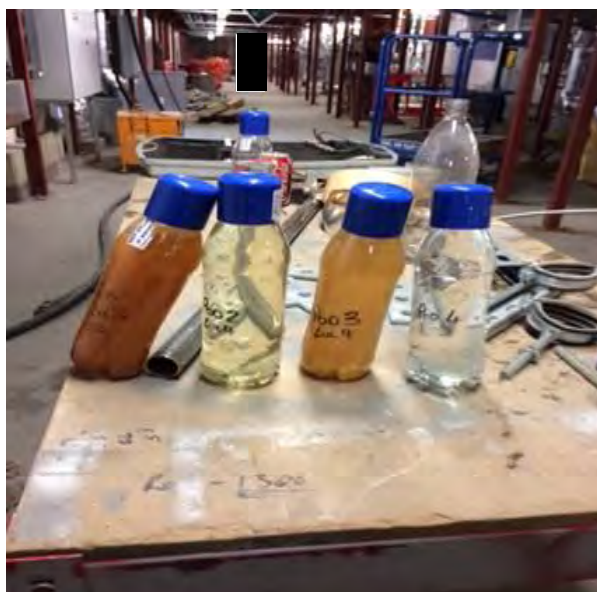
Prior to opening the Energy Centre pipework and integrating, BMCE undertook water sampling analysis of the Labs heating system. On the 24-11-14, following our Water Quality Testing on the Labs LTHW System, please see below results and photograph of water samples taken from Pod's 1-4. Our specialist sub-co advised a full system reflush due to the levels of contaminants in the various systems which all go back to the EC Labs pump sets.

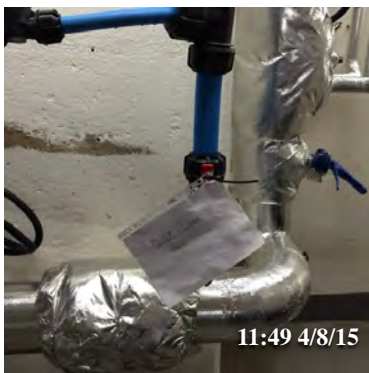
### Water Filter Breach

Raw water breach connection, valve open do not close notice fixed.  
1st breach connection.

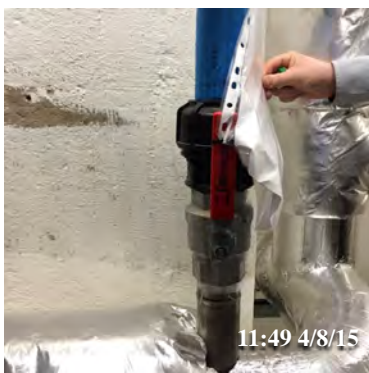
### Govan Road Supply Valve 1

Please advise why valve is closed, risk if valve is reopened onto a fault condition?

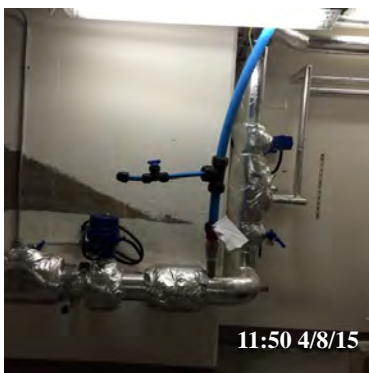
### Construction Site Water Take Off

This has this potentially introduces a dead leg into the hospital raw water supply on the breach pipe.

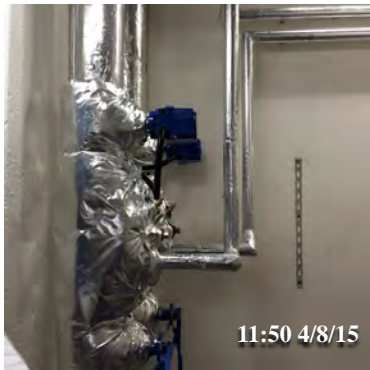
### Water Supply Automatic Transfer Valve

The supply valves are designed to automatically transfer site supply between both supply points every 11 hrs to prevent stagnation (dead legs) this is controlled via the BMS.

This function does not seem to be operating correctly as all 4 valves are in the fully open position?

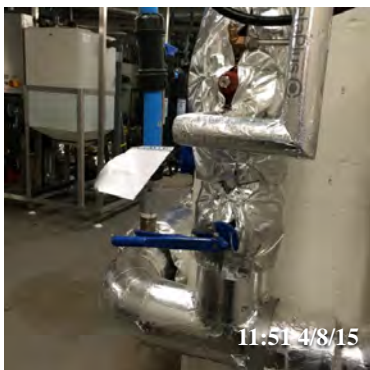
### Auto Valve Tank 1A

This valve is isolated crating a dead leg, is there a reason for this?

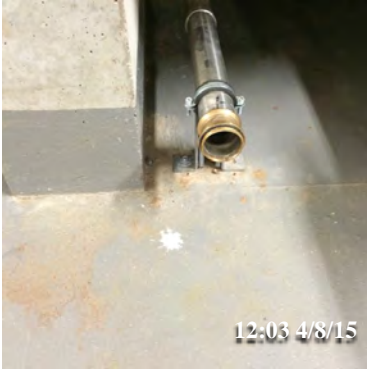
### Raw Water Tank A

Open ended discharge line, should be fitted with blank end.

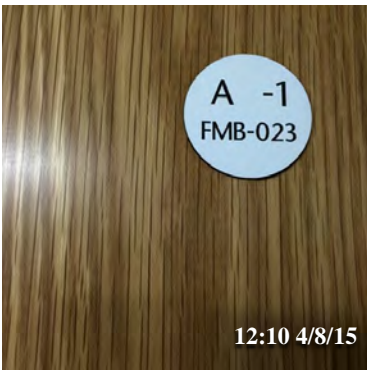
### Plant Room Keys

Both doors are not fitted with plant suited locks? Can these please be added to the PG2 suite?

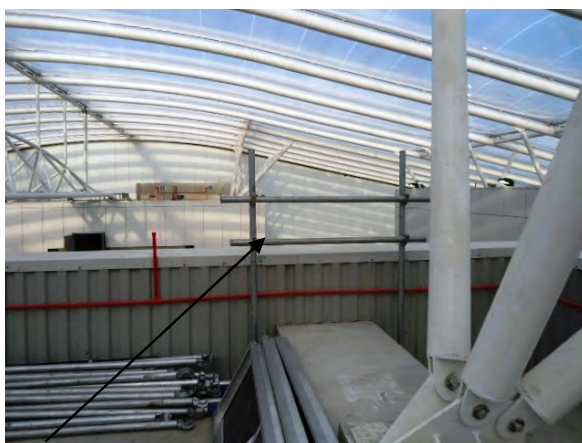
There is temporary scaffolding providing perimeter protection at concrete floor beams above the cores accessed from Level 12. The client intimated that protection is required. We have asked Brookfield to confirm when this will be undertaken. See Supervisor's Communication General Matters / Other Instructions (CI 13.1) No 242.

Temporary scaffolding providing perimeter protection.

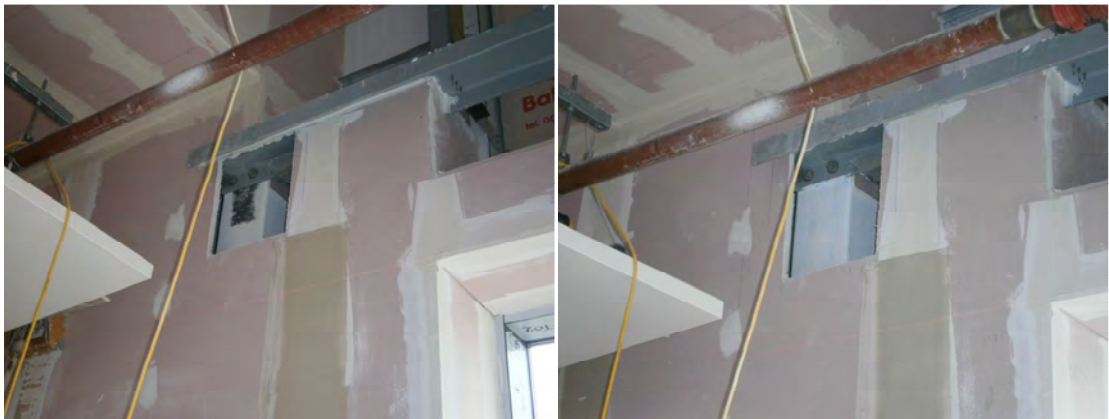
We carried out an inspection with Brookfield of part of the link corridor which will provide access between the Adult and Children's Hospital and Neurosurgery and the Teaching and Learning Centre. We noted that there was one area of incomplete intumescent coating to one column and not two as previously reported. Brookfield confirmed that they have addressed the problem and provide photographic evidence of the completed work.

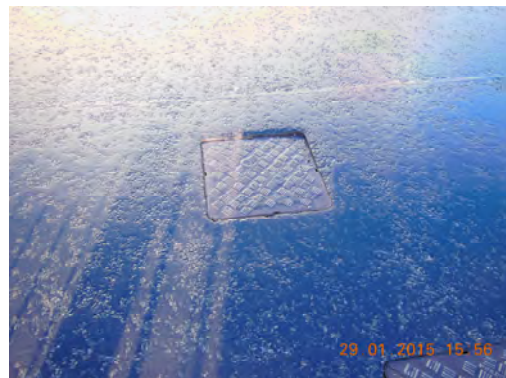
We reviewed Brookfield's NCR Tracker and noted the issues raised by the Package Managers. Brookfield confirmed that the tinting to the blockwork is complete to the pointing on the south and east elevations. An NCR has also been raised in relation to manholes which are below the level of the surrounding tar. (See photo opposite.)

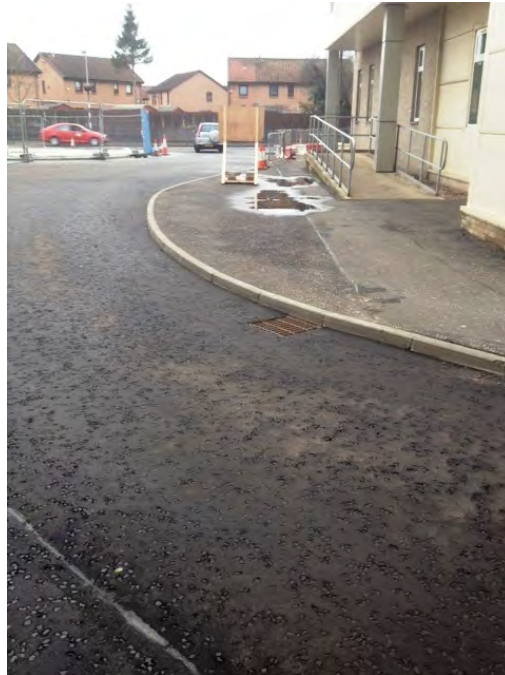
Footpath to the east side of the maternity unit.

We advised the Brookfield team on 16th December that ponding on the new extended footpath to the east side of the maternity unit has the potential to be a significant slip hazard in cold weather. We asked them to confirm their action to address this hazard. Brookfield has confirmed that Land Engineering have been instructed to lift the full width of tar and re-lay with a fall from the ramp to the new road kerb.

Ponding at the extended footpath area on the east side of the maternity unit, and potential specification non-compliance on sections of the footpath to the dual carriageway just north of the energy centre.

Brookfield had confirmed that work would commence week beginning 13<sup>th</sup> April. However they are awaiting an asphalt squad. (See Supervisor's Communication General Matters / Other Instructions (CI 13.1) No 237).

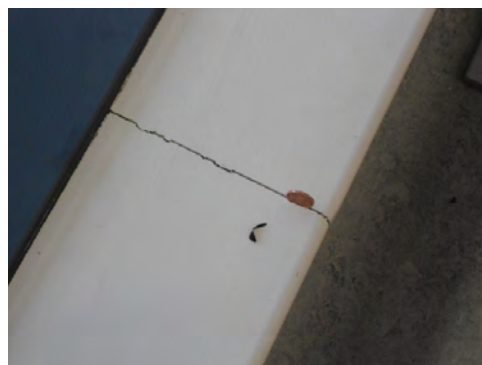
The joints at window cills are opening up. We asked Brookfield to confirm their remedial action to resolve this problem. They have filled and painted the joints but they have opened up again. They are sealing a joint with sealant to determine if this is a better solution. We await their response. See Supervisor's Notification of Defect (CI 42.2) No 99

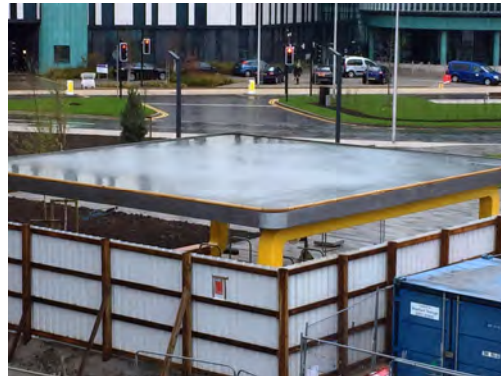
The Bicycle Shelter roof does not drain rainwater to the two corner outlets, consequently the rainwater is ponding. We asked Brookfield to confirm their proposed remedial action to resolve this defect. They have confirmed that following a meeting with the designer a level survey is required. The plan is to introduce a further outlet. See Supervisor's Notification of Defect (CI 42.2) No 129.

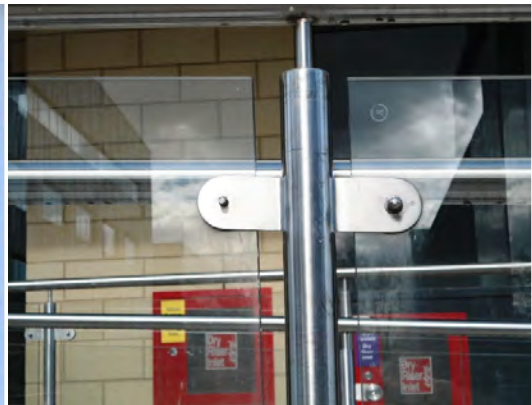
Nuts not fitted to glazed fixings to ramp.

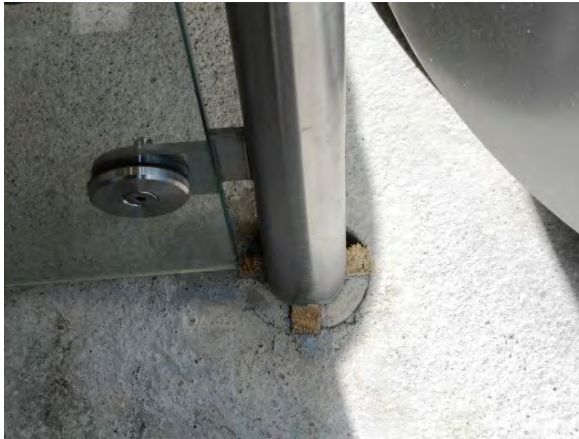
Timber wedges inappropriately used to support glazed panels.

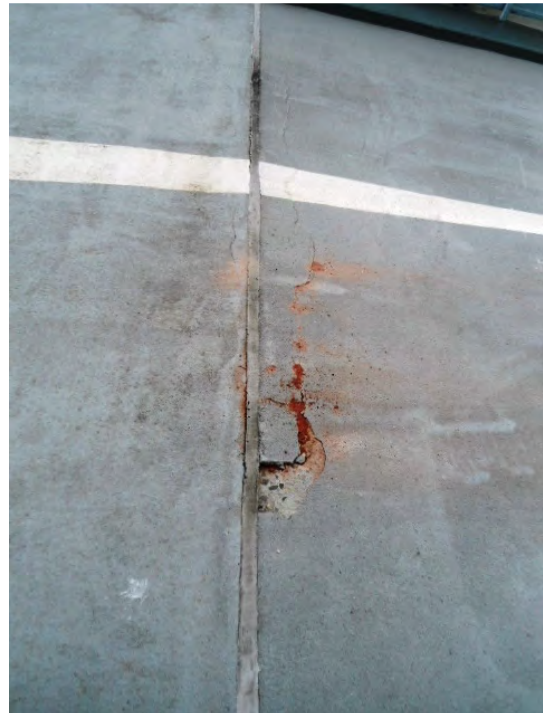
The concrete joint between the 6th floor and the down ramp is break up. We asked Brookfield to confirm the remedial measures to address this defect. They have instructed Dunne to carry out remedial works. See Supervisor's Notification of Defect (CI 42.2) No 132.

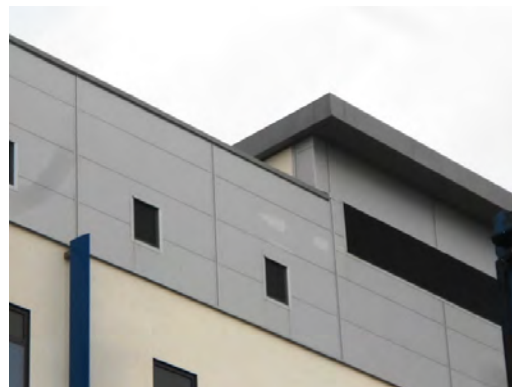
It appears that the cladding on the west facing elevation has been damaged and an unsuccessful attempt has been made to repair the damage. We asked Brookfield to confirm when this defect has been rectified. They have confirmed that this has been passed onto the sub-contractor Prater to rectify the unsuccessful attempt at the repair. See Supervisor's Notification of Defect (CI 42.2) No 137.

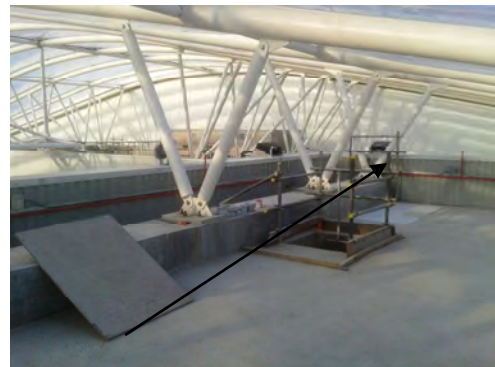
There is temporary scaffolding providing perimeter protection at concrete floor beams above the cores accessed from Level 12. The client intimated that protection is required. We have asked Brookfield to confirm when this will be undertaken. They are currently arranging for this work to be carried out. See Supervisor's Communication General Matters / Other Instructions (CI 13.1) No 242.

Temporary scaffolding providing perimeter protection.

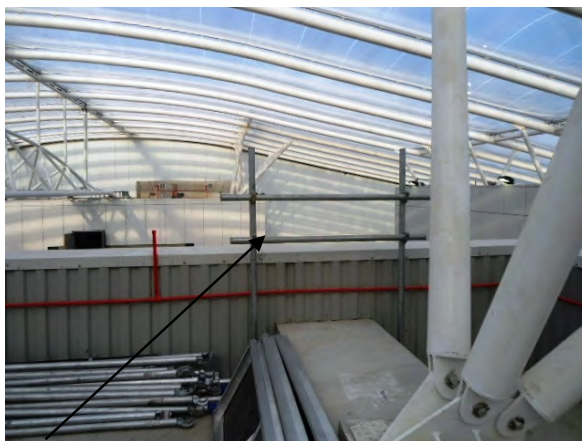
Temporary scaffolding providing perimeter protection.

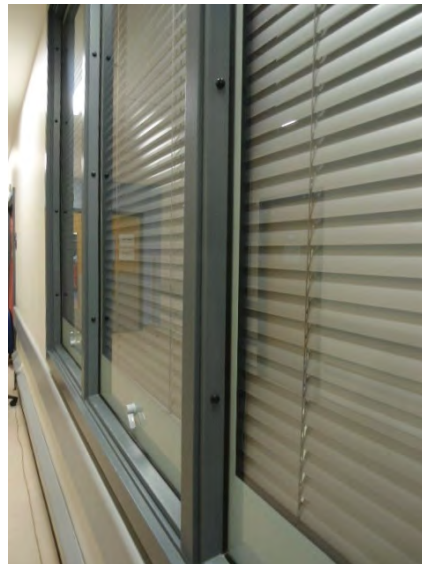
Following the discovery that Air Permeability Tests were not carried out within 36 isolation rooms in accordance with the Employer's Requirements NHS Guidance Documentations, document HBN 04-01. Brookfield is undertaken tests and remedial work to ensure the rooms are compliant.

During our inspection in the Hospital in September we were present during air permeability testing of room CCW-077 Bed 31. Additional work had to be carried out to the window beads by refitting them and fixing the screw heads with caps. Brookfield has been providing us with the test results for all rooms. There are currently 6 rooms requiring to be tested, 2 in Renal and 4 in Schiehallion. See Supervisor's Notification of Defect (C 42.2) No 138.

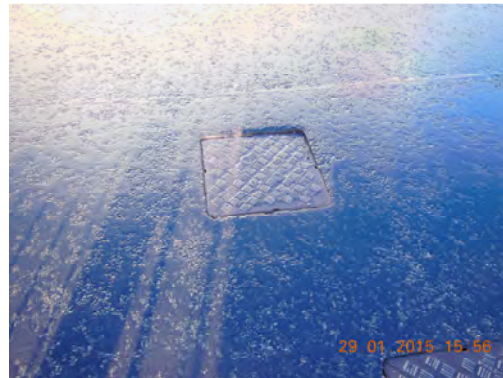
An NCR has also been raised in relation to manholes which are below the level of the surrounding tar. (See photo opposite.)

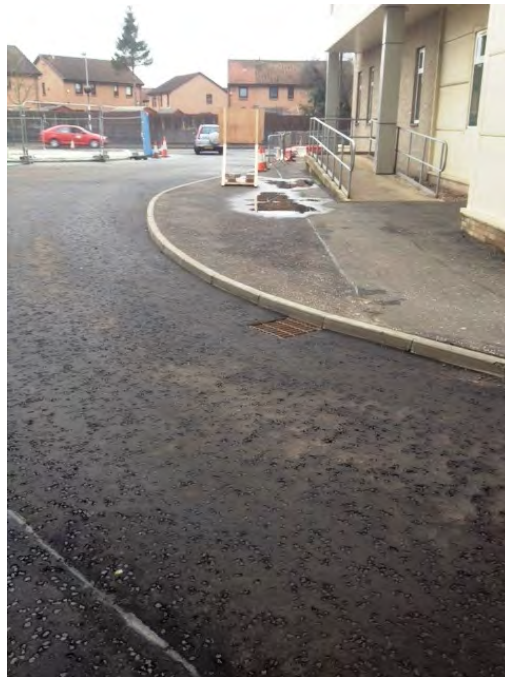
Footpath to the east side of the maternity unit.

We advised the Brookfield team on 16th December that ponding on the new extended footpath to the east side of the maternity unit has the potential to be a significant slip hazard in cold weather. We asked them to confirm their action to address this hazard. Brookfield has confirmed that Land Engineering have been instructed to lift the full width of tar and re-lay with a fall from the ramp to the new road kerb.

Brookfield had confirmed that work would commence week beginning 13<sup>th</sup> April. However they are awaiting an asphalt squad. (See Supervisor's Communication General Matters / Other Instructions (CI 13.1) No 237).

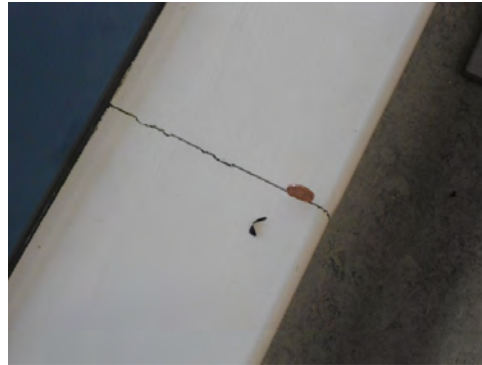
The joints at window cills are opening up. We asked Brookfield to confirm their remedial action to resolve this problem. They have filled and painted the joints but they have opened up again. They are sealing a joint with sealant to determine if this is a better solution. We await their response. See Supervisor's Notification of Defect (CI 42.2) No 99

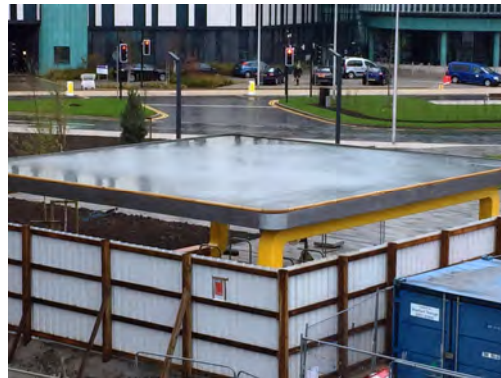
The Bicycle Shelter roof does not drain rainwater to the two corner outlets, consequently the rainwater is ponding. We asked Brookfield to confirm their proposed remedial action to resolve this defect. They have confirmed that following a meeting with the designer a level survey is required. The plan is to introduce a further outlet. See Supervisor's Notification of Defect (CI 42.2) No 129.

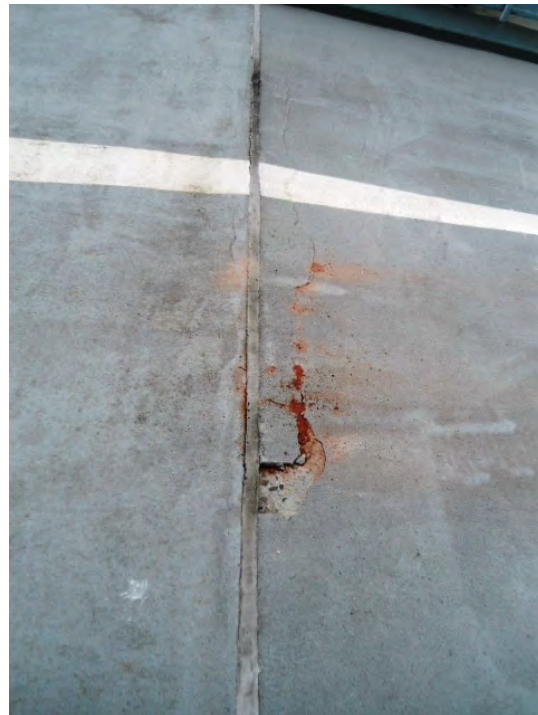
The concrete joint between the 6th floor and the down ramp is breaking up. We asked Brookfield to confirm the remedial measures to address this defect. They have instructed Dunne to carry out remedial works. See Supervisor's Notification of Defect (CI 42.2) No 132.

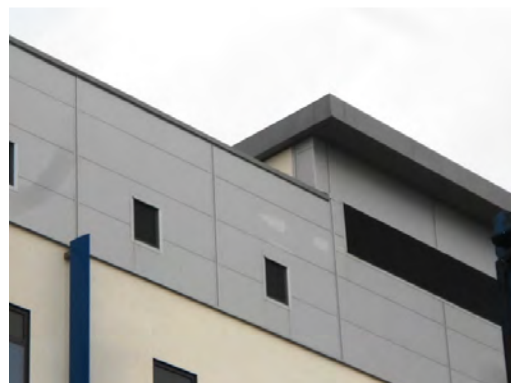
It appears that the cladding on the west facing elevation has been damaged and an unsuccessful attempt has been made to repair the damage. We asked Brookfield to confirm when this defect has been rectified. They have confirmed that this has been passed onto the sub-contractor Prater to rectify the unsuccessful attempt at the repair. See Supervisor's Notification of Defect (CI 42.2) No 137.

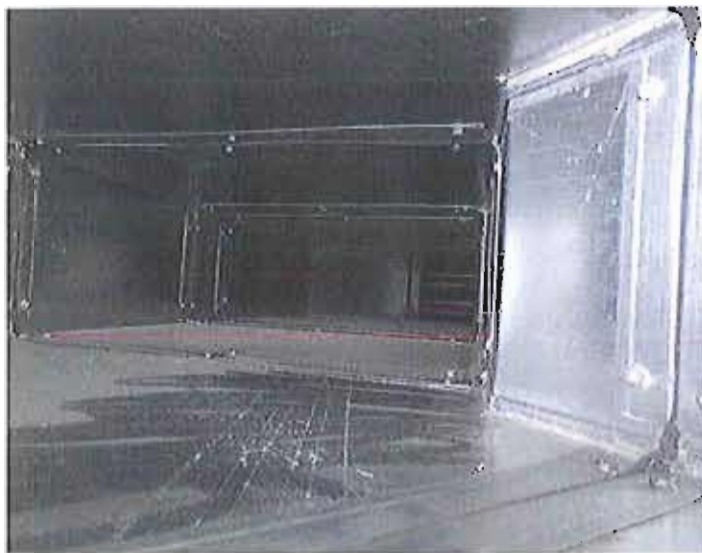
**1. Level 4 – Supply duct – Before clean.**

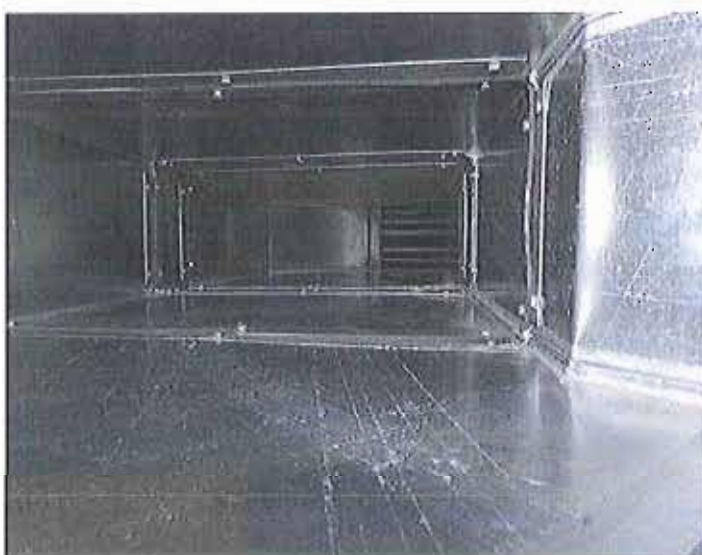
**2. Level 4 – Supply duct – After clean.**

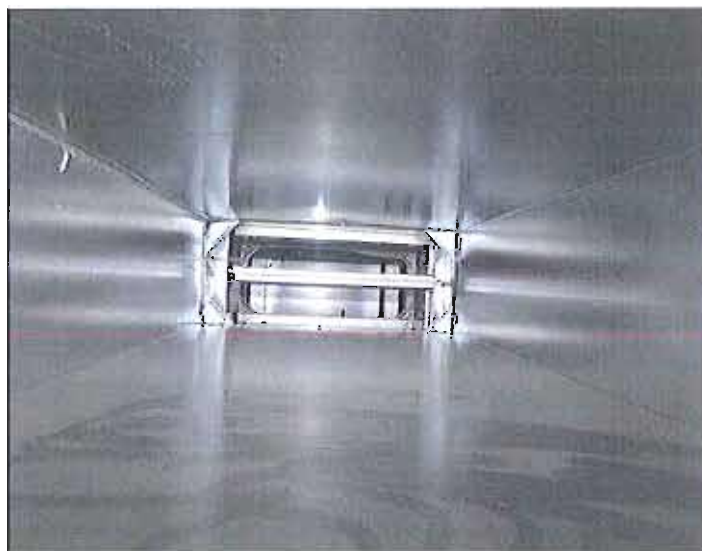
3. Level 4 – Supply duct – Before clean.

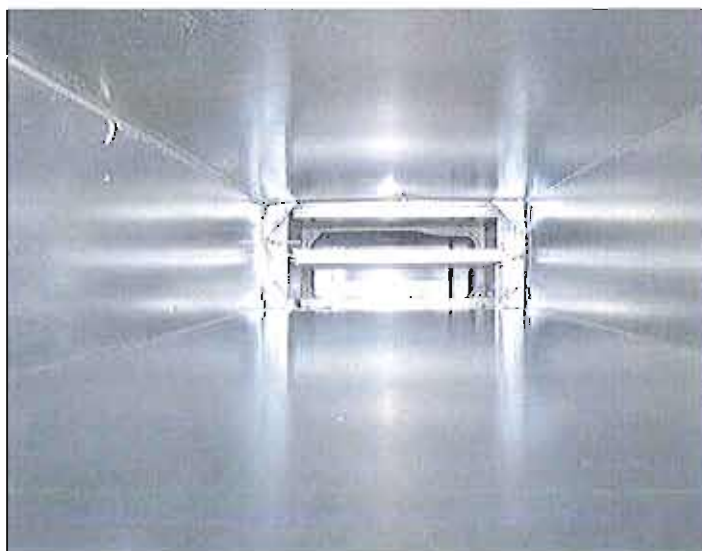
4. Level 4 – Supply duct – After clean.

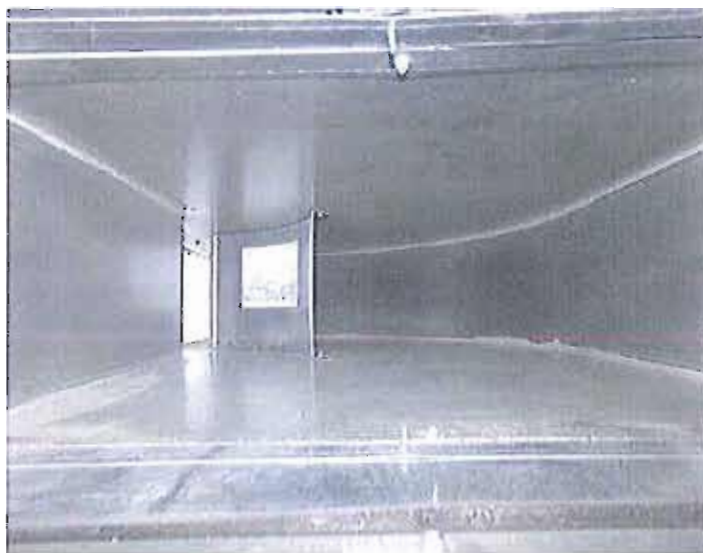
5. Level 4 – Supply duct – Before clean.

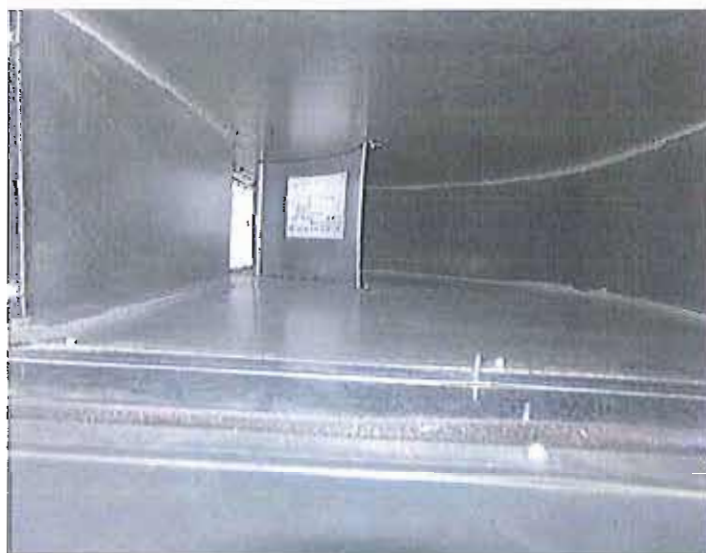
6. Level 4 – Supply duct – After clean.

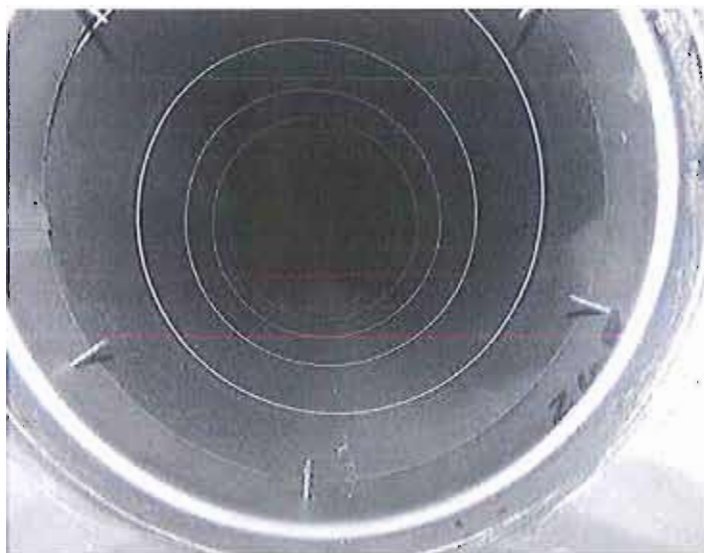
7. Level 4 – Supply duct – Before clean.

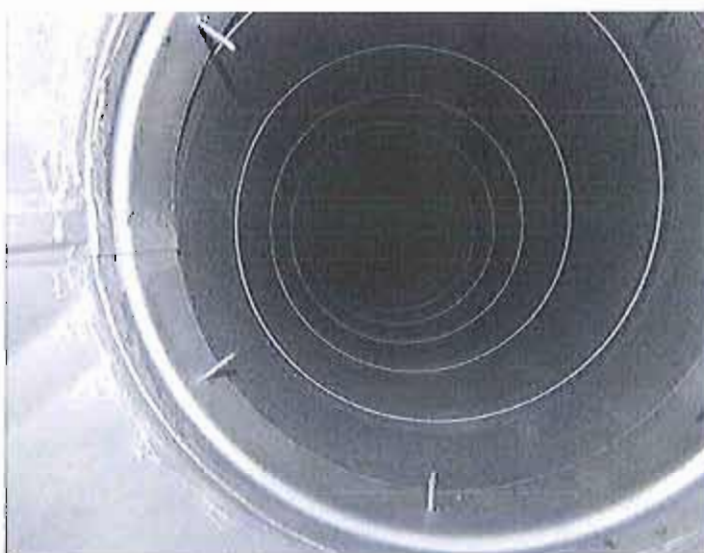
8. Level 4 – Supply duct – After clean.

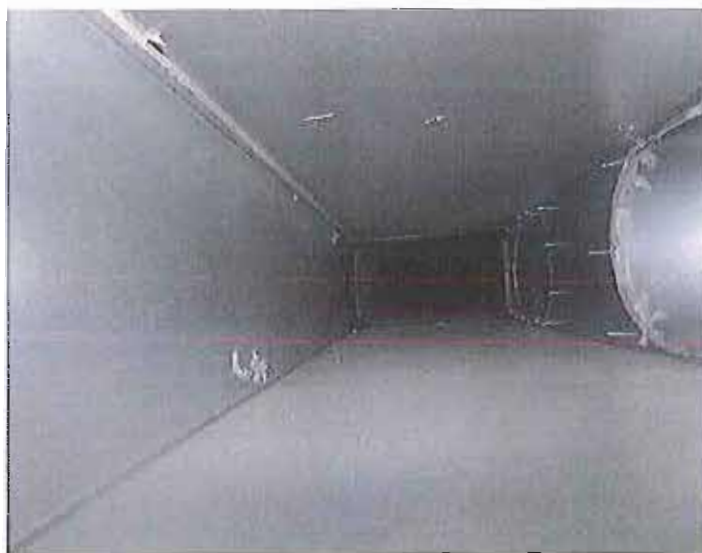
9. Level 4 – Supply duct – Before Clean.

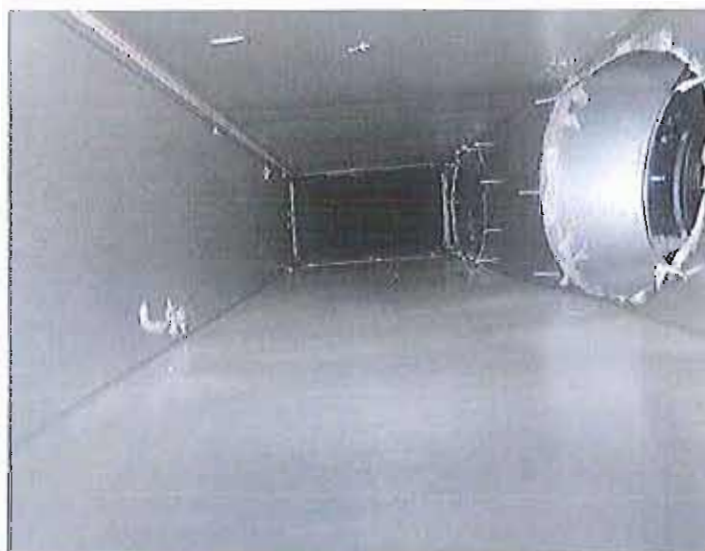
10. Level 4 – Supply duct – After Clean.

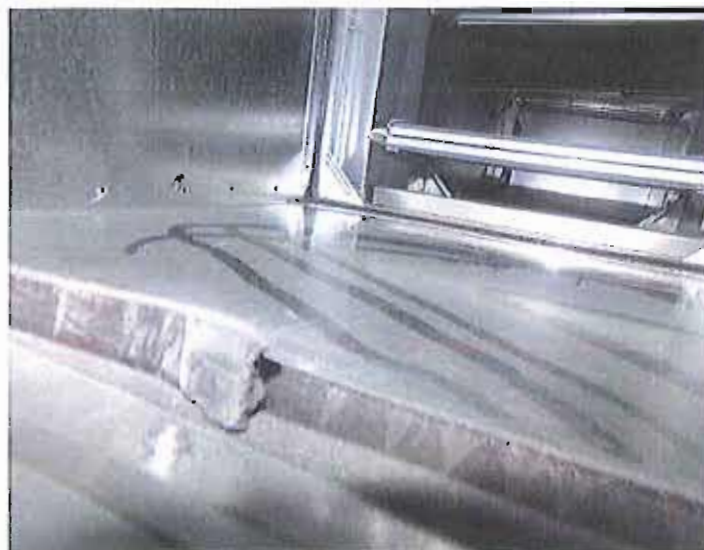
11. Level 4 – Supply duct – Before Clean.

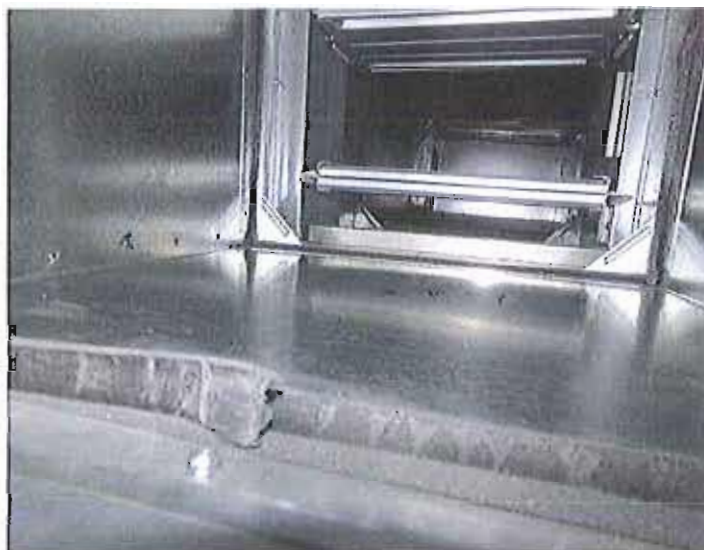
12. Level 4 – Supply duct – After Clean.

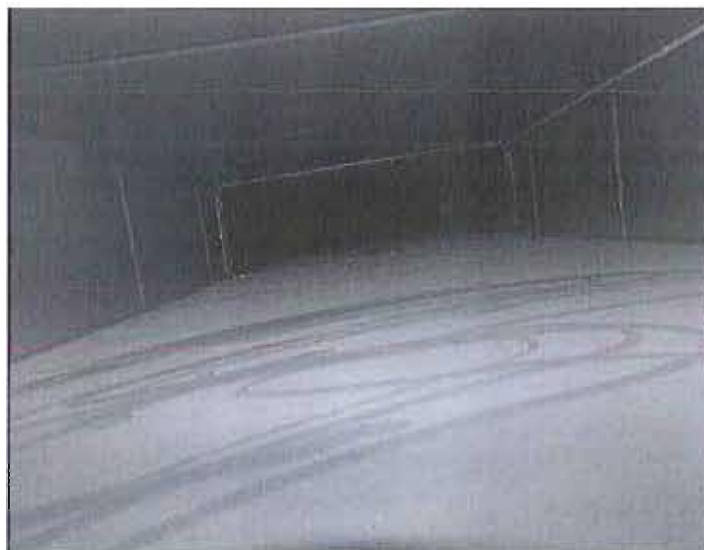
13. Level 4 – Supply duct – Before Clean.

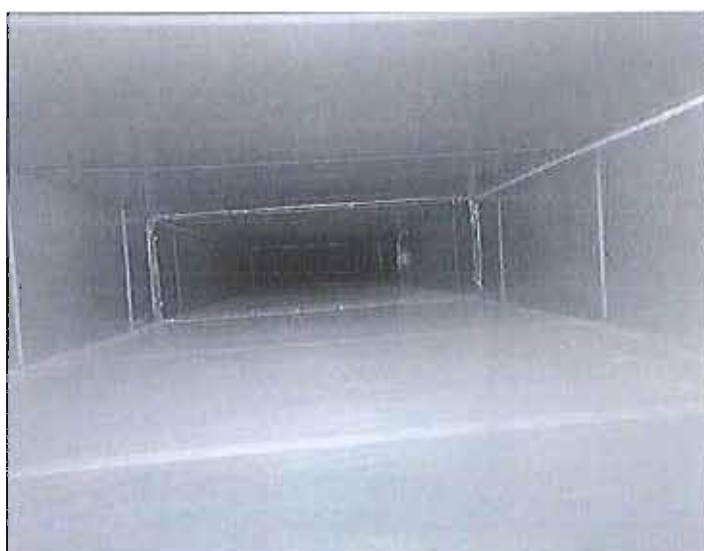
14. Level 4 – Supply duct – After Clean.

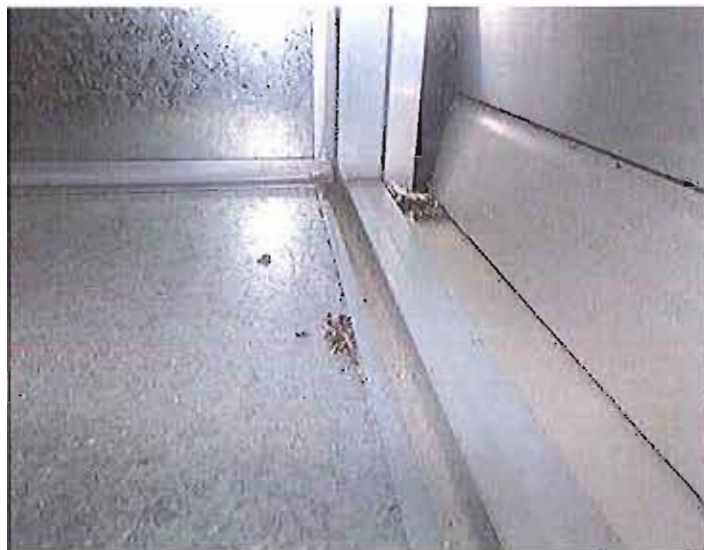
15. AHU 63 – Fresh air intake – Before Clean.

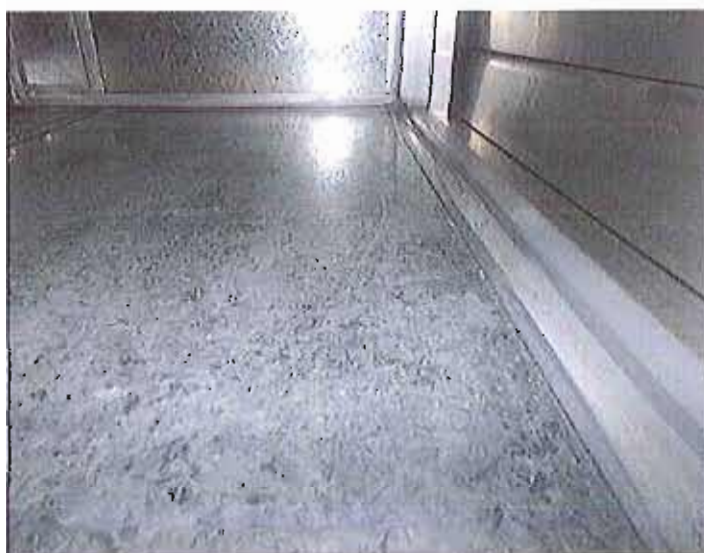
16. AHU 63 – Fresh air intake – After Clean.

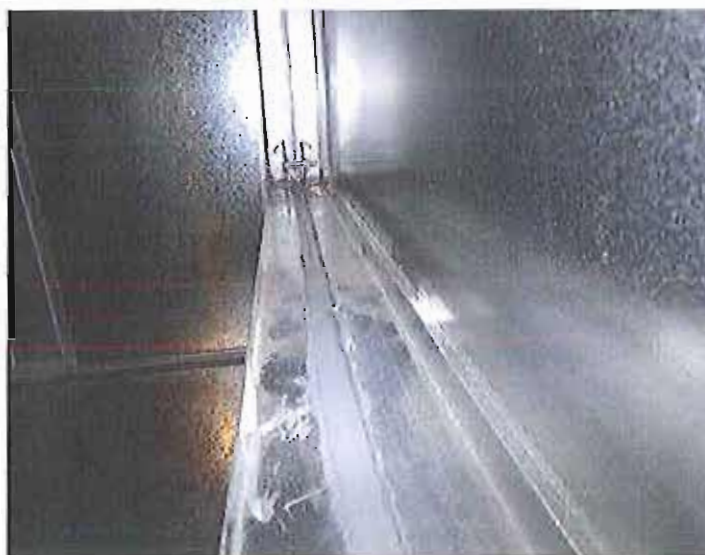
17. AHU 63 – Filter chamber – Before Clean.

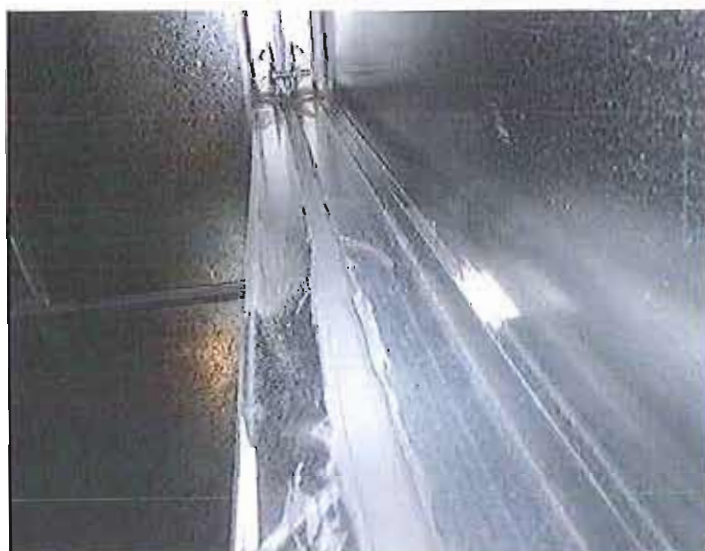
18. AHU 63 – Filter chamber – After Clean.

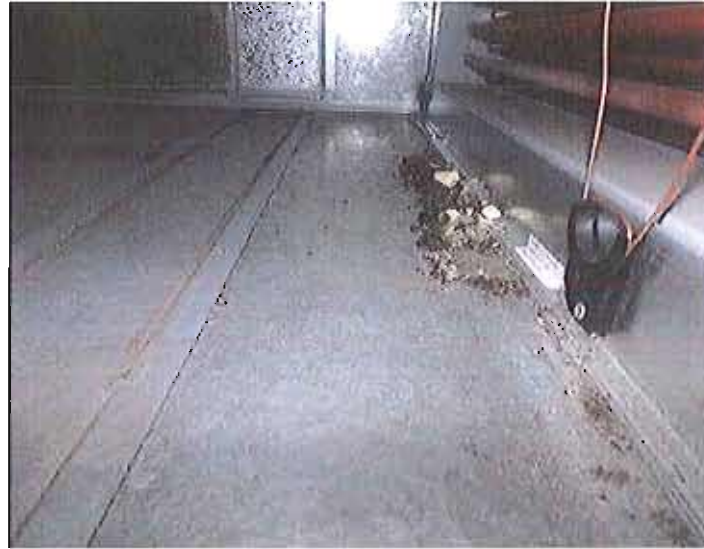
19. AHU 63 – Fan chamber – Before Clean.

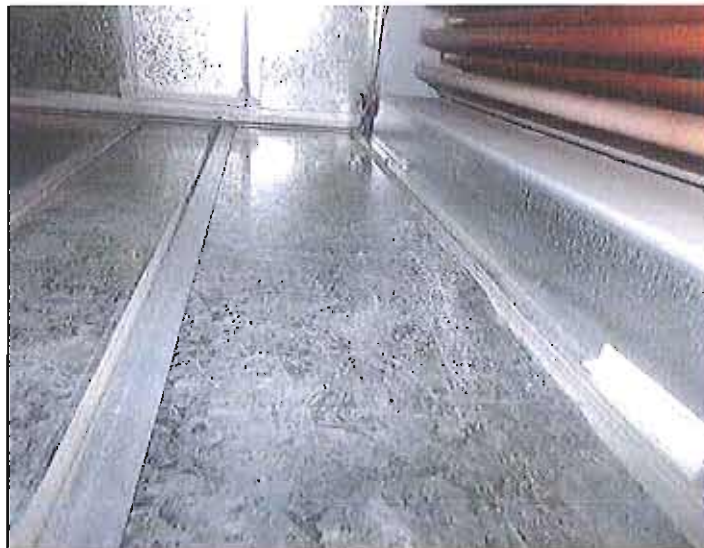
20. AHU 63 – Fan chamber – After Clean.

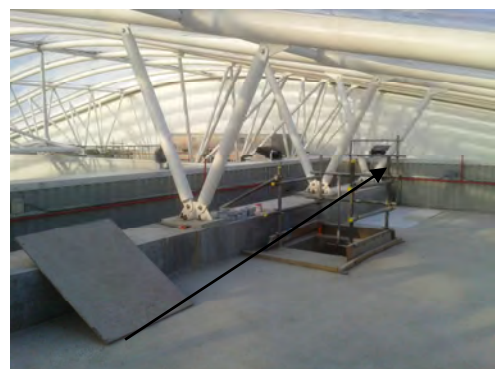
There is temporary scaffolding providing perimeter protection at concrete floor beams above the cores accessed from Level 12. The client intimated that protection is required. Brookfield has confirmed that M&S Engineering has taken site measurements and we await a date when the work will commence. See Supervisor's Communication General Matters / Other Instructions (CI 13.1) No 242.

Temporary scaffolding providing perimeter protection.
