# SCOTTISH HOSPITALS INQUIRY

## **Bundle of documents for Oral hearings commencing from 19 August 2024 in relation to the Queen Elizabeth University Hospital and the Royal Hospital for Children, Glasgow**

### **Bundle 12 - Estates Communications**

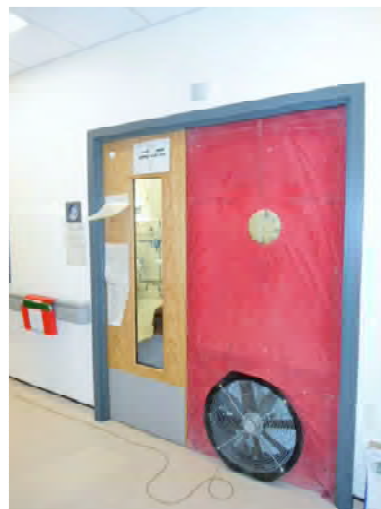
Following the discovery that Air Permeability Tests were not carried out within 36 isolation rooms in accordance with the Employer's Requirements NHS Guidance Documentations, document HBN 04-01. Brookfield is undertaken tests and remedial work to ensure the rooms are compliant.

During October we were in attendance during the successful air permeability test carried out in rooms A4 RENW-043 and A4 RENW-044. There are currently 2 in Schiehallion still to be tested. See Supervisor's Notification of Defect (C 42.2) No 139.

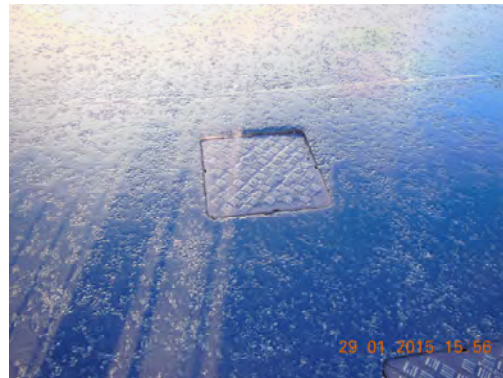
An NCR has also been raised in relation to manholes which are below the level of the surrounding tar. (See photo opposite.)

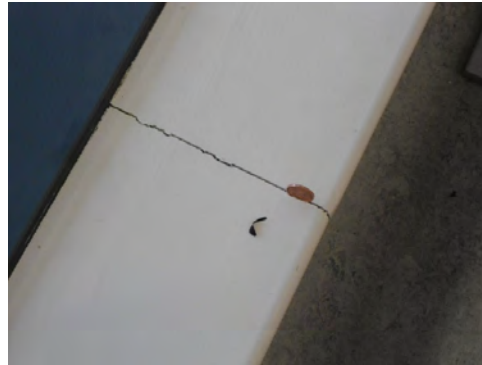
The joints at window cills are opening up. We asked Brookfield to confirm their remedial action to resolve this problem. They have filled and painted the joints but they have opened up again. They have sealed a joint with sealant to determine if this is a better solution. They intend to fill these cracks at the end of the defect liability period. See Supervisor's Notification of Defect (CI 42.2) No 99

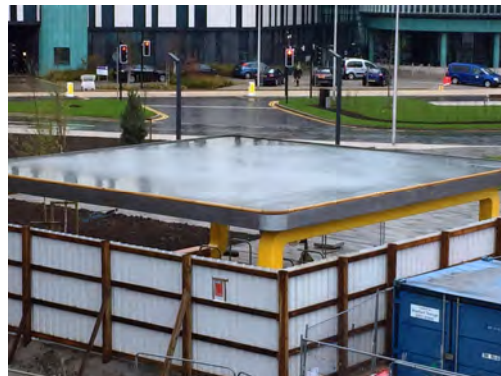
The Bicycle Shelter roof does not drain rainwater to the two corner outlets, consequently the rainwater is ponding. We asked Brookfield to confirm their proposed remedial action to resolve this defect. They have confirmed that following a meeting with the designer a level survey is required. The plan is to introduce a further outlet. See Supervisor's Notification of Defect (CI 42.2) No 129.

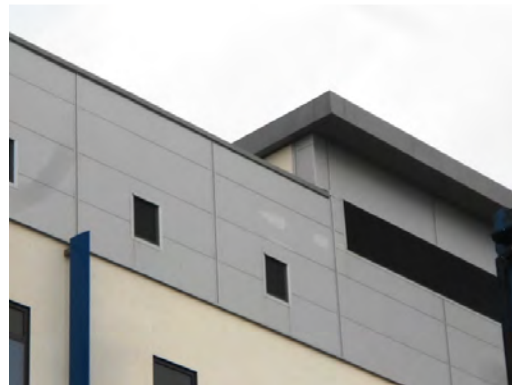
It appears that the cladding on the west facing elevation has been damaged and an unsuccessful attempt has been made to repair the damage. We asked Brookfield to confirm when this defect has been rectified. They have confirmed that this has been passed onto the sub-contractor Prater to rectify the unsuccessful attempt at the repair. See Supervisor's Notification of Defect (CI 42.2) No 137.

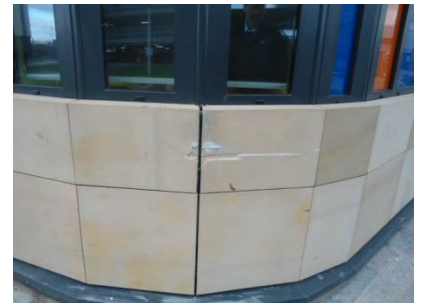
We noted that there is damage to the rain screen wall at the corner of the Royal Hospital for Children adjacent to the Children's Park. The rain screen sandstone cladding has sustained impact damage at ground floor level just below the windows. This may have been as a result of the adjacent works. We requested Brookfield to investigate the cause of the damage and advise on the proposed remedial action. We also asked them to confirm their proposals to prevent further incidents. Brookfield consequently investigated the damage and do not believe that this was caused by their works at the Children's play area. The type of plant that is working at that corner would have caused damage at a different height / location if it had come into contact with the building.

The only other activity within the area is the erection of the 20ft Christmas tree at the entrance of the Children's hospital. It is mounted in a concrete base which seems to have been sat in position by a forklift / Hiab, with the only access being round that corner. Following Brookfield's response, Supervisor's Communication General Matters / Other Instructions (CI 13.1) No 252 is now closed out.

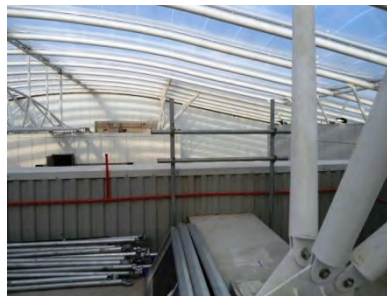
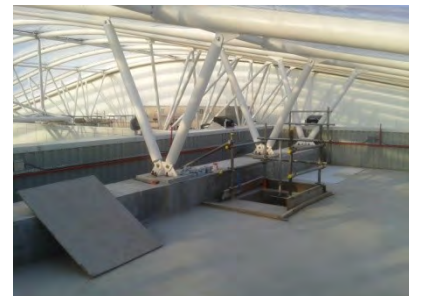
There is temporary scaffolding providing perimeter protection at concrete floor beams above the cores accessed from Level 12. The client intimated that protection is required. Brookfield has confirmed that M&S Engineering has taken site measurements and we await a date when the work will commence. See Supervisor's Communication General Matters / Other Instructions (CI 13.1) No 242.

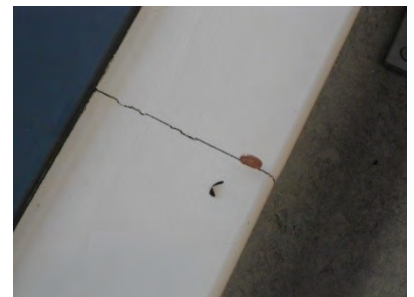
**4.4.3 Supervisor's Notification of Defect (CI 42.2) No 99**

The joints at window cills are opening up. We asked Brookfield to confirm their remedial action to resolve this problem. They have filled and painted the joints but they have opened up again. They have sealed a joint with sealant to determine if this is a better solution. They intend to fill these cracks at the end of the defect liability period.

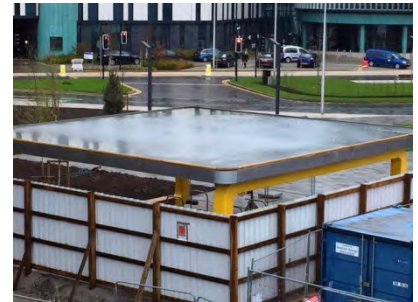
**4.4.7 Supervisor's Notification of Defect (CI 42.2) No 129.**

The Bicycle Shelter roof does not drain rainwater to the two corner outlets, consequently the rainwater is ponding. We asked Brookfield to confirm their proposed remedial action to resolve this defect. They have confirmed that following a meeting with the designer a level survey is required. The plan is to introduce a further outlet and be complete by the end of December.

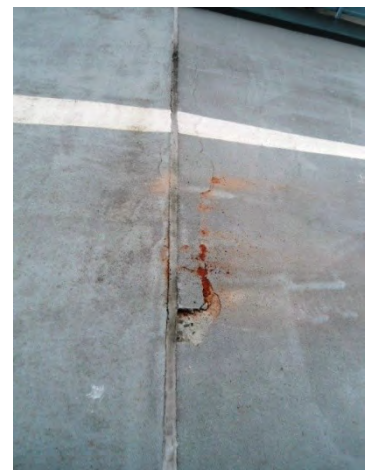
**4.4.8 Supervisor's Notification of Defect (CI 42.2) No 132**

The concrete joint between the 6th floor and the down ramp is breaking up. We asked Brookfield to confirm the remedial measures to address this defect. They have instructed Dunne to carry out remedial works but await details from WSP.

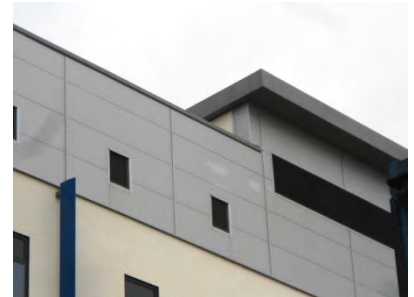
**4.4.10 Supervisor's Notification of Defect (CI 42.2) No 137.**

It appears that the cladding on the west facing elevation has been damaged and an unsuccessful attempt has been made to repair the damage. We asked Brookfield to confirm when this defect has been rectified. They have confirmed that this has been passed onto the sub-contractor Prater to rectify the unsuccessful attempt at the repair.

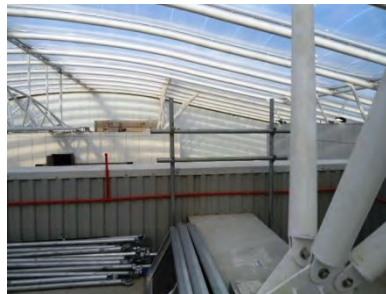
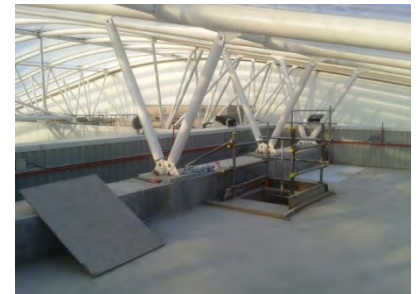
There is temporary scaffolding providing perimeter protection at concrete floor beams above the cores accessed from Level 12. The client intimated that protection is required. Brookfield has confirmed that M&S Engineering has taken site measurements and we await a date when the work will commence. See Supervisor's Communication General Matters / Other Instructions (CI 13.1) No 242.

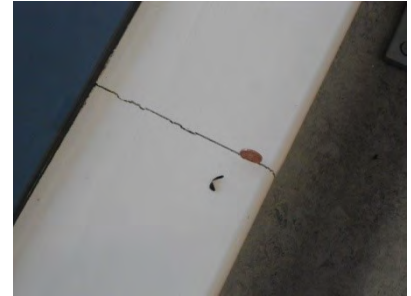
**4.4.2 Supervisor's Notification of Defect (CI 42.2) No 99**

The joints at window cills are opening up. We requested Brookfield to confirm the remedial action to resolve this problem. Brookfield has filled and painted the joints but they have opened up again. Thereafter Brookfield sealed a joint with sealant to determine if this resolved the defect. Accordingly, Brookfield intends to fill these cracks at the end of the defect liability period. We shall therefore retain this defect notification open.

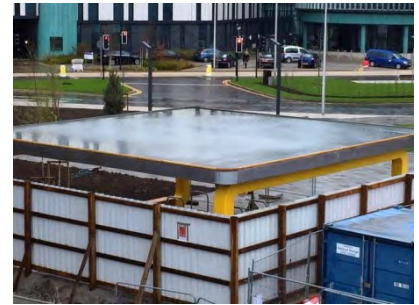
**4.4.6 Supervisor’s Notification of Defect (CI 42.2) No 129.**

The Bicycle Shelter roof does not drain rainwater to the two corner outlets, consequently the rainwater is ponding. We requested Brookfield to confirm their proposed remedial action to resolve this defect. They have confirmed that following a meeting with the designer a level survey is required. The plan is to introduce a further outlet and be complete by the end of December. We request current status of resolution of this defect from Brookfield.

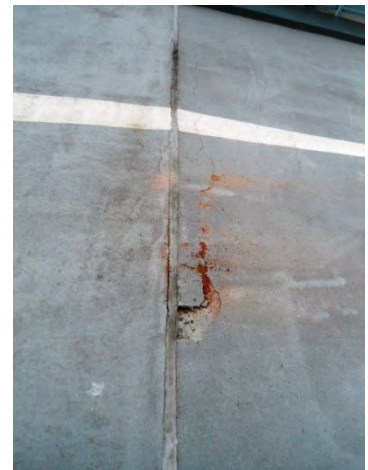
**4.4.7 Supervisor’s Notification of Defect (CI 42.2) No 132**

The concrete joint between the 6th floor and the down ramp is breaking up. We asked Brookfield to confirm the remedial measures to address this defect. They have instructed Dunne to carry out remedial works but await details from WSP.

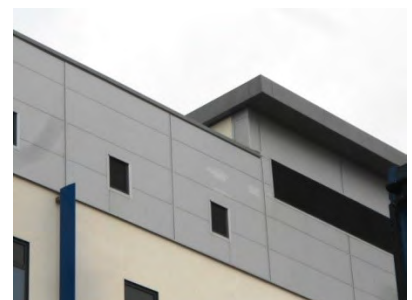
**4.4.9 Supervisor’s Notification of Defect (CI 42.2) No 137.**

The cladding on the west facing elevation has been damaged and an unsuccessful attempt has been made to repair the damage. We requested Brookfield to advise when this defect is to be rectified. Brookfield has confirmed that this has been passed onto the relevant sub-contractor Prater to rectify the unsuccessful attempt at the repair.

137	Seeking confirmation when the damaged cladding has been rectified.	01.07.15	Response received.
140	Defective spindles to privacy visicom panels to timber doors and screens.	29.09.15	Awaiting a rectification programme
141	The Board did not receive the cards/key numbers for the Bristol maid drugs cupboards at completion. Please provide these without delay.	13.10.15	Response received.
142	Seeking confirmation when the incomplete cladding on the underside of the Link Bridge between Royal Hospital for Children and the Neonatal Unit will be carried out.	09.11.15	Response received.
All other Defects Notifications raised have been closed out. A total of 142 defects notices have been issued to date.
