**Bundle of documents for Oral hearings
commencing from 13 May 2025 in relation
to the Queen Elizabeth University Hospital
and the Royal Hospital for Children,
Glasgow**

**Bundle 33
NEC3 Supervisor's Reports and Project
Supervisors Interface Action Notes**

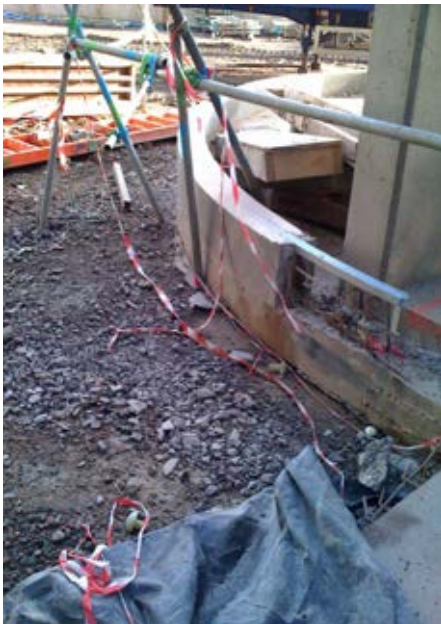
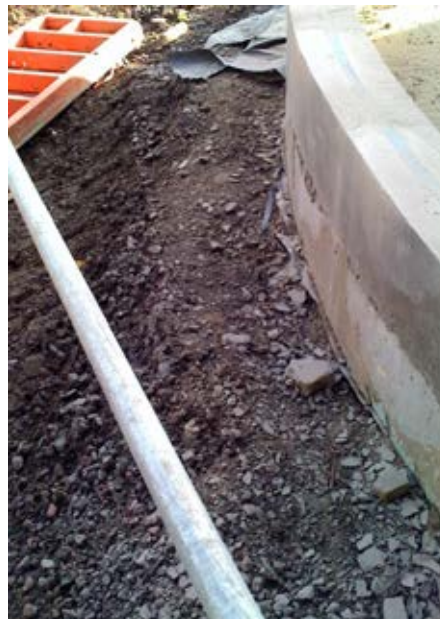
We noted that the DPM which should extend beyond the edge the ground beam at the Office Pod has been trimmed off flush. Drawing AA(21)37 indicates that the DPM should continue up the outer face of the ground beam to the underside of the structural copper cladding. We

2 & 3. DPC Around Pod Floor Slab: 19 November 2010

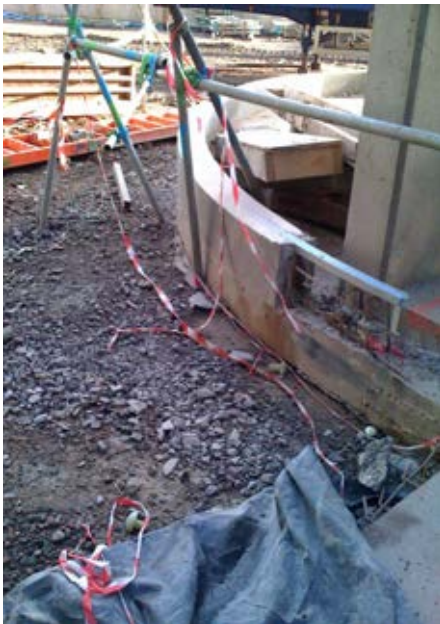
2 & 3. DPC Around Pod Floor Slab: 19 November 2010

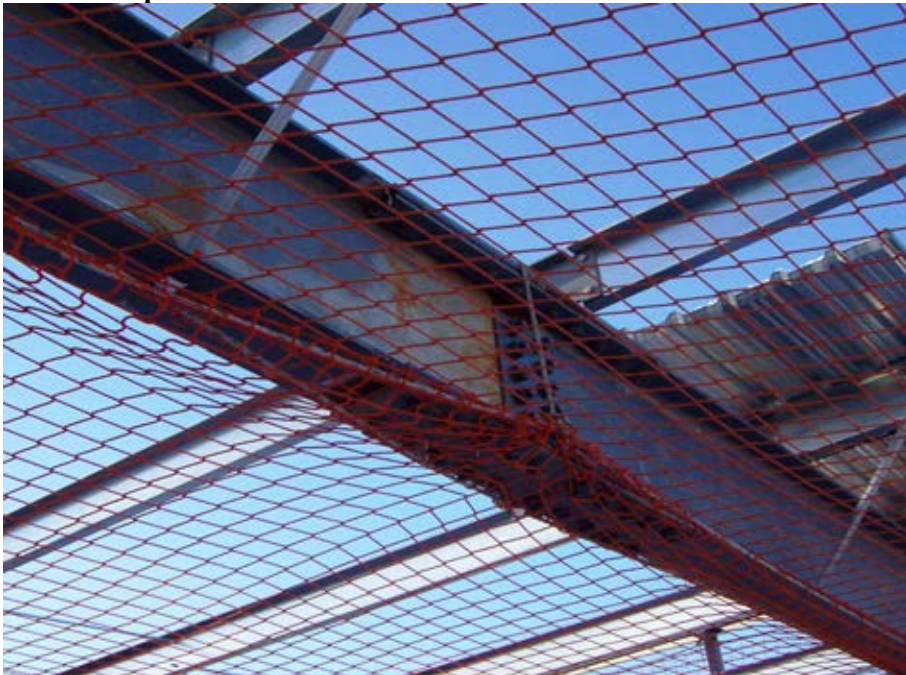
5. West Wing Roof Steelwork: Poor Surface Finish: 22nd November 2010

02	<p>We have requested the following information:</p> <p>Confirm when remedial measures will be undertaken to address the poor rust patches in the structural steel and notify us when the work is complete to allow us to carry out an inspection.</p> <p>Confirm the approved remedial action to ensuring that there is a continuous DPM in accordance with the drawing.</p> <p>Provide the QA Inspection and Test Plan for signing off the completion of the work prior to the commencement of the structural copper cladding.</p>	25.11.10	<p>Brookfield confirmed remedial action to be undertaken.</p> <p>Fosroc drawings approved by the Architect.</p> <p>Awaiting a response.</p>
03	<p>Provide full test results to BS 5234 for strength and stability for all partition types including impact damage and door slam tests for all door opening situations.</p> <p>Please provide the appropriate test results/certificates required for the partition in accordance with BS 476 for all fire resistance partitions.</p> <p>Please provide your written method statement/QA describing the erection procedures together with details of the quality checking and recording systems being implemented to ensure correct construction of partitions and correct location of partition types.</p> <p>Confirm if timber inserts are being fitted within the horizontal section of partition forming the door opening to provide strength and robustness.</p>	03.12.10	<p>Response received.</p> <p>Response received.</p> <p>Response received.</p> <p>Response received.</p>

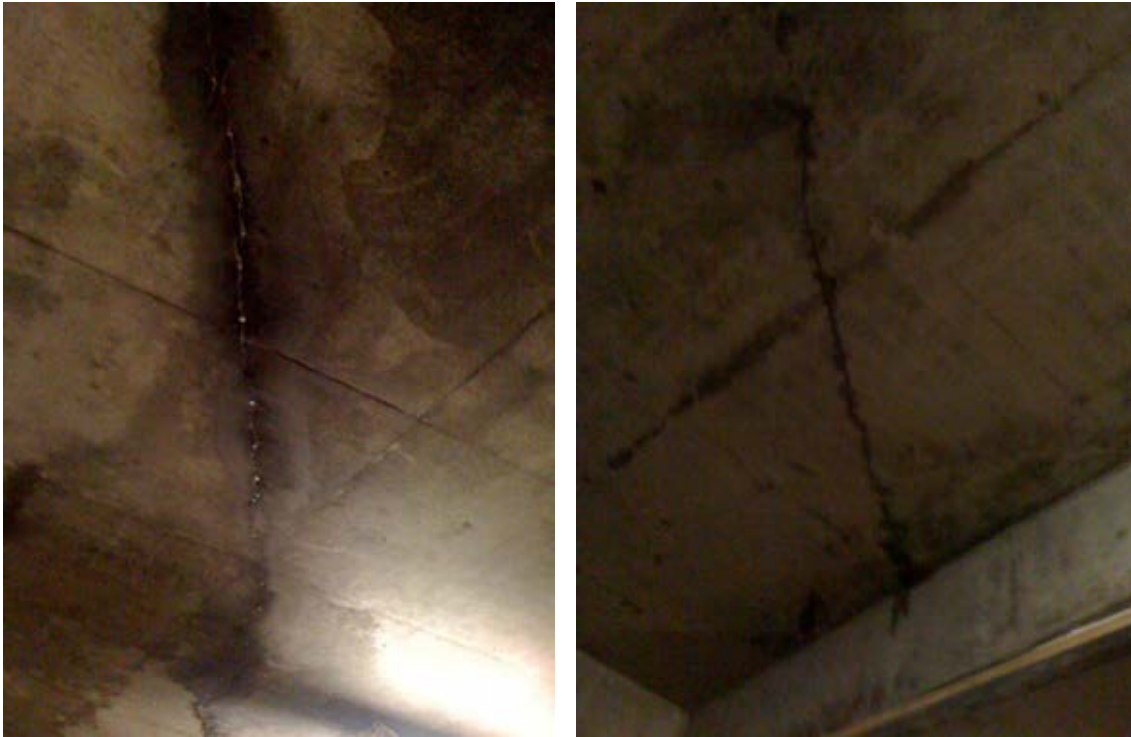
During the period the propping has been removed from the Mortuary and Tank areas in the basement, some cracks in these areas still being apparent and these are understood to be subject to survey. A report from the designers in respect of this issue is awaited.

3. Crack in Water Tank Area: 14th December 2010.

4. Crack in Mortuary Area: 14th December 2010.

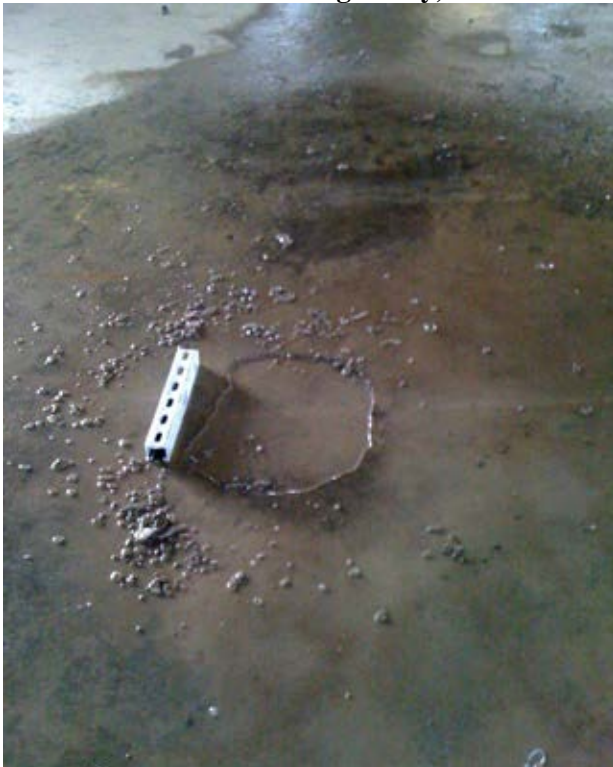
3. Concrete slab surface irregularity, 2nd Floor: 7th February 2011.

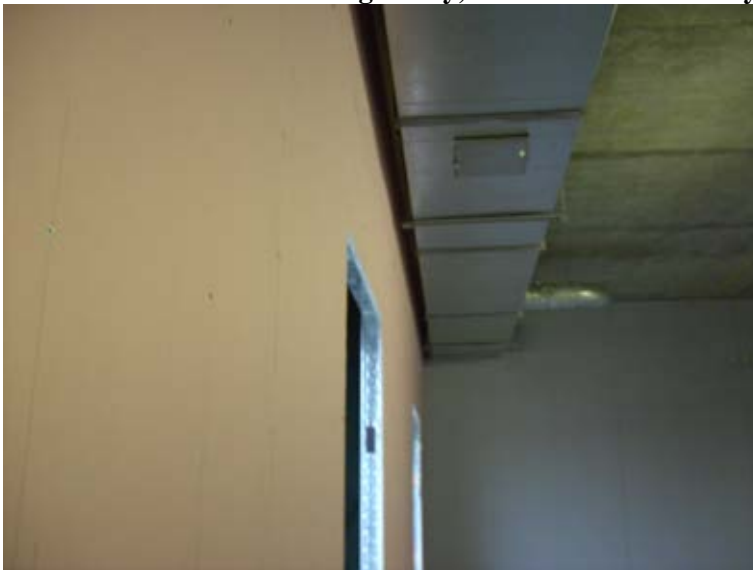
4. Boarding on Level 1, Areas 1 and 2 on the west elevation of the west wing are not fixed between the underside of the trunking and the concrete soffit (500mm) 14th February 2011.

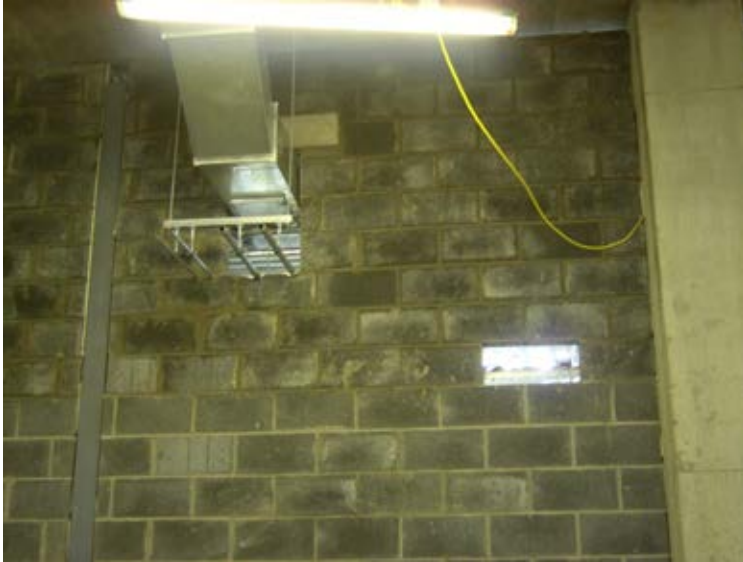
5. Lintel still to be fitted to service opening: 18th February 2011.

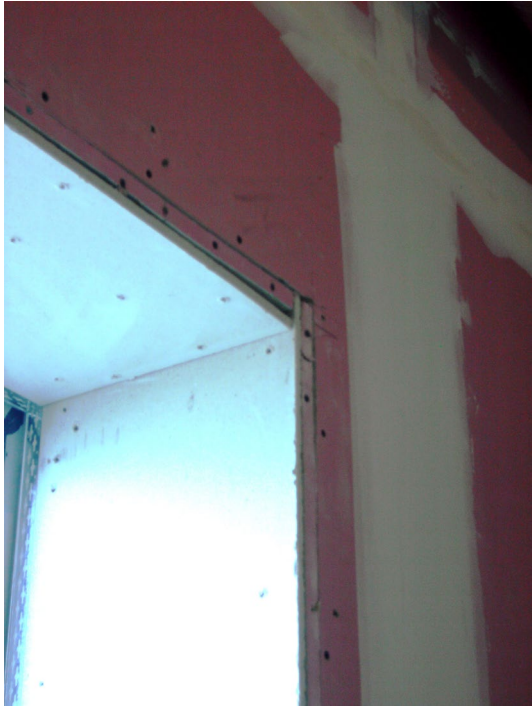
1. Poor plasterboard detail Level 1 West Elevation.

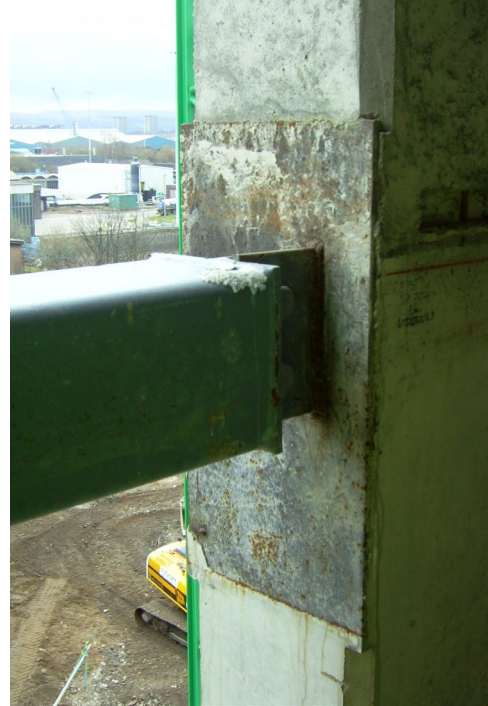
2. Rust on steel plate.

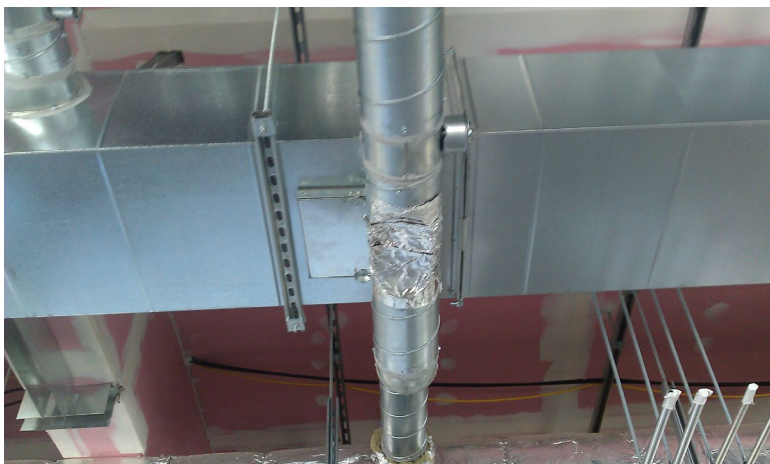
6 Restricted Access. April 2011

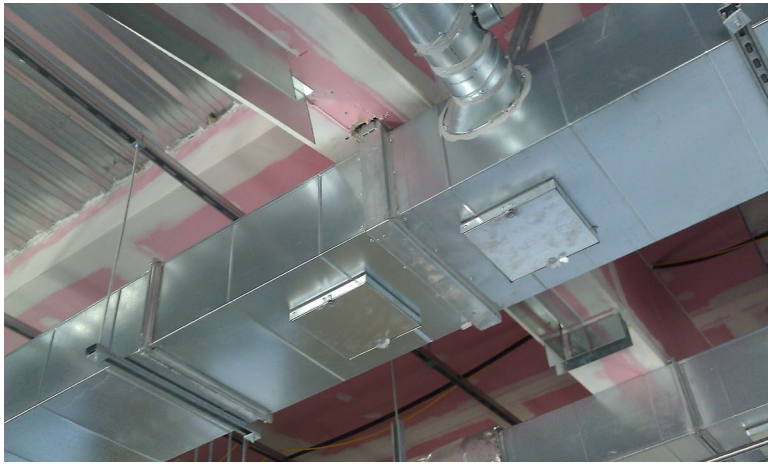
7. Fire damper in beam. April 2011

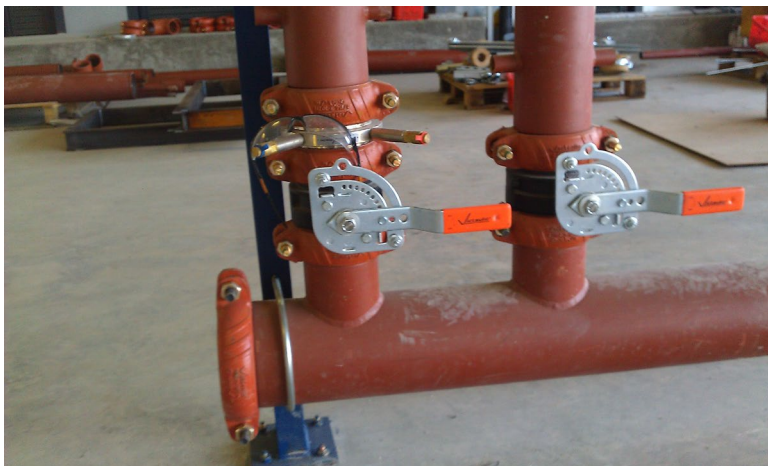
8. Commissioning Set not installed as manufactures recommendations. April 2011

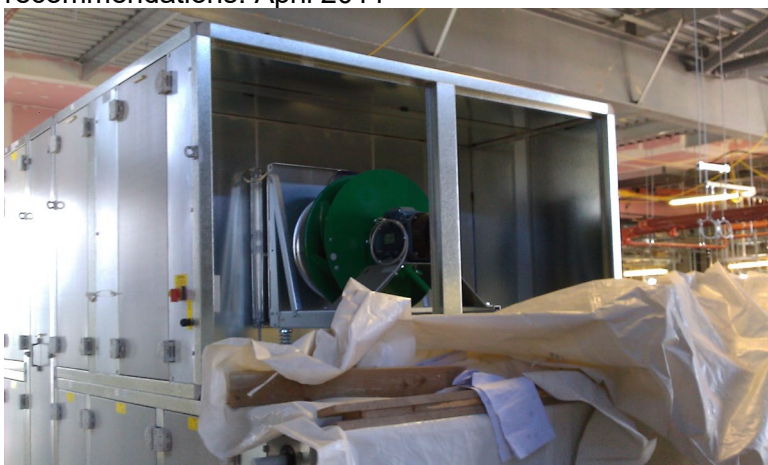
9. Unprotected AHU. April 2011

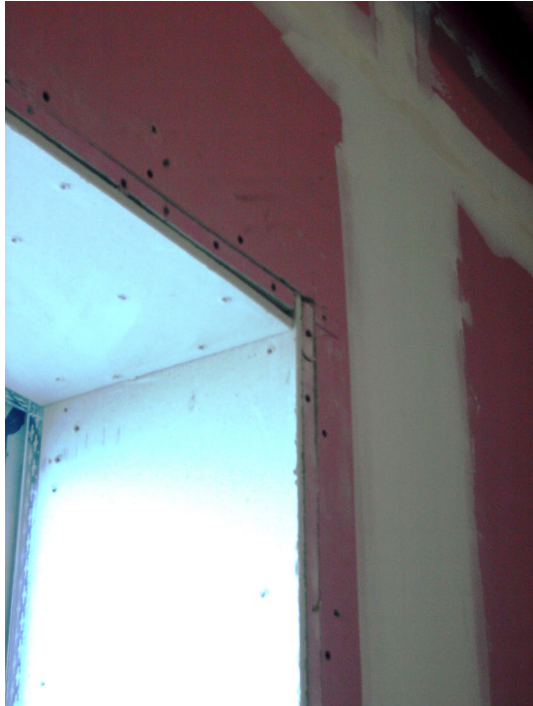
1. Poor plasterboard detail Level 1
West Elevation April 2011.

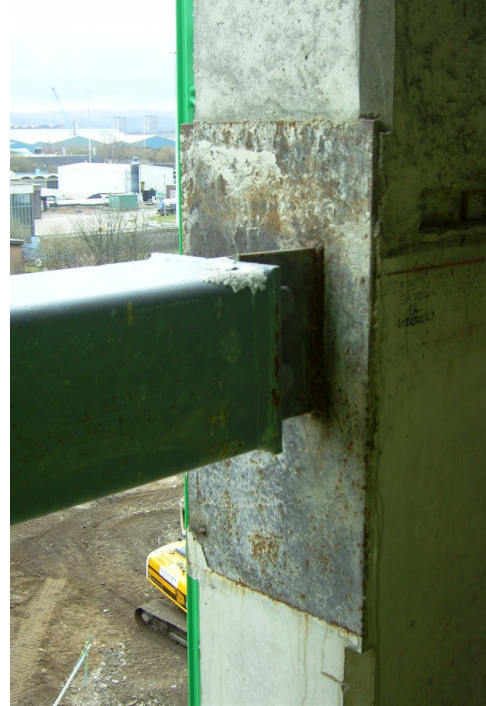
2. Rust on steel plate April 2011.

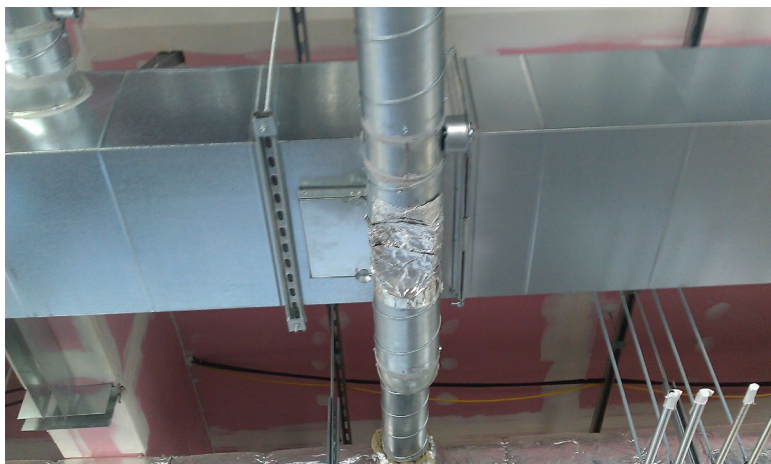
6 Restricted Access. April 2011.

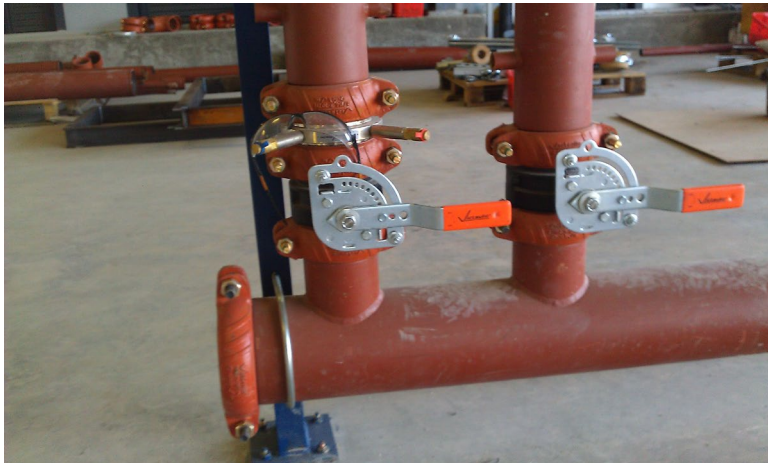
8. Commissioning Set not installed as manufactures recommendations. April 2011.

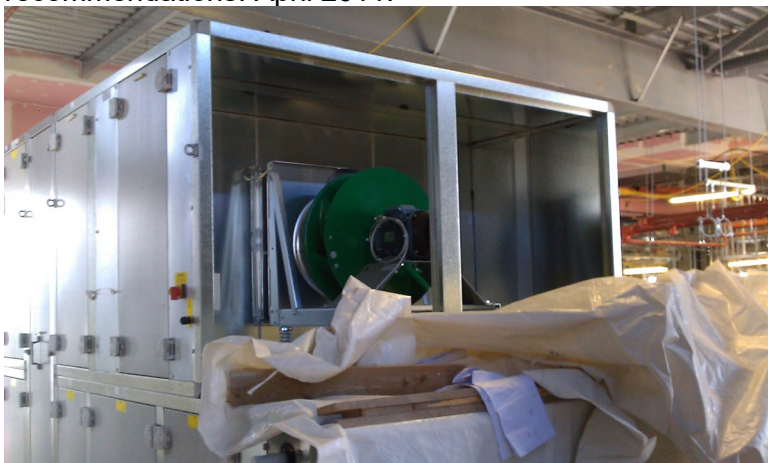
9. Unprotected AHU. April 2011.

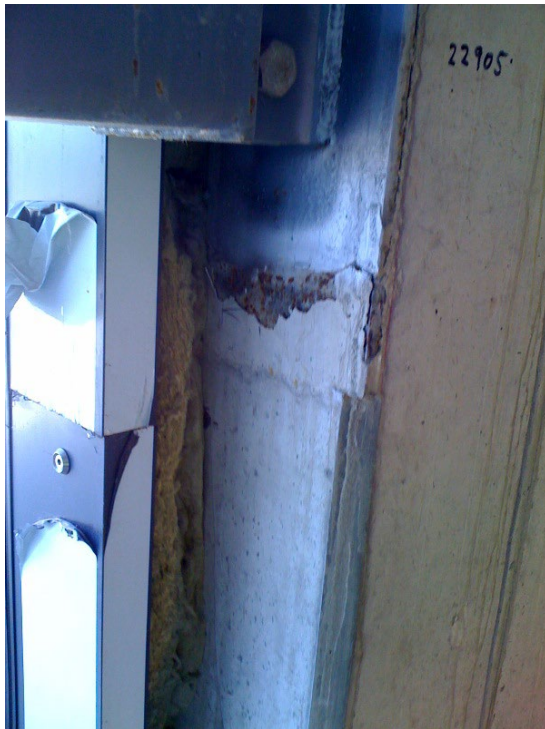
10. Incomplete touch up painting to the steel plates at the stairwells April 2011.

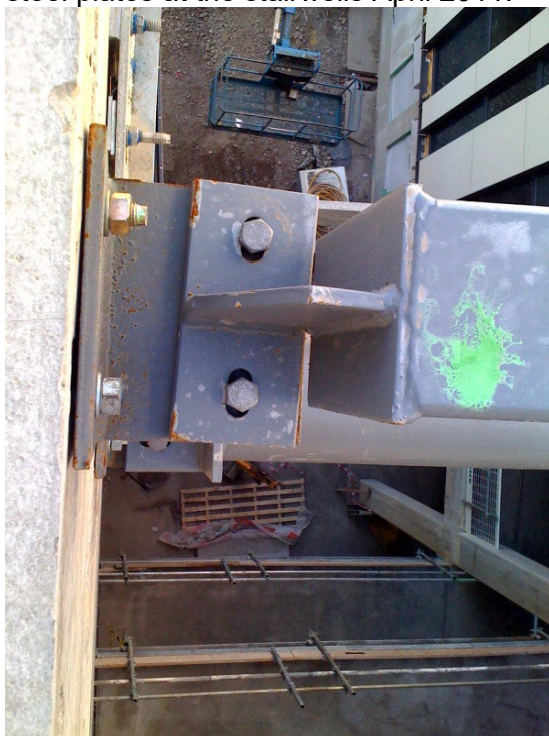
11. Tight bolt head to hole overlap April 2011.

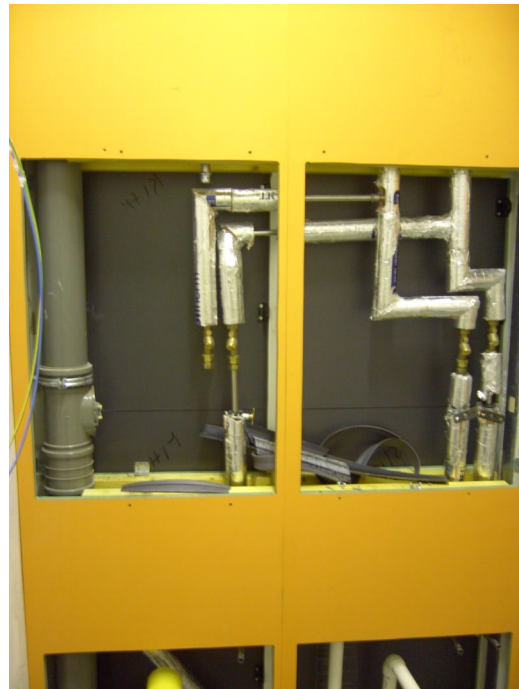
2. IPS panels between L1/B/057 and L1/B/058 May 2011.

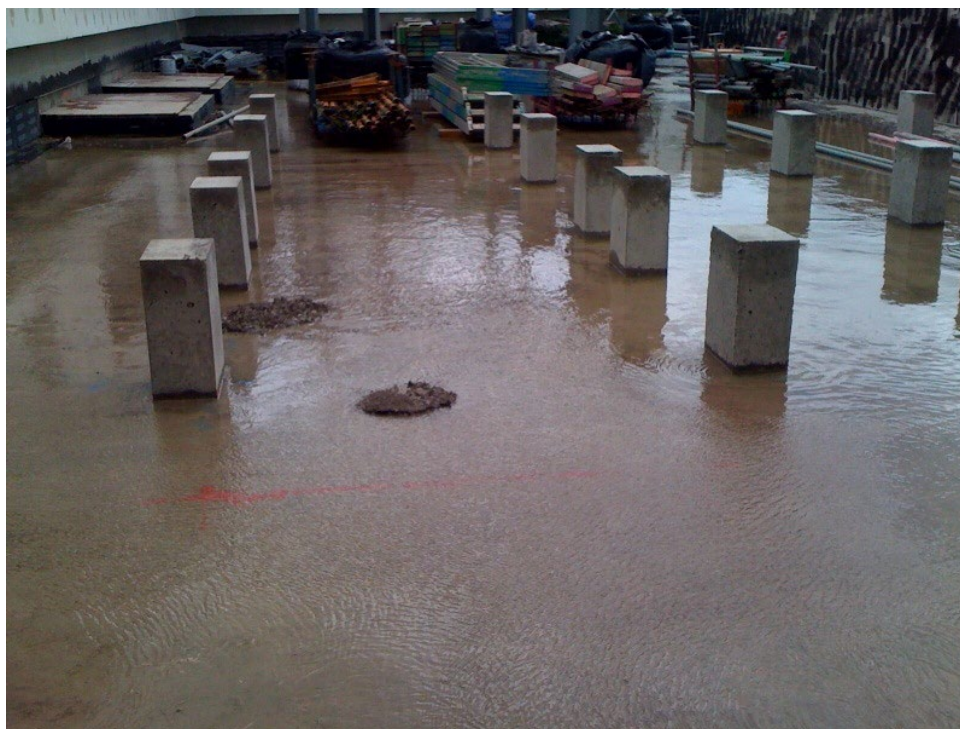
3. Ponding due to roof not laid to falls May 2011.

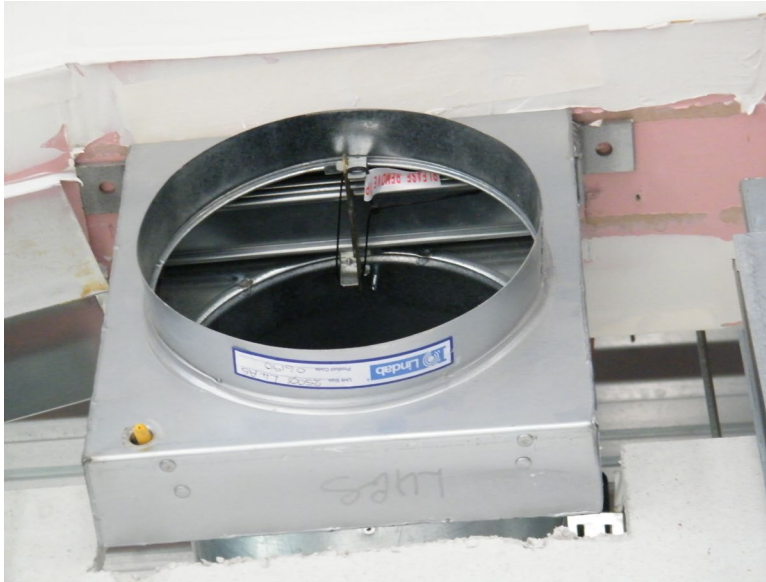
4. Fire Damper no fix to structure May 2011.

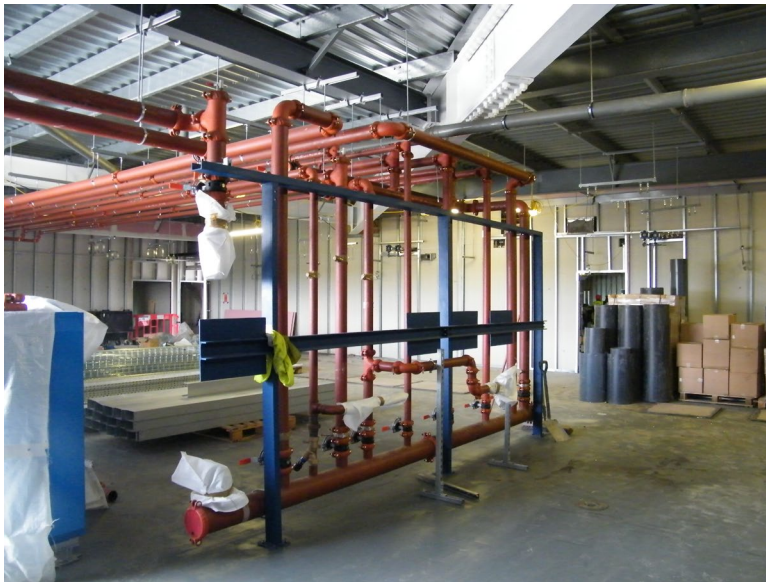
5. Pump / pipework support not fixed at top May 2011.

Ductwork, pipework and cable trays have been supported in a limited number of areas. All services should be supported independent of surrounding services. Brookfield has confirmed that they would address these situations during the snagging process, however since raising this communication we have noted other areas where the same problem arises. We shall continue to monitor this situation. (See Supervisor's Communication General Matters / Other Instructions (CI 13.1) No 30).

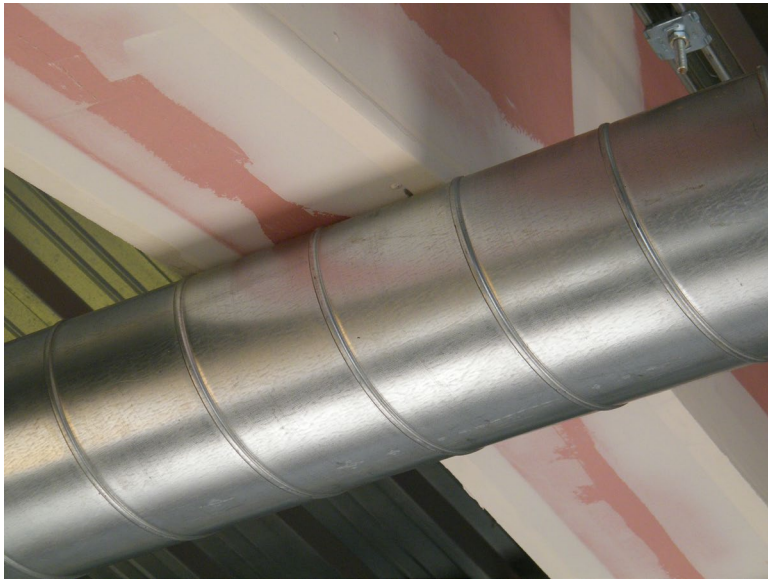
6 Ducts in contact with structure May 2011.

It was also noted in several places that there were ducts with open ends and in contact with the structure. Brookfield is aware of this and is in the process of addressing this issue. (See Supervisor's Communication General Matters / Other Instructions (CI 13.1) No 32).

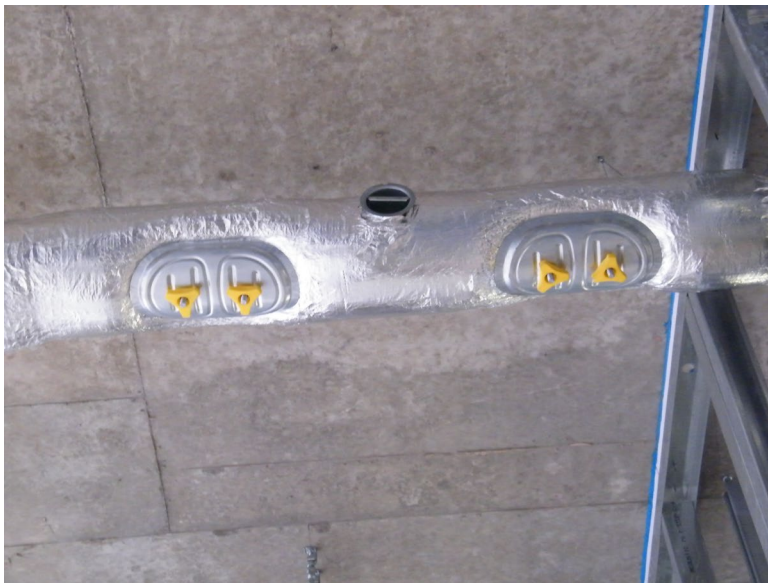
7. Inspection doors fitted over insulation May 2011.

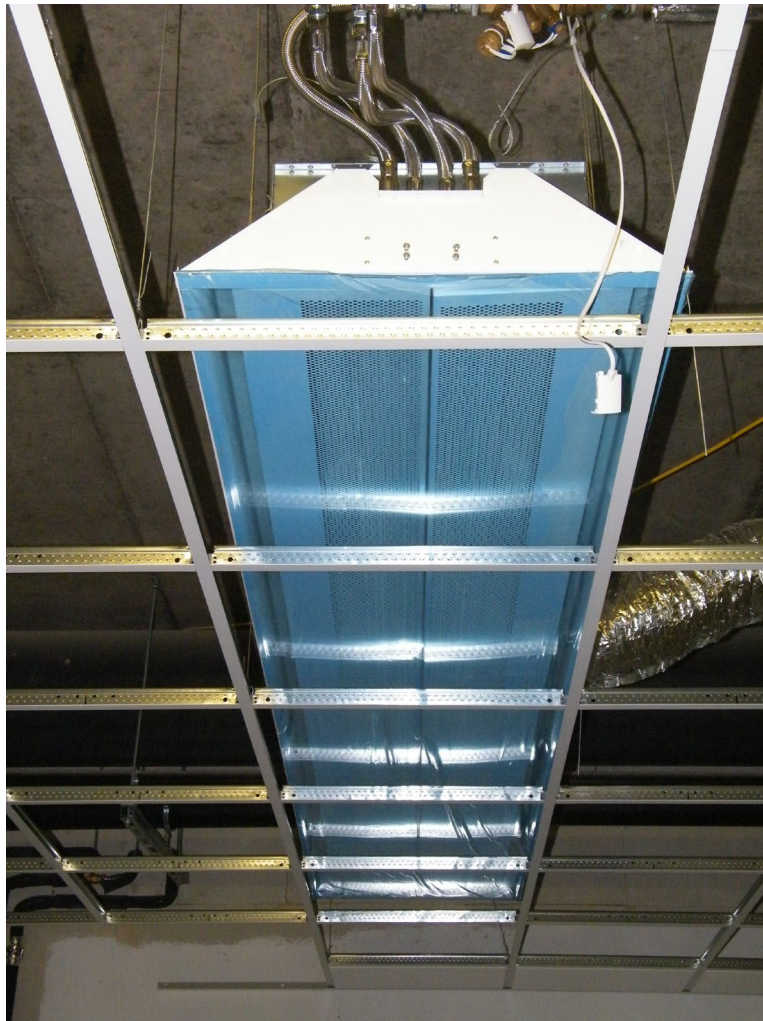
8. Chilled Beams not aligned and supports not suitable
May 2011.

We noted that flexible connections to the chilled beams were distorted and we have reminded Brookfield that these connections should be installed as per the manufacturer's recommendations. Brookfield has intimated that the chilled beams are not at their final mounting heights. On the second visit to drop the beams in to position the flexible connections should straighten and become unrestricted. We shall continue to monitor this on future visits. (See Supervisor's Communication General Matters / Other Instructions (CI 13.1) No 34).

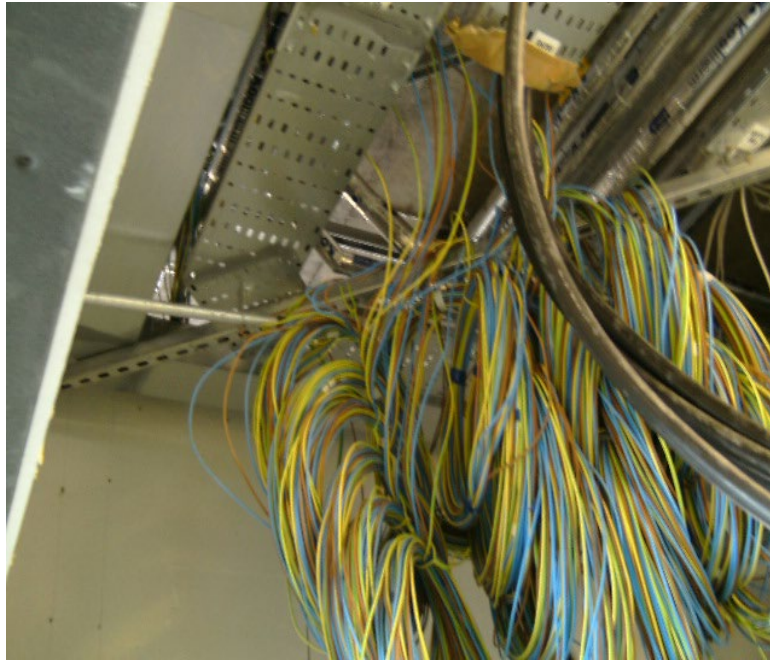
12. Cable protection required May 2011.

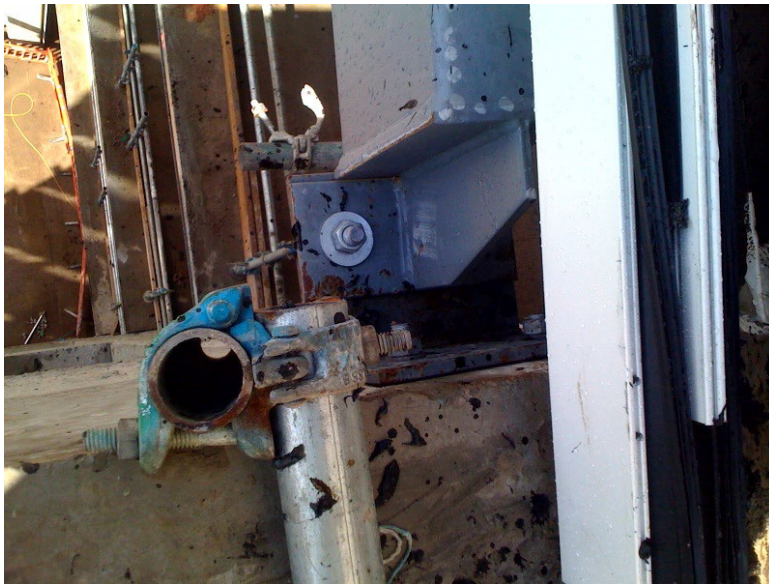
14. Solution to overlap of bolt head May 2011.

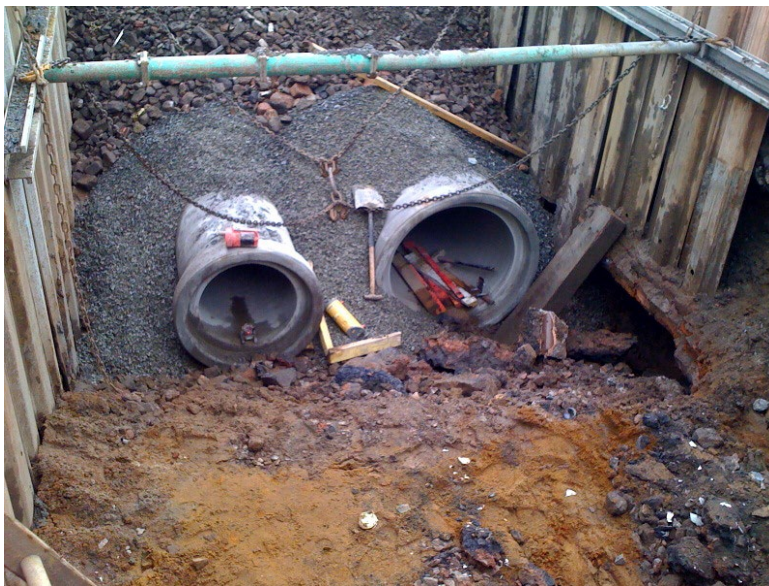
15. Gully positions adjacent to the outside edge wall. Falls readily to be feed to these positions may 2011.

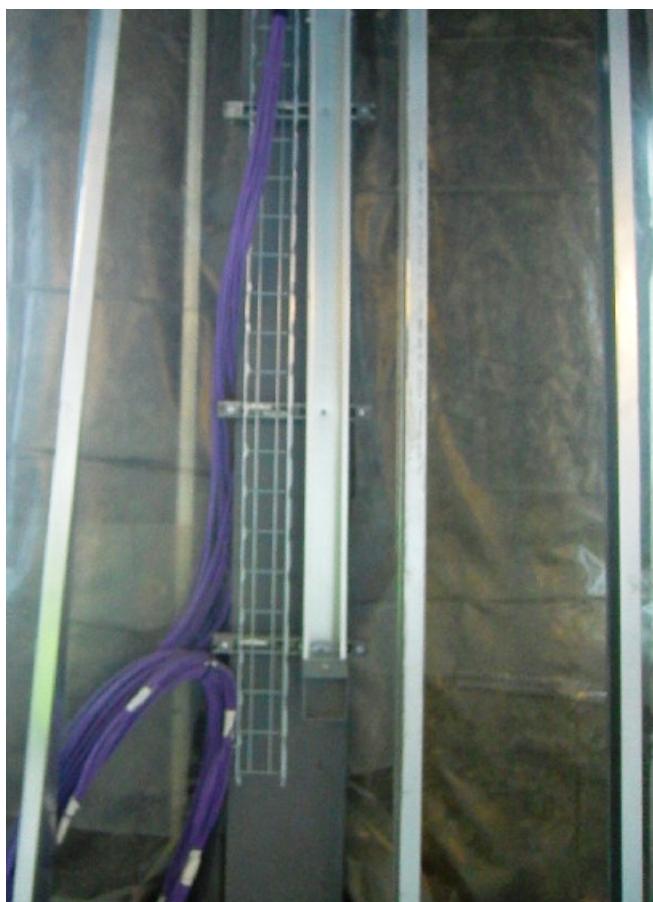
Following an inspection on site and discussions we noted that the columns shown on drawing AL(28)02.C had not been fire protection with intumescent paint or fire boarding.

3. Services require to be removed to allow intumescent coating.

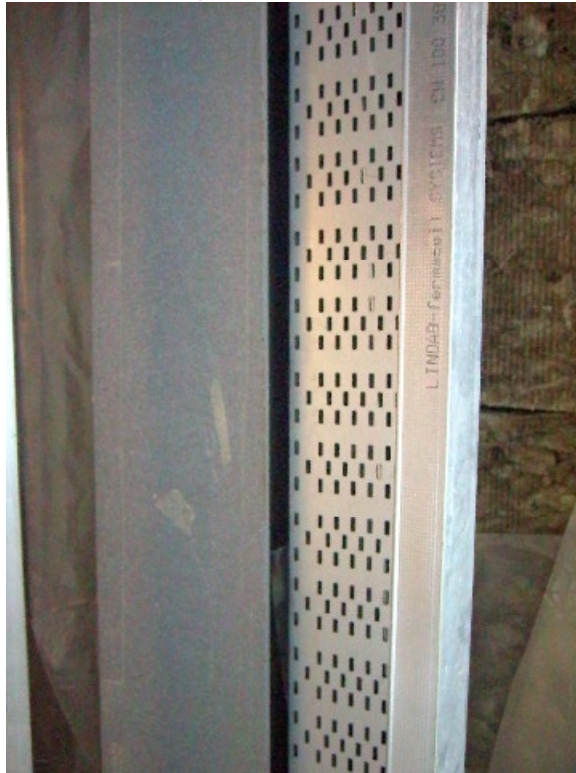
4. Service tray requires to be removed to allow intumescent coating.

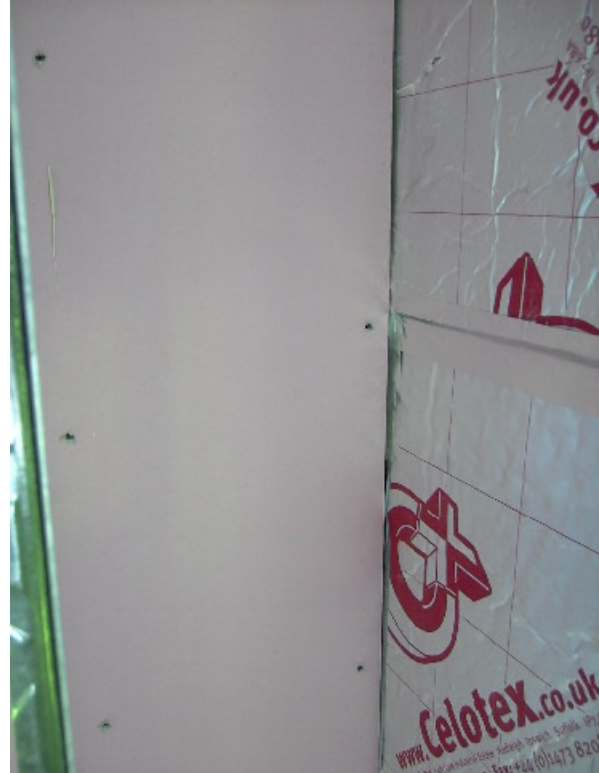
Following an inspection on site and discussions with Brookfield we noted that the columns show on drawing AL(28)02.C (Level 4) had not been fire protected with fire boarding.

5. Fire board on three sides. Celotex to be removed and fourth side boarded.

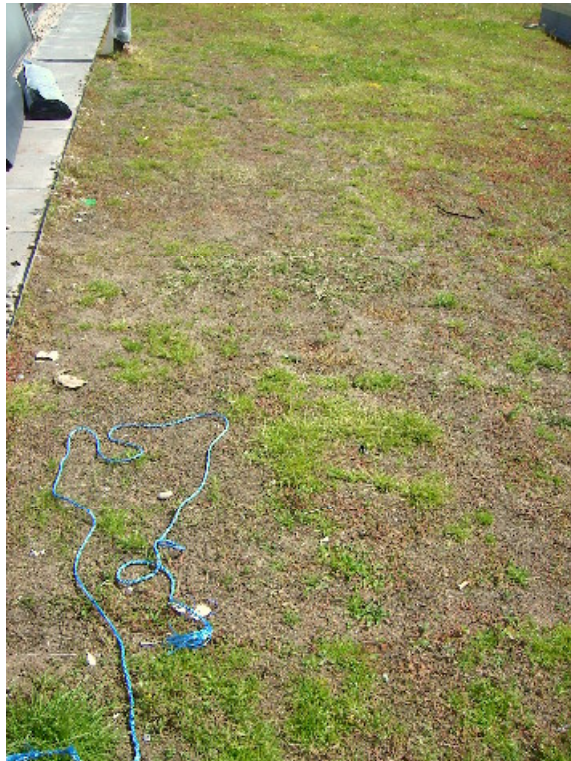
Following an inspection of the roof we noted that there were areas of sedum which had died back and also areas where the surface is predominately full of grass and weeds.

6. Bare areas on sedum room

We are seeking confirmation from Brookfield if the bare areas are to be recovered with sedum or seeded and if the grass areas are to be replaced with sedum or weeded. (See Supervisor's Communication General Matters / Other Instructions (CI 13.1) No 50).

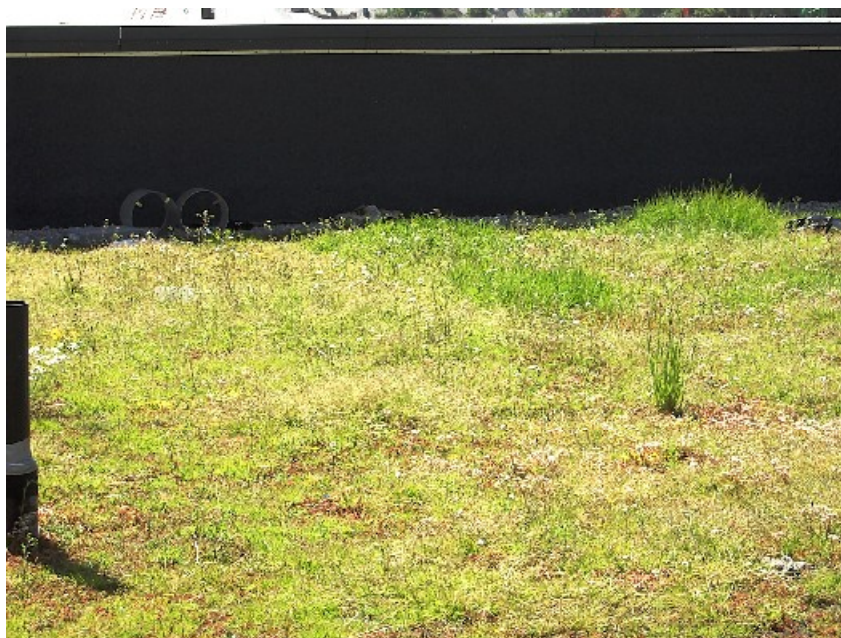
7. Areas of roof predominately covered in grass and weeds.

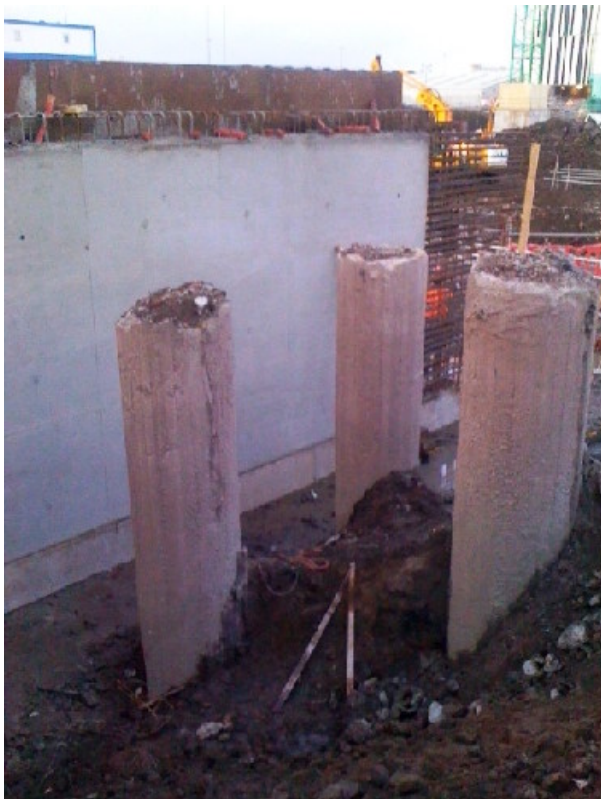
A major NCR has arisen in respect of tops of piles in several locations being found to be well outwith tolerance. Some of this was known at the end of December 2011 when a minipiling solution was planned for 2 No 3 pile cap foundations just north of Core G. Since then several other pile heads have been found, by independent survey, to be outwith tolerance. These are all in areas where the Contractor's methodology has resulted in piles protruding through the slopes of excavations for deep foundations. Full results of the survey are awaited, together with the Contractor's remedial proposals.

Piles out of alignment

The outstanding piling NCR issue is being addressed with a minipiling solution to replace the existing pile group being proposed.

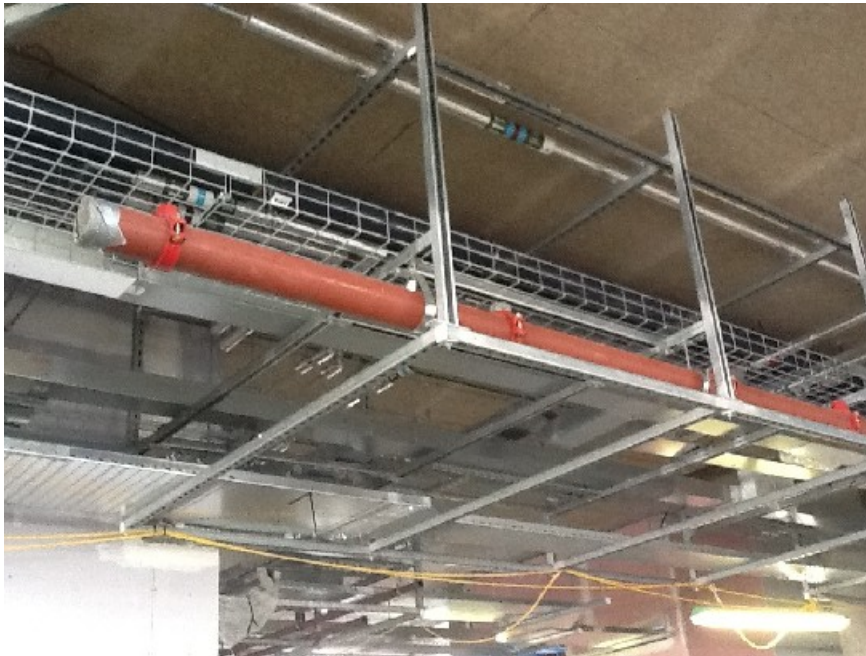
Photo No 3. Open ends of pipework sealed.

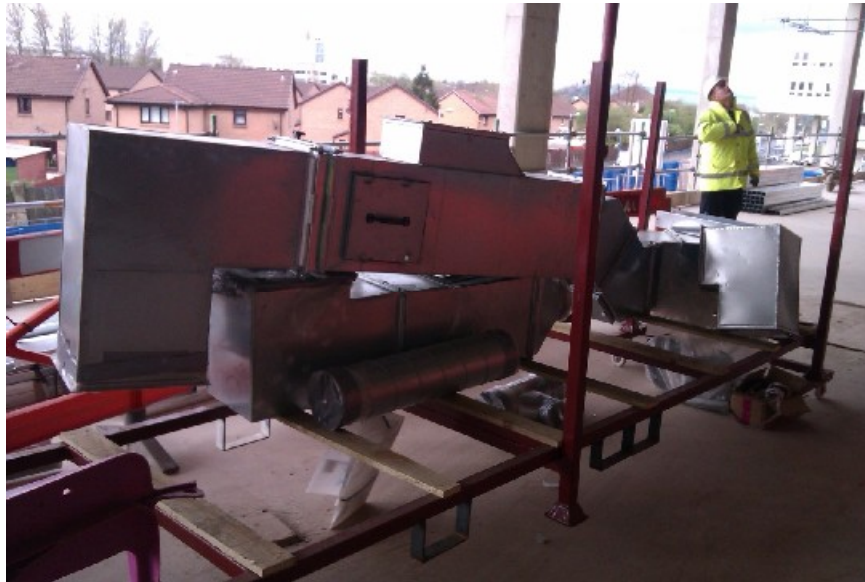
We noted that trunking is sustaining damage at the point of delivery. We are concerned about the level of damage to the ductwork and the subsequent amount of time re-working it on site to effect repairs. Brookfield has been requested to confirm action to prevent further damage and provide evidence that the existing damage has been repaired. (See Supervisor's Communication General Matters / Other Instructions (CI 13.1) No 01).

Photo No 5. Ductwork Delivery Method

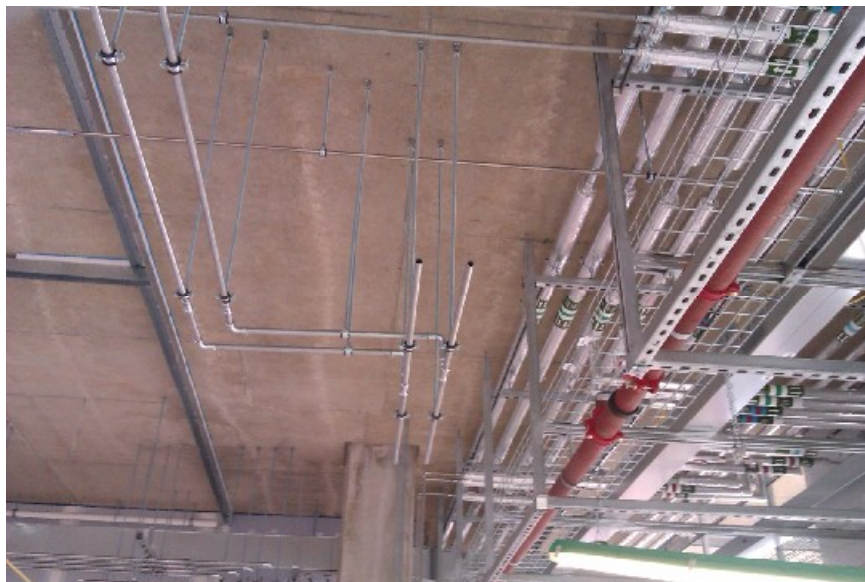
In general terms we are satisfied that the installations are being installed to the correct standard, and are of a good quality. However we are concerned that there are a number of open ends being left on the main pipework installations. There is also some damage to the ductwork sections as they arrive on site.

Photo 6. Open Ended Pipework.

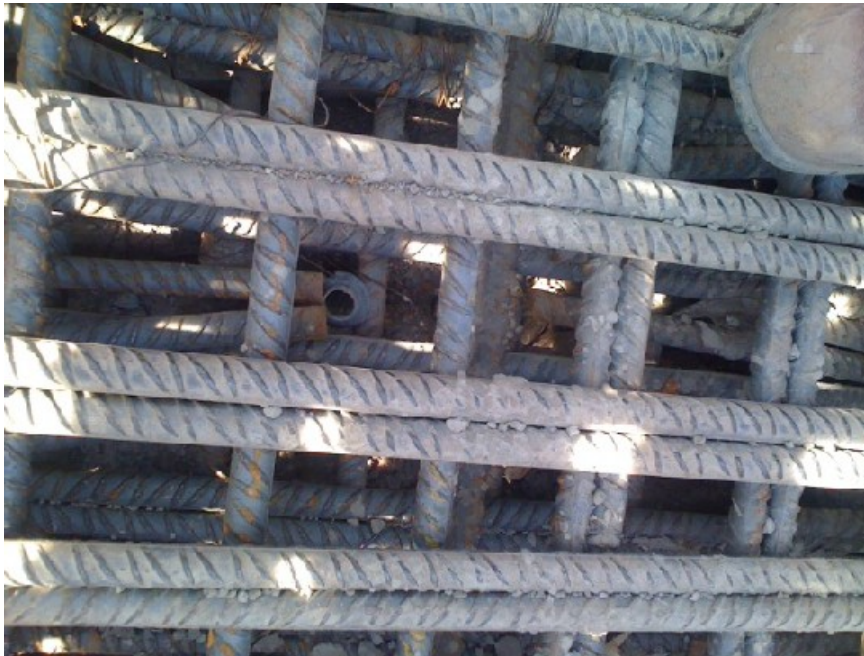
Photo No 7. Congested reinforcing.

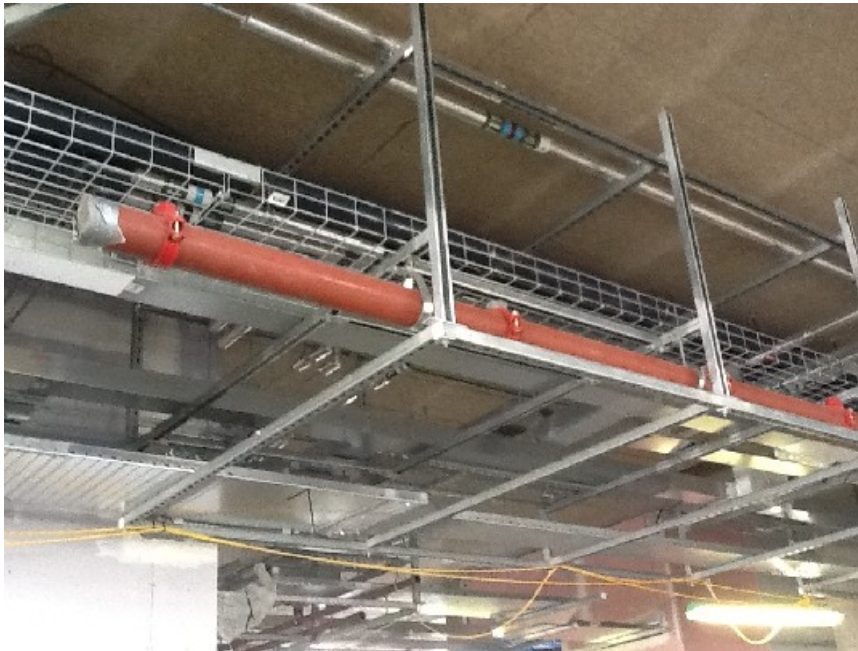
Photo No 3. Open ends of pipework sealed.

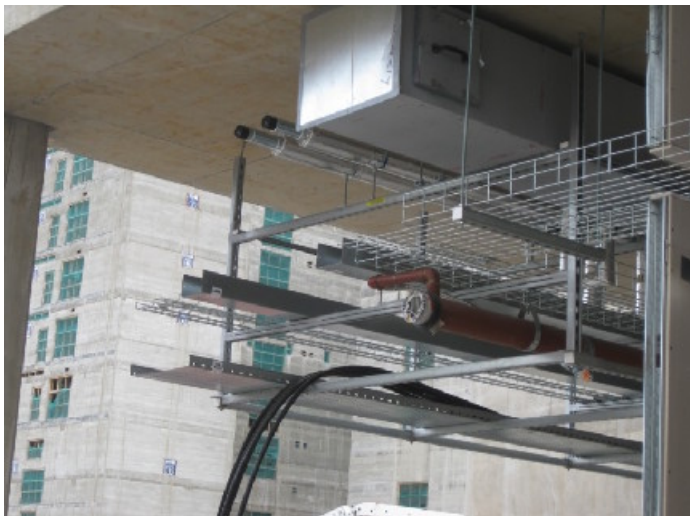
Photo 4 – M&E Installation Rig with Pipework Ends.

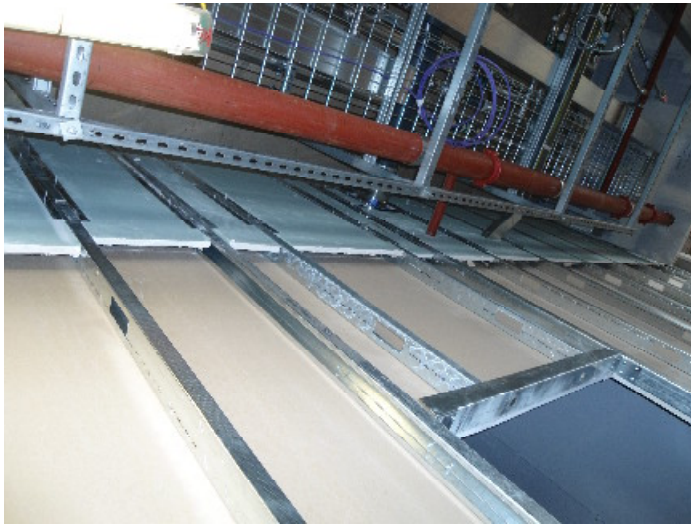
Photo 5 – Insulation not fitted to shaftwall.

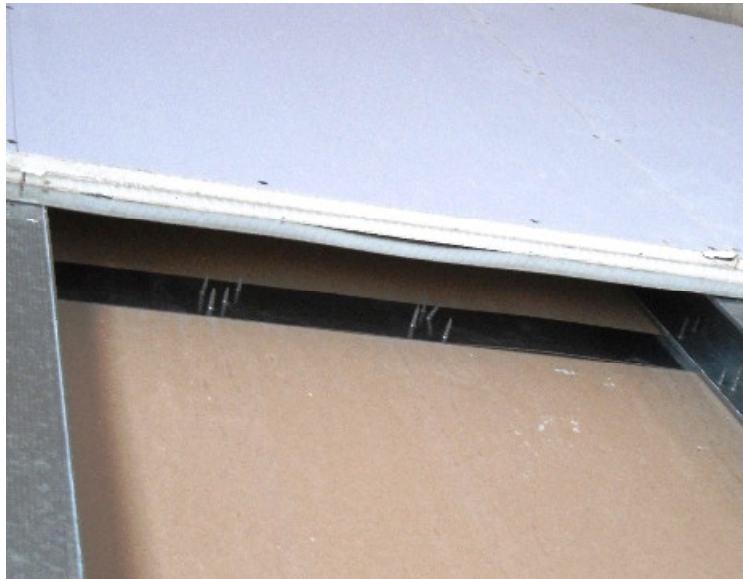
Photo 1 – Upper section of partition without insulation

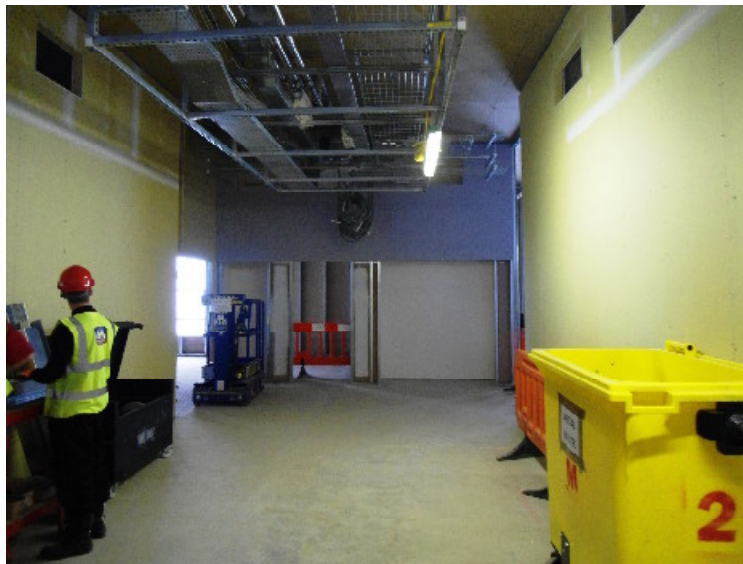
Photo 2 – Impact board fitted to Dirty Utility partitions
but not IPS and Electrical Cupboard.
