**Bundle of documents for Oral hearings
commencing from 13 May 2025 in relation
to the Queen Elizabeth University Hospital
and the Royal Hospital for Children,
Glasgow**

**Bundle 33
NEC3 Supervisor's Reports and Project
Supervisors Interface Action Notes**

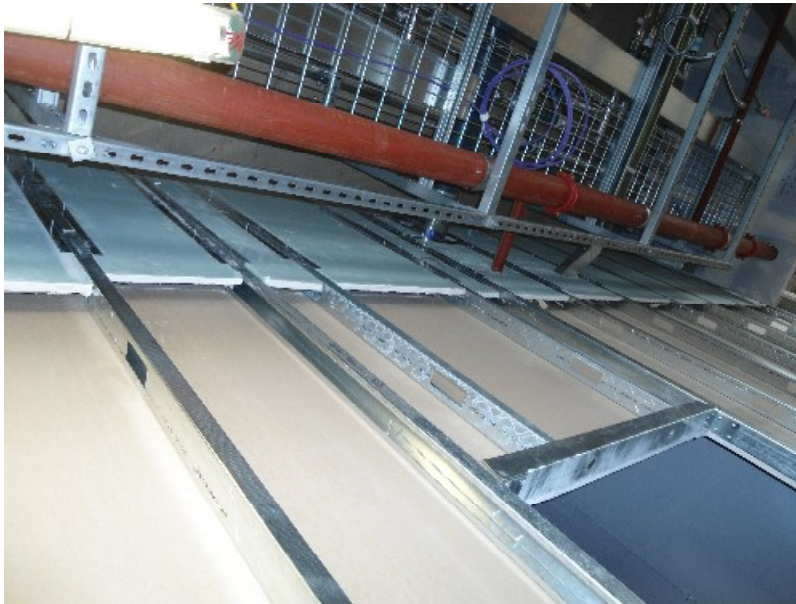
Photo 5 – Insulation not fitted to shaftwall.

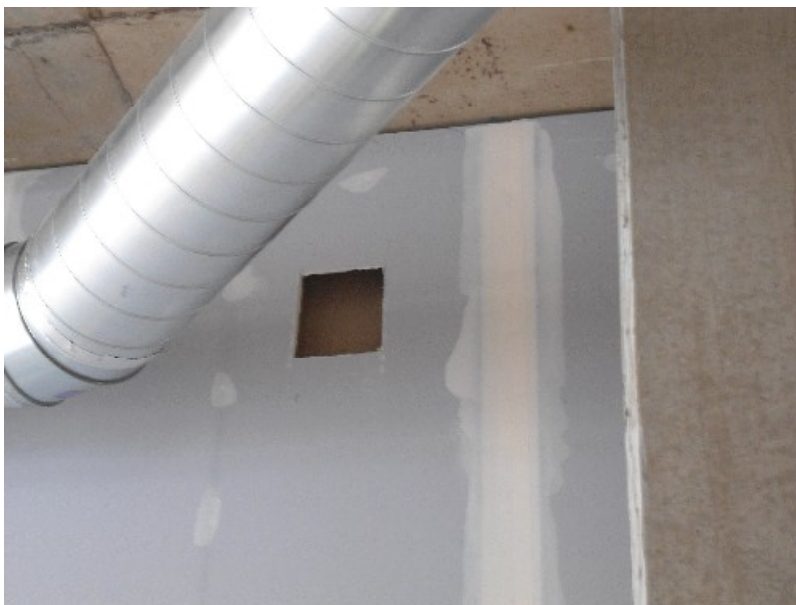
Photo 6 – Room THE-171 no insulation.

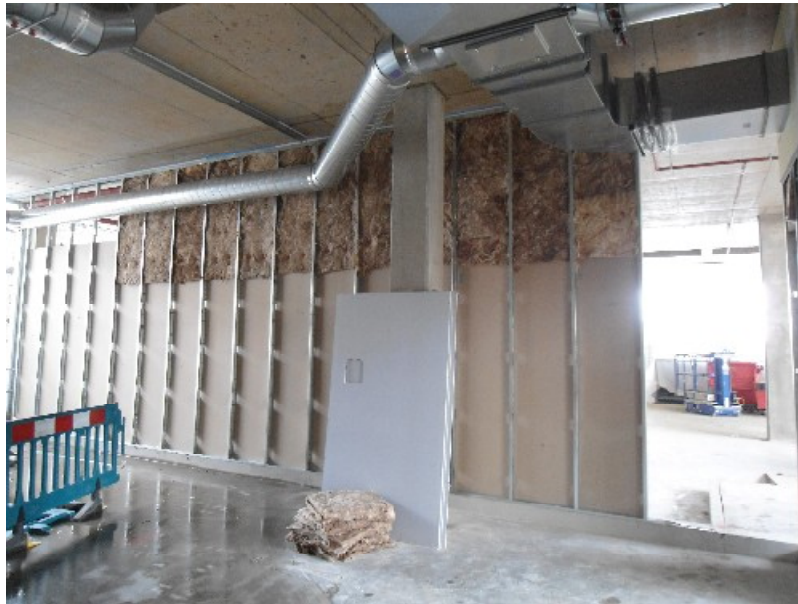
Photo 7 – Room THE-171 no insulation.

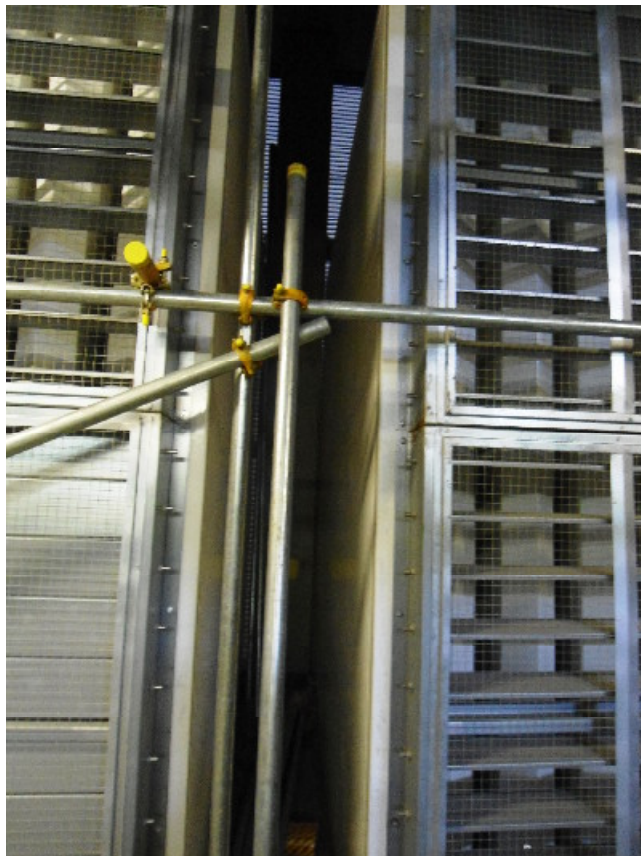
Photo 8 – Gap between acoustic intake louvers.

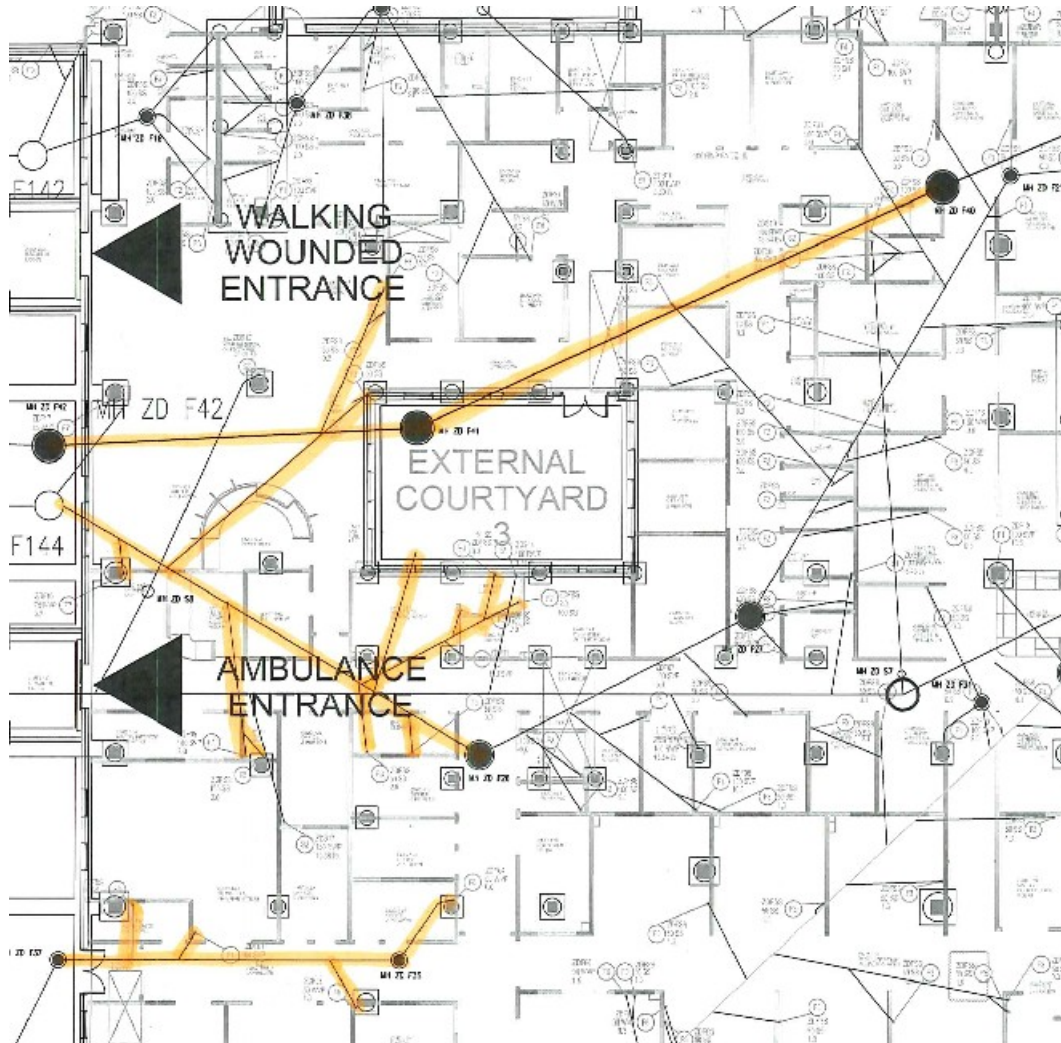
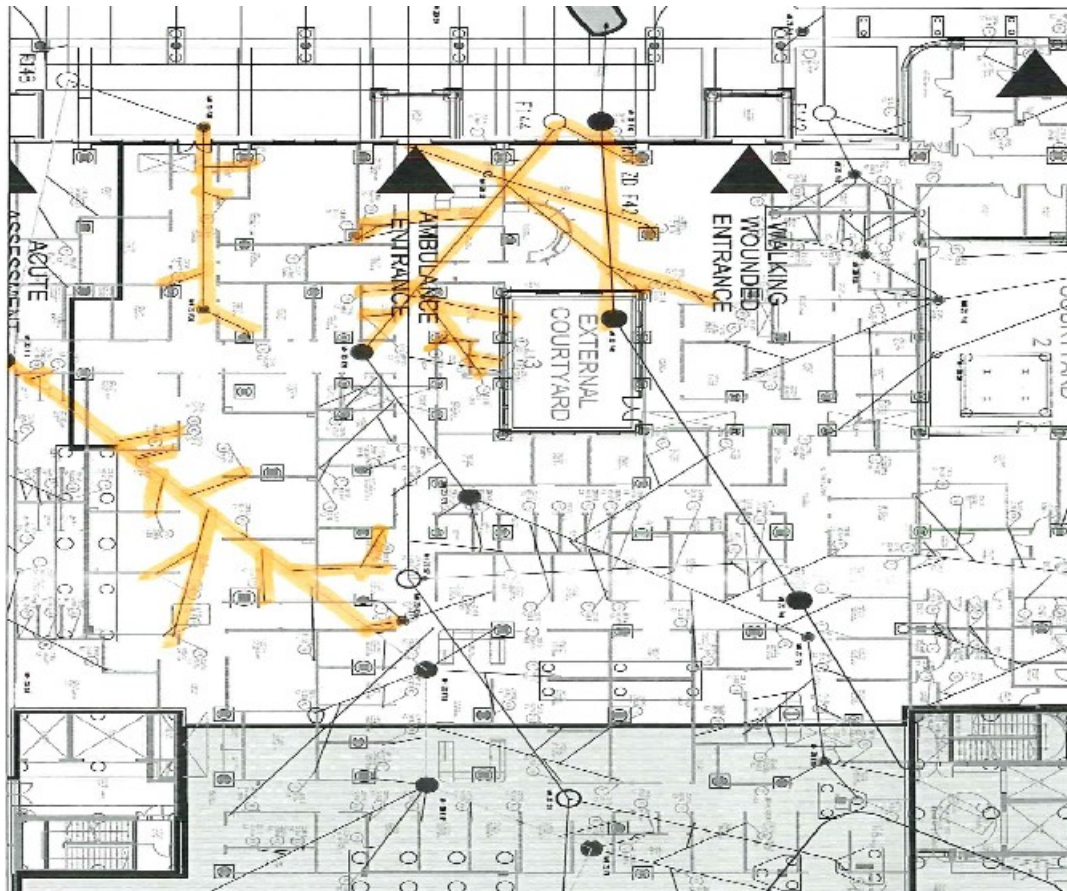
Ground Floor Zone D Drainage Tested

We witnessed drainage tests on the Ground Floor Zone D and all of the tests were successful.

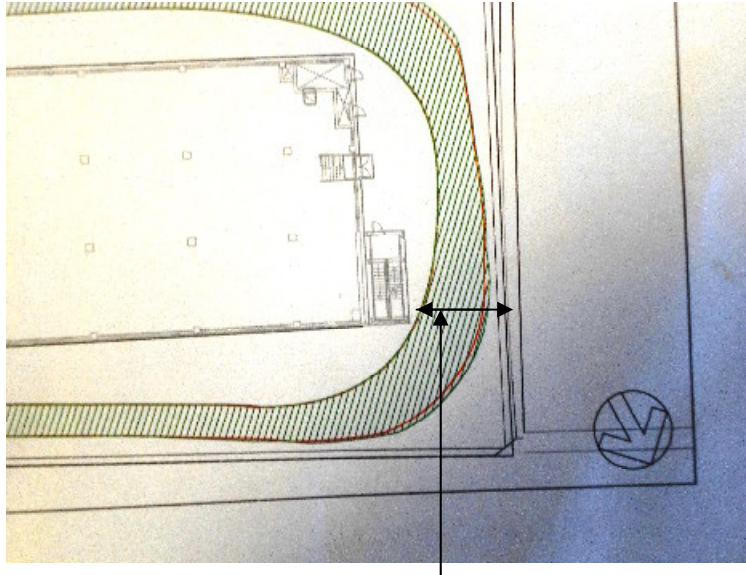
Photo 1 – Distance from corner of stair to edge of concrete approx 6700mm.

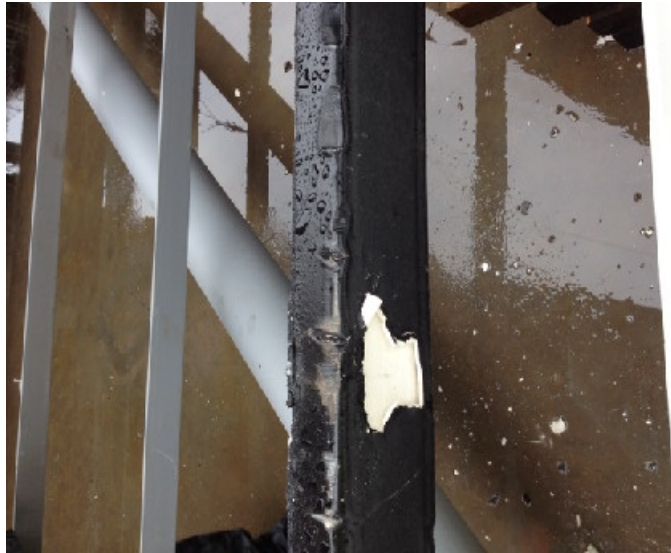
Photo 3 – Damaged intumescent cover.

Structural steelwork erection to the atrium walkway has continued during the period. As noted in the last report quality wise, the main concern is the damage to the fire protection coating (shop applied) on some sections. Brookfield is aware of this and the damaged areas are receiving intumescent coating.

Brookfield confirmed that the damage to the intumescent paint is due to the thickness required for the sections of steel. They have confirmed that Pierce are aware of this issue and are taking steps to remedy it without delaying erection. The steel has not been offered for inspection by Pierce. Brookfield has intimated that the steel was not mishandled on site and that the damage has occurred in the painting process. A painter is on site full time, carrying out repairs when weather allows. (Consequently Supervisor's Communication General Matters / Other Instructions (CI 13.1) No 24 is closed out.

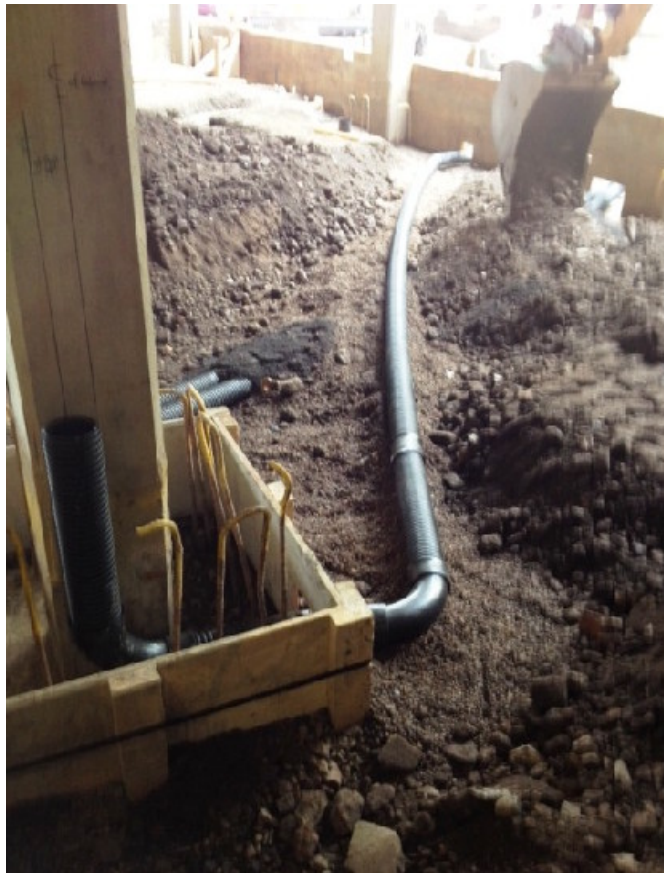
Photo 4 – Storm water drainage run in Zone D

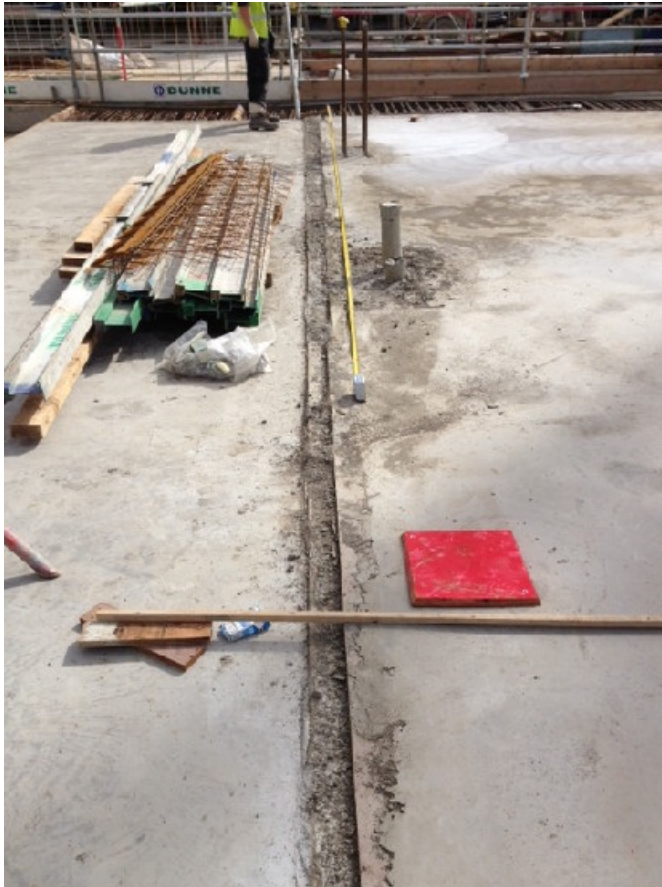
Photo 5 – change of level detail in 1st floor slab at Zone E

- Finish to ground floor in Zone F and 1st floor in Zone J (as last report)
- 20mm level change detail in 1st floor slabs at Zones E and J has been poorly formed and remedial action is required. This situation has persisted with no solution forthcoming.
- Cracks to the soffit of the suspended ground floor slab between Cores A, B, C and D being kept under review.
- Spalling to a couple of parapet walls at the top of Core G.
- Apparent on some pours towards the end of the period that significant elements of steelfixing and joiner work are still ongoing when concreting to a slab pour commences.

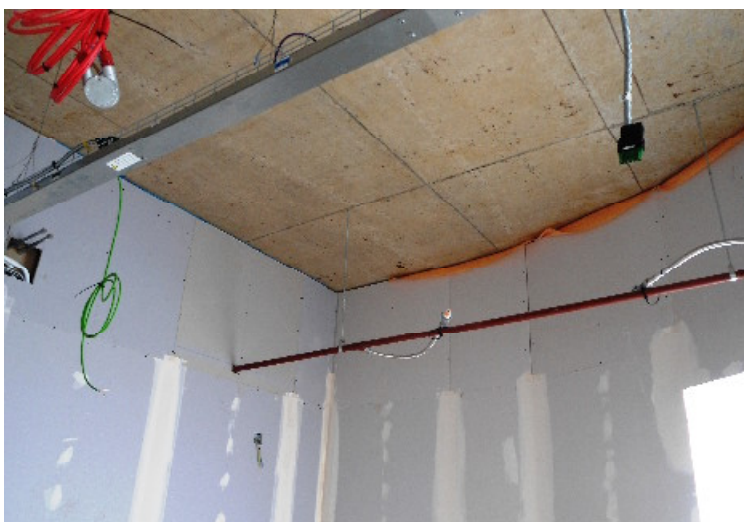
Photo 6 – horizontal joints not in accordance with NBS specification

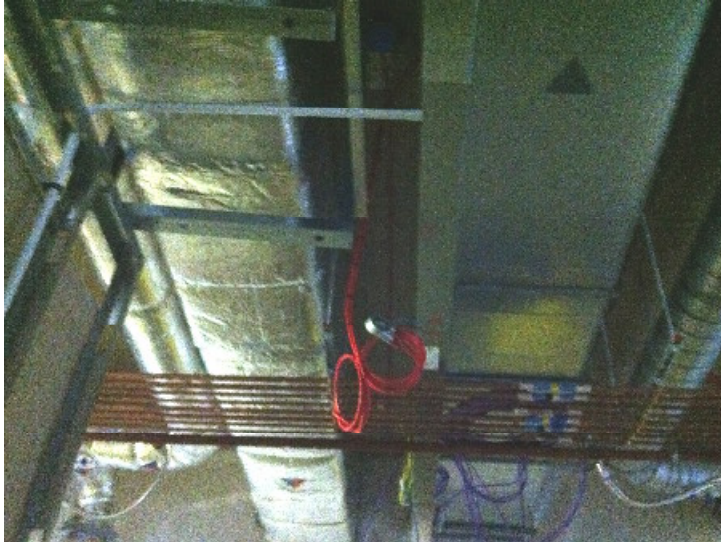
Photo 7 – ZG corridor CCW115 void detection has been located in close proximity and between ventilation ductwork.

We noted that across the first floor but more specifically noted within zone ZG corridor CCW115 void detection has been located in close proximity and in between ventilation ducts. There is also no void detection noted within CCU-009. We shall be issuing a Supervisor's Communication with Brookfield.

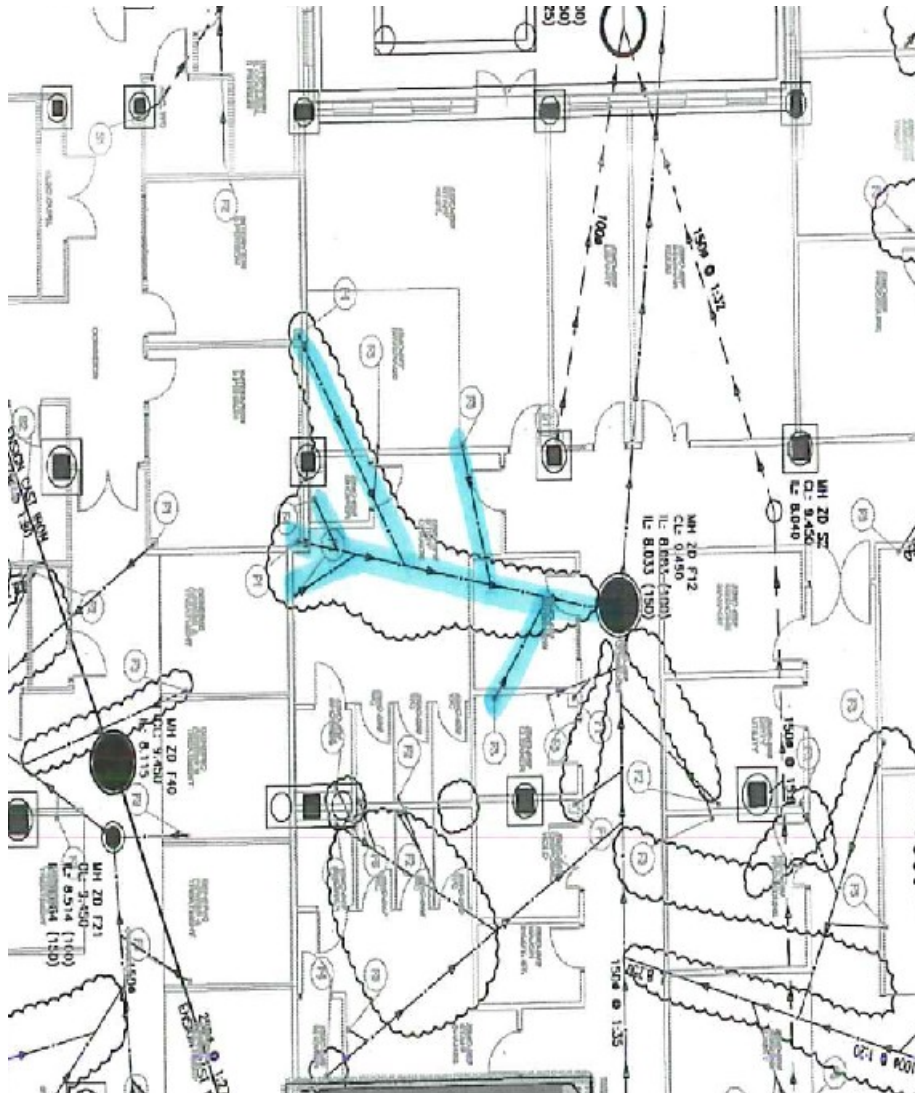
Ground Floor Zone D Drainage Tests

Below slab drainage installation has continued during the period in Zone D. Drain pressure tests have been carried out on all newly laid sections in this area. Test records are kept by Brookfield as part of their QA procedures and many independently witnessed by the Supervisor team.

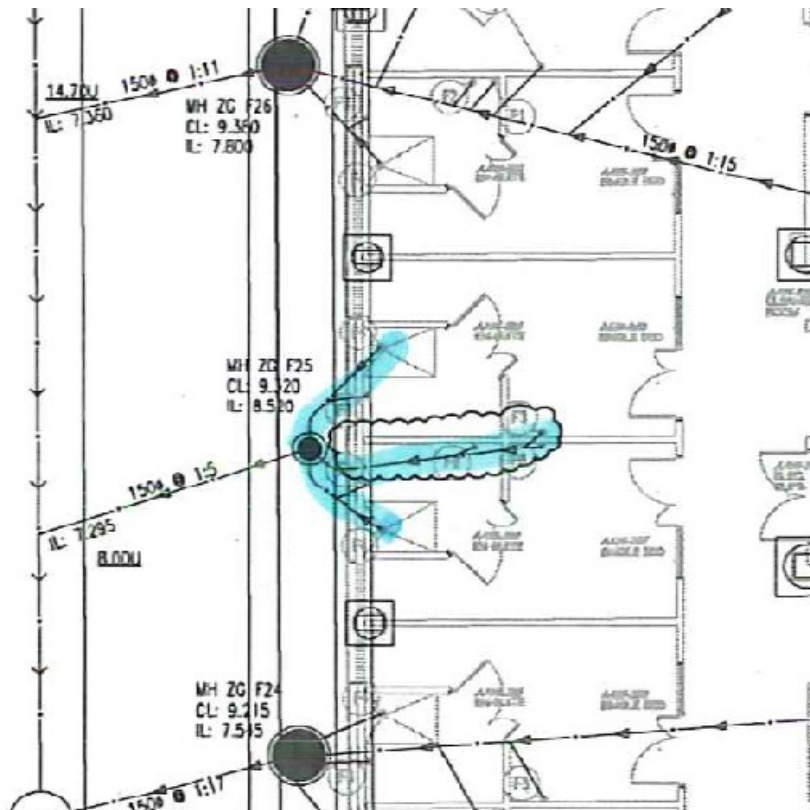
Ground Floor Rodding Test

Brookfield undertook below ground drainage rodding to prove that a future blockage could be cleared. These were successful and witnessed by the Supervisor team. Consequently Supervisor's Communication General Matters / Other Instructions (CI 13.1) No 19 is closed out.

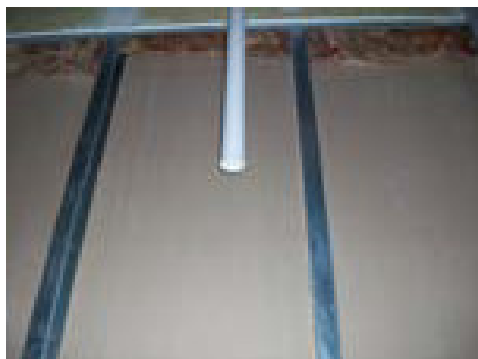
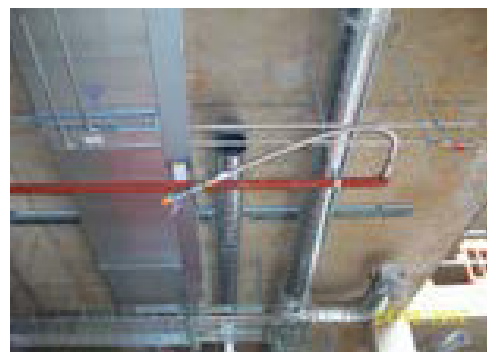
There were a number of locations on Level 1 where above floor drainage connections were not sealed. Brookfield confirmed that the "open end" were due to testing of the soil and waste pipes in Design Zone ZG through levels 00, 01 and 02. The plugs having been removed prior to tape being applied to seal the open end following the tests. Mercury QA checked all of the areas/rooms on each floor that contains drains and all were sealed on 02/08/12 between 11:00 and 12:30. Consequently Supervisor's Communication General Matters / Other Instructions (CI 13.1) No 28 is closed out.

We shall be raising Supervisor's Communication with Brookfield concerning locations where drainage pipework and ductwork is uncapped.

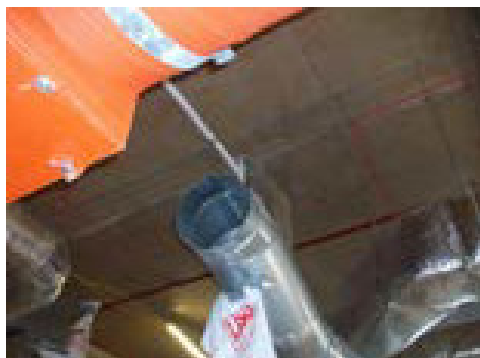
The installation of ventilation ductwork in the A&C hospital is progressing well, and has been installed to a good standard. It appears that any open ends are being sealed but we have noted some exceptions and these have been highlighted to the contractor. The level of damage occurring during the delivery process is much reduced from that previously reported, however the contractor should be reminded that care should be taken to avoid such damage occurring.

Ductwork not fully capped in Level 1 Vent Plant Room

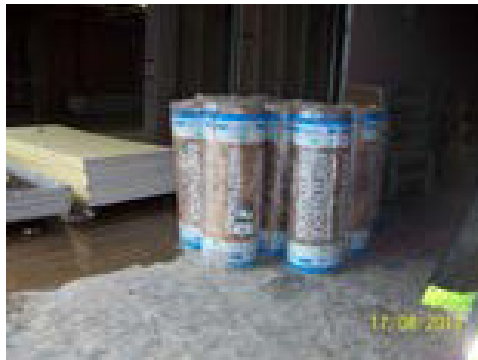
Insulation exposed to the elements

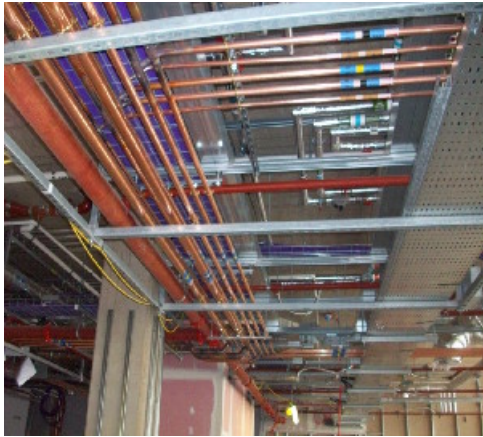
We note that a significant amount of medical gas pipework has now been installed. This includes pipework for some services which are no longer required on the contract. If this is confirmed by the client, then we would share their opinion that this should be removed, to avoid confusion at a later stage in the life of the building.

We noted that medical gas pipework are only supported on every section of unistrut on small bore pipework. Support intermittent on large bore pipework. We shall raise this with Brookfield.

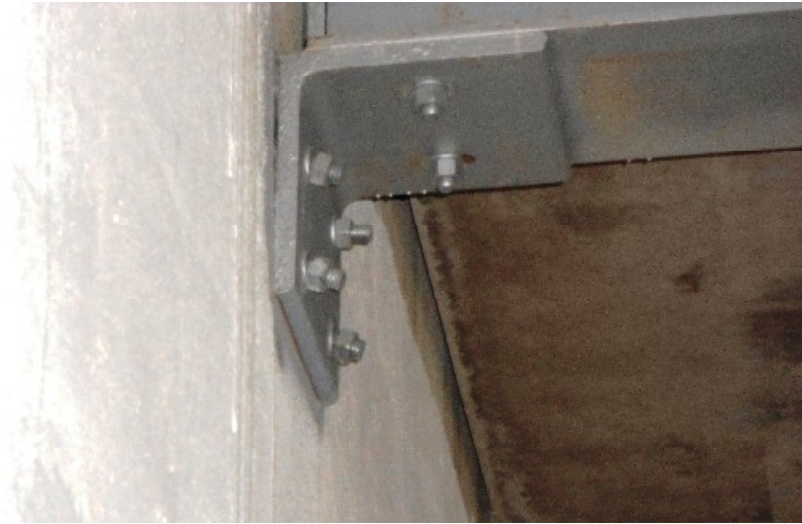
Photo 3 – Misaligned bolts.

We have asked Brookfield to confirm proposals to correct the misaligned bolts at the half landing in Core G between Level 3 and Level 4. (See Supervisor's Notification of Defect (CI 42.2) No 07).

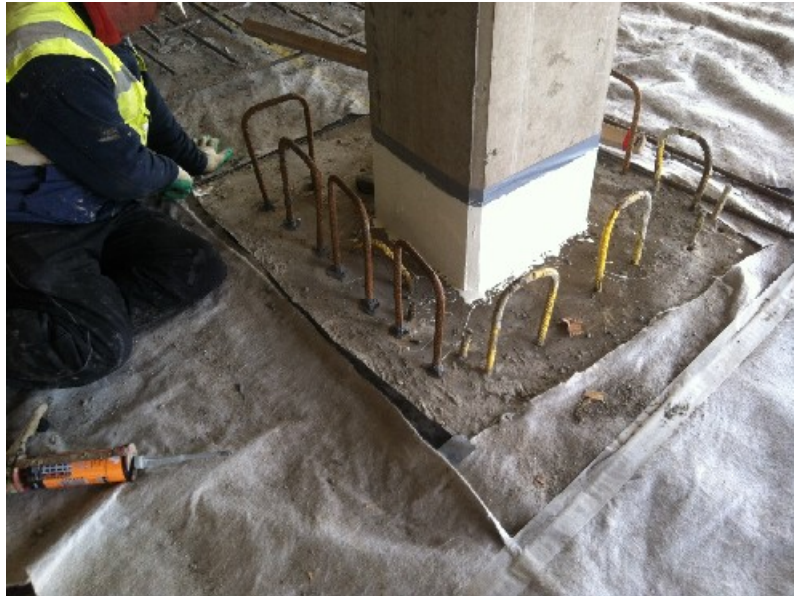
Photo 4 – New U bars drilled in 200 deep with resin anchor fixing.

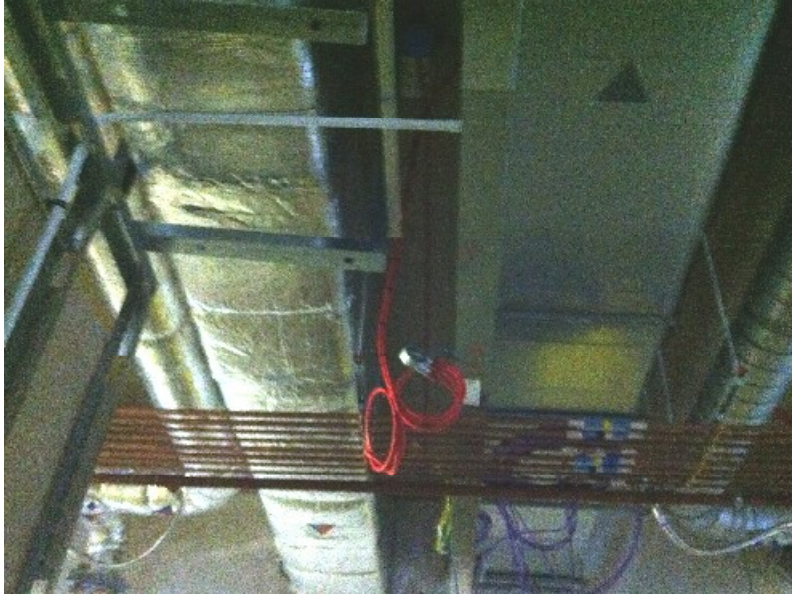
Photo 7 – ZG corridor CCW115 void detection has been located in close proximity and between ventilation ductwork.

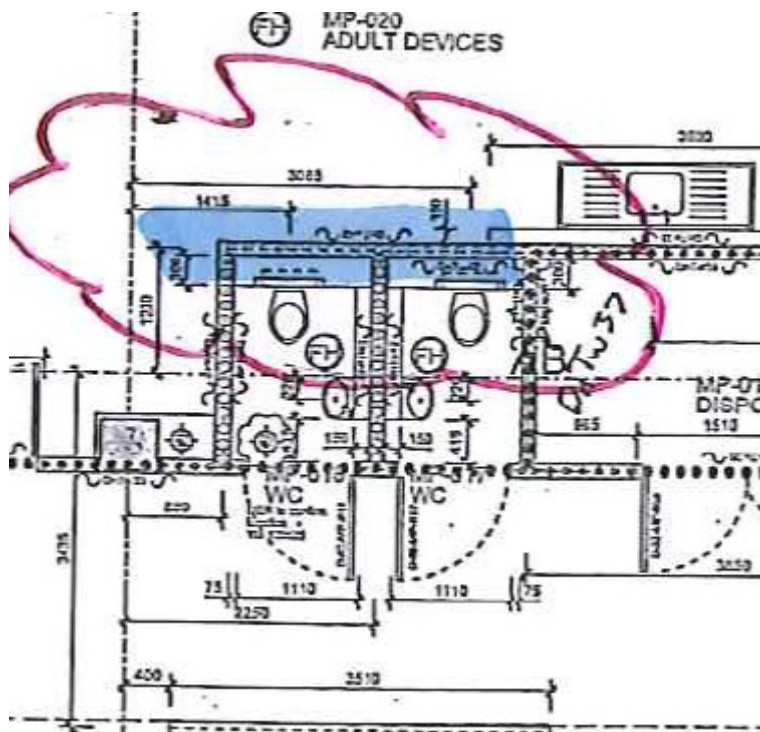
Partition opened up on Level 2.

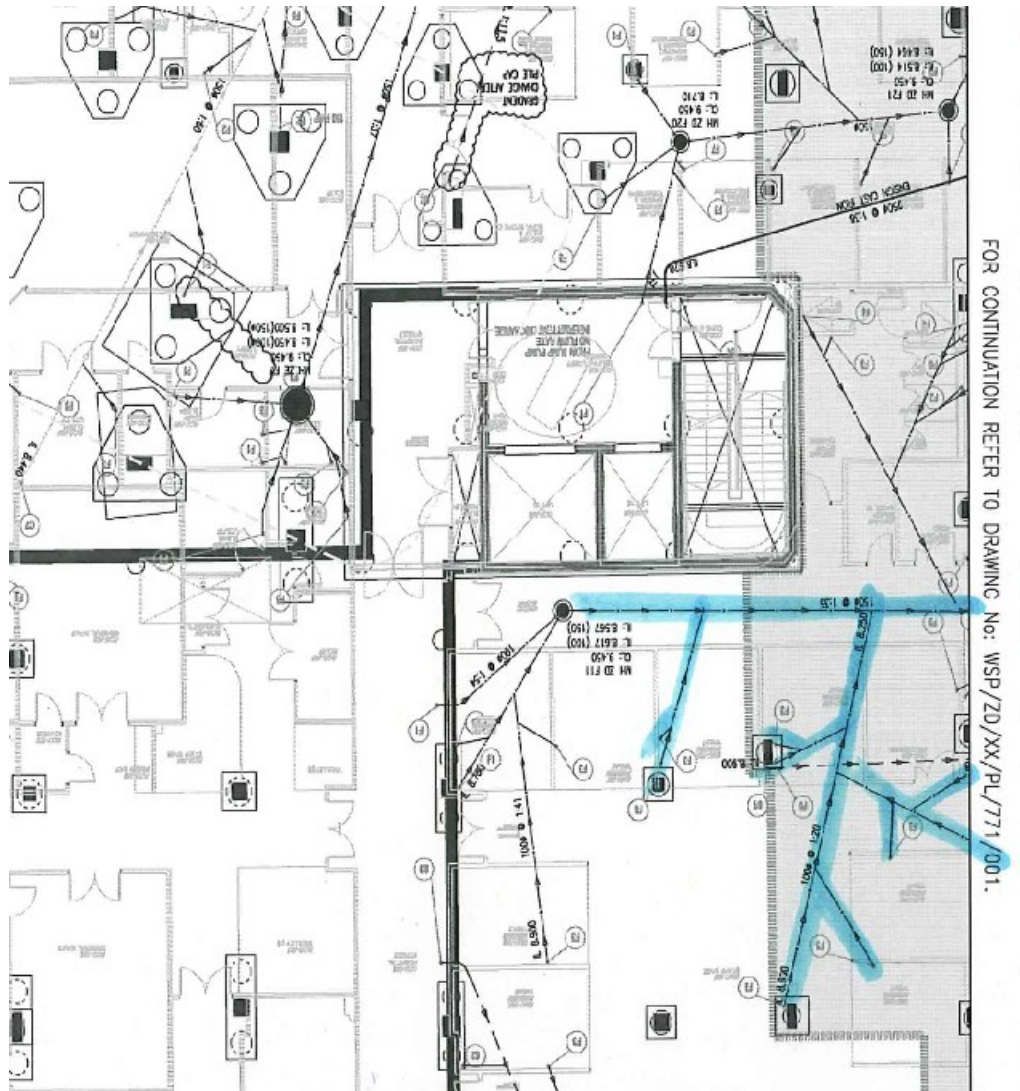
Ground Floor Area ZD

Below slab drainage installation has continued during the period. Drain pressure tests have been carried out on all newly laid sections in ZD and ZE. Test records are kept by Brookfield as part of their QA procedures and were independently witnessed by the Supervisor team.

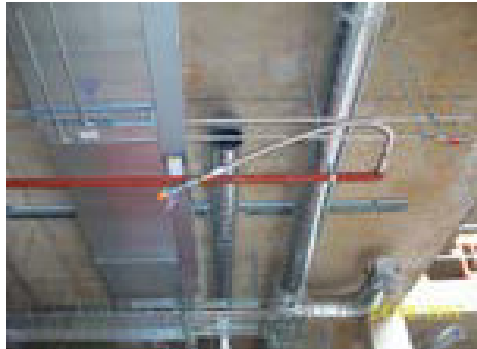
We noted that locations throughout have drainage pipework which is uncapped. Brookfield has confirmed that Mercury will blank off all open ends. Consequently Supervisor's Communication General Matters / Other Instructions (CI 13.1) No 34 is closed out. However we will continue to monitor this issue.

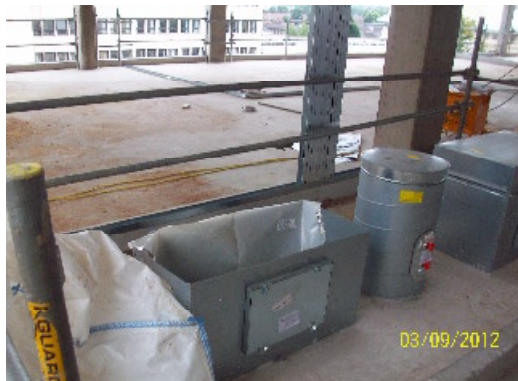
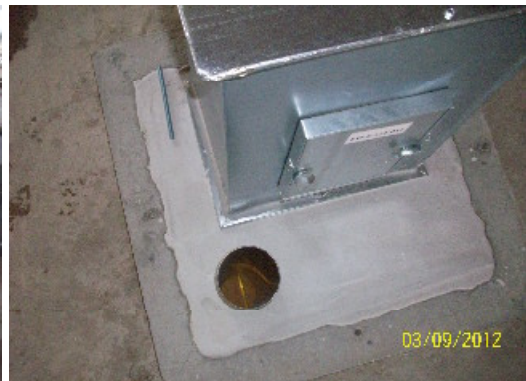
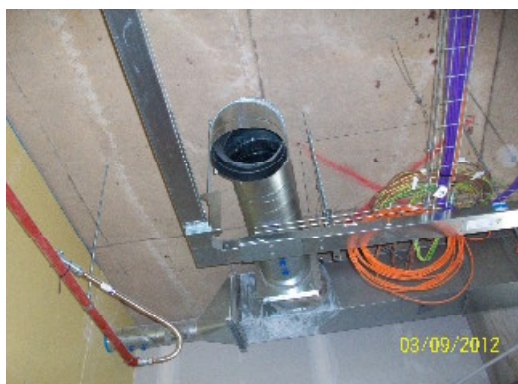
During an inspection on site we noted that there are sections of ductwork uncapped or not covered properly. We asked Brookfield to confirm when these have been capped/covered. Brookfield has confirmed that the ductwork in Plantroom 31 Level 3 is now capped off properly. They have also informed us that the pipe running through the fire stopping is a cable way and not a duct and therefore this is why is it not capped off.

We are awaiting confirmation from Brookfield concerning the opening above.

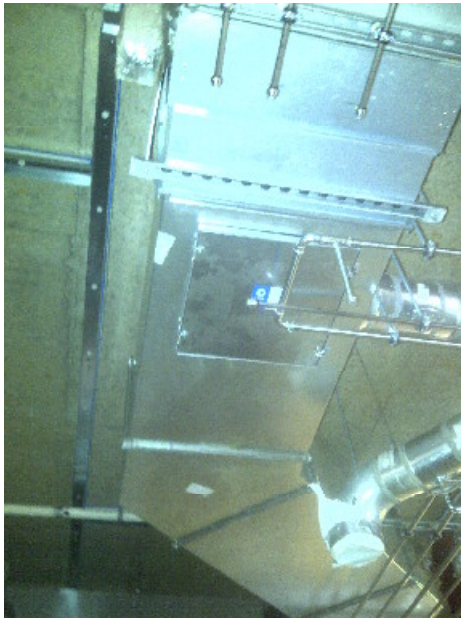
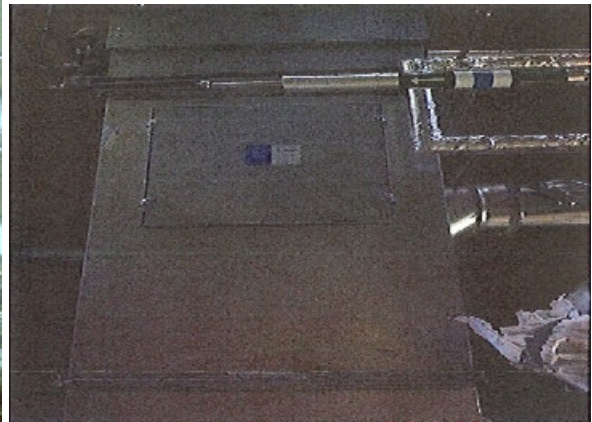
The duct access hatch is blocked by a chilled water pipework at ground floor area around DB cupboard AAW190. Brookfield has confirmed that the pipework has been rerouted. Consequently Supervisor's Communication General Matters / Other Instructions (CI 13.1) No 41 is close out. See photos below

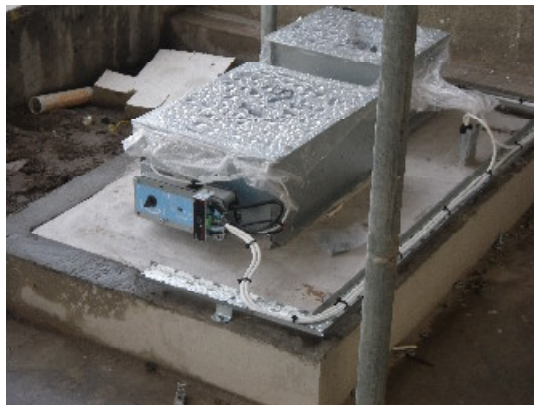
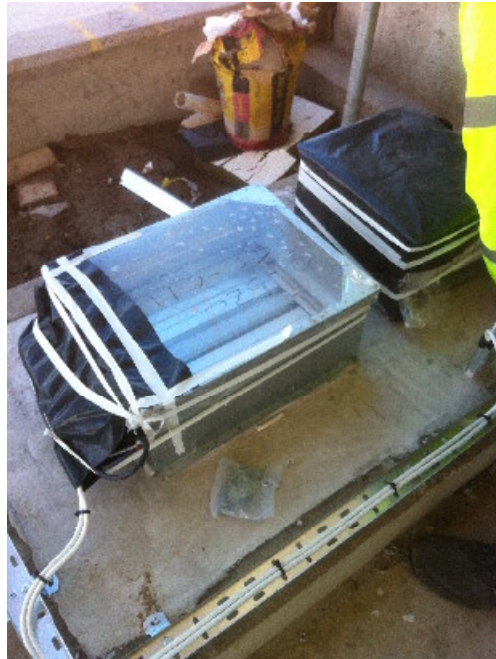
Ventilation controls on Level 3 Zone D were unprotected. We have asked Brookfield has addressed this covering the controls. Consequently Supervisor's Communication General Matters / Other Instructions (CI 13.1) No 42 is closed out.

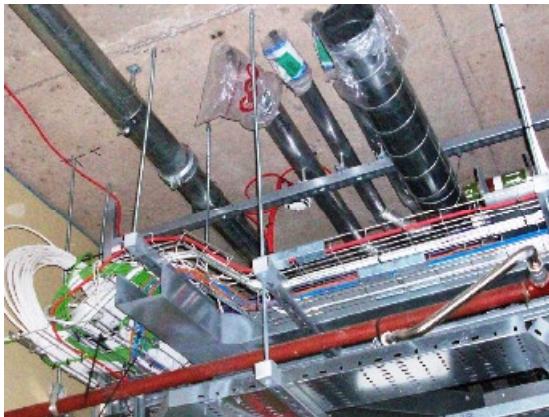
Confirm when removal dust caps from smoke detector heads have been replaced. Removal of caps at this stage of the contract may lead to the contamination of the detector heads. (See Supervisor's Communication General Matters / Other Instructions (CI 13.1) No 40). See photo below.

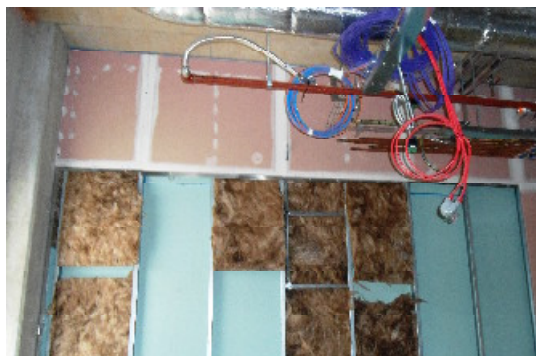
We noted that there was insulation missing from the upper section of the boarded partition. Brookfield has confirmed that the installation is compliant. Consequently Supervisor's Communication General Matters / Other Instructions (CI 13.1) No 36 is closed out. (See photos below)

**Room CCU-068. Partition with
insulation missing at high level**

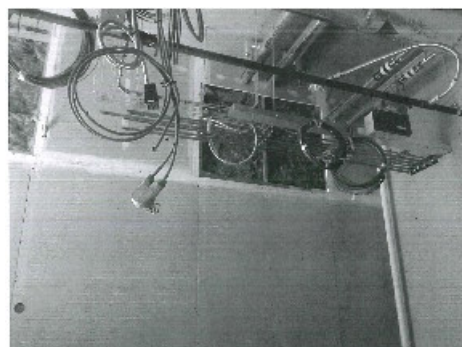
**Room CCU-068. Partition with
insulation fitted at high level**

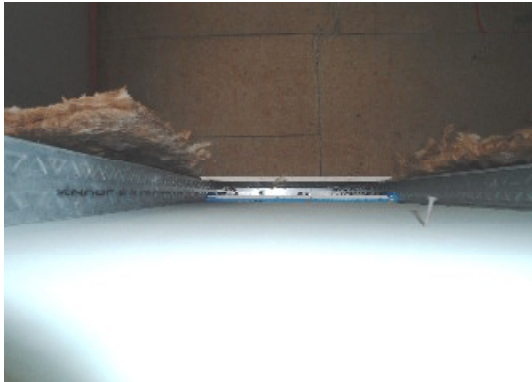
Room CCU-068. Insulation missing at high level

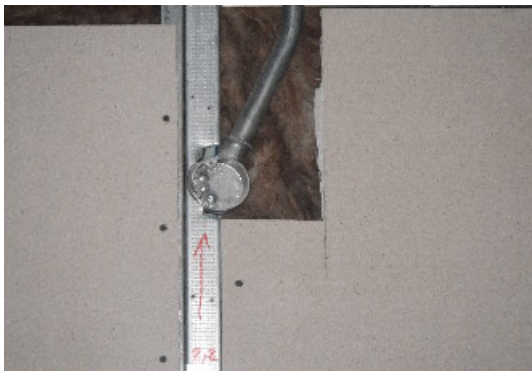
Part of the stud to the 60min partition in room CCU-012 has been cut out. This is not in compliance with Knaufs specification and would affect the performance of the 60 min fire rated partition. Brookfield confirmed that services have been relocated and the stud repaired with Knauf flat plate. Consequently Supervisor's Communication General Matters / Other Instructions (CI 13.1) No 39 is closed out. (See photos below)

Stud cut and services fixed to stud.

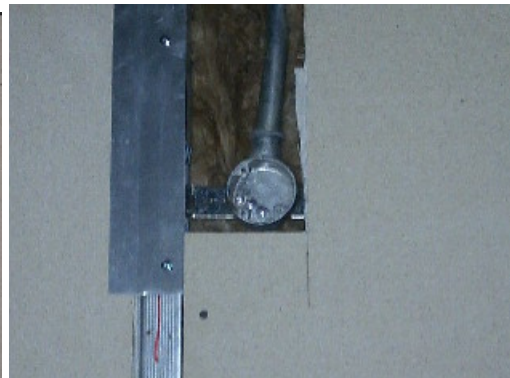
Services moved and stud strengthened.

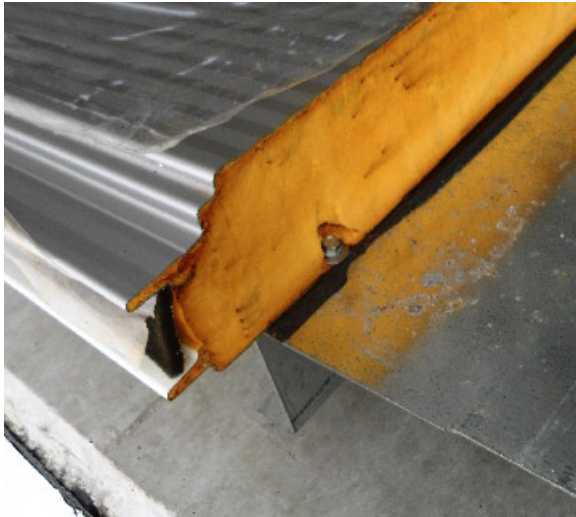
We noted that there was an incorrect fixing to the cladding in Courtyard 4. We have asked Brookfield to confirm when this has been addressed. (See Supervisor's Communication General Matters / Other Instructions (CI 13.1) No 35).

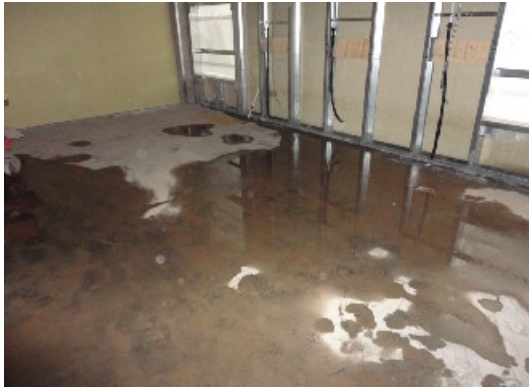
Water ingress as a result of rain penetration through walls and soffits were evident. We have asked Brookfield to advise on proposals for preventing rain penetration and QA procedure for remedials to water damaged finished/stored work elements. (See Supervisor's Communication General Matters / Other Instructions (CI 13.1) No 46).

Water ingress as a result of rain penetration through wall.

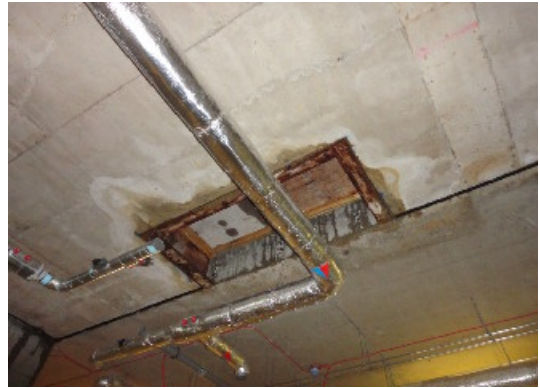
Water ingress as a result of rain penetration through soffit.

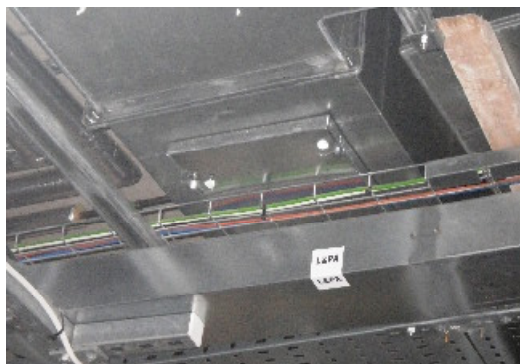
Duct access hatch blocked by chilled water pipework at ground floor area around DB cupboard AAW190. Confirm when this has been addressed.

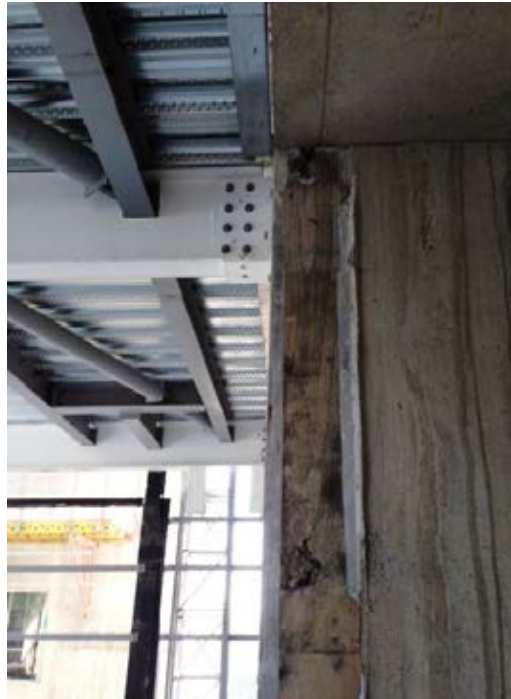
We have asked Brookfield to confirm if the attached hole without bolts to the steelwork bridge connections reflects the design intent and a response to this is still awaited. Associated with this we are aware that, as part of local snagging, bolts at some of these connection locations at the cores have been replaced. It may be that this will answer the query, but feedback is awaited. (See Supervisor's Communication General Matters / Other Instructions (CI 13.1) No 57)

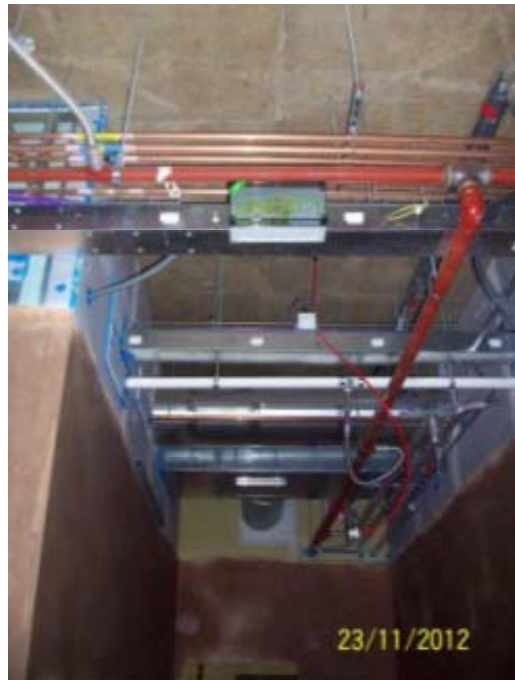
We have asked Brookfield to confirm that there are sufficient supports to the medical gases pipelines and that they are at the appropriate spacing for their diameter. See Supervisor's Communication General Matters / Other Instructions (CI 13.1) No 80.

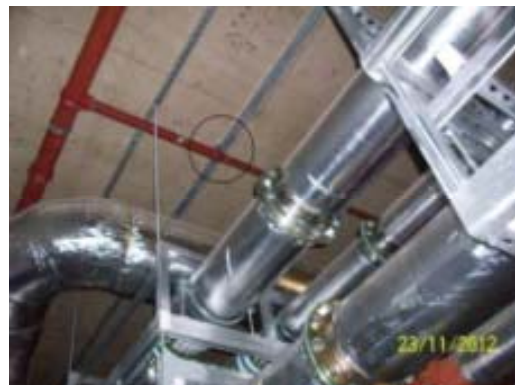
We have asked Brookfield to confirm the flow of water from the sprinkler head highlighted is not restricted by the adjacent section of unistrut. See Supervisor's Communication General Matters / Other Instructions (CI 13.1) No 74.

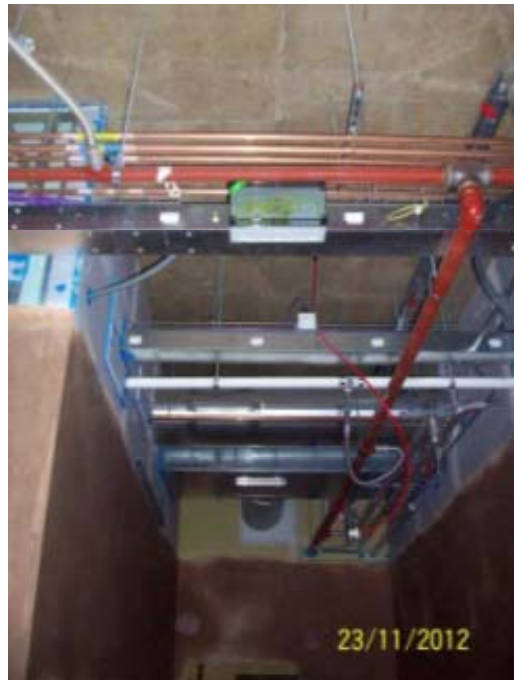
High level sprinkler heads appear inaccessible in a number of areas. We have asked Brookfield to confirm the access regime for sprinkler head maintenance / replacement. See Supervisor's Communication General Matters / Other Instructions (CI 13.1) No 75.

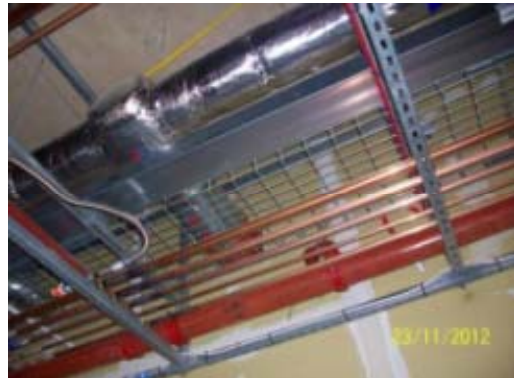
The electrical containment appears to be restricting access to duct access hatch Adjacent to riser THE-237. We have asked Brookfield to confirm duct hatch can be fully accessed without issue when finished ceiling is in place. See Supervisor's Communication General Matters / Other Instructions (CI 13.1) No 72.

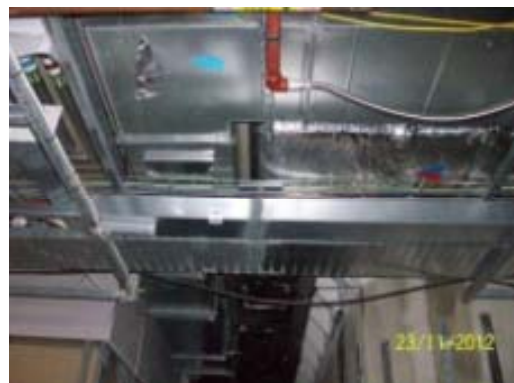
The electrical containment appears to be restricting access to duct access hatch Adjacent to riser THE-2127. We have asked Brookfield to confirm duct hatch can be fully access without issue when finished ceiling is in place. See Supervisor's Communication General Matters / Other Instructions (CI 13.1) No 73.

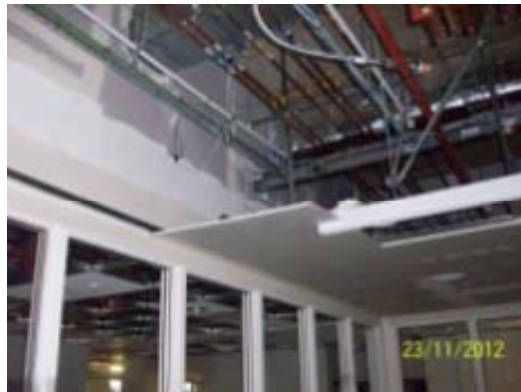
We have notified Brookfield that the hoist cabling is inadequately supported and they have raised this with Mercury. See Supervisor's Communication General Matters / Other Instructions (CI 13.1) No 77).

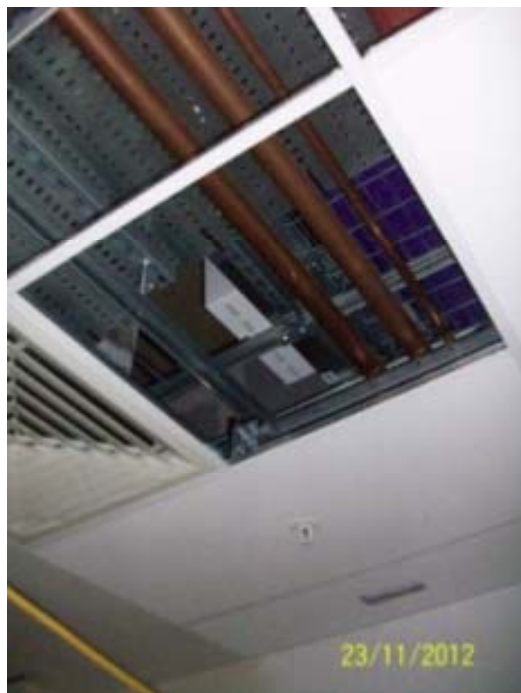
The junction box appears to be inaccessible due to the ceiling installation. We have asked Brookfield to confirm if this is the case. See Supervisor's Communication General Matters / Other Instructions (CI 13.1) No 79).

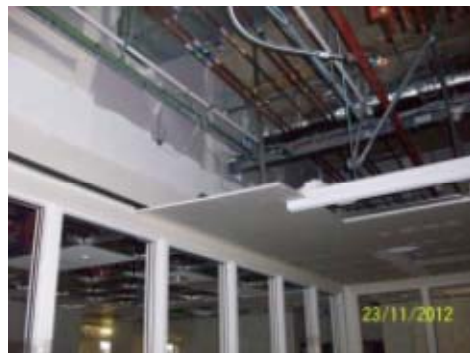
Void detection appears inadequate and inaccessible due to plasterboard ceiling. Please confirm void detection is adequate and can be accessed when ceiling installation is complete. See Supervisor's Communication General Matters / Other Instructions (CI 13.1) No 77 & 78).

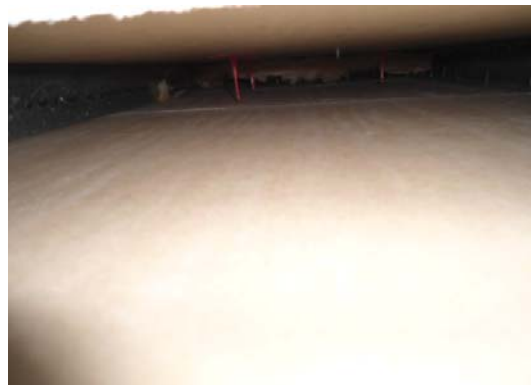
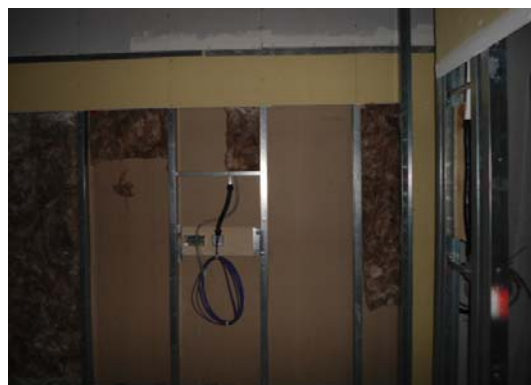
We noted that there was insulation missing from the upper sections of the boarded partitions in THE-202 General Theatre, THE-200 PREP and THE-206 ANAEST. There was insulation also missing approx 2m in length of the boarded out partition in the corridor PL2-203. We have asked Brookfield to confirm when the boards have been removed and the insulation has been fitted prior to boarding out the lower section to allow us to re-inspect the partition. See photos below.

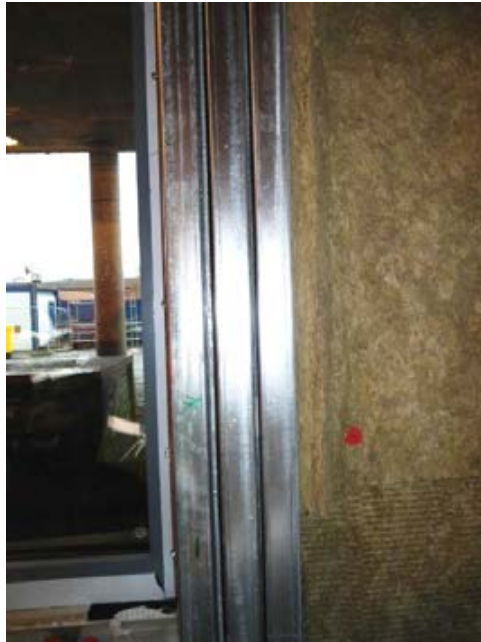
We noted that insulation has not been fitted inside the vertical SFS members at the right hand side of the right hand window in Room EMC-133 Seminar and Training Centre. There is also insulation poorly fitted with gaps. We have asked Brookfield to confirm remedial action to address this. (See Supervisor's Communication General Matters / Other Instructions (CI 13.1) No 67).

No insulation in sfs.
