**Bundle of documents for Oral hearings
commencing from 13 May 2025 in relation
to the Queen Elizabeth University Hospital
and the Royal Hospital for Children,
Glasgow**

**Bundle 33
NEC3 Supervisor's Reports and Project
Supervisors Interface Action Notes**

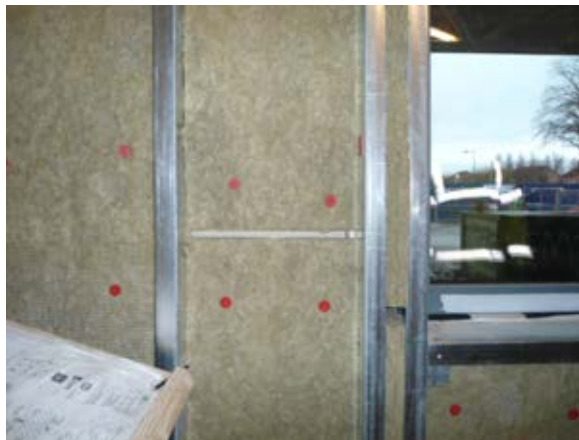
We noted that insulation has not been fitted inside the vertical SFS members at the right hand side of the right hand window in Room EMC-133 Seminar and Training Centre. There is also insulation poorly fitted with gaps. We have asked Brookfield to confirm remedial action to address this. (See Supervisor's Communication General Matters / Other Instructions (CI 13.1) No 67).

Gaps between insulation.

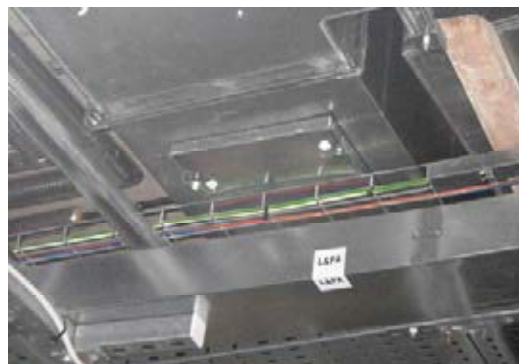
Duct access hatch blocked by chilled water pipework at ground floor area around DB cupboard AAW190. See photograph below. Contractor to confirm when this will be rectified.

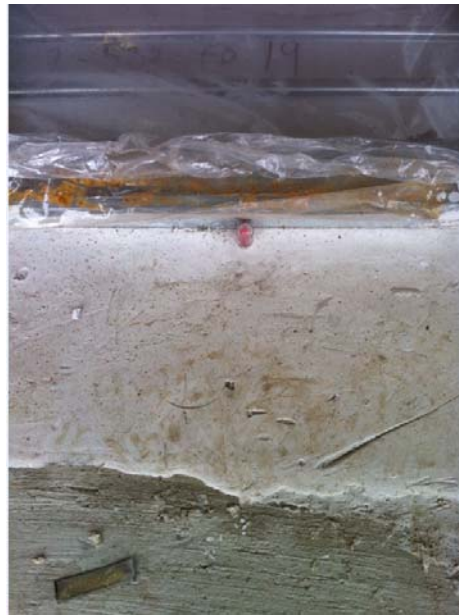
Damper in the duct on Level 3, Plant room is not sealed correctly. We have asked Brookfield to confirm when this has been addressed. Brookfield has investigated and the damper in duct is suitably covered and the fire seal is complete and intact. Consequently Supervisor's Notification of Defect (CI 42.2) No 18 is closed out.

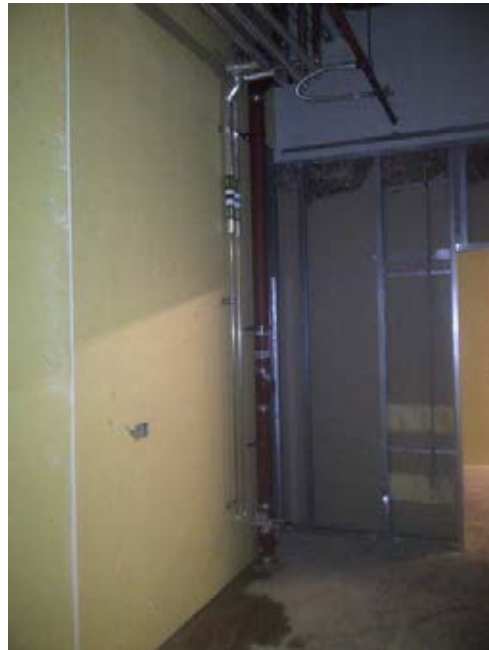
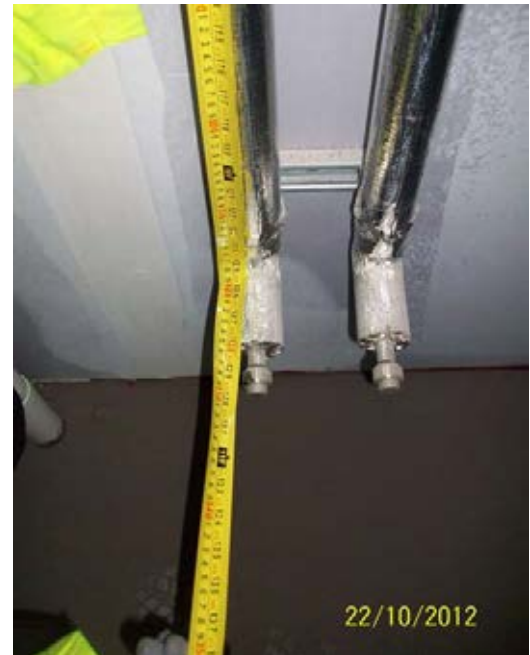
We noted a dead leg which exceeded 3m on Level 2, THE-126 Dirty UT and Level 1, Zone D CCW-201 Staff Lounge. Consequently we have raised Supervisor's Notification of Defect (CI 42.2) No 20 and have asked Brookfield to confirm when this is addressed.

Pipe work dead leg great than 3 meters. We have asked Brookfield to confirm when pipe work has been altered to comply with signed off design drawings. See Supervisor's Notification of Defect (CI 42.2) No 76

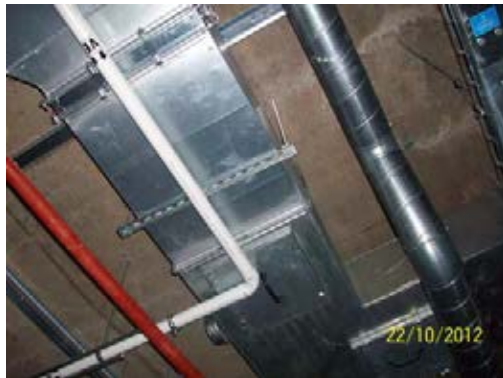
Before

There was restricted access to a duct hatch due to an SVP vent Level 1, Zone E Corridor space adjacent to RCF-xxx IT HUB. Brookfield has confirmed that the vent pipe has been re-routed. See photo below. Supervisor's Notification of Defect (CI 42.2) No 24) is closed out.

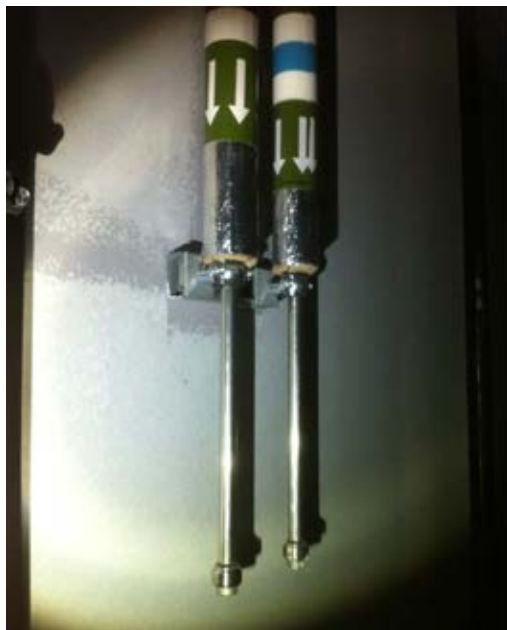
Pipework brackets were inadequately fixed on Level 1, Zone D CCW-201 Staff Lounge. Brookfield has addressed this consequently Supervisor's Notification of Defect (CI 42.2) No 25 is closed out.

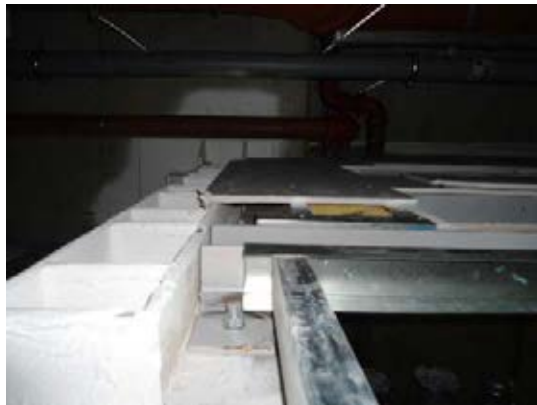
The area of plasterboard above and to the left of the double door in the 120min fire wall at grid ref AL.1 and AK does not have insulation above and mutual with the column. Confirm when this has been addressed. (See Supervisor's Notification of Defect (CI 42.2) No 31

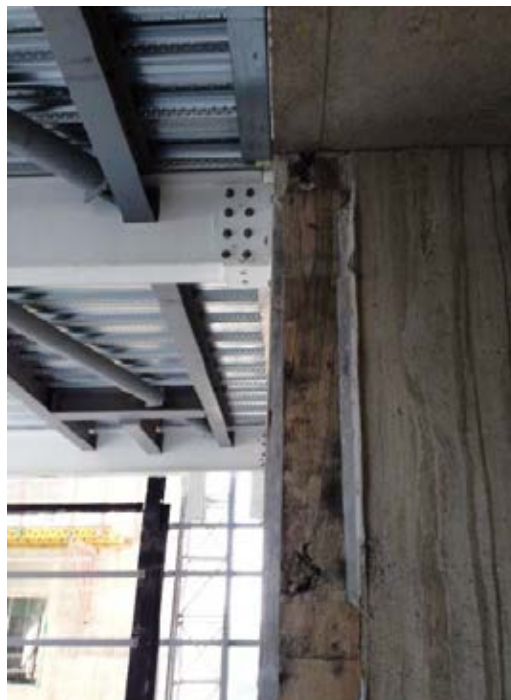
We have asked Brookfield to confirm if the attached hole without bolts to the steelwork bridge connections reflects the design intent and a response to this is still awaited. Brookfield is aware that, as part of local snagging, bolts at some of these connection locations at the cores have been replaced. It may be that this will answer the query, but feedback is awaited. (See Supervisor's Communication General Matters / Other Instructions (CI 13.1) No 57).

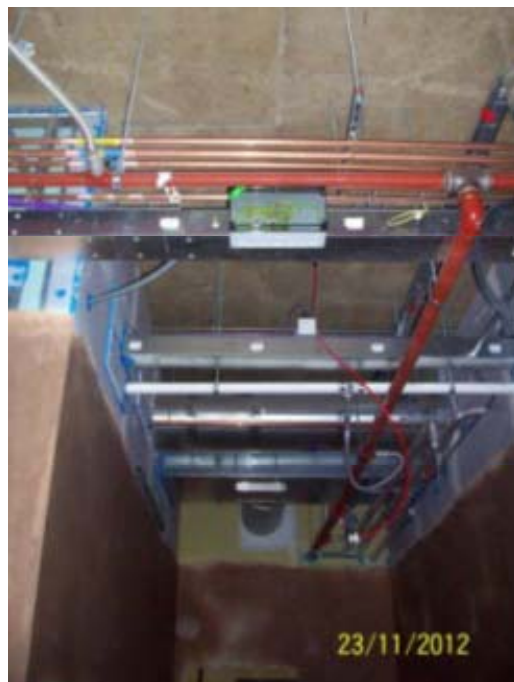
We have asked Brookfield to confirm the flow of water from the sprinkler head highlighted is not restricted by the adjacent section of unistrut. Brookfield has confirmed that the sprinkler head deflector appears to be under the unistrut and that the Sprinkler contractor will check this when they are installing the under services protection. If the head is shielded by the unistrut, they will turn the head pendant. See Supervisor's Communication General Matters / Other Instructions (CI 13.1) No 74.

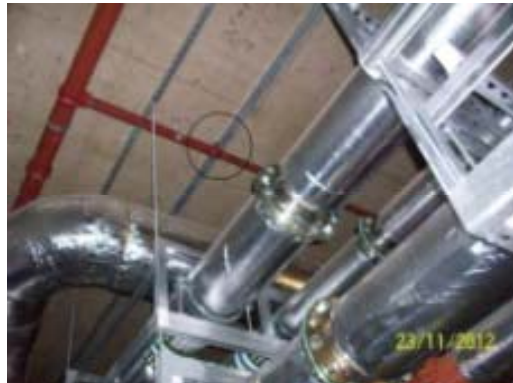
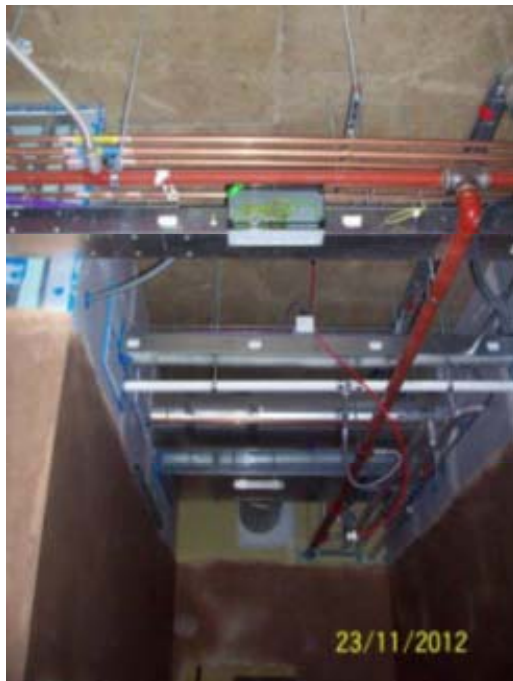
High level sprinkler heads appear inaccessible in a number of areas. We have asked Brookfield to confirm the access regime for sprinkler head maintenance / replacement. Brookfield intimated that this is not unusual in a plant room which is congested. However maintenance is obviously required. Note that replacement of heads should only be required after activation due to fire or damage. Air tests have been carried out on the installation so far. Atmosphere in the plant room is dry / no corrosion likely so heads should last 20 years without issue based on previous installations. They shall be re-tested at 10 year intervals. Notwithstanding any of this, where there are potential access issues, every effort will be made to reach the heads when required – if plant has to be removed to do so, then it will be removed. See Supervisor's Communication General Matters / Other Instructions (CI 13.1) No 75.

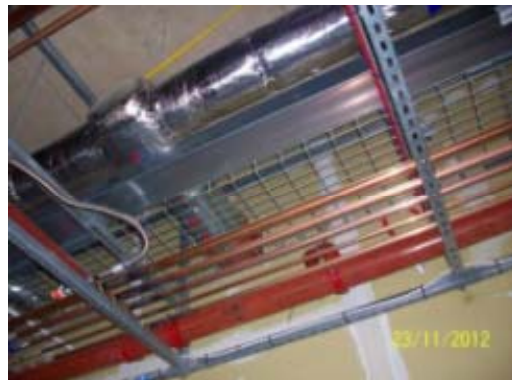
The electrical containment appears to be restricting access to duct access hatch Adjacent to riser THE-237. We have asked Brookfield to confirm duct hatch can be fully accessed without issue when finished ceiling is in place. Brookfield has confirmed that snagging is due to commence 10/12/12 and they will review this when complete. See Supervisor's Communication General Matters / Other Instructions (CI 13.1) No 72.

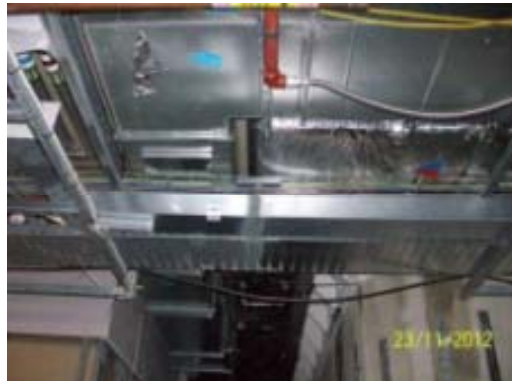
The electrical containment appears to be restricting access to duct access hatch Adjacent to riser THE-2127. We have asked Brookfield to confirm duct hatch can be fully accessed without issue when finished ceiling is in place. Brookfield has confirmed that snagging is due to commence 10/12/12 and they will review this when complete. See Supervisor's Communication General Matters / Other Instructions (CI 13.1) No 73.

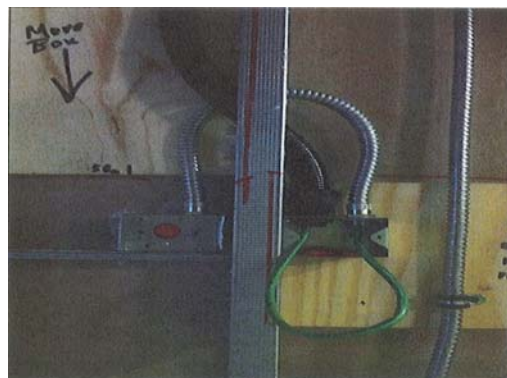
The 2no back boxes in room AAW – 297 Single Bedroom which had not been positioned properly have now been fitted at the required spacing. (See photo below. Supervisor's Communication General Matters / Other Instructions (CI 13.1) No 69 is closed out).

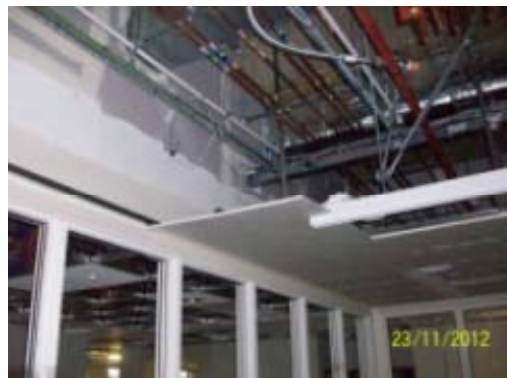
Void detection appears inadequate and inaccessible due to plasterboard ceiling. Brookfield has advised us Scotshield have carried out and continue to carry out site surveys regarding detection coverage. Currently they have identified additional heads to be installed – Mercury is awaiting formal report. They understand that Scotshield continue to review installation on all floors to ensure sufficient coverage but this is WIP. (See Supervisor's Communication General Matters / Other Instructions (CI 13.1) No 77).

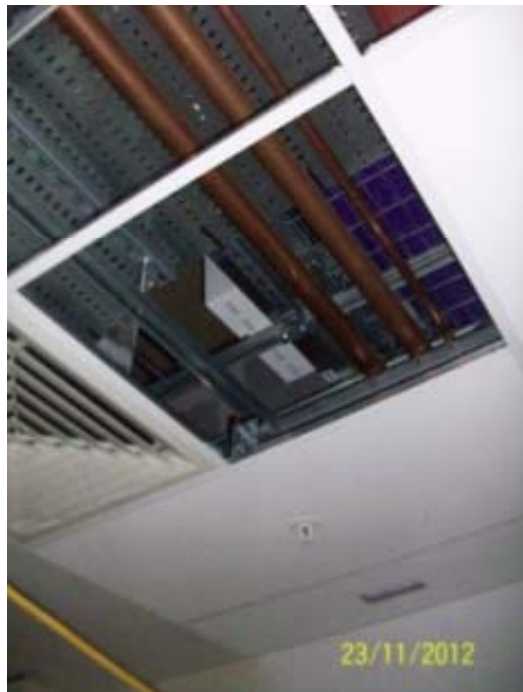
The junction box appears to be inaccessible due to the ceiling installation. We have asked Brookfield to confirm if this is the case. Brookfield has confirmed that the grille shown adjacent to CCW 061 is in fact not connected to the ductwork system and is just a transfer grille (CVG). It can therefore be used as an access hatch to get to the junction box. However the rest of the corridor will be reviewed to check that there is sufficient access. This area has been off limits due to flooring works. (See Supervisor's Communication General Matters / Other Instructions (CI 13.1) No 79).

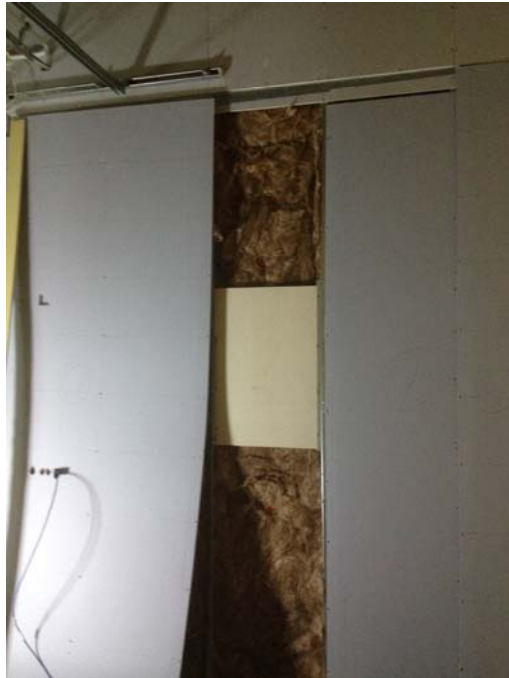
We noted that there was insulation missing from the upper sections of the boarded partitions in THE-202 General Theatre, THE-200 PREP and THE-206 ANAEST. There was insulation also missing approx 2m in length of the boarded out partition in the corridor PL2-203. Brookfield has confirmed that the boards have been removed and the insulation has been fitted. See photos below.

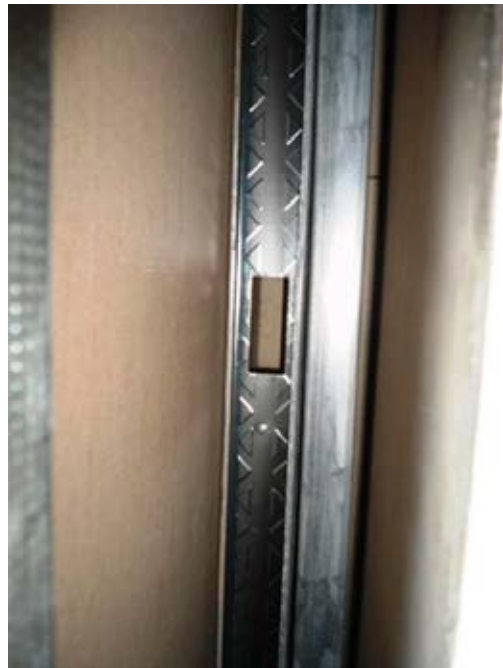
There was no insulation in the 60 minute fire resistant partition adjacent to the column in room THE-108 on Level 2. There was also no insulation at high level where the conduit passes inside the partition. Brookfield has confirmed that the insulation at high level has been replaced and has provided photographic evidence. (See Supervisor's Communication General Matters / Other Instructions (CI 13.1) No 84).

No insulation at end of partition

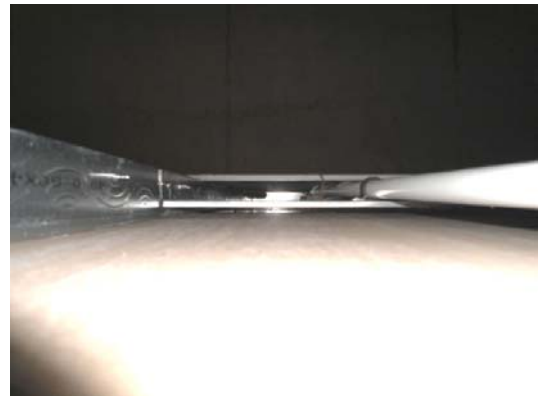
No insulation at high level.

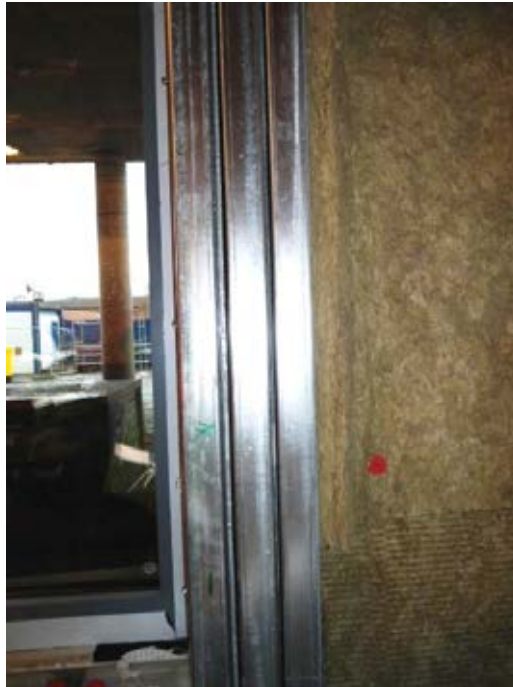
We noted that insulation has not been fitted inside the vertical SFS members at the right hand side of the right hand window in Room EMC-133 Seminar and Training Centre. There is also insulation poorly fitted with gaps. We have asked Brookfield to confirm remedial action to address this. (See Supervisor's Communication General Matters / Other Instructions (CI 13.1) No 67).

No insulation in sfs.

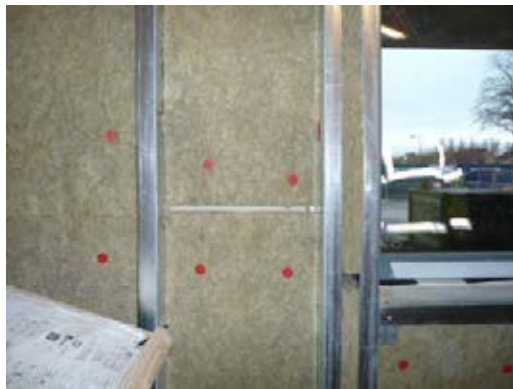
Gaps between insulation.

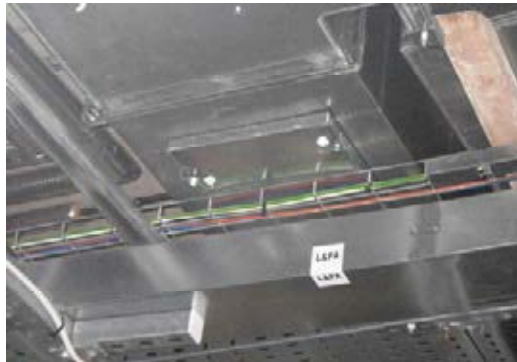
Duct access hatch blocked by chilled water pipework at ground floor area around DB cupboard AAW190. See photograph below. Contractor to confirm when this will be rectified.

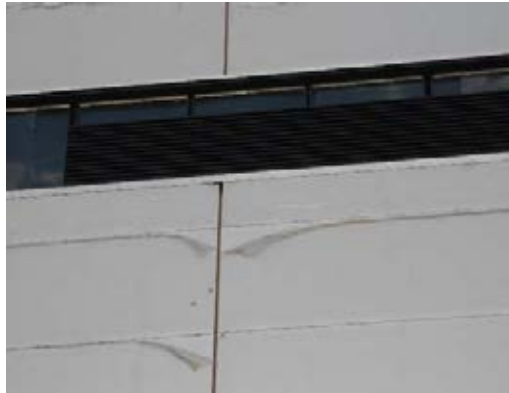
One of the fixings to the cladding is visible beneath the capping pieces and the cladding is indented. Brookfield has confirmed that the vertical 'top hat' flashing is still to be installed and this will cover the fixing and the indent. A joint inspection will be arranged between ourselves and Brookfield to inspect the 'top hat'. (See Supervisor's Notification of Defect (CI 42.2) No 16).

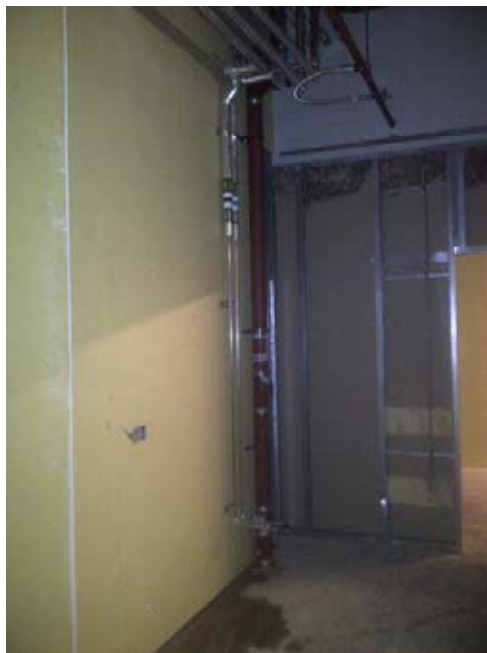
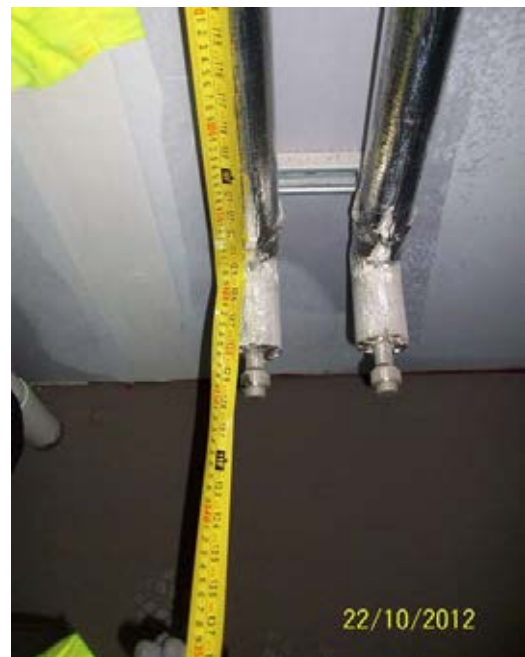
We noted a dead leg which exceeded 3m on Level 2, THE-126 Dirty UT and Level 1, Zone D CCW-201 Staff Lounge. Consequently we have raised Supervisor's Notification of Defect (CI 42.2) No 20 and have asked Brookfield to confirm when this is addressed.

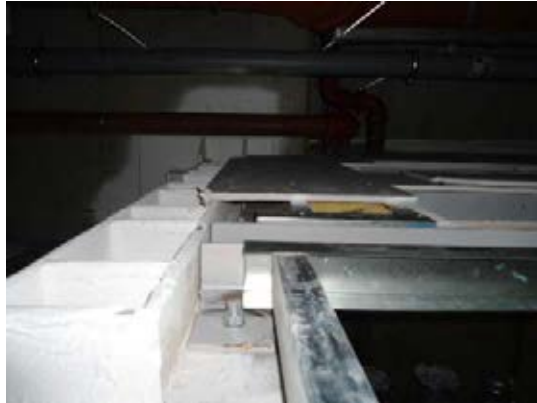
The area of plasterboard above and to the left of the double door in the 120min fire wall at grid ref AL.1 and AK does not have insulation above and mutual with the column. Brookfield has confirmed that this is Work in Progress and the top hat has not been installed to the South Elevation.

This will be addressed in January 2013, when CS will be invited to the joint inspection noted above. (See Supervisor's Notification of Defect (CI 42.2) No 31.

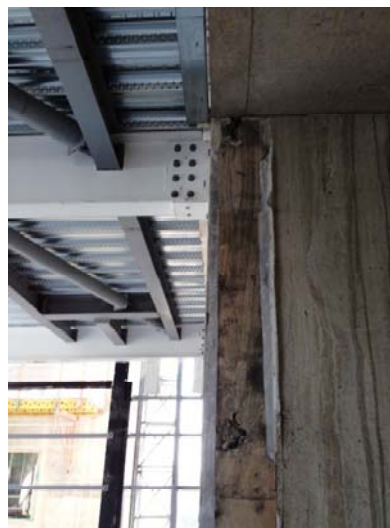
We have asked Brookfield to confirm if the attached hole without bolts to the steelwork bridge connections reflects the design intent and a response to this is still awaited. Brookfield is aware that, as part of local snagging, bolts at some of these connection locations at the cores have been replaced. It may be that this will answer the query, but feedback is awaited. (See Supervisor's Communication General Matters / Other Instructions (CI 13.1) No 57

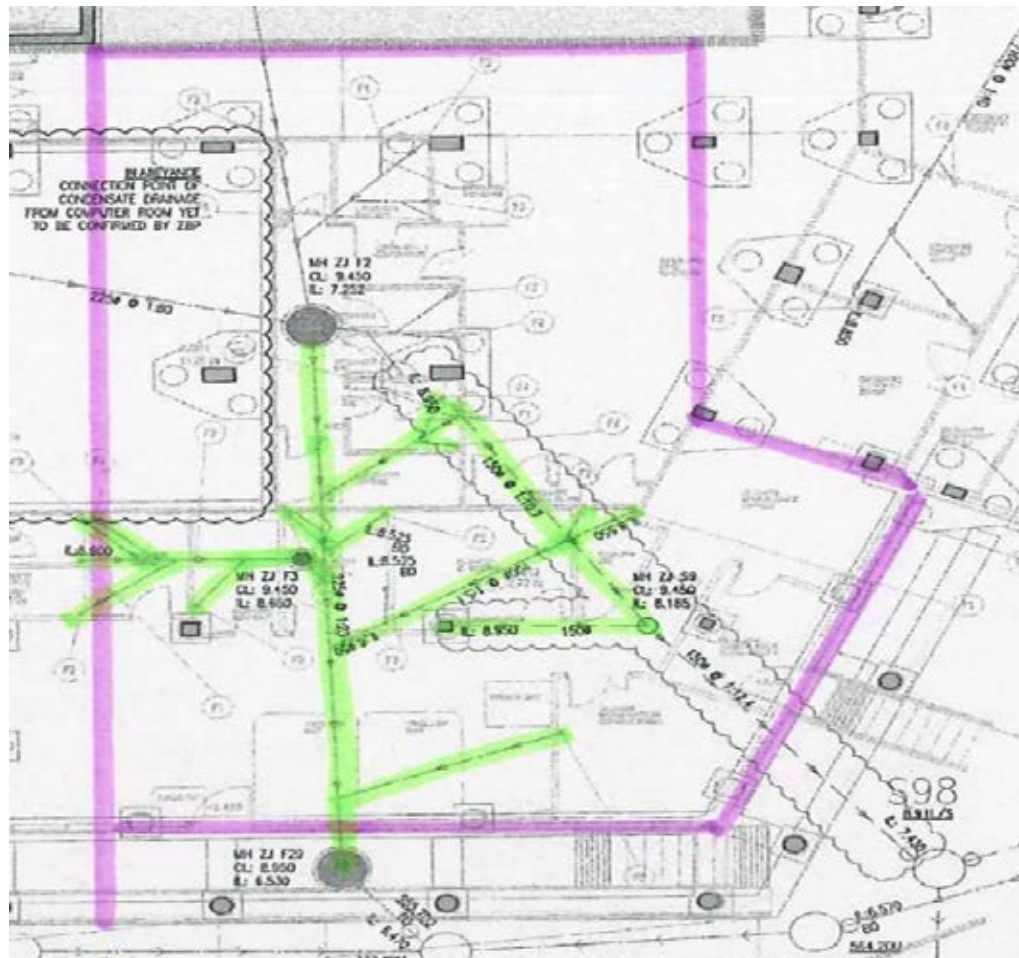
Below ground drainage on the Ground Floor Zone J Pour 1.

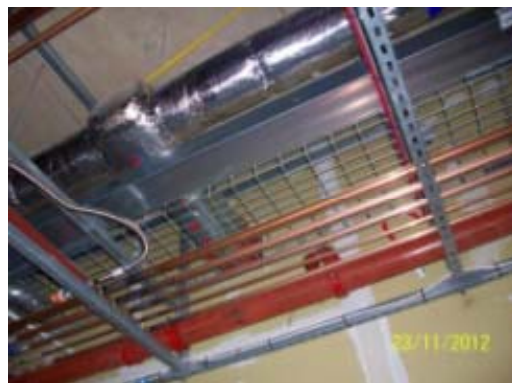
The electrical containment appears to be restricting access to duct access hatch Adjacent to riser THE-237. We have asked Brookfield to confirm duct hatch can be fully accessed without issue when finished ceiling is in place. Brookfield has confirmed that snagging is due to commence in December and they will review this when complete. See Supervisor's Communication General Matters / Other Instructions (CI 13.1) No 72.

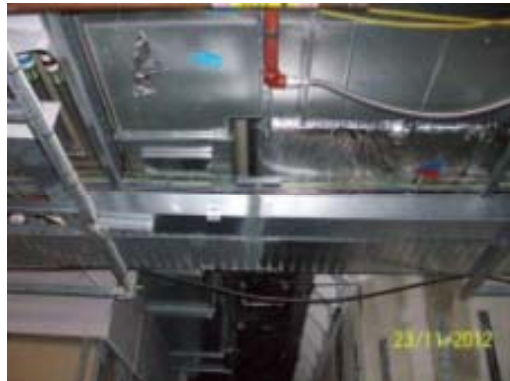
Following an inspection on site we have asked Brookfield to confirm that the access hatch within ductwork in room EMC-062 shall still be accessible after the medical gases and ceiling installation is complete. See Supervisor's Communication General Matters / Other Instructions (CI 13.1) No 91.

We have concerns that access may be restricted to the hatch within room AAW-349. Consequently we asked Brookfield to confirm that the access to the hatch within the ductwork shall still be accessible after the medical gases and ceiling installation are complete. Brookfield has responded confirming that the 2 white run at a parallel height and is below the ductwork, therefore, will not interfere with the hatch. They cannot identify any potential access problems when the ceiling is fitted. We shall continue to monitor this when the ceiling is fitted. Supervisor's Communication General Matters / Other Instructions (CI 13.1) No 94 is closed out.

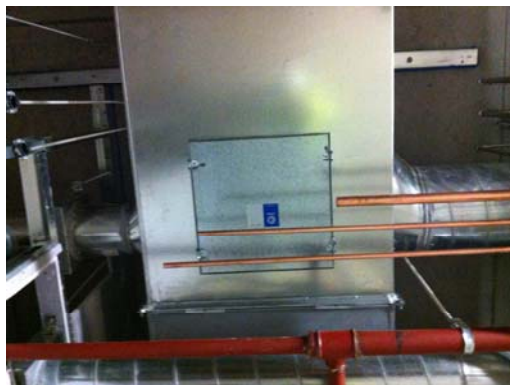
We observed that ductwork penetrating the walls of the Dirty Utility Rooms in the Theatre Suites were not dampened (fire dampers). Consequently we have raised Supervisor's Communication General Matters / Other Instructions (CI 13.1) No 97 asking for clarification. This was observed in many Dirty Utility Rooms. We noted that ductwork was insulated.

Brookfield confirmed that the insulated ductwork is Supply ductwork which is fire rated underneath the insulation.

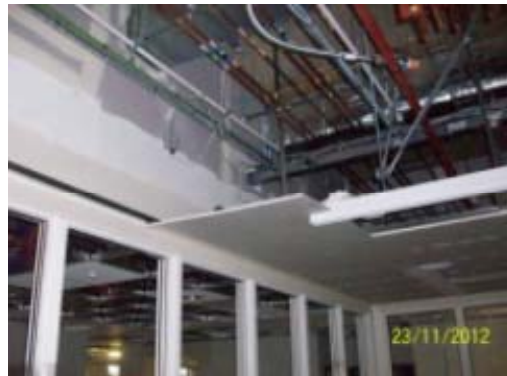
Void detection appears inadequate and inaccessible due to plasterboard ceiling. Brookfield has advised us Scotshield have carried out and continue to carry out site surveys regarding detection coverage. Currently they have identified additional heads to be installed – Mercury is awaiting formal report. They understand that Scotshield continue to review installation on all floors to ensure sufficient coverage but this is work in progress. (See Supervisor's Communication General Matters / Other Instructions (CI 13.1) No 77

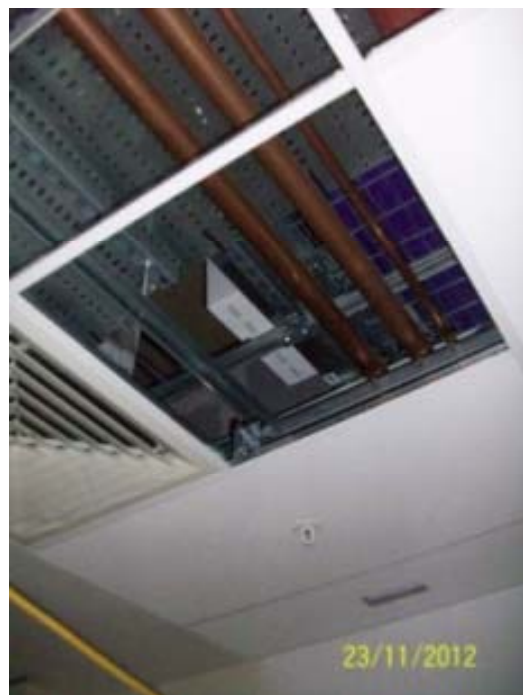
The junction box appears to be inaccessible due to the ceiling installation. We have asked Brookfield to confirm if this is the case. Brookfield has confirmed that the grille shown adjacent to CCW 061 is in fact not connected to the ductwork system and is just a transfer grille (CVG). It can therefore be used as an access hatch to get to the junction box. However the rest of the corridor will be reviewed to check that there is sufficient access. This area has been off limits due to flooring works. (See Supervisor's Communication General Matters / Other Instructions (CI 13.1) No 79).

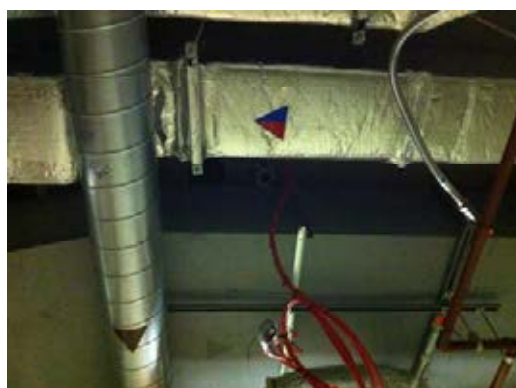
Hoist cabling in CCW 051 is inadequately supported. Brookfield confirmed this has been clipped and a photograph will follow as soon as they get access back into the area. The detail shown will be that for the rest of the hoist cabling. (See Supervisor's Communication General Matters / Other Instructions (CI 13.1) No 78).

There appears to be restrictive space for the void detection. We have asked Brookfield to confirm if void detector above the ductwork is providing adequate protection. (See Supervisor's Communication General Matters / Other Instructions (CI 13.1) No 90).

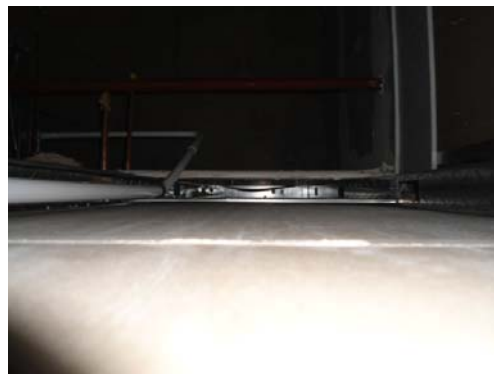
An inspection was carried out with Brookfield on Level 0 and we noted that insulation was missing at high level and had also been disturbed as a result of electrical work in room AAW-255 EN-SUITE. Brookfield instructed Astins to correct these issues. We will continue to monitor these during future visits.

No insulation

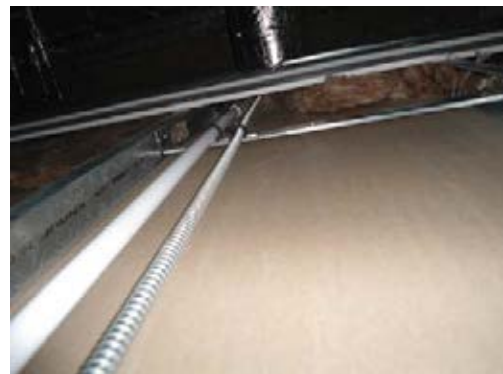
Insulation disturbed

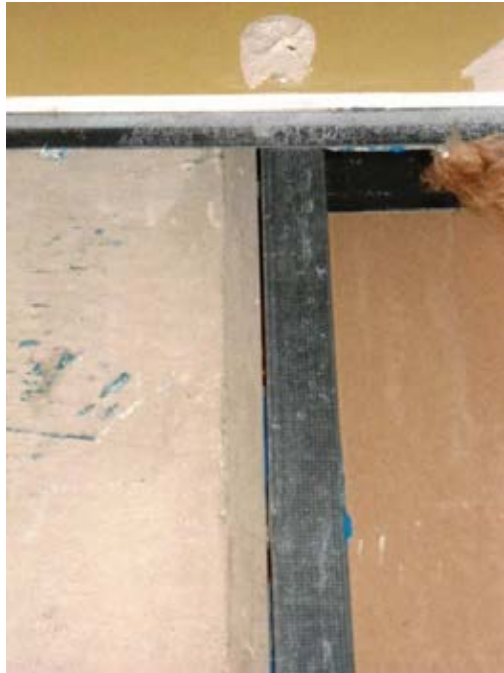
We noted in several locations that the intumescent sealant between some studs and columns were insufficient and the studs were not fixed securely. Brookfield instructed Astins to rectify this problem. A tool box talk has been carried out. We shall continue to monitor this.

Insufficient seal between column and stud

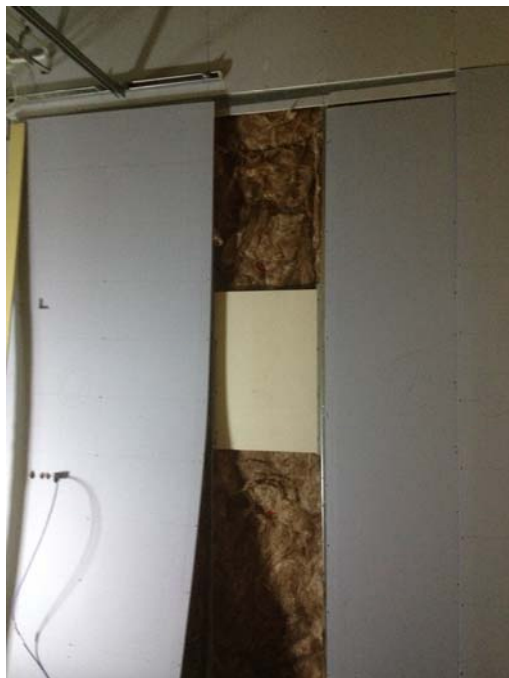
We noted that there was insulation missing from the upper sections of the boarded partitions in THE-202 General Theatre, THE-200 PREP and THE-206 ANAEST. There was insulation also missing approx 2m in length of the boarded out partition in the corridor PL2-203. Brookfield has confirmed that the boards have been removed and the insulation has been fitted. See photo below.

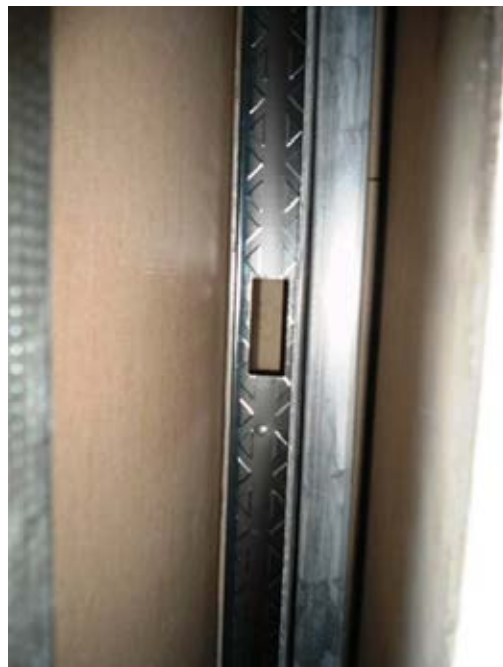
During an inspection we noted that there was no insulation at the junction of the inner face of the external wall and the end of the partition between rooms AAW-258 & AAW-257. We asked Brookfield to confirm when this will be addressed as this is required to prevent flanking transmission of sound between rooms. Brookfield confirmed that there are several instances of this detail in this area and they will all get completed at the 2nd side boarding stage. The windows were not installed at the 1st fix stage of partition installation hence they were not taken through at the time. We subsequently inspected the partition to witness the completed work. Consequently Supervisor's Communication General Matters / Other Instructions (CI 13.1) No 83 is closed out.

No insulation at end of partition

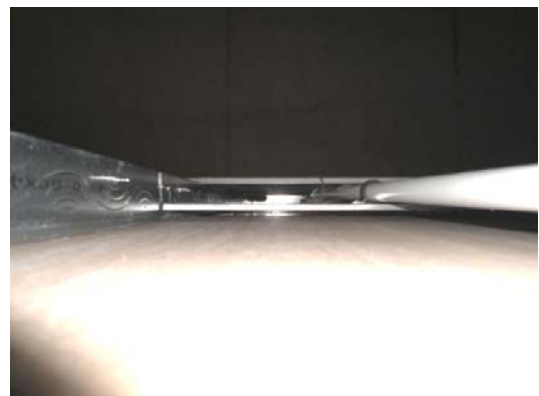
There was no insulation in the 60 minute fire resistant partition adjacent to the column in room THE-108 on Level 2. There was also no insulation at high level where the conduit passes inside the partition. Brookfield has confirmed that the insulation at high level has been replaced and has provided photographic evidence. Consequently Supervisor's Communication General Matters / Other Instructions (CI 13.1) No 84 is closed out.

No insulation at high level.

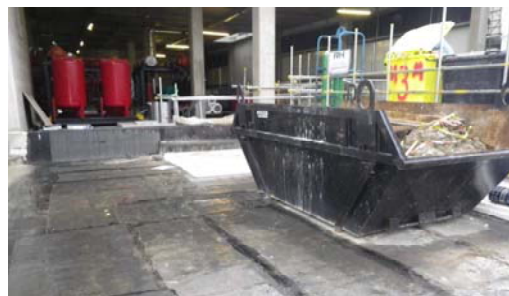
A loaded skip was placed on the unprotected roof on level 3 resulting in potential damage to the roof. Brookfield confirmed that the skip has been removed and an inspection of the roof is to be carried out. See Supervisor's Communication General Matters / Other Instructions (CI 13.1) No 100).

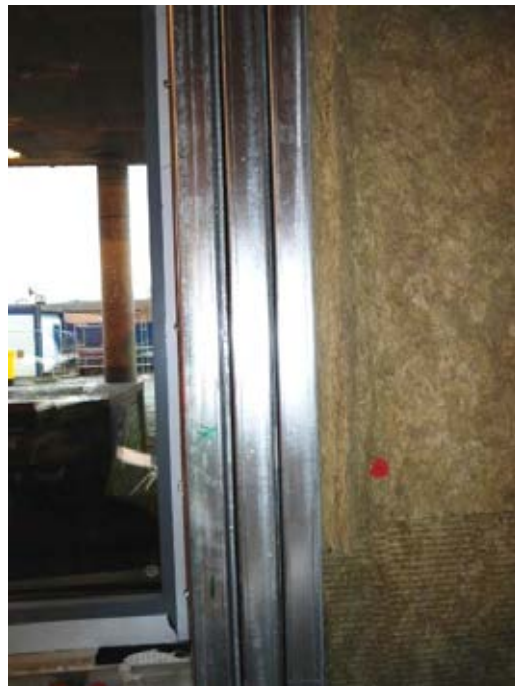
We noted that insulation has not been fitted inside the vertical SFS members at the right hand side of the right hand window in Room EMC-133 Seminar and Training Centre. There is also insulation poorly fitted with gaps. We have asked Brookfield to confirm remedial action to address this. (See Supervisor's Communication General Matters / Other Instructions (CI 13.1) No 67).

No insulation in sfs.

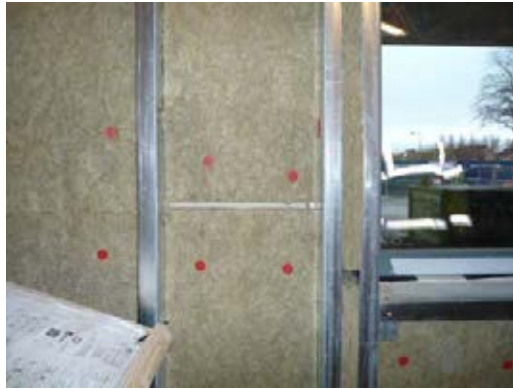
Gaps between insulation.

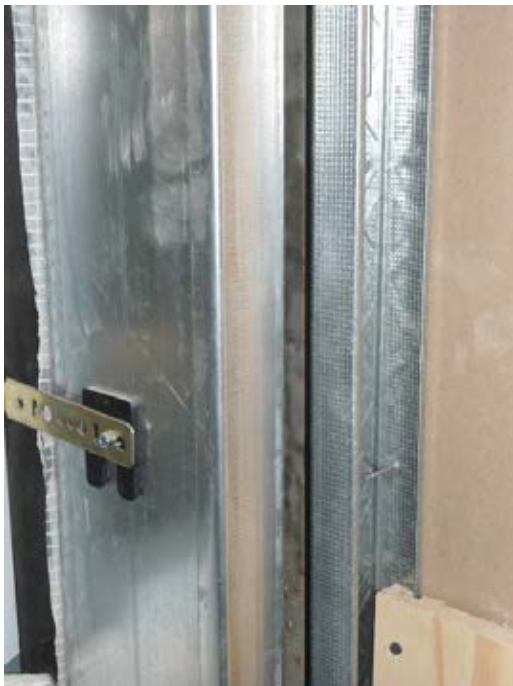
We noted during an inspection that there were a couple of locations where there was no insulation between the SFS members immediately behind the end of the partitions adjacent to the external elevation in room AAW-258. Brookfield made this aware to the operatives and this will be addressed. We will continue to monitor this in future visits.

No insulation behind partition.

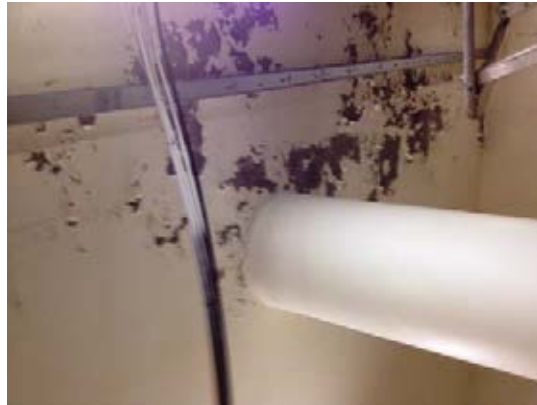
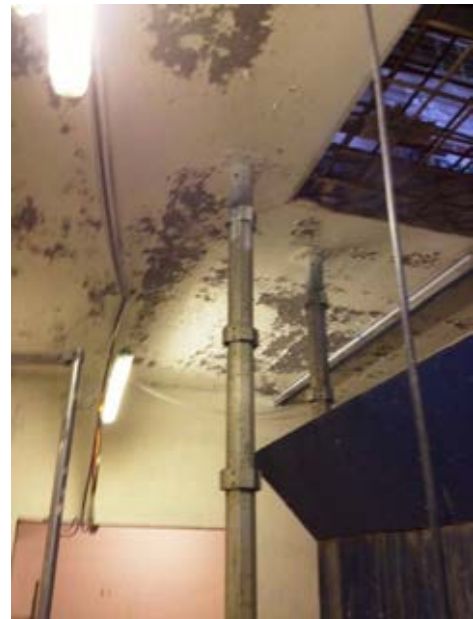
We noted that there is flaking paintwork on the soffit of the ground floor slab in the basement area between Cores A, B, C , D. We have asked Brookfield to confirm remedial measures to address this and when it will be carried out. (See Supervisor's Communication General Matters / Other Instructions (CI 13.1) No 96).

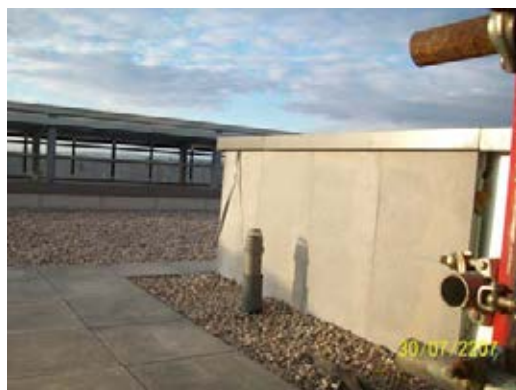
We noted that roof was generally complete, however we observed that lightning protection tape was not secured to the building in a number of locations and have raised this with Brookfield. Brookfield has confirmed that this is work in progress and is aware that a number of lightning tapes are not secured. A review was carried out to determine remedial works and this will be rectified. We shall continue to monitor this. (Supervisor's Communication General Matters / Other Instructions (CI 13.1) No 98 is closed out.

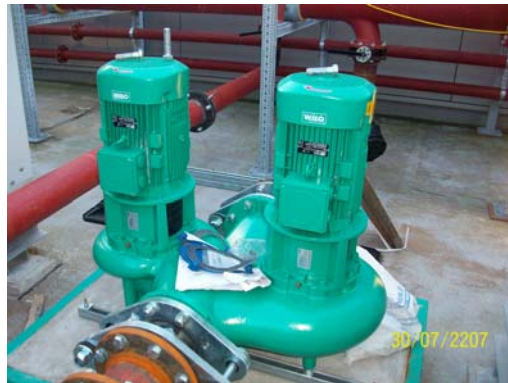
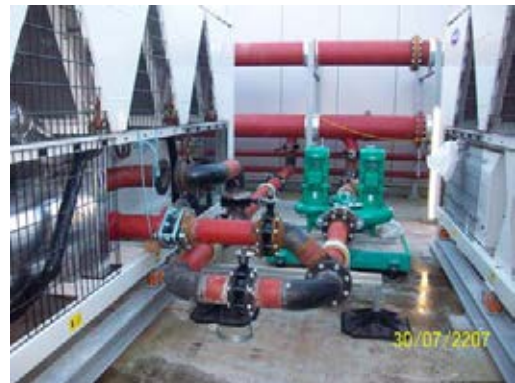
We asked Brookfield to confirm that the external WILO pumps are suitable for an outdoor and exposed location. They have confirmed that the pumps are suitable. Consequently Supervisor's Communication General Matters / Other Instructions (CI 13.1) No 99 is closed out.

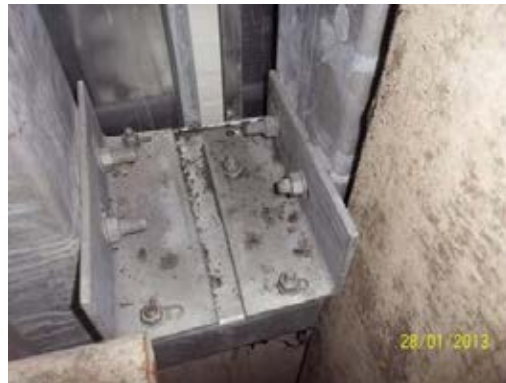
We raised a Defect Notification for a Steel angle plate which is too short on Level 3 Zone G. Brookfield has completed the remedial work. Consequently Supervisor's Notification of Defect (CI 42.2) No 09 is closed out.

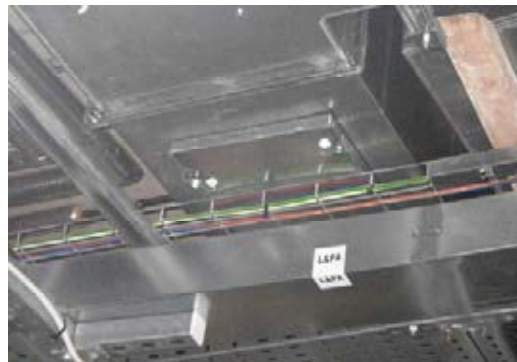
Duct access hatch blocked by chilled water pipework at ground floor area around DB cupboard AAW190. See photograph below. Contractor to confirm when this will be rectified.

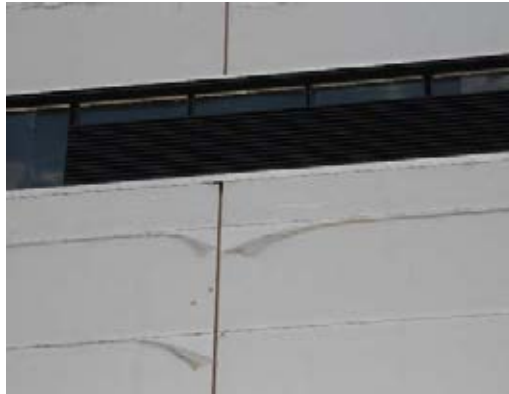
One of the fixings to the cladding is visible beneath the capping pieces and the cladding is indented. Brookfield has confirmed that the vertical 'top hat' flashing is still to be installed and this will cover the fixing and the indent. A joint inspection will be arranged between ourselves and Brookfield to inspect the 'top hat'. (See Supervisor's Notification of Defect (CI 42.2) No 16).

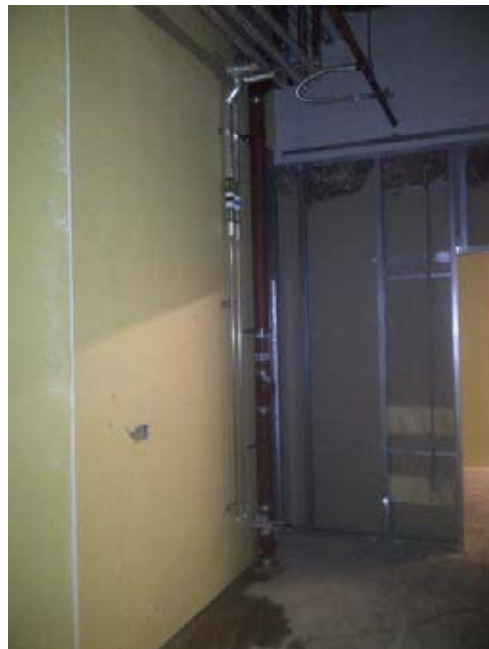
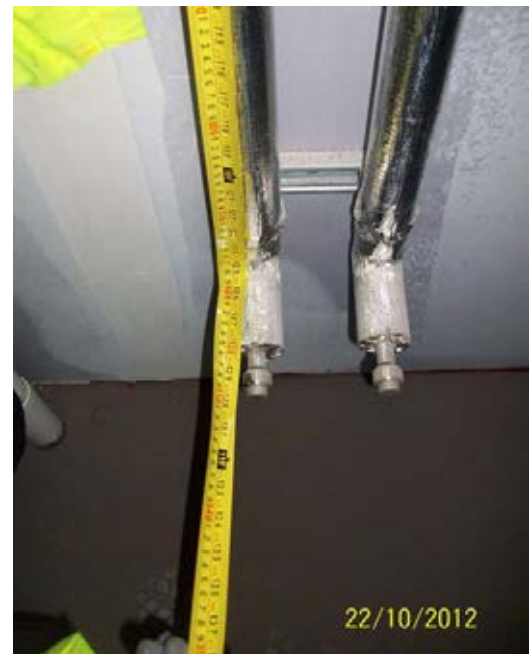
We noted a dead leg which exceeded 3m on Level 2, THE-126 Dirty UT and Level 1, Zone D CCW-201 Staff Lounge. Consequently we have raised Supervisor's Notification of Defect (CI 42.2) No 20 and have asked Brookfield to confirm when this is addressed.

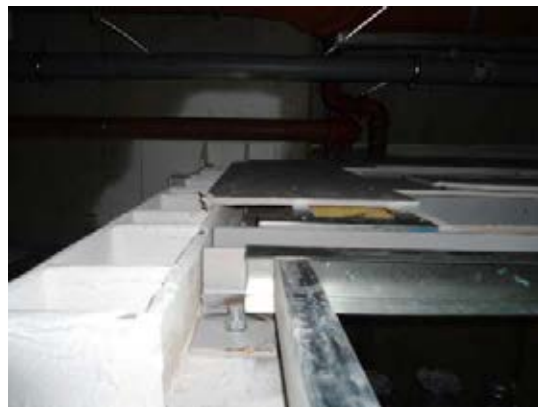
The area of plasterboard above and to the left of the double door in the 120min fire wall at grid ref AL.1 and AK does not have insulation above and mutual with the column. Brookfield has confirmed that this is Work in Progress and the top hat has not been installed to the South Elevation. This will be addressed in January 2013, when CS will be invited to the joint inspection noted above. (See Supervisor's Notification of Defect (CI 42.2) No 31.

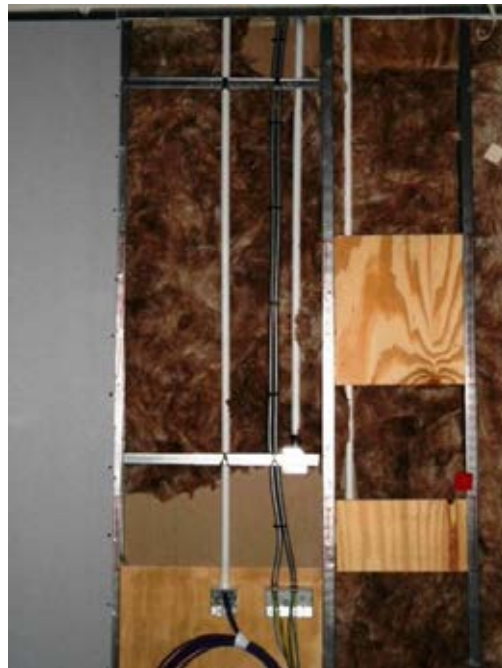
We noted during a joint inspection with Brookfield that insulation had been disturbed during the installation of the electrical work. It also had not been fitted behind vertical conduit. These if not remedied would lead to a failure of the acoustic performance of the partition. We raised this with Brookfield and they have since confirmed that this has been remedied and photographic evidence has been provided. (See Supervisor's Communication General Matters / Other Instructions (CI 13.1) No 36.

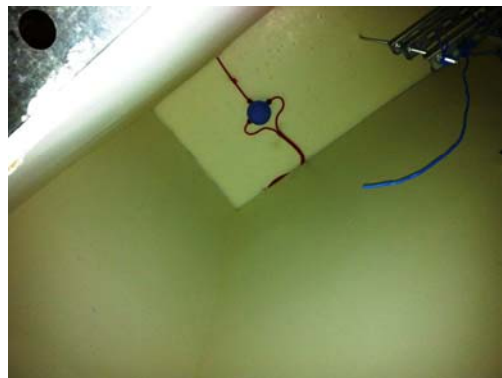
At this time the smoke detector isn't in the centre of the room. Consequently this issue still requires to be resolved. (See Supervisor's Communication General Matters / Other Instructions (CI 13.1) No 37.

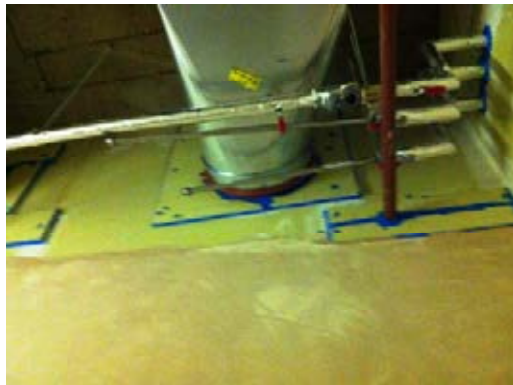
A review was carried out on the fire rated ductwork crossing the dirty utilities on each of the level 2 theatre suites we noted that in a number of occasions the fire rated ductwork did not penetrate into the neighbouring space greater than 150mm as detailed on the approved design drawings. We asked Brookfield to ensure that fire rated ductwork complies with this requirement and review all other penetrations providing notification of any that do not comply and evidence that they have been corrected in compliance with design drawings. We have provided Brookfield with locations following our site inspection.

Brookfield has confirmed that the installation has been reviewed on site the majority of cases extend beyond 100mm with perhaps 4 at a minimum. It appears that the 150mm extension was missed during the installation of Zones D & G but then picked up and going forward this has been accommodated.

(See Supervisor's Communication General Matters / Other Instructions (CI 13.1) No 38).

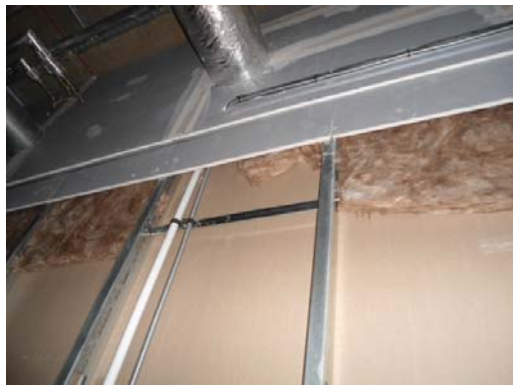
We noted during a joint inspection with Brookfield that insulation has been disturbed behind the boards at high level as a result of electrical installation work. If this is not corrected the acoustic quality of the partition adversely affected. We have asked Brookfield to confirm when this has been remedied. (See Supervisor's Communication General Matters / Other Instructions (CI 13.1) No 39).

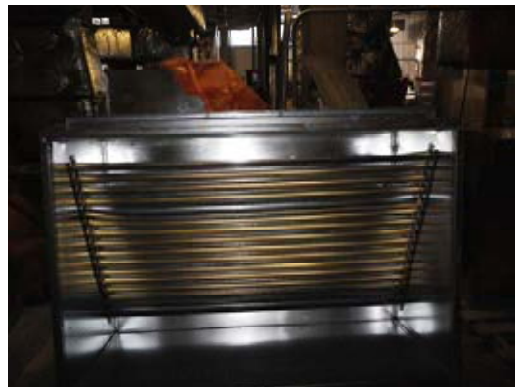
Level 2 Zone D plant area

We have brought to Brookfield's attention a few locations where there are damaged components (See photographs below). They have uploaded these onto their IDMS system to be resolved as part of their snagging rectification process.

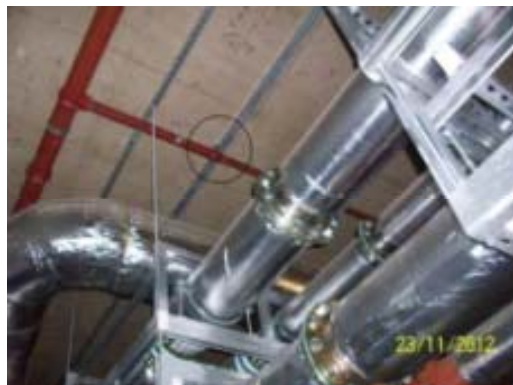
We have asked Brookfield to confirm the flow of water from the sprinkler head highlighted is not restricted by the adjacent section of unistrut. Brookfield has confirmed that the sprinkler head deflector appears to be under the unistrut and that the Sprinkler contractor will check this when they are installing the under services protection. If the head is shielded by the unistrut, they will turn the head pendant. Awaiting photograph showing completed work. See Supervisor's Communication General Matters / Other Instructions (CI 13.1) No 74.

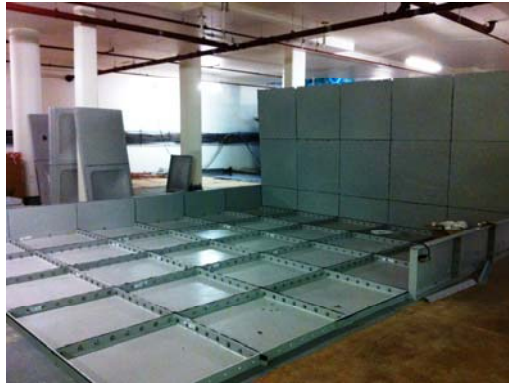
tank there would be a need to wet vac each 1m x 1m pod to fully drain the tank as the flanges are internal. We would seek confirmation that these requirements has gone through a risk assessment and has been signed off by the CDM Assessor. See Supervisor's Communication General Matters / Other Instructions (CI 13.1) No 89.
