**Bundle of documents for Oral hearings
commencing from 13 May 2025 in relation
to the Queen Elizabeth University Hospital
and the Royal Hospital for Children,
Glasgow**

**Bundle 33
NEC3 Supervisor's Reports and Project
Supervisors Interface Action Notes**

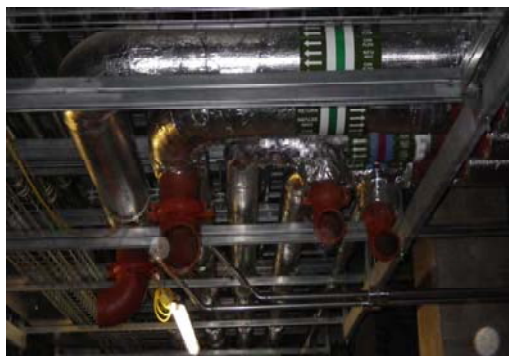
There are open ended pipework in the plant room on Level 3 Zone D. Consequently we have raised Supervisor's Communication General Matters / Other Instructions (CI 13.1) No 102 Brookfield has covered the open ended pipes and provided photographic evidence. This Communication is now closed out.

Pipes uncovered.

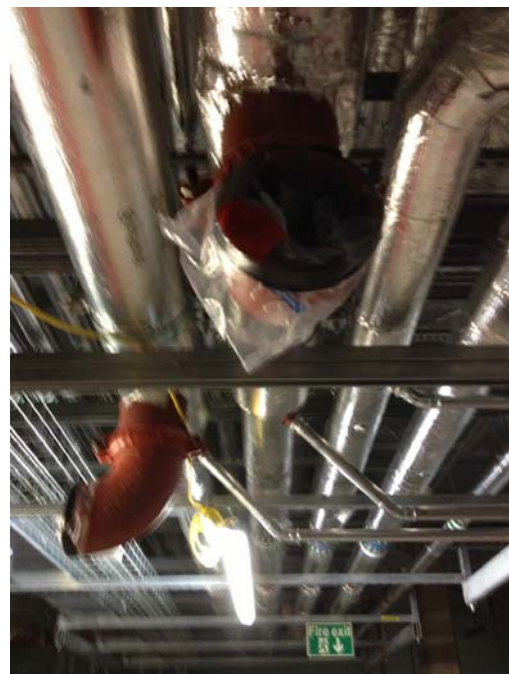
Pipes covered

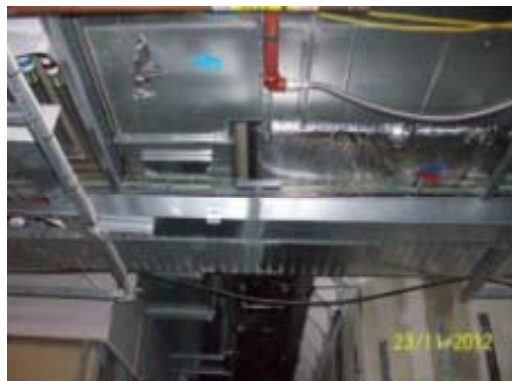
The electrical containment appears to be restricting access to duct access hatch Adjacent to riser THE-2127. We have asked Brookfield to confirm that the duct hatch can be fully accessed without issue when the finished ceiling is in place. Brookfield has confirmed that snagging is due to commence in December and they will review this when complete. See Supervisor's Communication General Matters / Other Instructions (CI 13.1) No 73

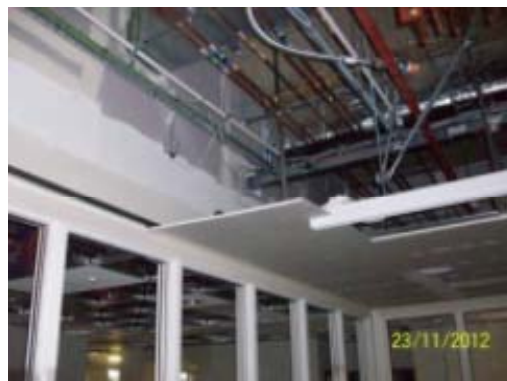
Void detection appears inadequate and inaccessible due to plasterboard ceiling. Brookfield has advised us Scotshield have carried out and continue to carry out site surveys regarding detection coverage. Currently they have identified additional heads to be installed – Mercury is awaiting formal report. They understand that Scotshield continue to review installation on all floors to ensure sufficient coverage but this is work in progress. (See Supervisor's Communication General Matters / Other Instructions (CI 13.1) No 77

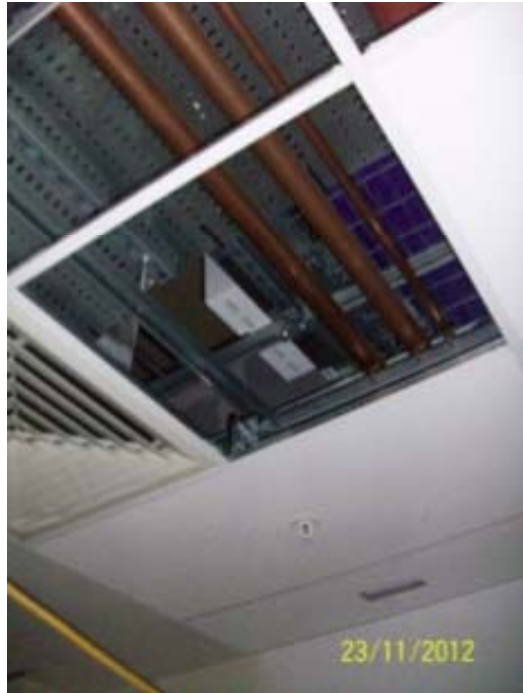
The junction box appears to be inaccessible due to the ceiling installation. We have asked Brookfield to confirm if this is the case. Brookfield has confirmed that the grille shown adjacent to CCW 061 is in fact not connected to the ductwork system and is just a transfer grille (CVG). It can therefore be used as an access hatch to get to the junction box. However the rest of the corridor will be reviewed to check that there is sufficient access. This area has been off limits

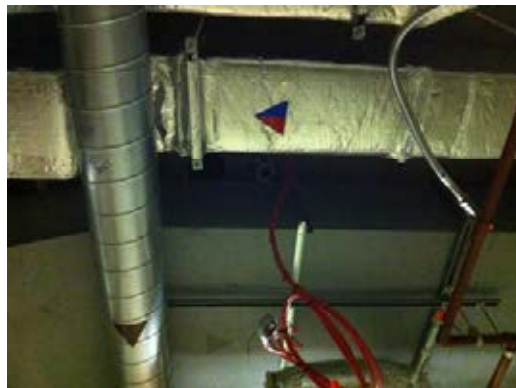
There appears to be restrictive space for the void detection. We have asked Brookfield to confirm if void detector above the ductwork is providing adequate protection. (See Supervisor's Communication General Matters / Other Instructions (CI 13.1) No 90).

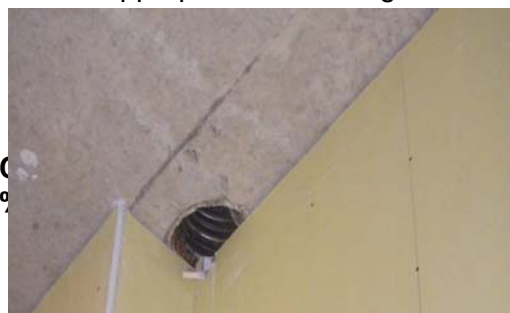
We noted on Level 2 that the drainage outlet in the ceiling was restricted and brought this to Brookfield's attention. They have confirmed that the Partition will need to be cut out & boxed around the aperture once pipework is installed to ensure appropriate fire rating is achieved. We shall continue to monitor this during future visit to the site.

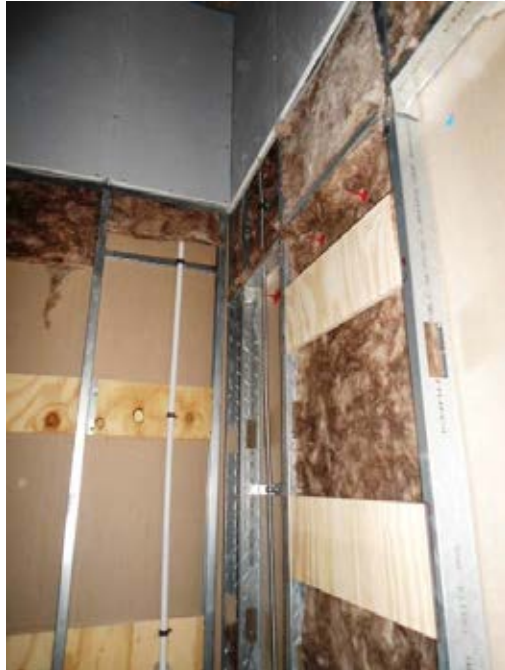
During a visit to site we noted that a vertical stud in the corner of room STW-082 had not been fitted properly. Brookfield took the appropriate action and refitted the stud and adjusted the patrisis and first fix electrical work.

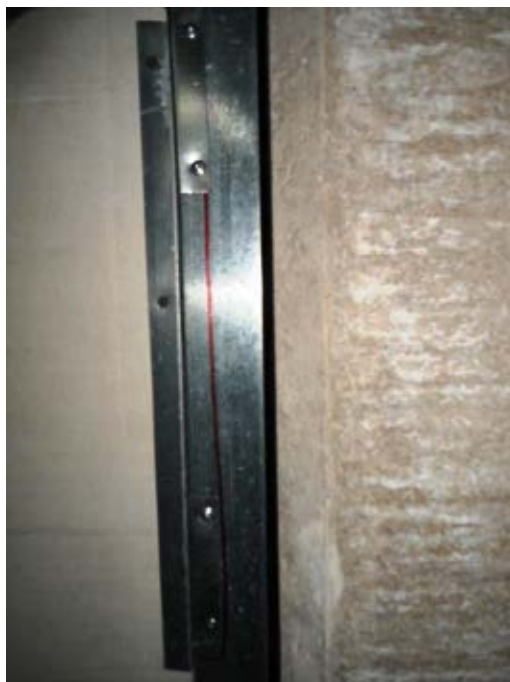
We also noted that the vertical stud in room STW-015 had not been fitted and sealed against the concrete column adequately. Brookfield addressed this by cladding the column and provided photographic evidence.

Vertical stud not tight to the column.

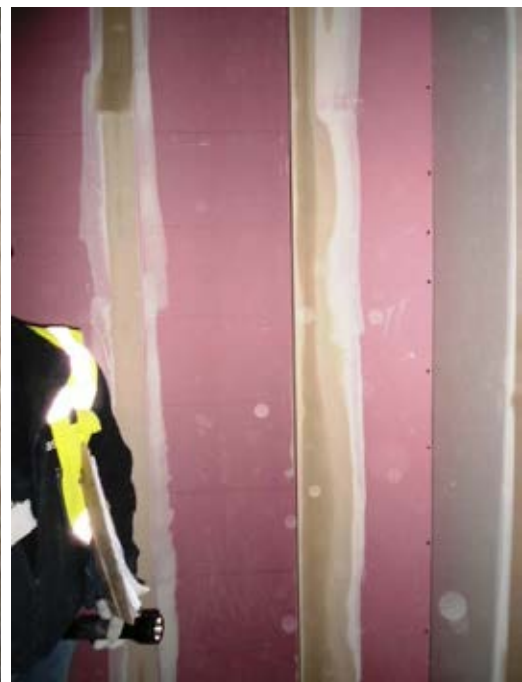
Solution column encased.

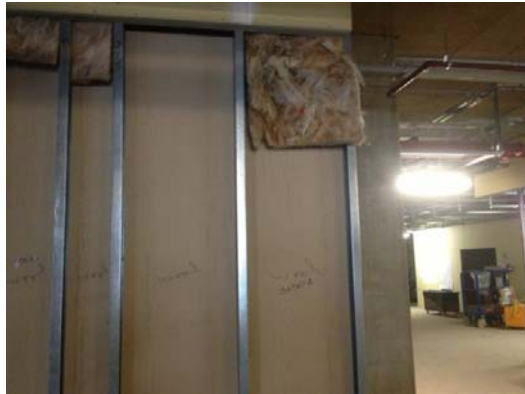
A joint inspections was carried out with Brookfield on Level 2 and we noted that insulation had fallen out of the partition at high level in Zone E. Brookfield recorded this and confirmed that this would be addressed.

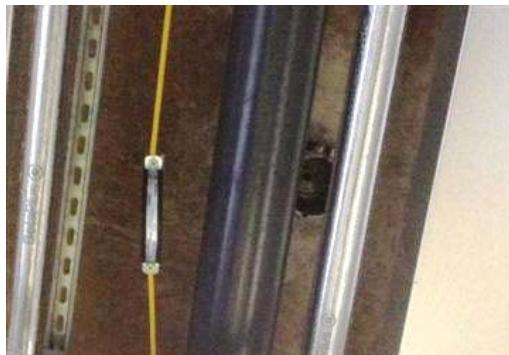
During a joint inspection with Brookfield we noted that the Rain Water Outlet in Corridor 2-529 (zone J) clashed with module services. Brookfield confirmed that the module services would be altered to enable the connection.

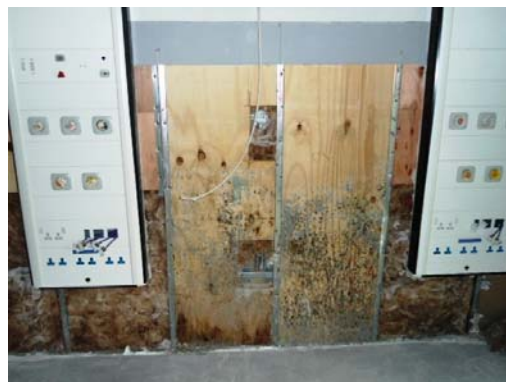
During a joint inspection with Brookfield they made us aware that partitions affected by mildew are being stripped as the building is made watertight.

Boards affected by mildew

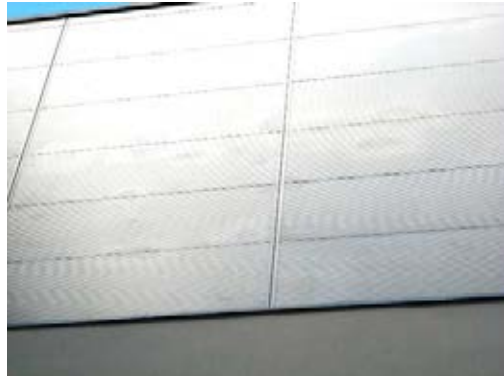
Attempts to carry out repairs to damaged sections of panel cladding in Courtyards 4 & 5 have proved unsuccessful. This has been recorded by Brookfield and we are aware that there are plans to paint the entire surfaces of the damaged panels. Consequently we seek confirmation from the manufacturer that the onsite repair/painting of the panels will have the same life expectancy as the factory produced painted finish. We have also asked Brookfield to provide details of the methodology to carry out on site painting. (See Supervisor's Communication General Matters / Other Instructions (CI 13.1) No 103).

Unsuccessful repairs to cladding in Courtyard 5.

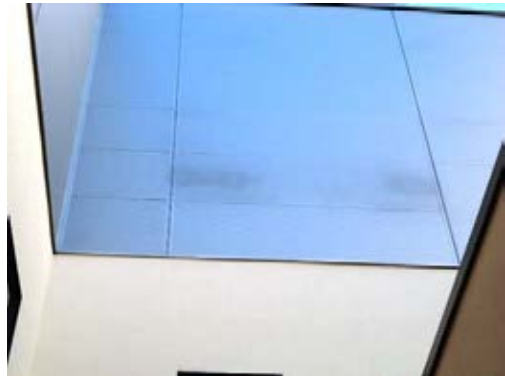
Unsuccessful repairs to cladding in Courtyard 4.

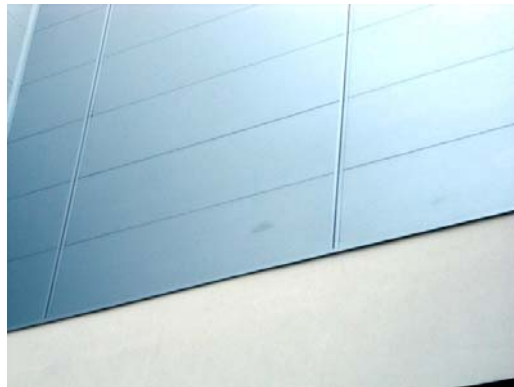
Unsuccessful repairs to cladding in Courtyard 3.

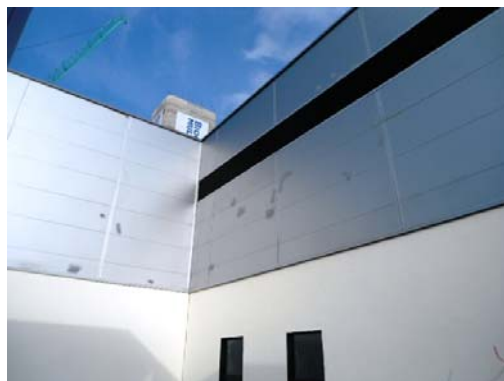
There are also unsuccessful repairs to cladding above Courtyard 3. See photograph below.

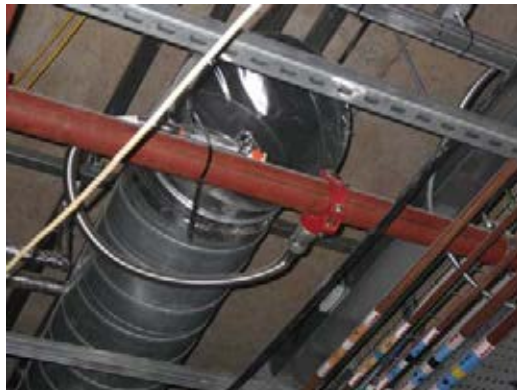
We have asked Brookfield to confirm that the fire damper actuator highlights in room EMC-011 can be accessed on completion of the cold water and ceiling installation. (See Supervisor's Communication General Matters / Other Instructions (CI 13.1) No 92).

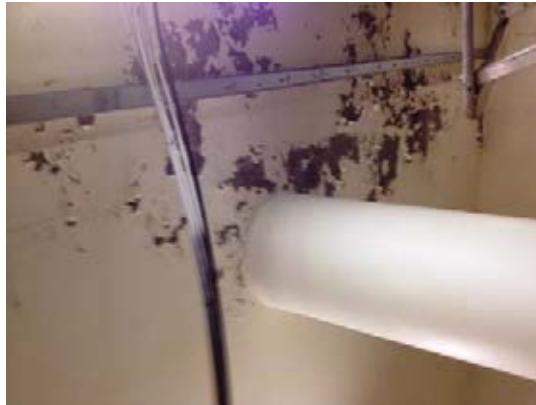
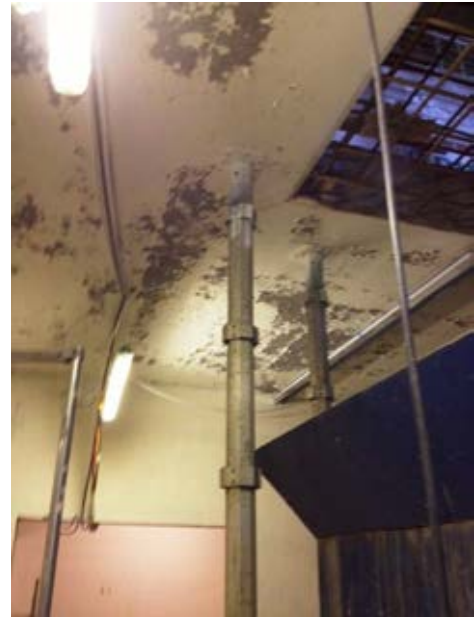
We noted that there is flaking paintwork on the soffit of the ground floor slab in the basement area between Cores A, B, C , D. We have asked Brookfield to confirm remedial measures to address this and when it will be carried out. (See Supervisor's Communication General Matters / Other Instructions (CI 13.1) No 96).

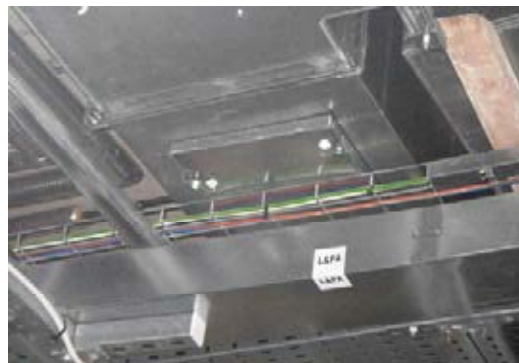
Motorised damper inaccessible due to adjacent duct in Plant Room. Brookfield is investigating this and will report. (See Supervisor's Notification of Defect (CI 42.2) No 12).

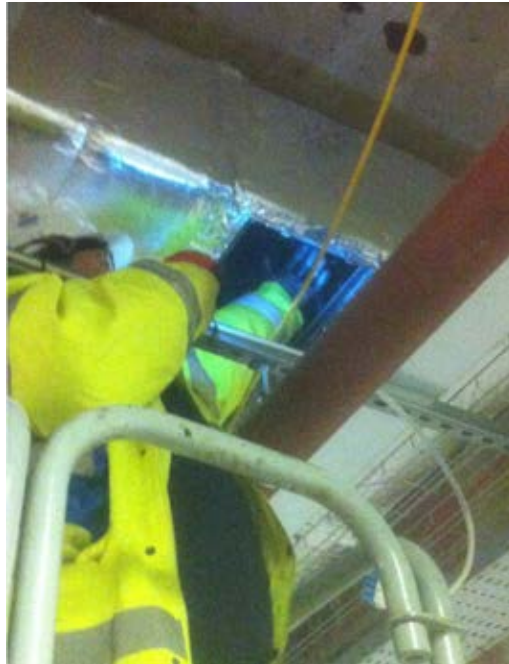
Ductwork obstructed by modular frame Zone H. Brookfield is investigating this and will report (See Supervisor's Notification of Defect (CI 42.2) No 14

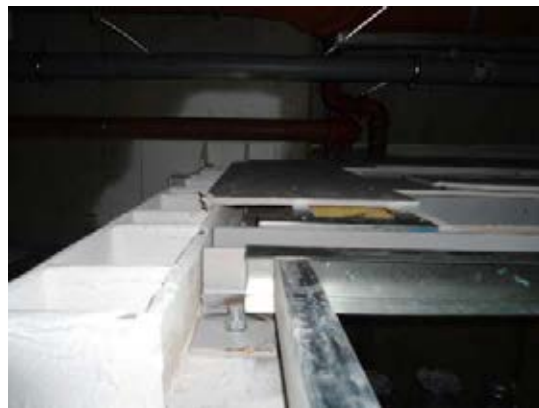
Before

The area of plasterboard above and to the left hand side of the double door in at grid ref AL.1 and AK which did not have insulation has now been addressed. Consequently Supervisor's Notification of Defect (CI 42.2) No 31 is closed out.

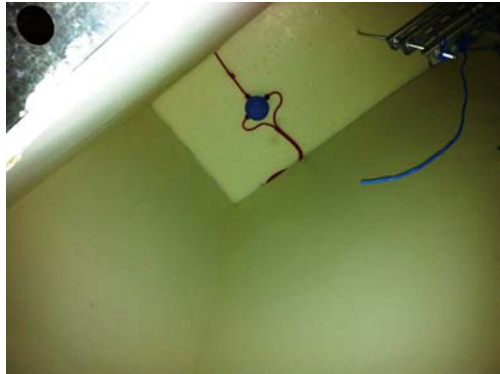
BS5389 recommends that smoke detectors should not be mounted within 500mm of any walls or partitions. This does not appear to have been achieved in room AAW-384. We asked Brookfield to confirm when this has been remedied.

Brookfield has responded stating that BS5839 does recommend smoke detectors to be more than 500mm away from any obstruction, however, in some instances where the room overall size is less than 1100mm from wall to wall it is not possible to achieve this. The fire risk assessment will require that these rooms are to be protected such as electrical riser cupboards as shown in the photograph with the detector being centralized in the room. These rooms are protected but noted as a variation to BS5839 in the Fire Alarm Certificate.

At this time the smoke detector isn't in the centre of the room. Consequently this issue still requires to be resolved. (See Supervisor's Communication General Matters / Other Instructions (CI 13.1) No 37.

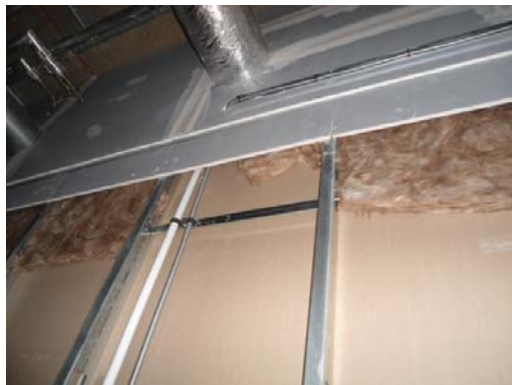
We noted during a joint inspection with Brookfield that insulation has been disturbed behind the boards at high level as a result of electrical installation work. If this is not corrected the acoustic quality of the partition adversely affected. We have asked Brookfield to confirm when this has been remedied. (See Supervisor's Communication General Matters / Other Instructions (CI 13.1) No 39).

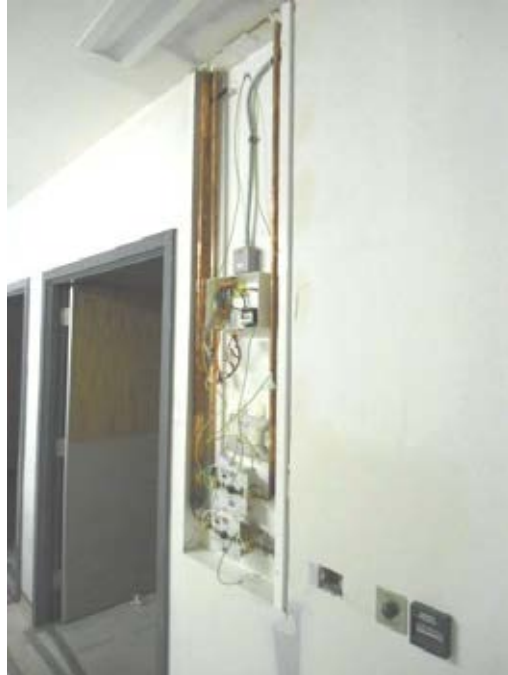
AVSU corridor side of room CCW-019

An AVSU penetration has been incorporated into a hazard room partition on the corridor side of room CCW-019 Disposal Hold in accordance with drawing AST-XX-XX-DT-252-088. This does not show Kanuf board behind the AVSU. HTM 05-02 Table A1 states that the wall should have the integrity of 30 minutes and the method of exposure is to be each side separately. We asked Brookfield to confirm that the section of partition housing the AVSU can achieve 30 minute.

AVSU on level 2 which did not have a back board. This was brought to Brookfield's attention and corrected. (See Supervisor's Notification of Defect (CI 42.2) No 40).

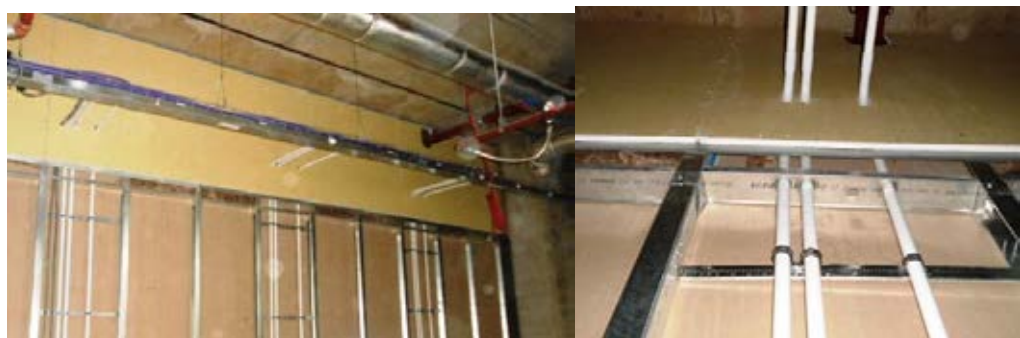
Insulation has been removed or displaced at high level where conduits are fitted within the partition. If not addressed this would reduce the acoustic performance of the partition and allow the transfer of heat across the cavity. We have asked Brookfield to confirm when this has been addressed so that it can be inspected before second boarding is complete. (See Supervisor's Notification of Defect (CI 42.2) No 41).

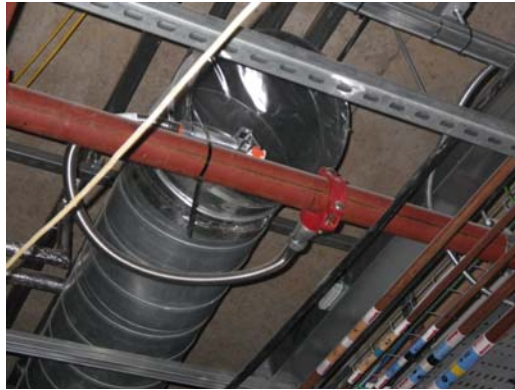
We noted that there was restrictive access to the ducting on Level 2 Zone D Corridor THE-328. We have asked Brookfield to confirm when this has been

addressed. (See Supervisor's Communication General Matters / Other Instructions (CI 13.1) No 42).

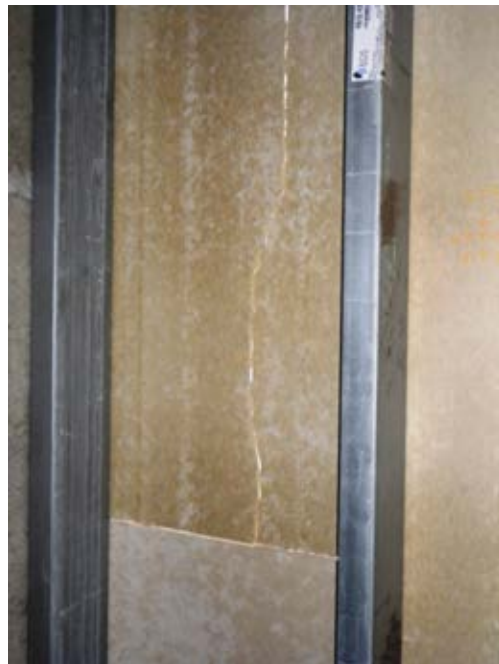
Crack in board.

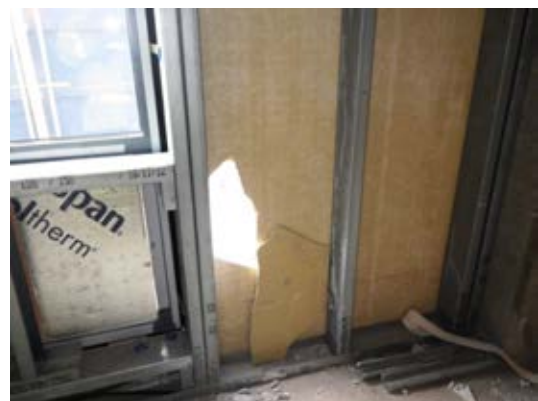
Damaged Board.

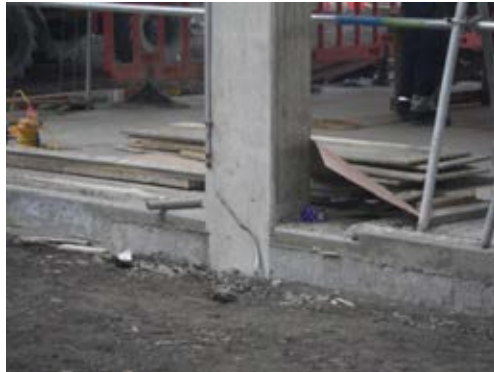
Damage to tape.

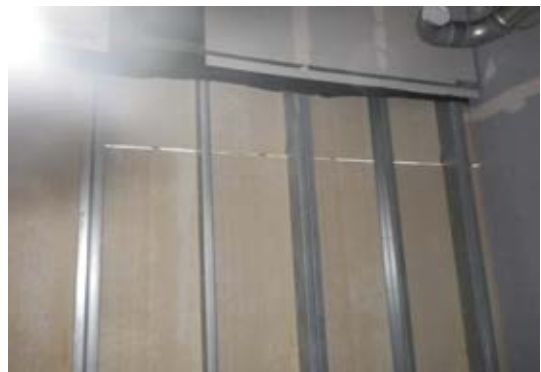
Excessive joint in boards.

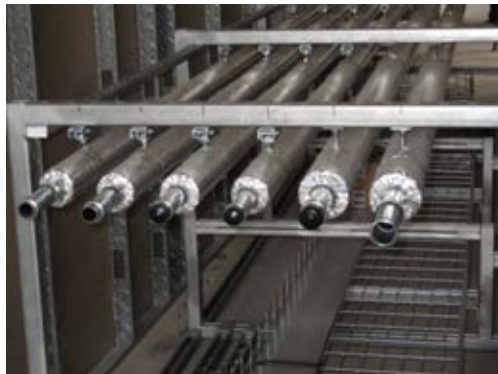
Open ends.

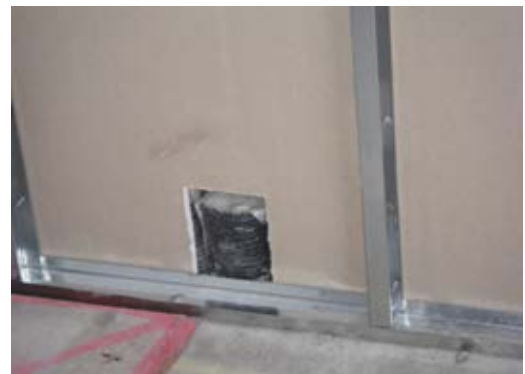
Board cut out.

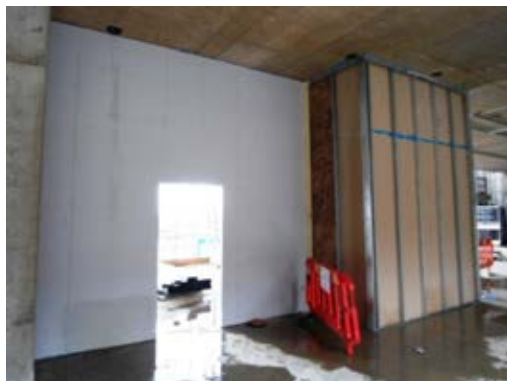
Water damaged boards.

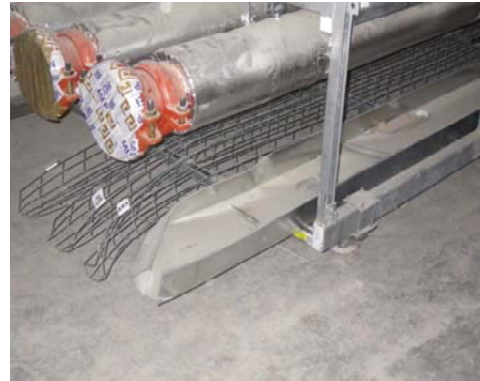
Damaged module.

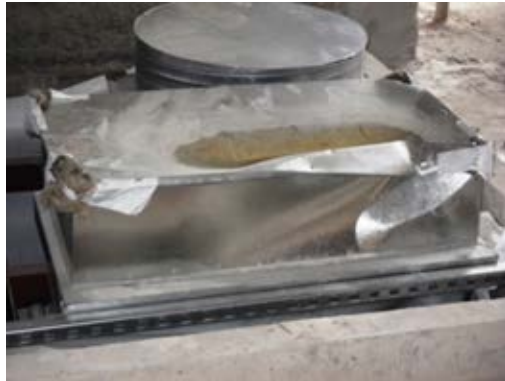
Damaged duct Level 3 Plant Zone D

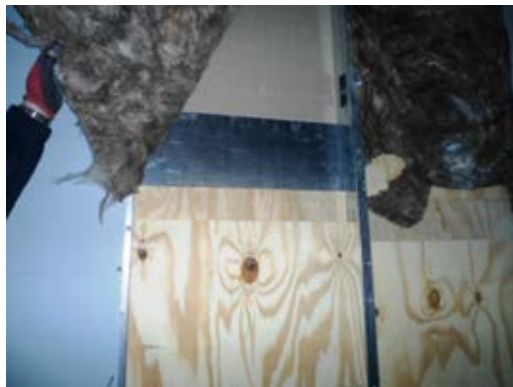
During the check on Level 0 it was noted that insulation had been missing behind large areas of pattresses. This was fixed immediately but we expressed our concerns that if unchecked in other locations would result in the partition not providing the required acoustic specification. Brookfield has confirmed that a toolbox talk has been carried out to avoid this reoccurring.

Insulation missing behind pattresses.

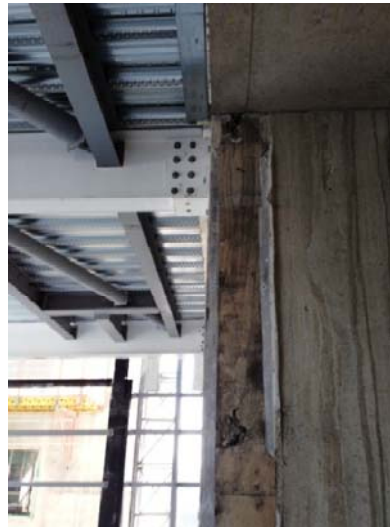
We believe that Supervisor's Communication General Matters / Other Instructions (CI 13.1) No 57 has been physically addressed on site but an appropriate formal response from Brookfield in this respect is still awaited to enable us to close out this item. (See photograph on following page).

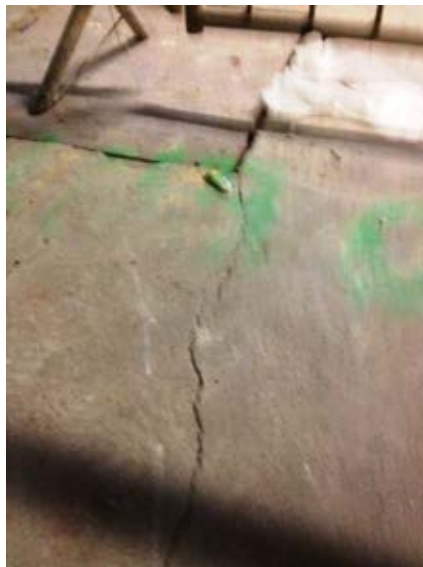
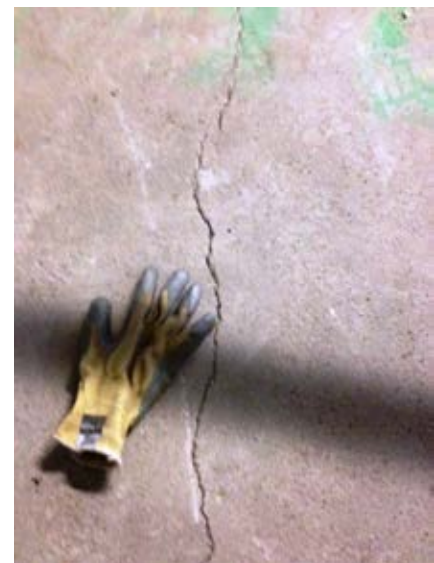
A significant crack has been observed in Zone G ground floor slab, pour No7. It extends from a corner of a MH cover a distance of approximately 5m into Zone D pour 2. We have asked Brookfield to investigate this, review with their designers and provide a brief summary report on the likely cause. Brookfield has informed us that cores have been taken and has provided us with photographic evidence. The crack is less than 1mm and is acceptable to WSP.

Brookfield has informed us that the shot blasting process formed a V groove at the top of the crack in the surface of the finished slab which showed an exaggerated crack of up to 5mm.

Cracks in Level 0 floor

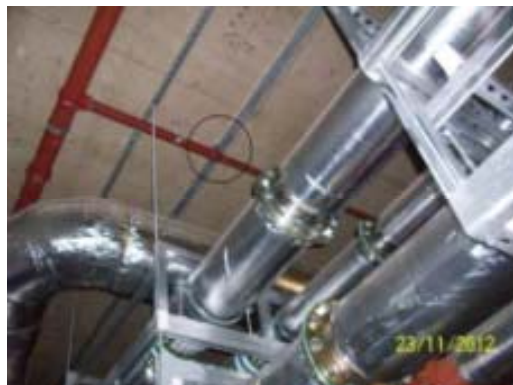
We have asked Brookfield to confirm the flow of water from the sprinkler head highlighted is not restricted by the adjacent section of unistrut. Brookfield has confirmed that the sprinkler head deflector appears to be under the unistrut and that the Sprinkler contractor will check this when they are installing the under services protection. If the head is shielded by the unistrut, they will turn the head pendant. Awaiting photograph showing completed work. See Supervisor's Communication General Matters / Other Instructions (CI 13.1) No 74.

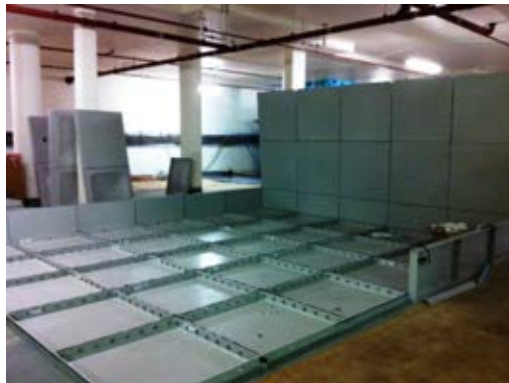
Brookfield has informed us that the Balmoral water tank for the Sprinkler System is designed to sit directly on the floor slabs. The relevant standard that these tanks are designed to is BS EN 13280 (2001).

In response to Brookfield's comments we believe that to fully drain the tank there is a requirement to enter a confined space. Also, due to the construction of the tank there would be a need to wet vac each 1m x 1m pod to fully drain the tank as the flanges are internal. Brookfield is seeking confirmation from the CDM Coordinator in relation to risk assessments. See Supervisor's Communication General Matters / Other Instructions (CI 13.1) No 89.

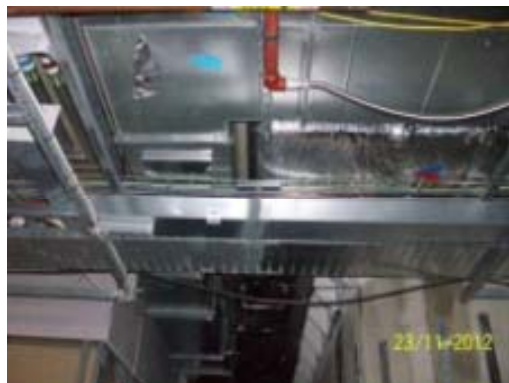
The electrical containment appears to be restricting access to duct access hatch Adjacent to riser THE-2127. We have asked Brookfield to confirm duct hatch can be fully accessed without issue when finished ceiling is in place. Brookfield has commenced the snagging and the new hatch is still to be formed. See Supervisor's Communication General Matters / Other Instructions (CI 13.1) No 73.

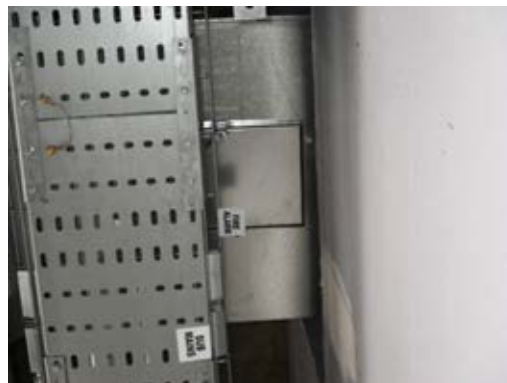
We noted that there was restricted access to ductwork in the corridor near Atrium Void Core C. Brookfield are reviewing this issue and will report back with their remedial measures to allow easier access. See Supervisor's Communication General Matters / Other Instructions (CI 13.1) No 110.

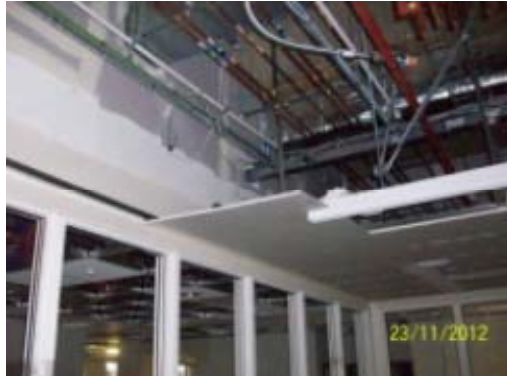
Void detection appears inadequate and inaccessible due to plasterboard ceiling. Brookfield has advised us Scotshield have carried out and continue to carry out site surveys regarding detection coverage. Currently they have identified additional heads to be installed – Mercury is awaiting formal report. They understand that Scotshield continue to review installation on all floors to ensure sufficient coverage but this is work in progress. (See Supervisor's Communication General Matters / Other Instructions (CI 13.1) No 77.

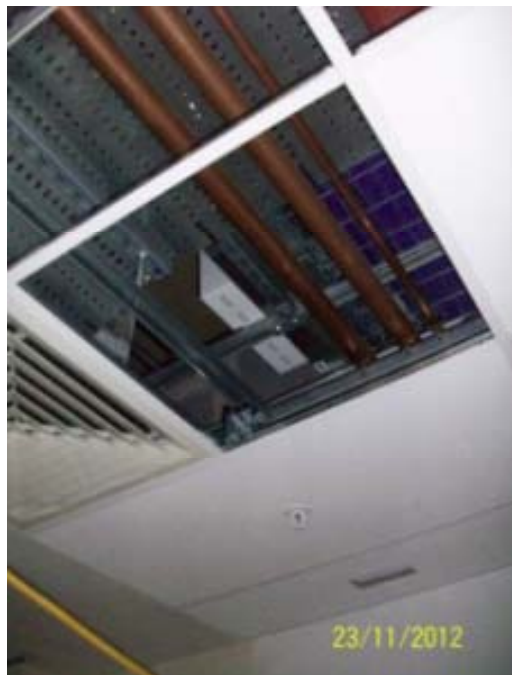
The junction box appears to be inaccessible due to the ceiling installation. We have asked Brookfield to confirm if this is the case. Brookfield has confirmed that the grille shown adjacent to CCW 061 is in fact not connected to the ductwork system and is just a transfer grille (CVG). It can therefore be used as an access hatch to get to the junction box. However the rest of the corridor will be reviewed to check that there is sufficient access. This area has been off limits due to flooring works. (See Supervisor's Communication General Matters / Other Instructions (CI 13.1) No 79).

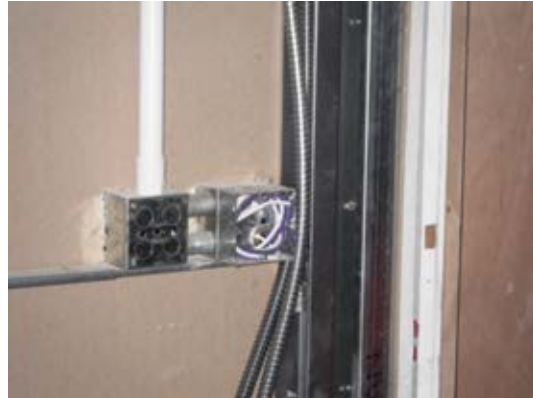
We noted that electrical boxes have been fitted back to back on Level 0 Zone G corridor AAW-355. We have asked Brookfield to confirm when the back boxes will be repositioned to avoid this practice. We have also asked Brookfield to confirm that no screws are fitted from outside to inside of back boxes. Brookfield is reviewing this and will report back. (See Supervisor's Communication General Matters / Other Instructions (CI 13.1) No 109).

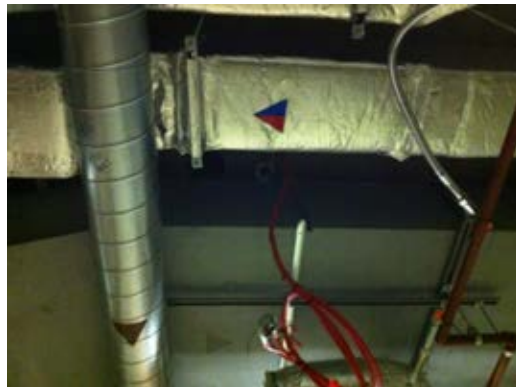
There appears to be restrictive space for the void detection. We have asked Brookfield to confirm if void detector above the ductwork is providing adequate protection. (See Supervisor's Communication General Matters / Other Instructions (CI 13.1) No 90).

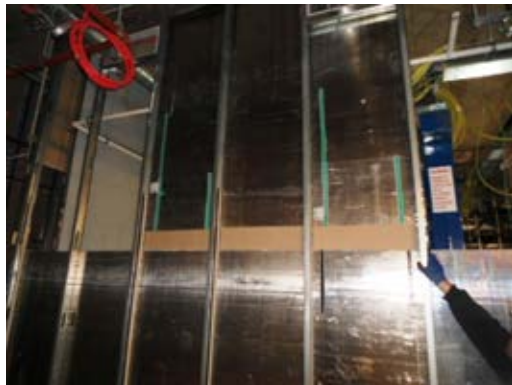
We noted that the gap between the lead lined sheets fixed from the soffit and the sheet fitted from the floor had been filled with a board which was not lead lined. This detail does not comply with the current approved details. We have asked Brookfield to confirm that the proposal has been approved by Knauf and reviewed by the NHS. (See Supervisor's Communication General Matters / Other Instructions (CI 13.1) No 108).

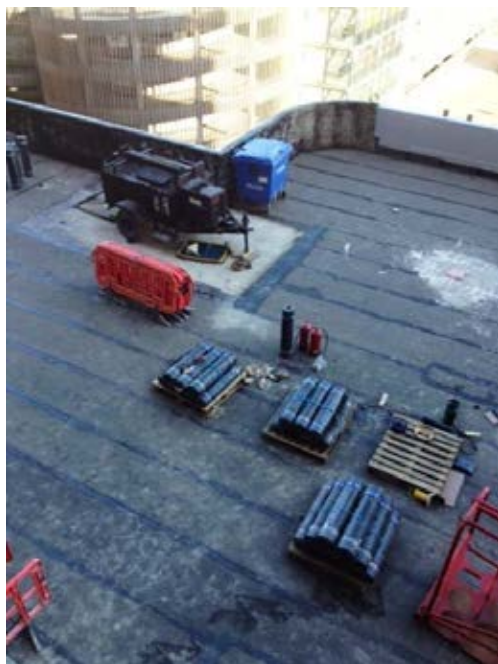
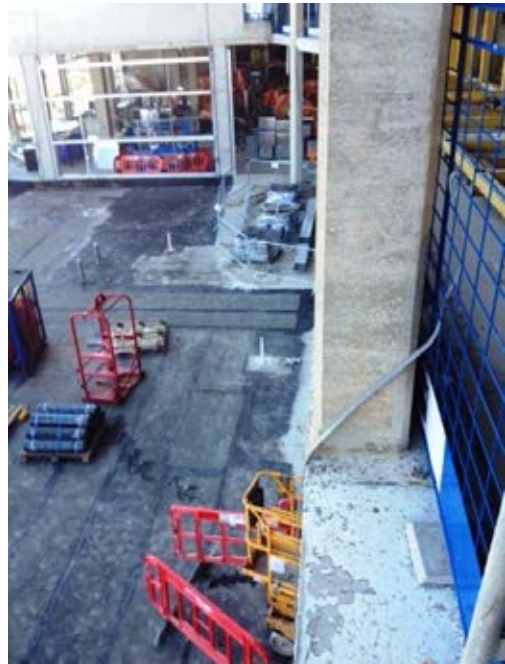
We have also asked them to confirm that the small incomplete areas where the boiler is located on level 3 will be completed in accordance with the manufacturer's requirements. This includes carrying out any remedial work to damaged membrane as a result of storing items on the roof.

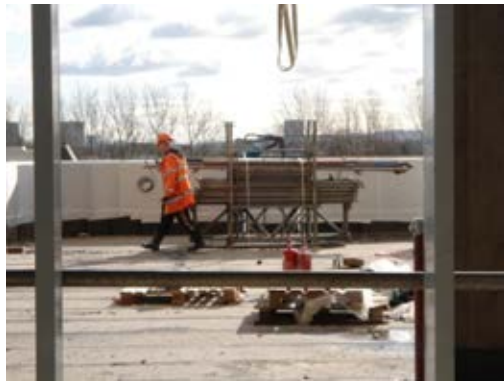
We are concerned that the materials and debris on roofs Level 2 Zone H and Level 4 Core F will damage the protective membrane. We have asked Brookfield to ensure that all risks of damage are removed from all roofs.

Materials being stored directly on the protective membrane

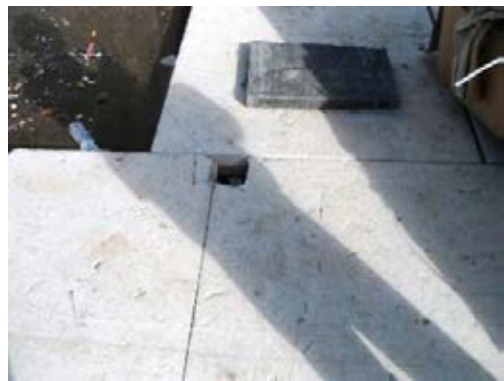
Damaged insulation

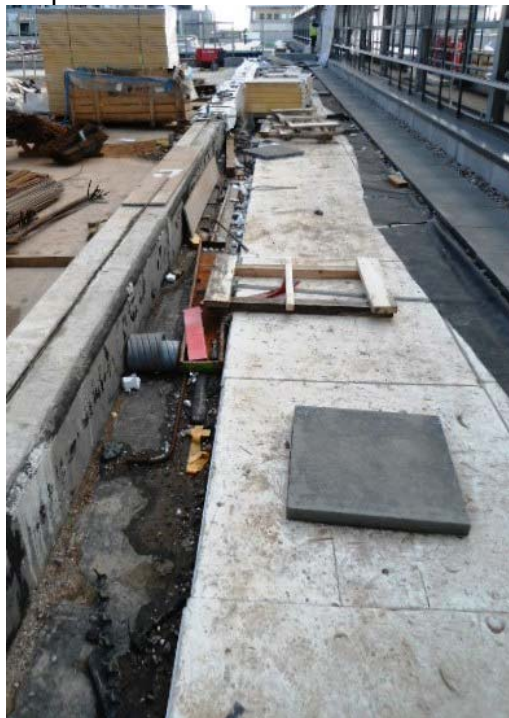
Debris and materials on the roof which could damage the protective membrane.

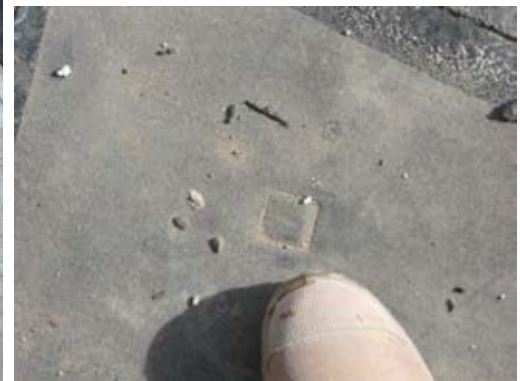
Indent in protective membrane.

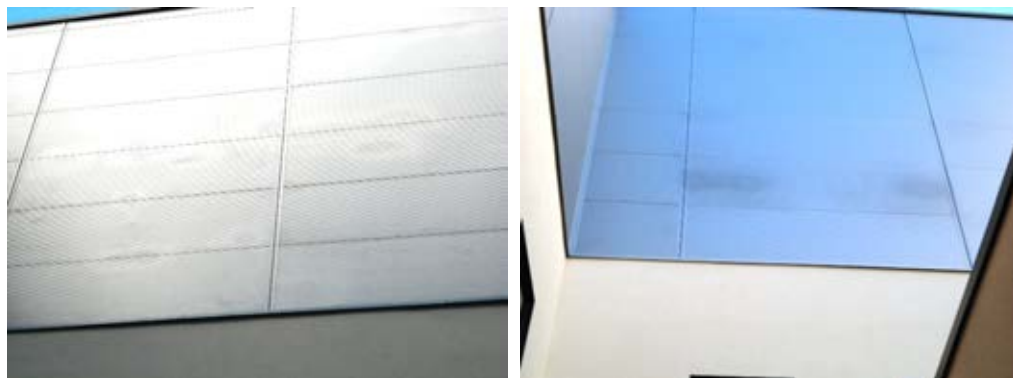
Attempts to carry out repairs to damaged sections of panel cladding in Courtyards 4 & 5 have proved unsuccessful. This has been recorded by Brookfield and we are aware that there are plans to paint the entire surfaces of the damaged panels. Consequently we seek confirmation from the manufacturer that the onsite repair/painting of the panels will have the same life expectancy as the factory produced painted finish. We have also asked Brookfield to provide details of the methodology to carry out on site painting. (See Supervisor's Communication General Matters / Other Instructions (CI 13.1) No 103).

Examples of unsuccessful repairs to cladding in

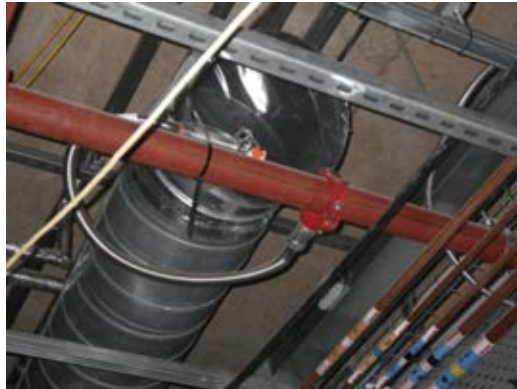
We have asked Brookfield to confirm that the fire damper actuator highlights in room EMC-011 can be accessed on completion of the cold water and ceiling installation. (See Supervisor's Communication General Matters / Other Instructions (CI 13.1) No 92).

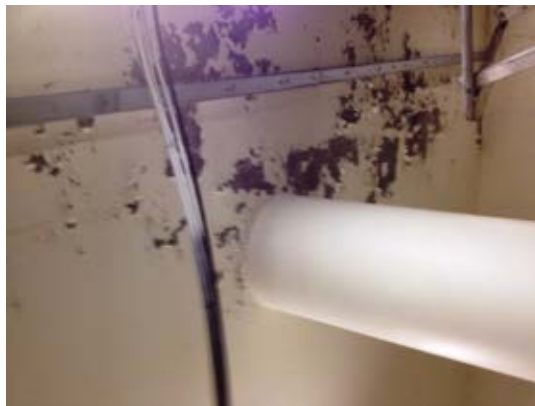
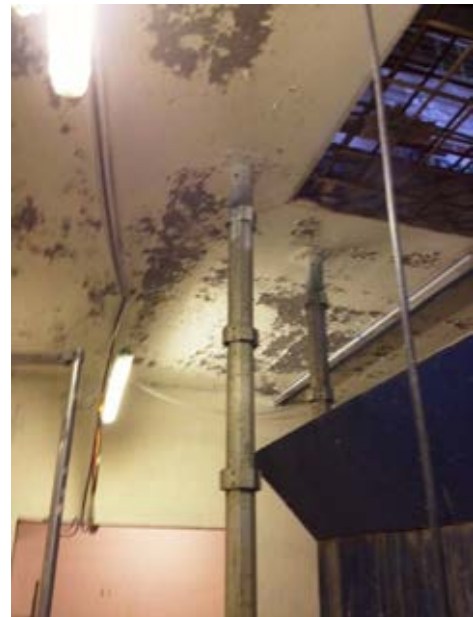
We noted that there is flaking paintwork on the soffit of the ground floor slab in the basement area between Cores A, B, C and D. Brookfield has confirmed that remedial measures will be taken to address this. They confirmed that remedial work will not be carried out until the Atrium is watertight. (See Supervisor's Communication General Matters / Other Instructions (CI 13.1) No 96).

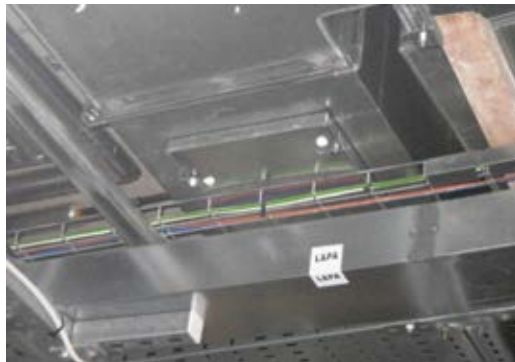
Duct access hatch blocked by chilled water pipework at ground floor area around DB cupboard AAW190. See photograph below. Contractor to confirm when this will be rectified.

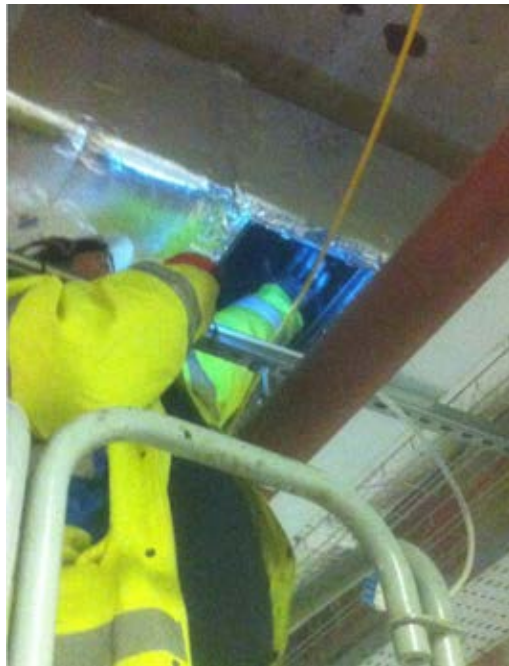
Restricted access to ductwork access hatch in corridor adjacent to Zone H near Stair Core F. Brookfield has intimated that the hatch is not restricted and access can readily be gained. We revisited the hatch and are still of the opinion that access to the hatch is not feasible as can be seen in Mercury's photograph which shows an attempt to access the hatch without the ceilings. (See Supervisor's Notification of Defect (CI 42.2) No 13).

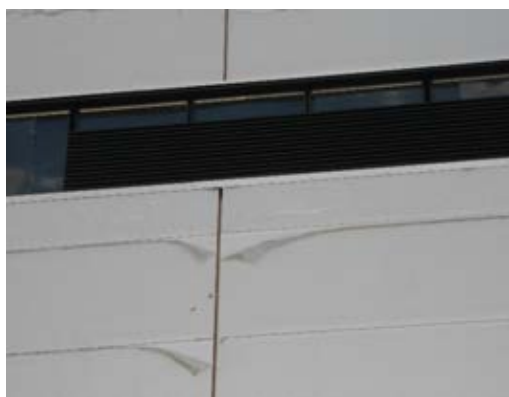
One of the fixings to the cladding is visible beneath the capping pieces and the cladding is indented. Brookfield has confirmed that the vertical 'top hat' flashing is still to be installed and this will cover the fixing and the indent. A joint inspection will be arranged between ourselves and Brookfield to inspect the 'top hat'. (See Supervisor's Notification of Defect (CI 42.2) No 16).

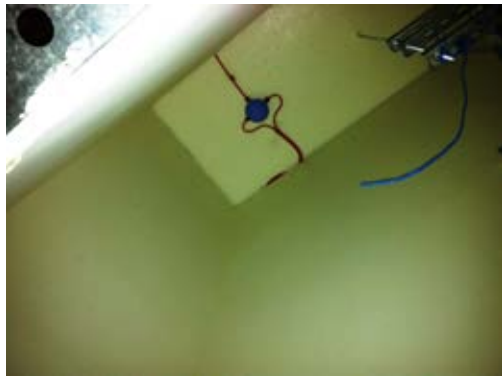
BS5389 recommends that smoke detectors should not be mounted within 500mm of any walls or partitions. This does not appear to have been achieved in room AAW-384. We asked Brookfield to confirm when this has been remedied.

instances where the room overall size is less than 1100mm from wall to wall it is not possible to achieve this. The fire risk assessment will require that these rooms are to be protected such as electrical riser cupboards as shown in the photograph with the detector being centralized in the room. These rooms are protected but noted as a variation to BS5839 in the Fire Alarm Certificate.

At this time the smoke detector isn't in the centre of the room. Consequently this issue still requires to be resolved. (See Supervisor's Communication General Matters / Other Instructions (CI 13.1) No 37.

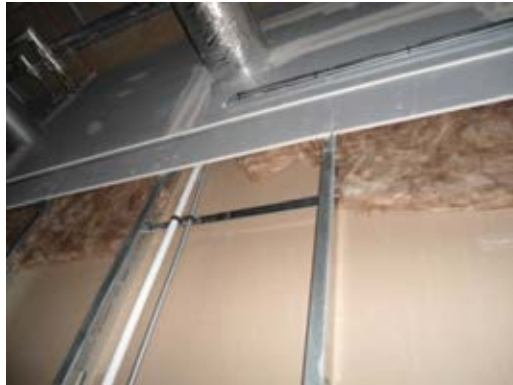
We noted during a joint inspection with Brookfield that insulation has been disturbed behind the boards at high level as a result of electrical installation work. If this is not corrected the acoustic quality of the partition adversely affected. We have asked Brookfield to confirm when this has been remedied. (See Supervisor's Communication General Matters / Other Instructions (CI 13.1) No 39).

39	Insulation dislodged at high level due to electrical work. Confirm when remedied.	16.01.13	Open	Red
40	AVSU incorporated into hazard room partition. Confirm that the partition housing the AVSU can achieve 30 minutes on the corridor side of the partition.	20.02.13	Response received.	Yellow
41	Insulation removed and displaced from the partition at high level. Conform when this has been addressed.	21.02.13	Open	Red
42	Restrictive access to duct. Confirm when addressed.	26.02.13	Open	Red
43	Screws within the back boxes. Advise when this has been rectified.	05.03.13	Open	Red
44	Provide programme for replacing damaged cladding.	11.03.13	Open	Red

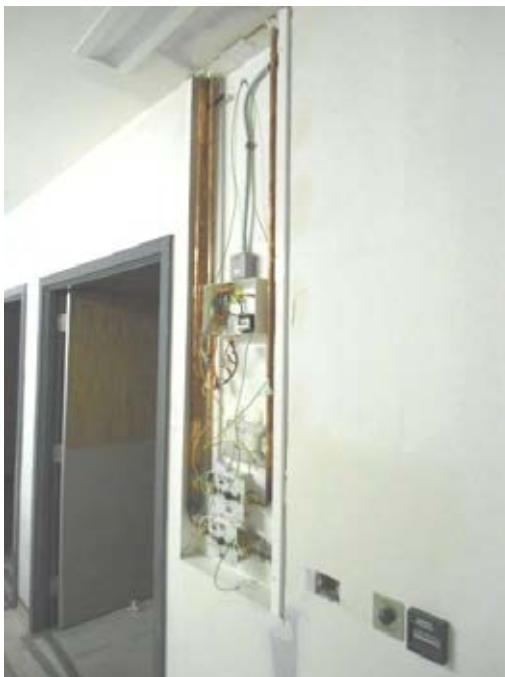
AVSU corridor side of room CCW-019

An AVSU penetration has been incorporated into a hazard room partition, on the corridor side of room CCW-019 Disposal Hold in accordance with drawing AST-XX-XX-DT-252-088 which does not show Kanuf board behind the AVSU. HTM 05-02 Table A1 states that the wall should have the integrity of 30 minutes and the method of exposure is to be each side separately.

We asked Brookfield to confirm that the section of partition housing the AVSU can achieve 30 minutes. We were shown a location elsewhere on level 1 which had been constructed in such a manner that there was a back board providing fire protection on the corridor side. However there was an AVSU on level 2 which did not have a back board. This was brought to Brookfield's attention and corrected. We have since asked Brookfield if they intend to carry out an 85 point inspection to this partition on the room side of the AVSU to confirm that the detail has been built correctly. (See Supervisor's Notification of Defect (CI 42.2) No 40).

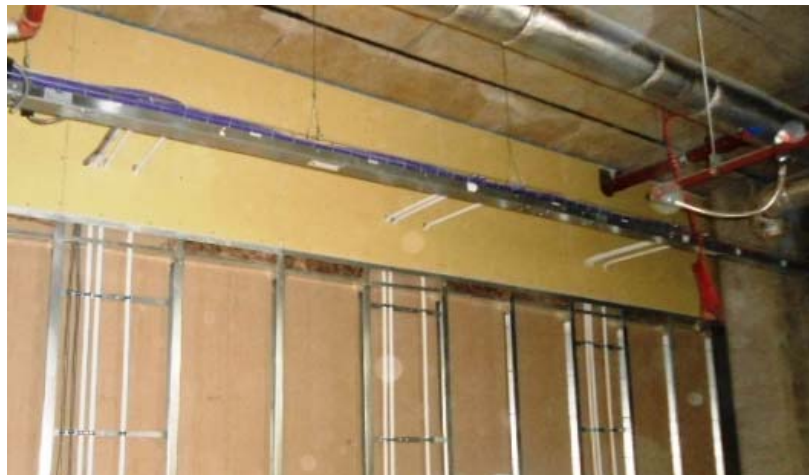
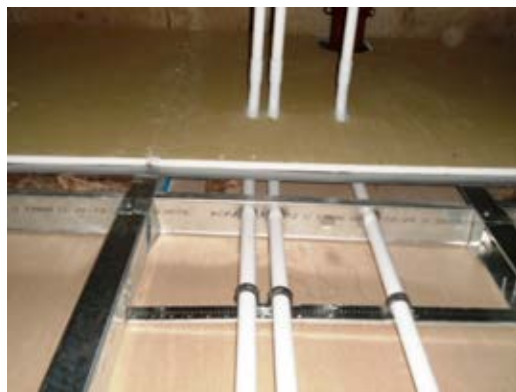
Insulation has been removed or displaced at high level where conduits are fitted within the partition. If not addressed this would reduce the acoustic performance of the partition and allow the transfer of heat across the cavity. We have asked Brookfield to confirm when this has been addressed so that it can be inspected before second boarding is complete. (See Supervisor's Notification of Defect (CI 42.2) No 41).

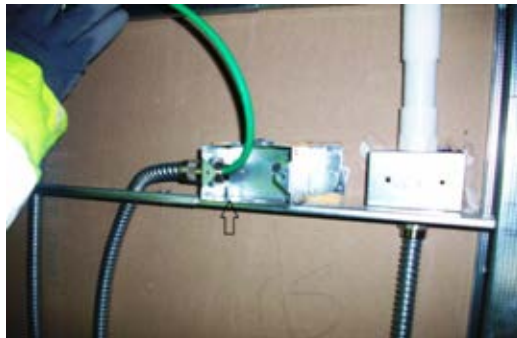
A few metal boxes have been fixed by driving screws from outside to inside leaving the sharp edge of the screws within the box. This could result in cable damage. Brookfield has advised us that in some instances, Mercury have been able to remove the screws on the inside and fix the back boxes through the rear of the box. Rubber sleeves have been fitted over screw and then covered with putty pads, consequently there are no screws in contact with cables. In this instance we accept the remedial work of the boxes identified. However if any other locations are identified with screw heads protruding into electrical accessories these will require to be removed and refixed from the correct side. Supervisor's Communication General Matters / Other Instructions (CI 13.1) No 43 is closed out.

Screws fixed through back boxes.

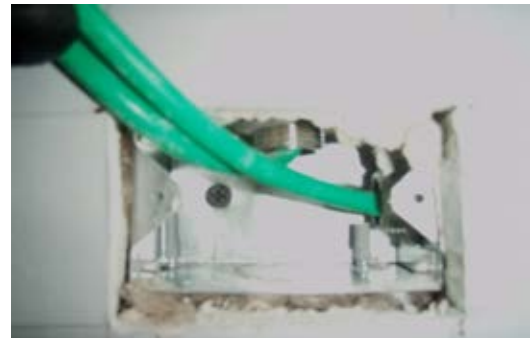
Rubber sleeves over screws.

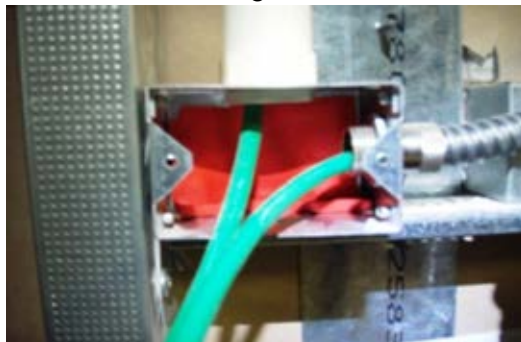
Putty pads lining over sleeves
