**Bundle of documents for Oral hearings
commencing from 13 May 2025 in relation
to the Queen Elizabeth University Hospital
and the Royal Hospital for Children,
Glasgow**

**Bundle 33
NEC3 Supervisor's Reports and Project
Supervisors Interface Action Notes**

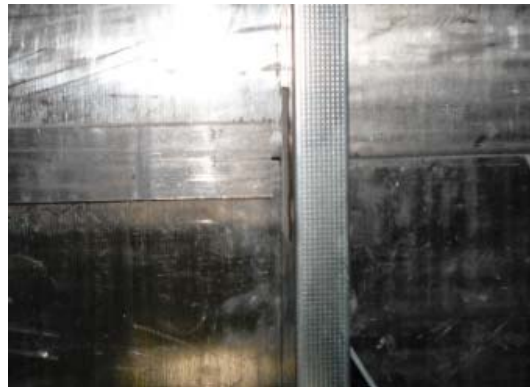
We noted that there were gaps between lead lined noggins and vertical studs on Level 2. We are aware that there is a proposal to cover the noggins with lead and we asked Brookfield to confirm that the proposal has been approved by Knauf and reviewed by the NHS. (See Supervisor's Communication General Matters / Other Instructions (CI 13.1) No 45).

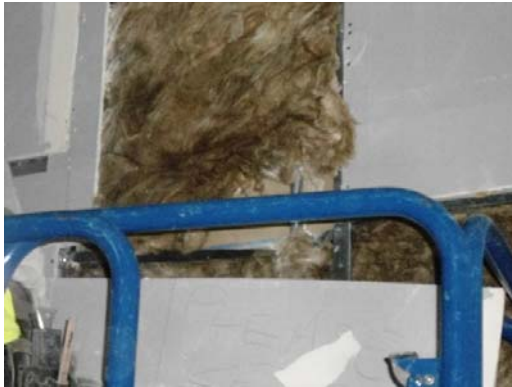
During the check on Level 0 Area 519 it was noted that insulation had been disturbed and a void left as a result of the service installation. The insulation was fixed immediately. This is another incident where insulation has been disturbed and in some previous instances removed during the installation of services. We recorded our concerns in last month's report that if unchecked in other locations would result in the partition not providing the required acoustic specification. We asked Brookfield to confirm how they will manage to prevent this problem reoccurring. Brookfield confirmed that Mercury have raised the situation with their Managers and Supervisors and held a tool box talk on the 22nd April and Mercury is committed to it. Brookfield has intimated that Satins are ultimately responsible for Astins partitions and should inform Mercury prior to closing up the partitions. Supervisor's Communication General Matters / Other Instructions (CI 13.1) No 113 is closed out but we will continue to monitor the ongoing work.

Insulation disturbed behind the boarding.

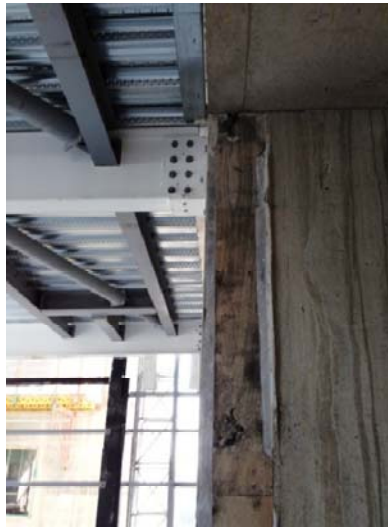
Brookfield has provided us with a copy of WSP's e-mail confirming that the crack is less than 1mm and is acceptable to WSP. Consequently Supervisor's Communication General Matters / Other Instructions (CI 13.1) No 107 is closed out.

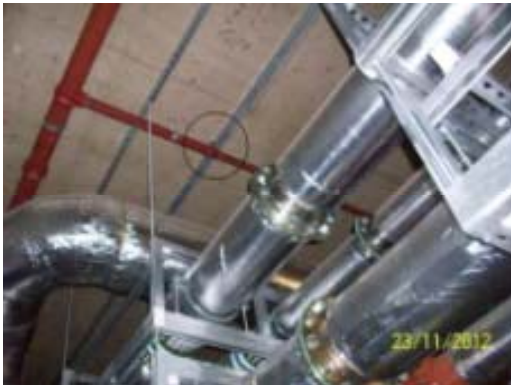
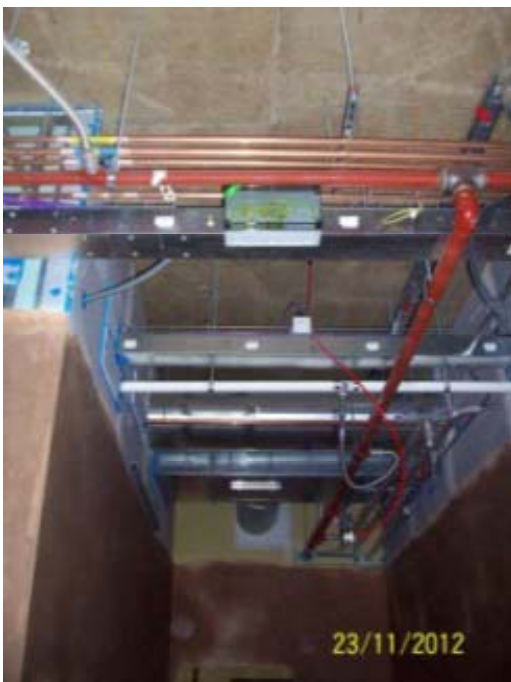
High level sprinkler heads appear inaccessible in a number of areas. Brookfield is reviewing potential access issues in an effort to find a solution. See Supervisor's Communication General Matters / Other Instructions (CI 13.1) No 75.

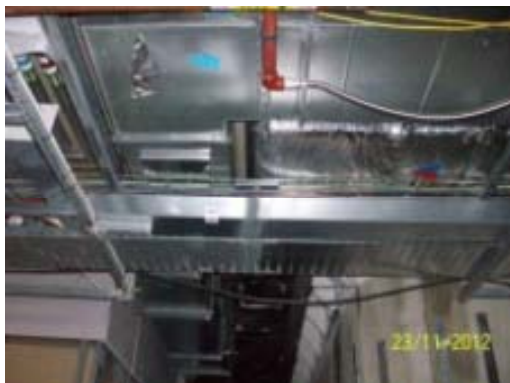
The electrical containment appears to be restricting access to duct access hatch Adjacent to riser THE-2127. We have asked Brookfield to confirm duct hatch can be fully accessed without issue when finished ceiling is in place. Brookfield has commenced the snagging and the new hatch is still to be formed. See Supervisor's Communication General Matters / Other Instructions (CI 13.1) No 73.

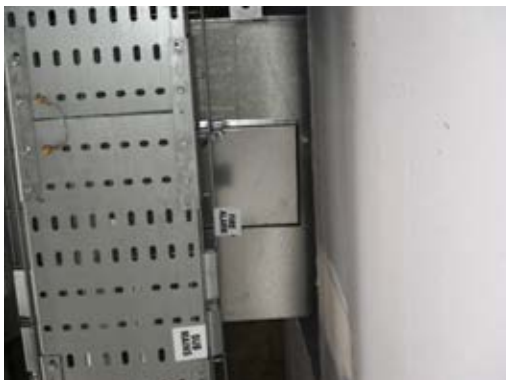
We noted that there was restricted access to ductwork in the corridor near Atrium Void Core C. Brookfield confirmed that the tray to be re-routed or access hatch re-positioned. See Supervisor's Communication General Matters / Other Instructions (CI 13.1) No 110.

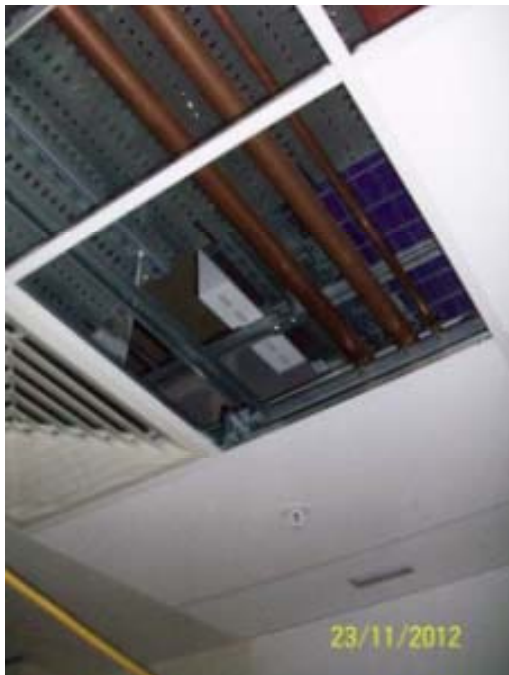
The junction box appears to be inaccessible due to the ceiling installation. We have asked Brookfield to confirm if this is the case. Brookfield has confirmed that the grille shown adjacent to CCW 061 is in fact not connected to the ductwork system and is just a transfer grille (CVG). It can therefore be used as an access hatch to get to the junction box. However the rest of the corridor will be reviewed to check that there is sufficient access. This area has been off limits due to flooring works. (See Supervisor's Communication General Matters / Other Instructions (CI 13.1) No 79).

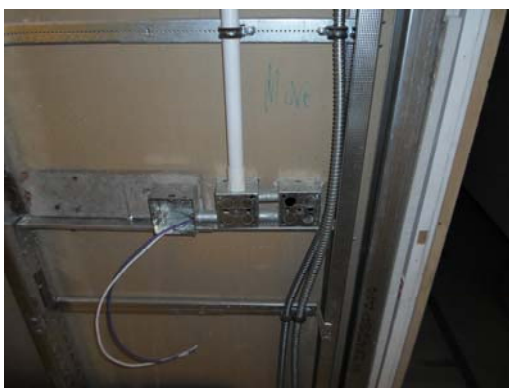
We noted that electrical boxes have been fitted back to back on Level 0 Zone G corridor AAW 162 IT hub room. Brookfield confirmed that back to back boxes have been moved. Screws that have been fitted from outside the boxes to inside will be removed or covered with caps. Supervisor's Communication General Matters / Other Instructions (CI 13.1) No 109 is closed.

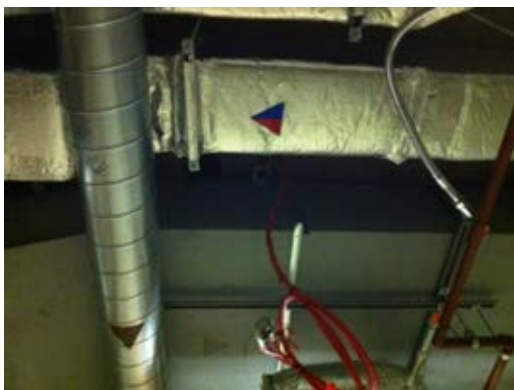
There appears to be restrictive space for the void detection. The Scotshield updated drawings following the changes by Building Control to the Fire Strategy are awaited. Once these are received by Mercury these will be issued to confirm adequate protection. (See Supervisor's Communication General Matters / Other Instructions (CI 13.1) No 90).

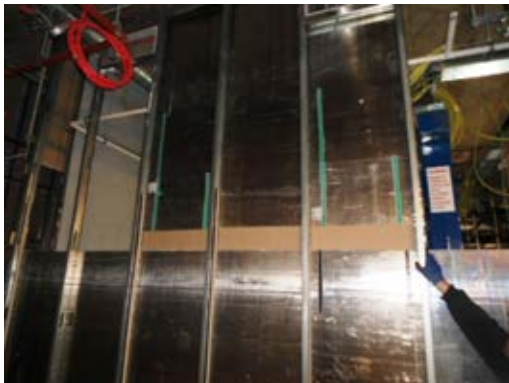
We noted that the gap between the lead lined sheets fixed from the soffit and the sheet fitted from the floor had been in filled with a board which was not lead lined. Brookfield has confirmed that Knauf has approved a new detail drawing and has been given a 'B' Status by the NHS. We await a further response from Astins as to how the detail addresses the junctions at the studs and dwangs. (See Supervisor's Communication General Matters / Other Instructions (CI 13.1) No 108).

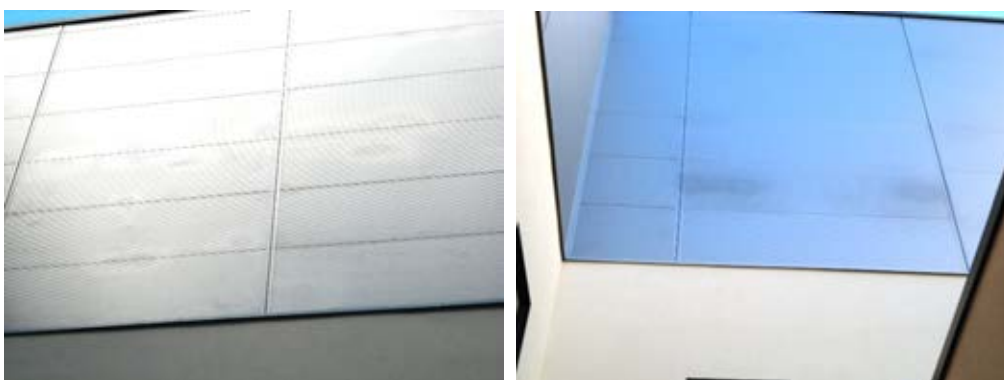
Examples of unsuccessful repairs to cladding in

- Specification of the material being applied including relevant product data sheets.
- Confirmation of Guarantee/ Warranty for the re-spray.
- Confirmation that the re-spray will provide the same life expectancy as the factory produced painted finish from the panel supplier.
- Confirmation from Rukki that their Warranty is not compromised.
- Company profile/CV from KRJ Painting Services, including Projects where they have previously repaired panels, including if possible testimonials from previous clients.
- Preparation of the areas previously repaired, prior to this operation.

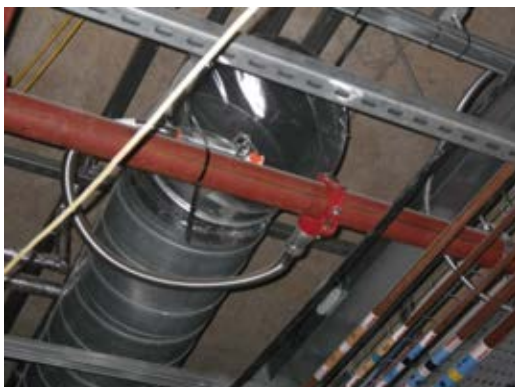
We have asked Brookfield to confirm that the fire damper actuator highlights in room EMC-011 can be accessed on completion of the cold water and ceiling installation. (See Supervisor's Communication General Matters / Other Instructions (CI 13.1) No 92).

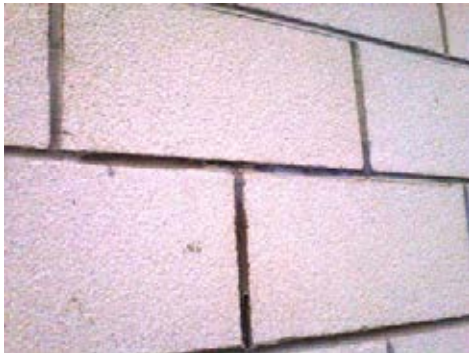
The quality and standard of workmanship of the blockwork at the curve of the south east elevations is poor. An area of blockwork has already been taken down and the blockwork as shown in the photographs below is subject to an NCR raised by Brookfield. One of the lintels on the east elevation has deflected and Brookfield has also raised this with their sub-contractor

Inconsistent pointing both colour and quality.

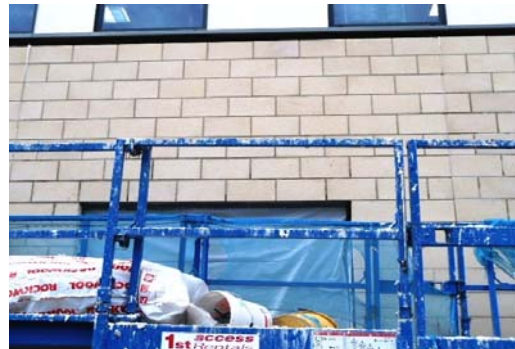
Lintel deflected.

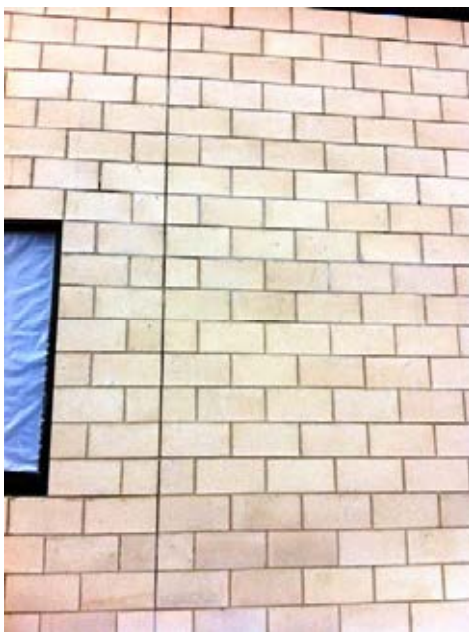
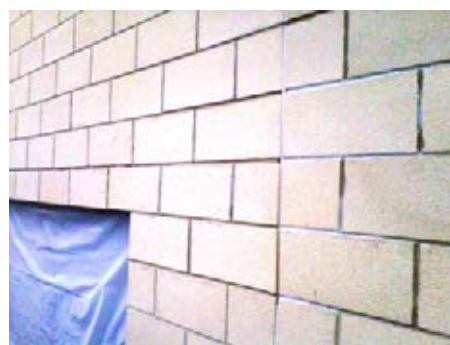
Poor quality blockwork with irregular beds and poor pointing

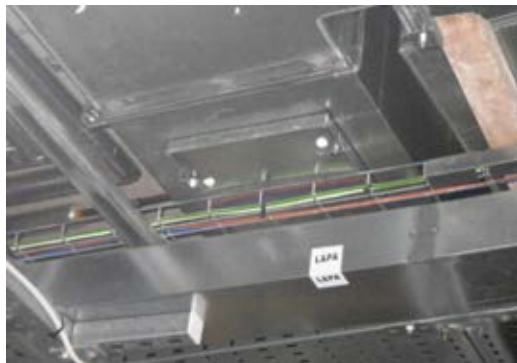
Duct access hatch blocked by chilled water pipework at ground floor area around DB cupboard AAW190. See photograph below. Contractor to confirm when this will be rectified.

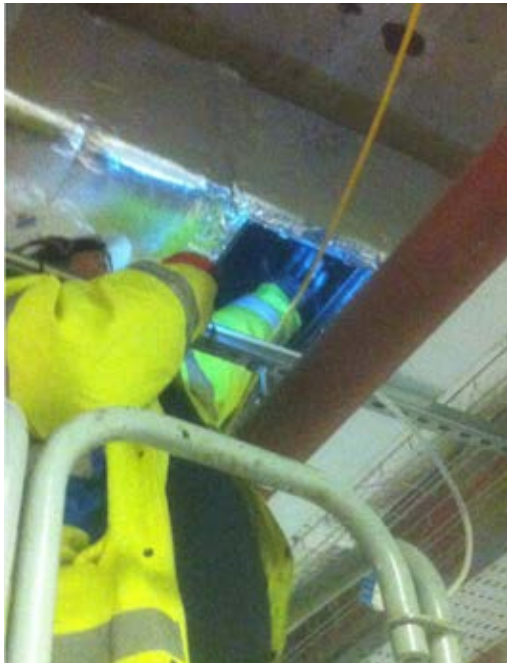
Restricted access to ductwork access hatch in corridor adjacent to Zone H near Stair Core F. Brookfield has intimated that the hatch is not restricted and access can readily be gained. We revisited the hatch and are still of the opinion that access to the hatch is not feasible as can be seen in Mercury's photograph which shows an attempt to access the hatch without the ceilings. (See Supervisor's Notification of Defect (CI 42.2) No 13).).

Ductwork obstructed by modular frame Zone H. Brookfield is investigating this and will report (See Supervisor's Notification of Defect (CI 42.2) No 14).

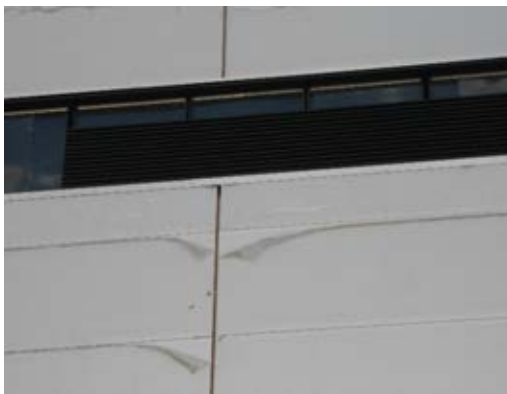
One of the fixings to the cladding is visible beneath the capping pieces and the cladding is indented. Brookfield has confirmed that the vertical 'top hat' flashing is still to be installed and this will cover the fixing and the indent. A joint inspection will be arranged between ourselves and Brookfield to inspect the 'top hat'. (See Supervisor's Notification of Defect (CI 42.2) No 16).

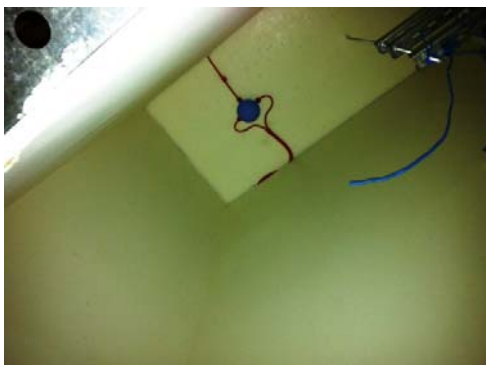
BS5389 recommends that smoke detectors should not be mounted within 500mm of any walls or partitions. This does not appear to have been achieved in room AAW-384. We asked Brookfield to confirm when this has been remedied.

At this time the smoke detector isn't in the centre of the room. Consequently this issue still requires to be resolved. (See Supervisor's Communication General Matters / Other Instructions (CI 13.1) No 37).

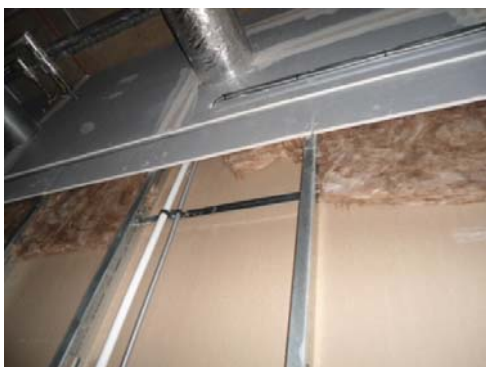
We noted during a joint inspection with Brookfield that insulation has been disturbed behind the boards at high level as a result of electrical installation work. If this is not corrected the acoustic quality of the partition adversely affected. We have asked Brookfield to confirm when this has been remedied. (See Supervisor's Communication General Matters / Other Instructions (CI 13.1) No 39).

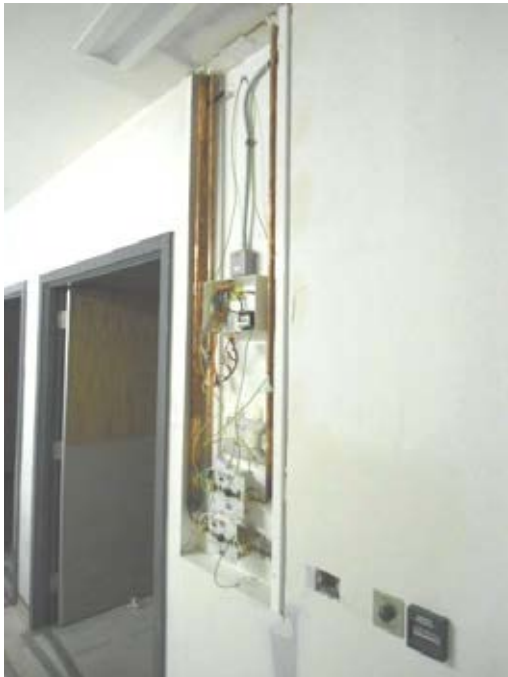
AVSU corridor side of room CCW-019

An AVSU penetration has been incorporated into a hazard room partition, on the corridor side of room CCW-019 Disposal Hold in accordance with drawing AST-XX-XX-DT-252-088 which does not show Kanuf board behind the AVSU. HTM 05-02 Table A1 states that the wall should have the integrity of 30 minutes and the method of exposure is to be each side separately.

We asked Brookfield to confirm that the section of partition housing the AVSU can achieve 30 minutes. We were shown a location elsewhere on level 1 which had been constructed in such a manner that there was a back board providing fire protection on the corridor side. However there was an AVSU on level 2 which did not have a back board. This was brought to Brookfield's attention and corrected. We have since asked Brookfield if they intend to carry out an 85 point inspection to this partition on the room side of the AVSU to confirm that the detail has been built correctly. (See Supervisor's Notification of Defect (CI 42.2) No 40).

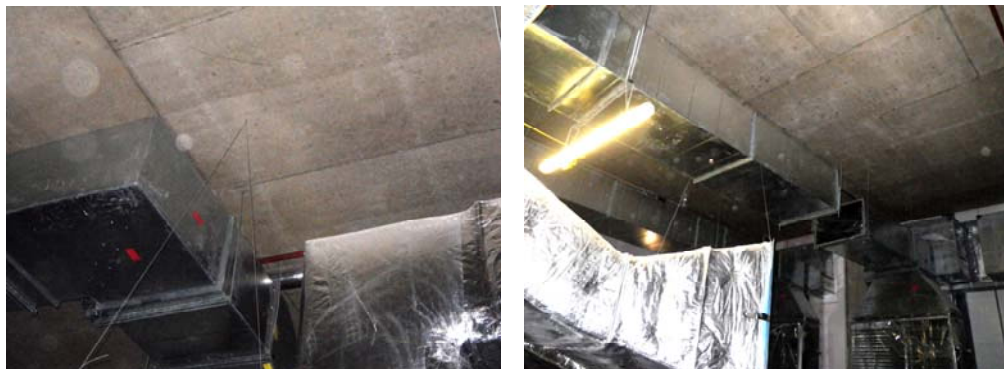
We have asked Brookfield to confirm the measures to address the restricted access problem to the ductwork access hatch on Level 3 Zone A near room GW1-042. See Supervisor's Communication General Matters / Other Instructions (CI 13.1) No 48).

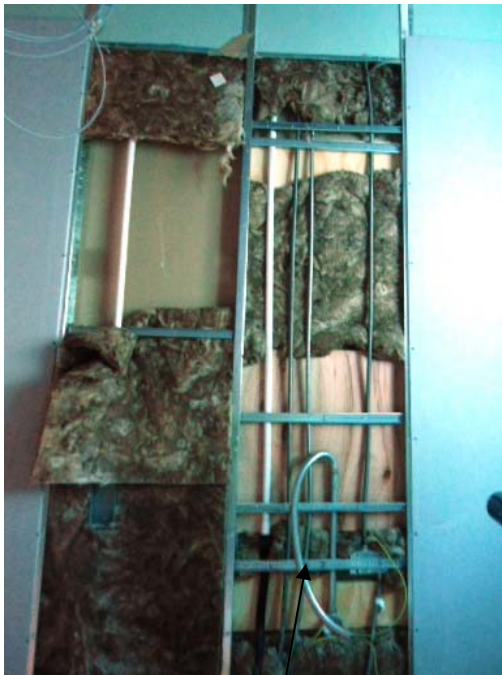
An 85 point check was carried out on Level 1 in room OPD-028. Insulation was missing from behind a pattrass. As a result of this other areas were opened up in two other rooms and one of these had a piece of insulation missing. Astins carried out additional 85 point quality inspections on Level 1 to monitor the quality of the construction of their partitions. We witnessed the opening up of additional two rooms with no failures found.

Insulation missing behind pattress

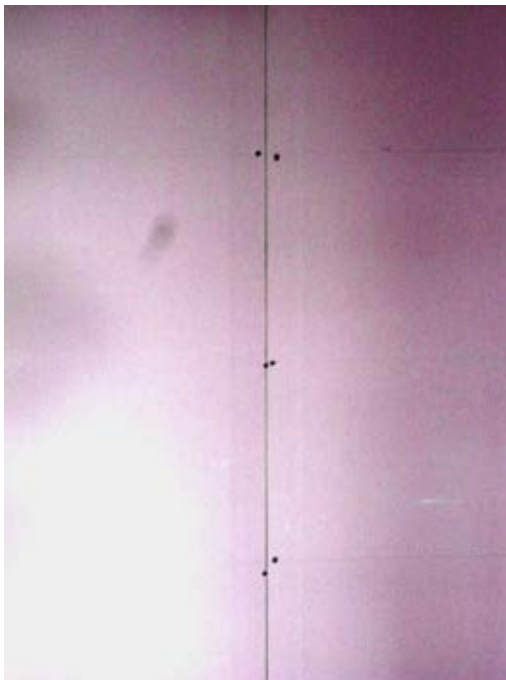
Screws too close to the edge.

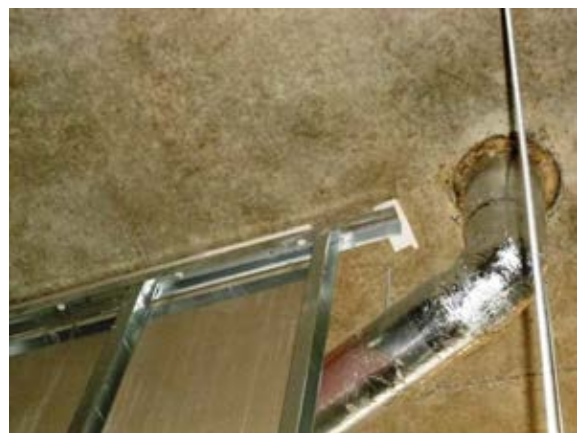
Sealant missing at headtracks.

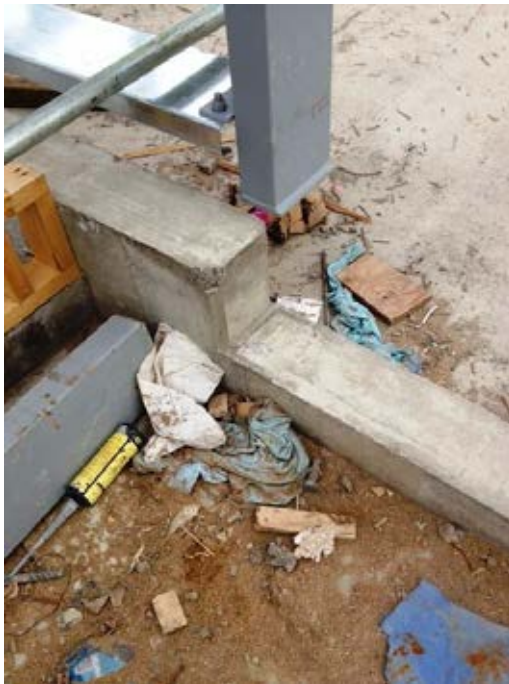
Several areas of steelwork in the Children's Hospital Zone B have significant paint damage. Brookfield has confirmed that the painter will return to site (when the liner sheet is in place to offer sufficient protection) to carry out the remedial painterwork. See Supervisor's Communication General Matters / Other Instructions (CI 13.1) No 119.

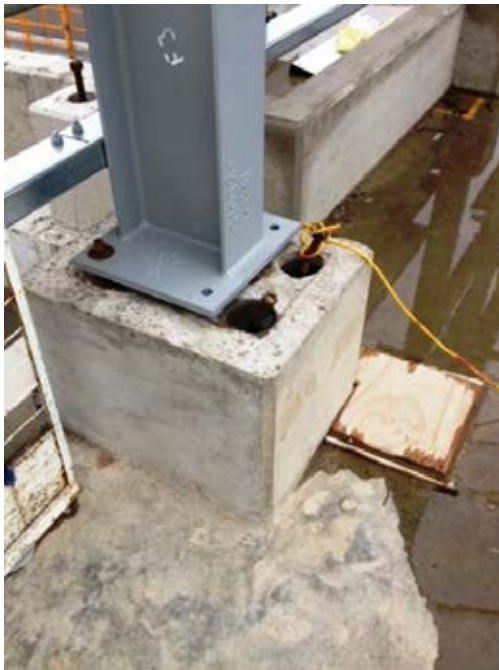
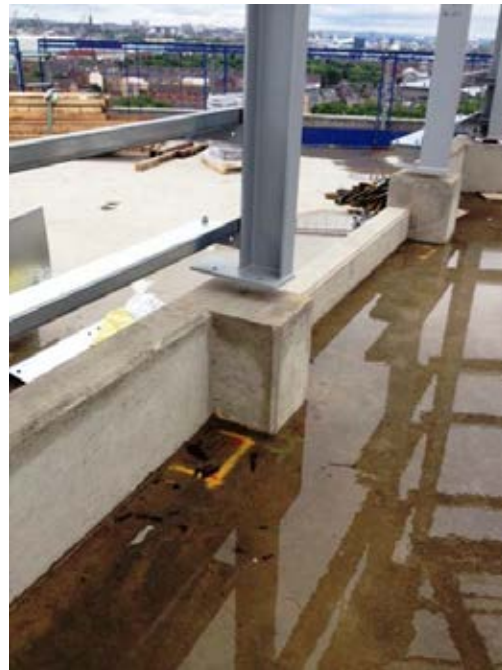
We asked Brookfield to advise on the proposed remedial actions to the non-compliant steelwork/concrete bases on the roof of the SE section of the ACH, and confirm that such measures will be in accordance with the specification. Brookfield has informed us that the solution has been developed by the steelwork contractor alongside WSP and agreed by WSP for those bases where the HD bolts do not align with the steelwork baseplate. This remedial work has been carried out, and, apart from paintwork, appears to be satisfactory. Contractor's proposals for the 'floating' columns are still awaited. See Supervisor's Communication General Matters / Other Instructions (CI 13.1) No 125.

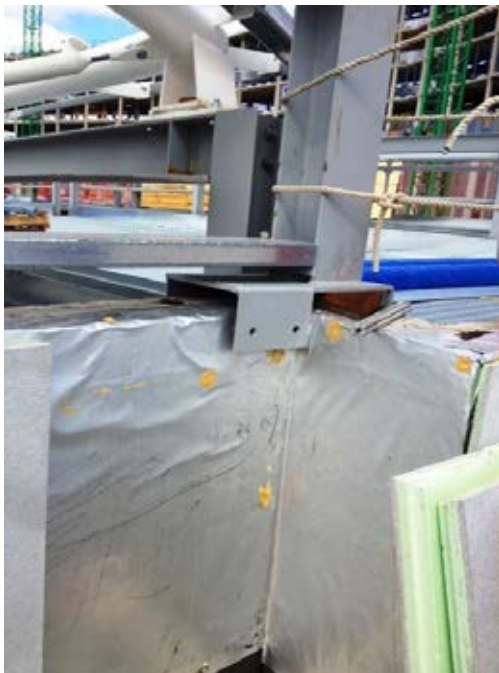
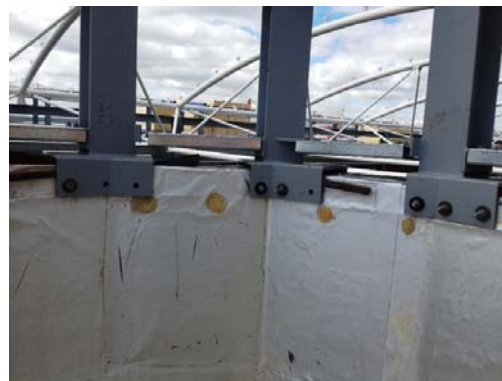
We asked Brookfield to provide proposals to meet the design intent for the Children's Hospital Roof Steelwork Zone A where bolts are missing at the parapet. Brookfield reported that they were aware of this situation and has had previous discussions with William McColgan WSP during a visit to site. This will be escalated with WSP and a formal response will follow. See Supervisor's Communication General Matters / Other Instructions (CI 13.1) No 128.

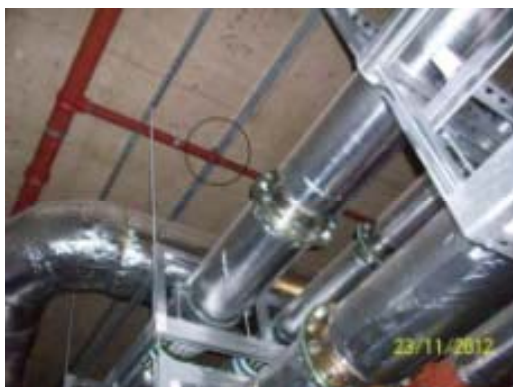
We have asked Brookfield to confirm the flow of water from the sprinkler head highlighted is not restricted by the adjacent section of unistrut. Brookfield has confirmed that the sprinkler head deflector appears to be under the unistrut and that the Sprinkler contractor will check this when they are installing the under services protection. If the head is shielded by the unistrut, they will turn the head pendant. Still awaiting photograph showing completed work. See Supervisor's Communication General Matters / Other Instructions (CI 13.1) No 74.

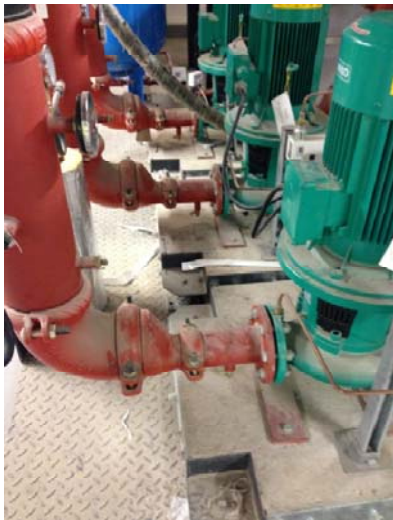
LTHW pumps are mounted on inertia bases however, there are no pump flexes. Vibration will transmit through pipework as a result. Possible longer term leakage/ damage through pipework joints. Please confirm if this has been considered and if there any measures are proposed to address this. (See Supervisor's Communication General Matters / Other Instructions (CI 13.1) No 123.

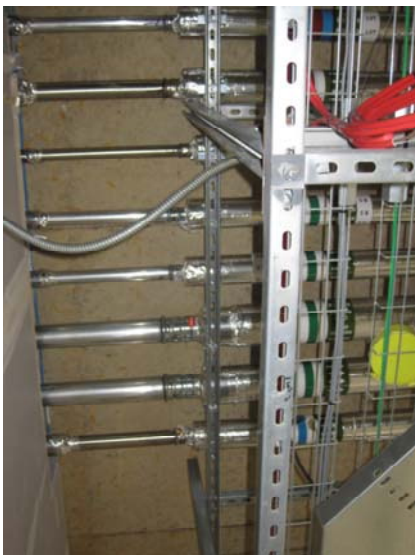
Level 2 Zone H. Pipework connections above line of unistrut. Access appears difficult. We have asked Brookfield to confirm that future access will be available.

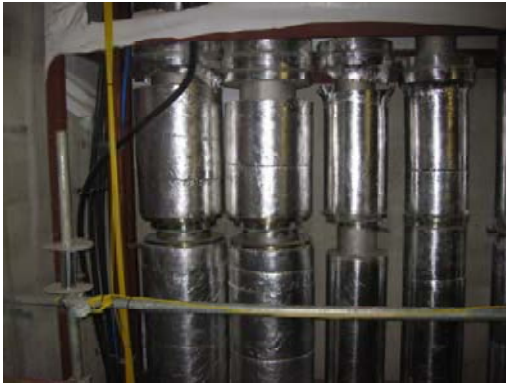
Level 2 / Zone K. Current access to install chiller water riser pipework appears difficult. We have asked Brookfield to confirm that future access will be available once walls are constructed?

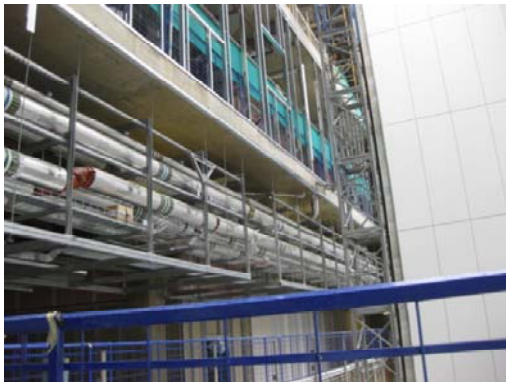
Level 3 /Zone H. Pipe Racks in area shown below have multiple levels of pipe work. We have asked Brookfield to confirm that future access will be available. (See Supervisor's Communication General Matters / Other Instructions (CI 13.1) No 126).

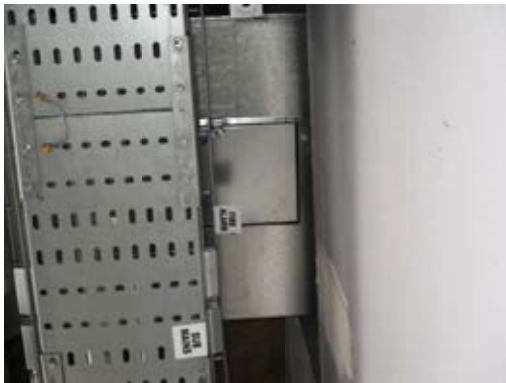
We noted that there was restricted access to ductwork in the corridor near Atrium Void Core C. Brookfield confirmed that the tray is to be re-routed or access hatch re-positioned. (See Supervisor's Communication General Matters / Other Instructions (CI 13.1) No 110.

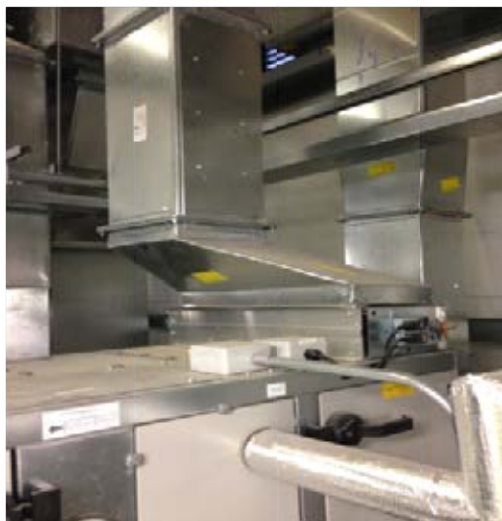
We noted that the air handling unit 21AHU16 supply duct transition does not appear to comply with HVAC DW144 clause 11.6 & 11.7 which could result in high pressure loss.

We have asked Brookfield to confirm the design philosophy in relation to this observation and any proposed remedial measures. (See Supervisor's Communication General Matters / Other Instructions (CI 13.1) No 121).

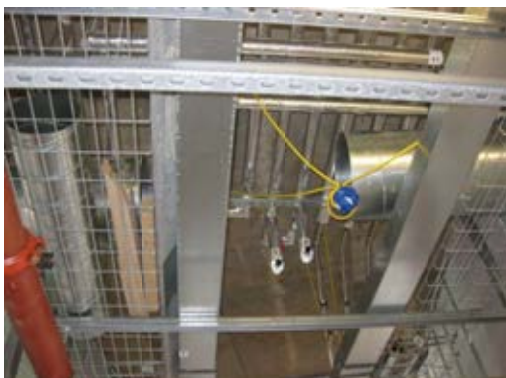
There is an open duct in the corridor at high level outside room 23HU 044 and we have brought this to Brookfield's attention that it needs to be sealed to prevent contamination/ dust ingress.

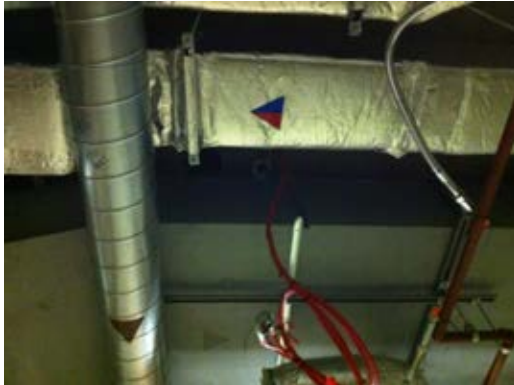
There appears to be restrictive space for the void detection. The Scotshield updated drawings following the changes by Building Control to the Fire Strategy are awaited. Once these are received by Mercury these will be issued to confirm adequate protection. Still awaiting drawing. (See Supervisor's Communication General Matters / Other Instructions (CI 13.1) No 90).

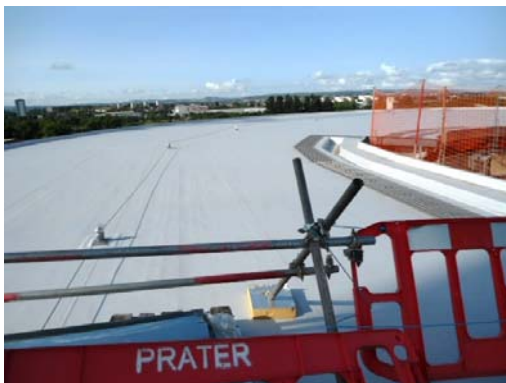
Finished Area of Sarna Roof

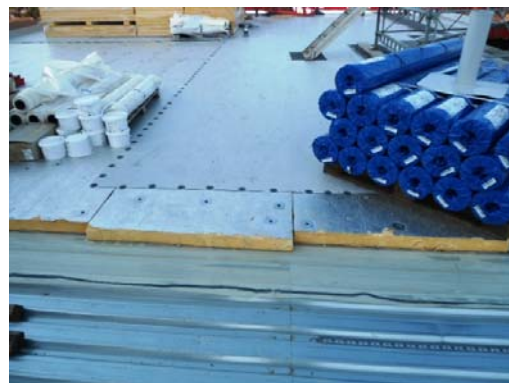
Sarna Roof in Progress

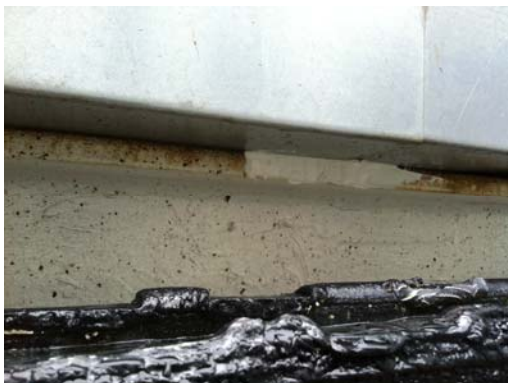
During an inspection with Brookfield we observed that there were areas of damaged intumescent paint on the steelwork to the Atrium Bridge. A subsequent inspection was carried out and the areas were coated with the exception of one damaged area of paintwork. Brookfield provided photographic evidence that the work was completed.

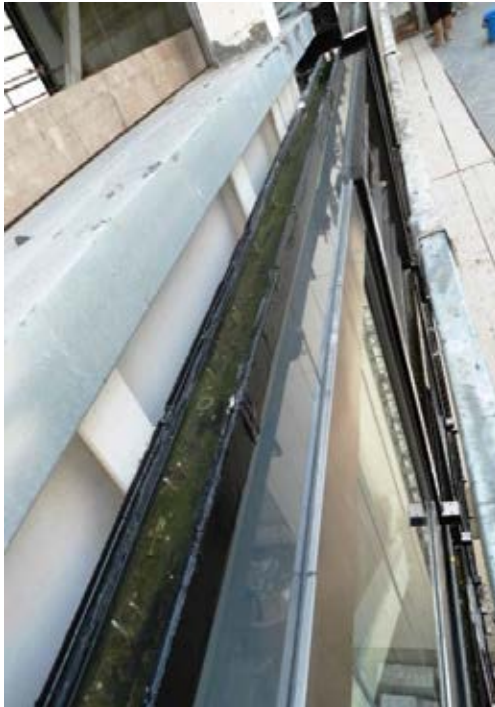
There were steel troughs at the openings to the pods which were full of water. These have since been encased to prevent water gaining entry to these areas.

Trough full of water.

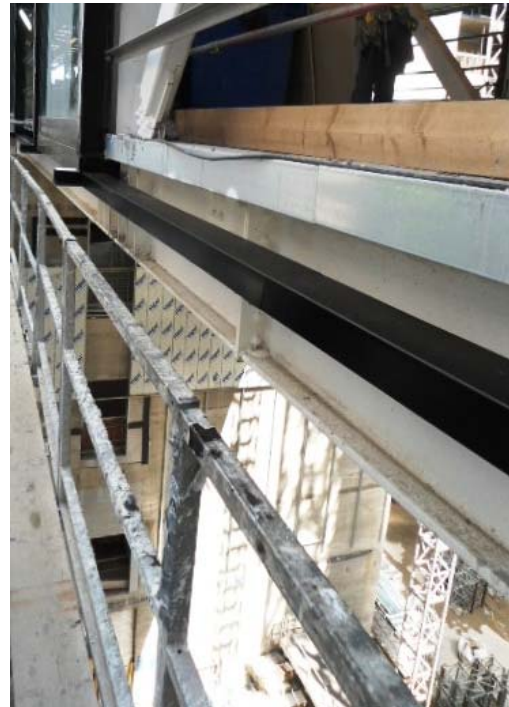
Trough covered.

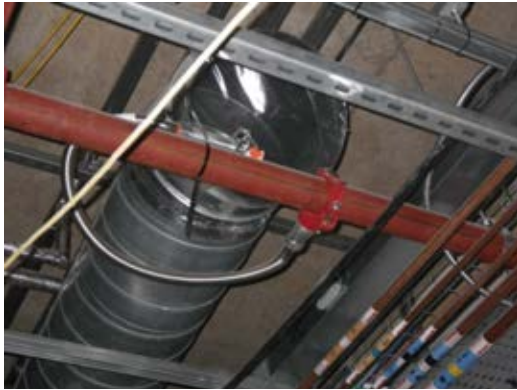
We noted during our inspections on Level 1 that the duct mounted heater battery coil exposed at high level adjacent riser in Area ref CCI 047 is not cover to prevent dust / debris ingress. We have asked Brookfield to address this. (See Supervisor's Communication General Matters / Other Instructions (CI 13.1) No 127).

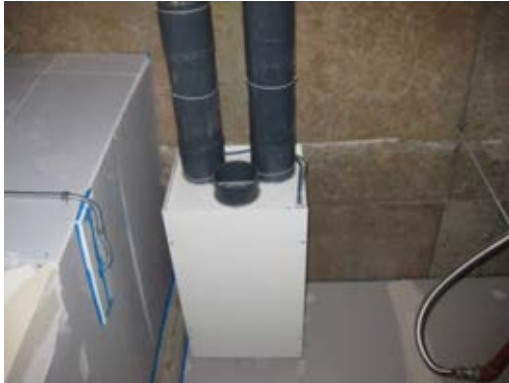
Pneumatic tube box at CCW 073 Bay 1 has an exposed end. We have informed and await confirmation that they have blacked it off. (See Supervisor's Communication General Matters / Other Instructions (CI 13.1) No 130).

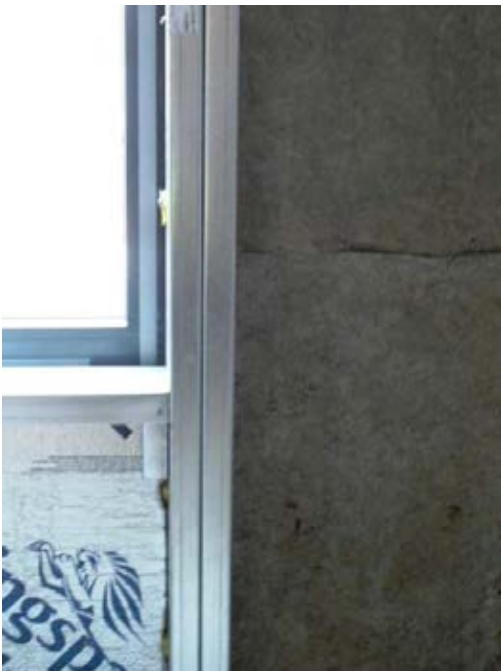
We noted that insulation has not been fitted inside the vertical SFS forming the window openings of the ground floor children's Hospital resulting in cold bridging. We have asked Brookfield to confirm the measures they intend to take to address this. (See Supervisor's Communication General Matters / Other Instructions (CI 13.1) No 129).

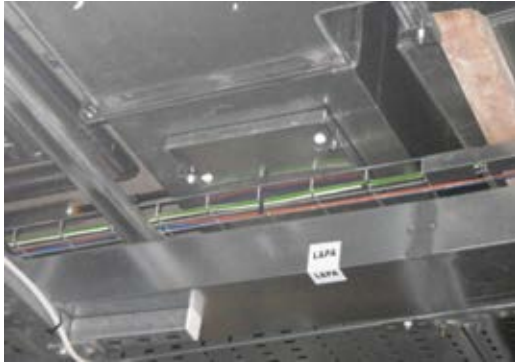
Duct access hatch blocked by chilled water pipework at ground floor area around DB cupboard AAW190. See photograph below. We have asked Brookfield to confirm

when this will be rectified. (See Supervisor's Communication General Matters / Other Instructions (CI 13.1) No 56).

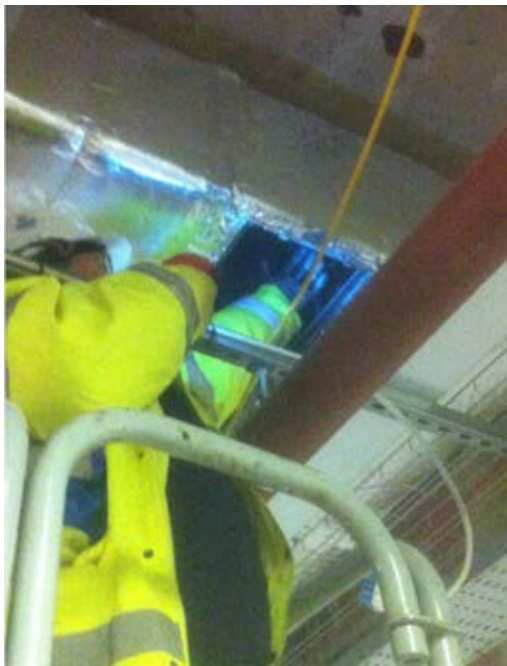
Restricted access to ductwork access hatch in corridor adjacent to Zone H near Stair Core F. Brookfield has intimated that the hatch is not restricted and access can readily be gained. We revisited the hatch and are still of the opinion that access to the hatch is not feasible as can be seen in Mercury's photograph which shows an attempt to access the hatch without the ceilings. We are still awaiting a response. (See Supervisor's Notification of Defect (CI 42.2) No 13).

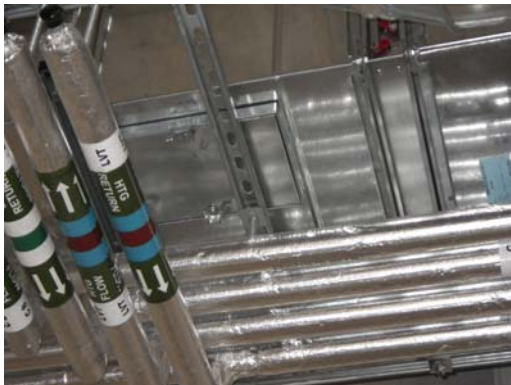
We have asked Brookfield to confirm the measures to address the restricted access problem to the ductwork access hatch on Level 3 Zone A near room GW1-042. See Supervisor's Communication General Matters / Other Instructions (CI 13.1) No 48).

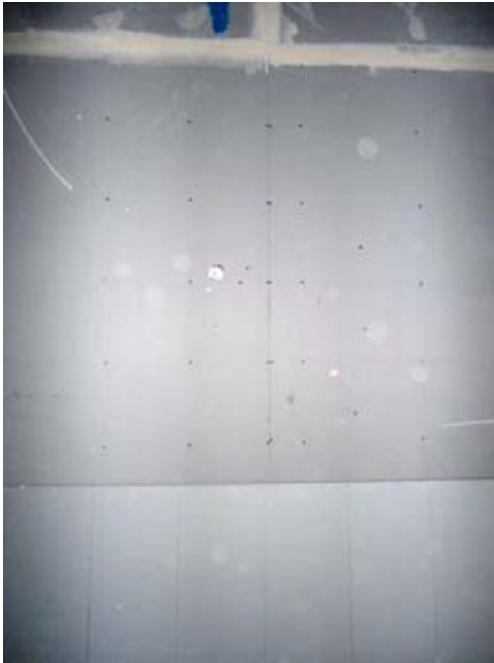
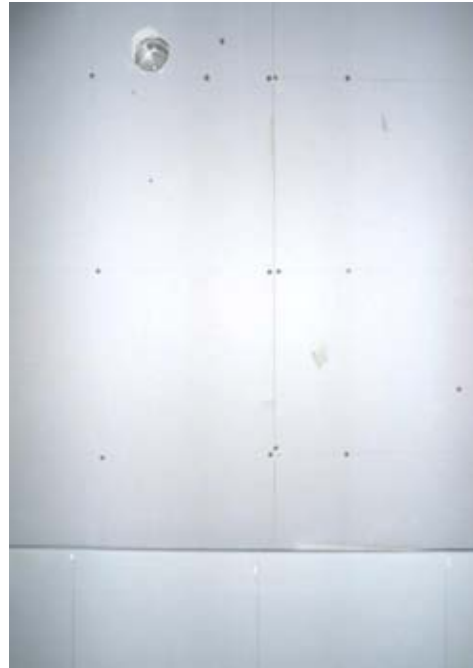
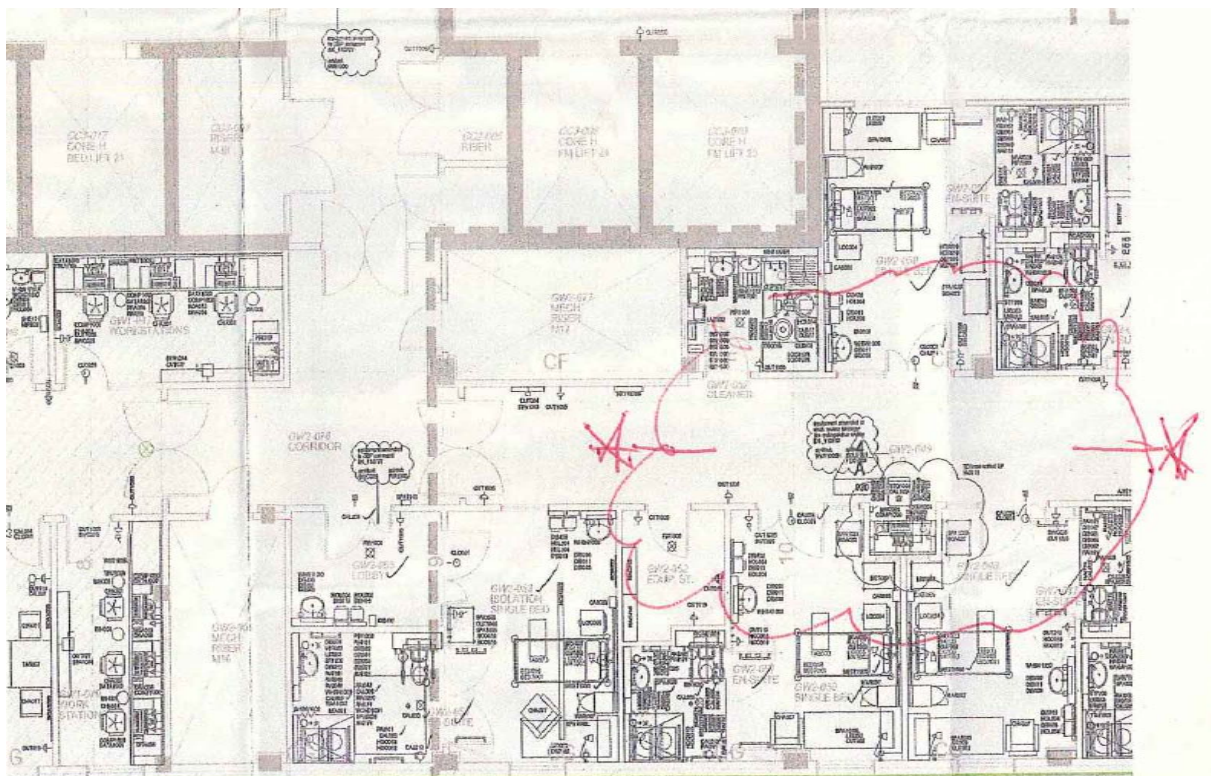
Two access hatches are blocked by containment in the corridor. See photos and location below.

We have asked Brookfield to confirm when appropriate access has been provided so that we can re-inspect the hatches. (See Supervisor's Communication General Matters / Other Instructions (CI 13.1) No 53).

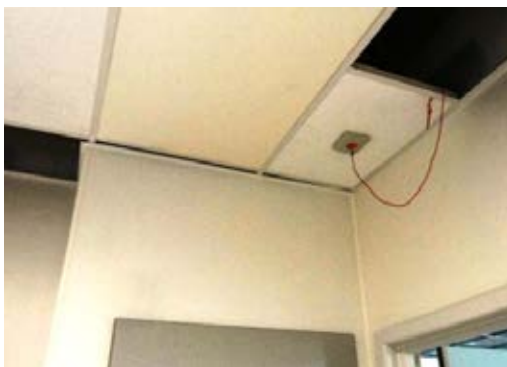
Ceiling not finished properly

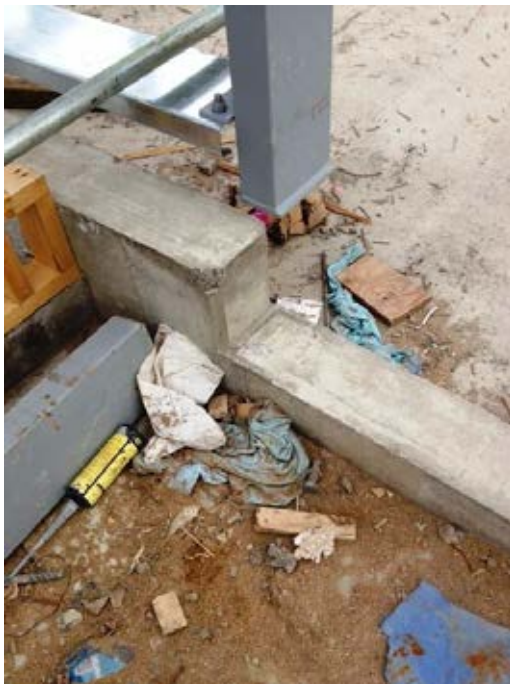
Two internal RHS columns in the Children's Hospital Zone B appear to be held up by adjoining steelwork. This may be work in progress, but we asked Brookfield to confirm the final detailing. Brookfield has informed us that the final detail is a connection to concrete. The concrete works and subsequent bolting up will be undertaken prior to the installation of any cladding. See Supervisor's Communication General Matters / Other Instructions (CI 13.1) No 118.

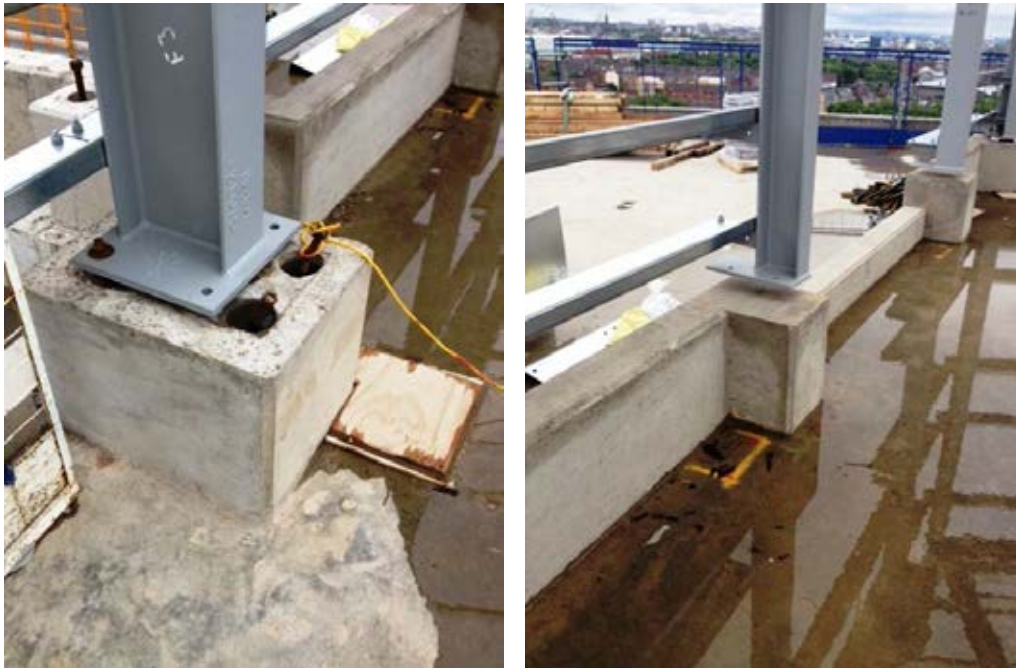
We asked Brookfield to advise on the proposed remedial actions to the non-compliant steelwork/concrete bases on the roof of the SE section of the ACH, and confirm that such measures will be in accordance with the specification. Brookfield has informed us that the solution has been developed by the steelwork contractor alongside WSP and agreed by WSP for those bases where the HD bolts do not align

with the steelwork baseplate. This remedial work has been carried out, and, apart from paintwork, appears to be satisfactory. Contractor's proposals for the 'floating' columns are still awaited. See Supervisor's Communication General Matters / Other Instructions (CI 13.1) No 125.

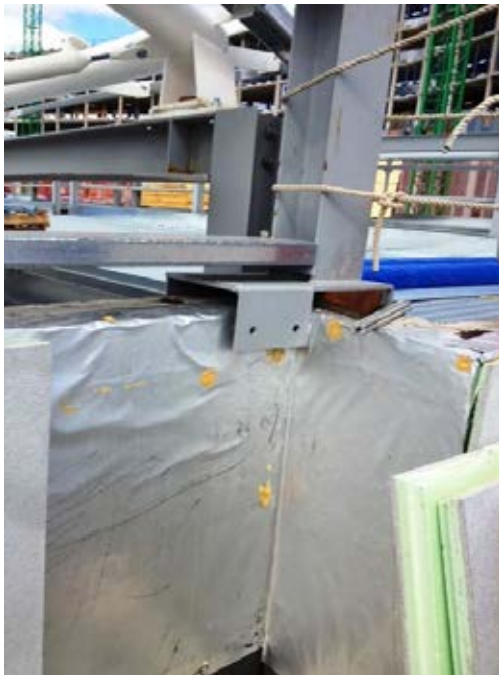
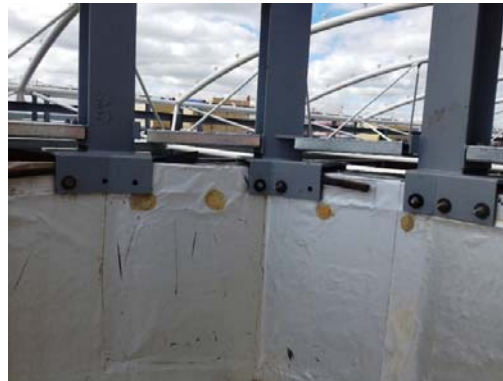
We asked Brookfield to provide proposals to meet the design intent for the Children's Hospital Roof Steelwork Zone A where bolts are missing at the parapet. Brookfield reported that they were aware of this situation and has had previous discussions with William McColgan WSP during a visit to site. This will be escalated with WSP and a formal response will follow. (See Supervisor's Communication General Matters / Other Instructions (CI 13.1) No 128).

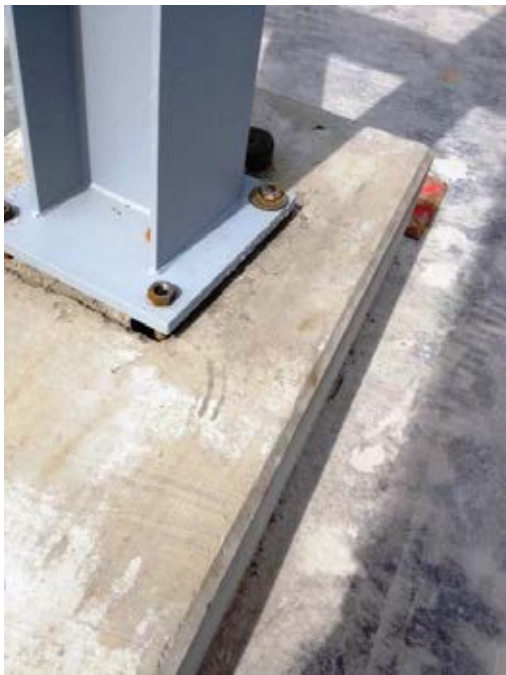
We have asked Brookfield to advise us of the remedial proposals for those column bases where there is at present insufficient nut connection to bolt thread. Brookfield has confirmed that these details have been consistently incorrect throughout and will secure a detail via JDP/WSP. (See Supervisor's Communication General Matters / Other Instructions (CI 13.1) No 131).

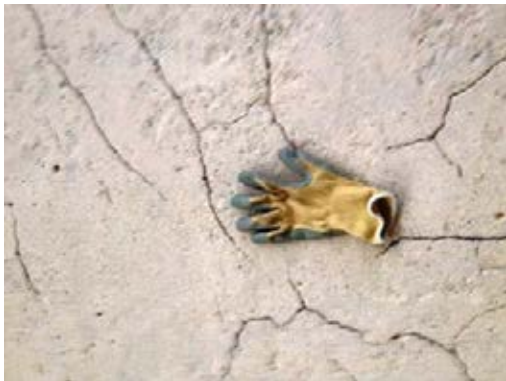
Several large cracks have appeared in Children's Hospital Zone A, 4th Floor Concrete Slab. We asked Brookfield if they could investigate and confirm that the specification requirements are met or provide details of proposed remedial action. Brookfield's Manager Samson Abogunleruri discussed this issue with Capita

Symonds Willie Roxburgh on site. The situation was explained that the cracks had appeared following the blasting of the floors, similar to Supervisor's Communication 107. This area has now been screeded with no sign of cracking. In addition the soffit below was viewed and it was agreed that the outcome was the same as identified in our response to Supervisor's Communication 107. (Consequently Supervisor's Communication General Matters / Other Instructions (CI 13.1) No 132 is closed out.

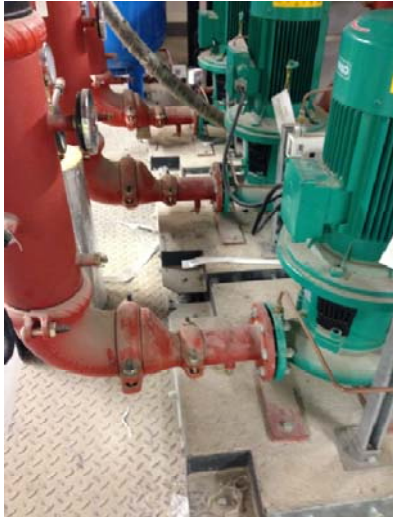
LTHW pumps are mounted on inertia bases however, there are no pump flexes. Vibration will transmit through pipework as a result. Possible longer term leakage/damage through pipework joints. We asked Brookfield to confirm if this has been considered and if there any measures are proposed to address this. Brookfield has provided us with an independent vibration testing data verifies that three Victaulic couplings in close proximity to a vibration source (pump, equipment etc.) provide superior vibration attenuation in piping systems. Consequently Supervisor's Communication General Matters / Other Instructions (CI 13.1) No 123 is closed out.

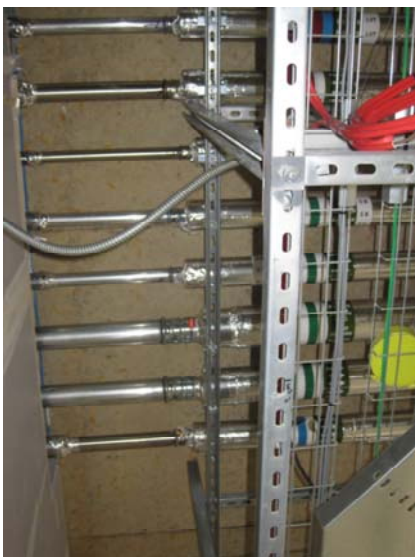
Level 2 Zone H. Pipework connections above line of unistrut. Access appears difficult. We have asked Brookfield to confirm that future access will be available.
