**Bundle of documents for Oral hearings
commencing from 13 May 2025 in relation
to the Queen Elizabeth University Hospital
and the Royal Hospital for Children,
Glasgow**

**Bundle 33
NEC3 Supervisor's Reports and Project
Supervisors Interface Action Notes**

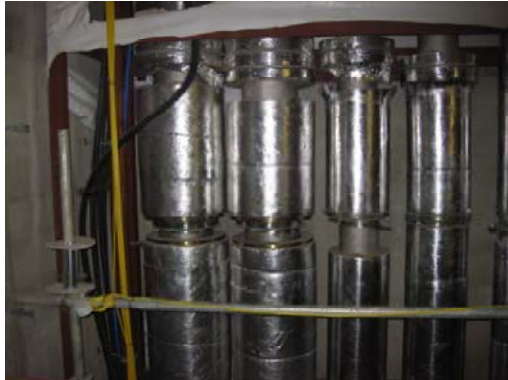
Level 2 / Zone K. Current access to install chiller water riser pipework appears difficult. We have asked Brookfield to confirm that future access will be available once walls are constructed?

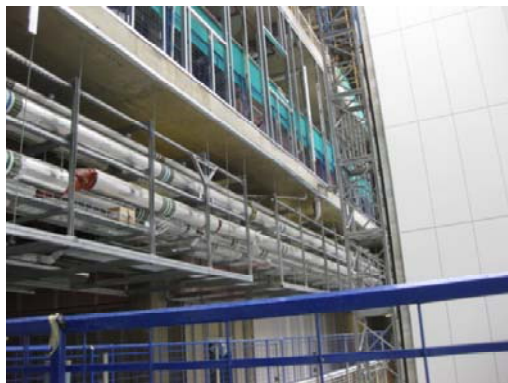
Level 3 / Zone H. Pipe Racks in area showed below have multiple levels of pipe work. We have asked Brookfield to confirm that future access will be available. Brookfield confirmed that access to the 3 areas identified will be accessible for FM in compliance with ER Section 5.13. The access arrangements for this item will be recorded as part of the Access Strategy Tracker which is currently being developed by Brookfield and Brookfield. (See Supervisor's Communication General Matters / Other Instructions (CI 13.1) No 126).

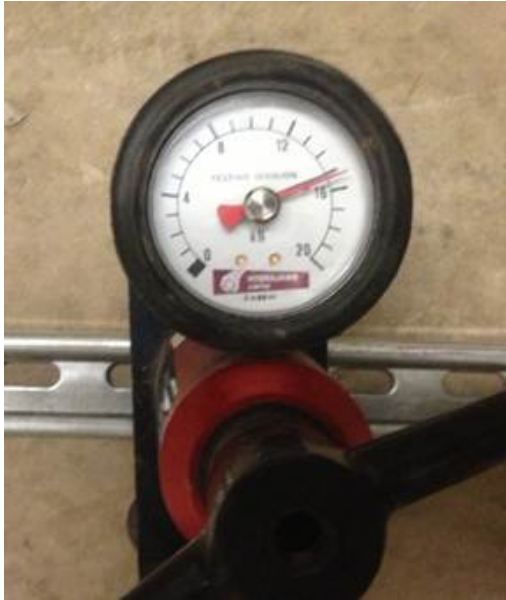
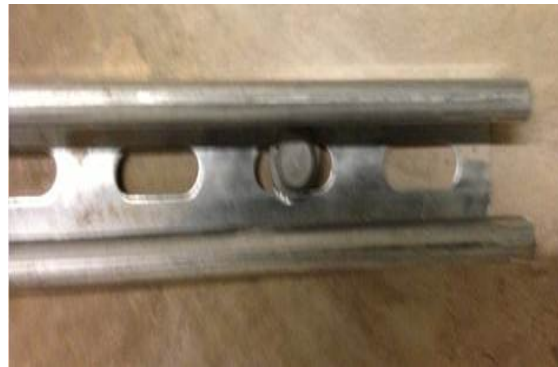
Test of TAPCON fixings

During an inspection we noted that the pipework modules in Plant Room PR31 adjacent sub-station 2A are being installed utilising drop rods with Unistrut hangers. These are supported in some cases by what appear to be small size bolt fixings and 10mm drop rods. The bolt and washer fixing shear strength causes concern as the washer itself may fail when pipework is filled increasing weight. We asked Brookfield to confirm methodology for structural support of pre-fabricated pipework modules. In addition, lateral restraints are not currently installed.

They have confirmed that the methodology for structural support of pre-fabricated modules is correct. They have also confirmed that the drop rods for plant room modules are 12mm. They have informed us that the TAPCON fixings are suitable for the application with the "washer" being an integral part of the fixing head. Independent test confirms span of 800mm Unistrut capable of supporting a minimum of 1.5 tonnes, each bolt head at slot taking a minimum of 0.75 tonnes without any deflection of the channel at the slot where the fixing was made. Nine bolts per side on

a typical 4,800mm plant room module giving an overall support of 13.5 tonnes minimum. They intimated that the heaviest plant room module they have on the site is MEP-5773-PR31-122-001 - Module dry is 1850kg + Water is 1575kg, Total = 3425kg.

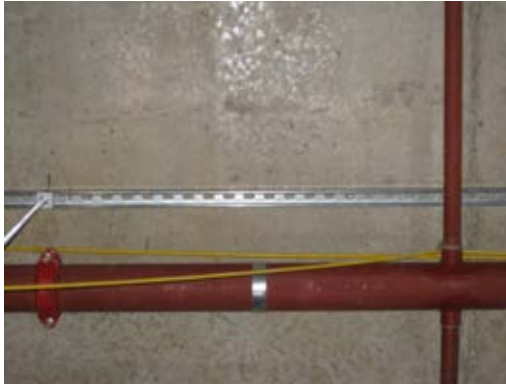
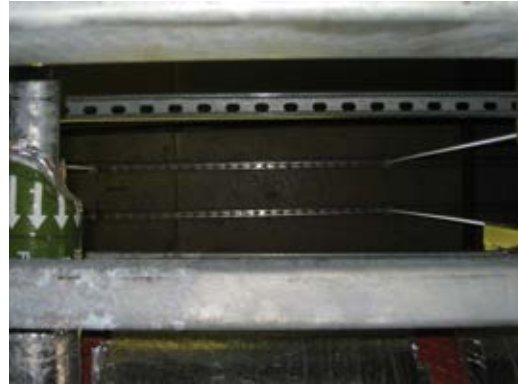
We noted that the unistrut pipework support had visibly bent under weight of pre-fabricated pipework module in Plant room PR31 adjacent sub-station 2A.

This will become more pronounced when pipework is filled with water. We asked Brookfield to confirm that the structural supports utilised are compliant with the design intent. Brookfield has replied that the frames are suitable for their intended function and have provided calculations. They have informed us that this appears to have been mechanical damage and not deformation due to weight of the services. We have not found any fitted modules with bowed frames in this manner. Further investigations are being carried out by Brookfield and Mercury. (See Supervisor's Communication General Matters / Other Instructions (CI 13.1) No 135).

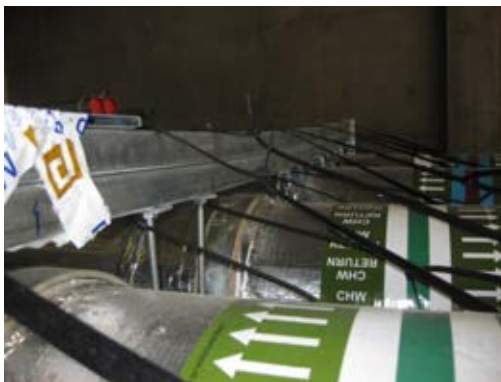
We noted a clash between the cold water pipes and drainage connection in the corridor and room OPD-031. Brookfield has confirmed that they are investigating this issue. (See Supervisor's Communication General Matters / Other Instructions (CI 13.1) No 143).

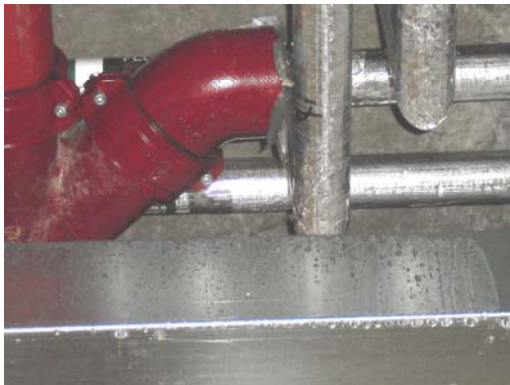
We noted that sprinkler system pipe was clashing with the electrical trunking in rooms DMW-044 AND 045 and AFD-004 on Level 2. This was discussed with Brookfield and they confirmed that they would address this.

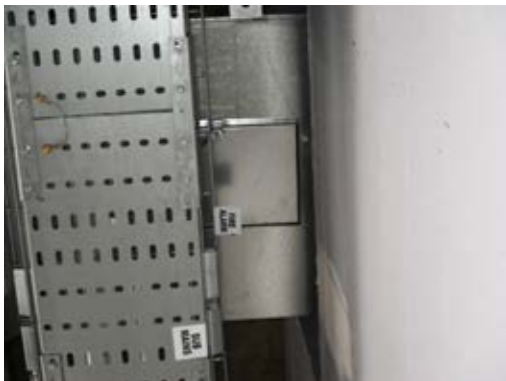
We noted that the air handling unit 21AHU16 supply duct transition does not appear to comply with HVAC DW144 clause 11.6 & 11.7 which could result in high pressure loss.

Brookfield has confirmed that ductwork is not in compliance to drawing/specification and will be replaced. However we await the design philosophy in relation to the proposed remedial measures. (See Supervisor's Communication General Matters / Other Instructions (CI 13.1) No 121).

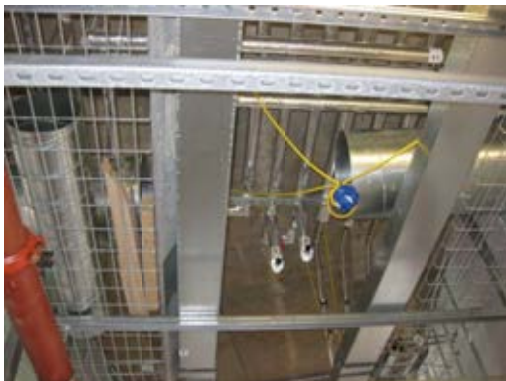
Plant room PR31. Fire rating of fans adjacent to atrium – west side of building.

We have asked Brookfield to confirm that the fire rating of the flexible connections and supporting system in Plant room PR31 is equivalent to the overall system requirements. The fan is located adjacent to atrium at the west side of building. We have also asked them to confirm fire rating of fans (observed as non-bifurcated type). Brookfield confirmed that this is currently being investigated by Mercury and a formal response will be issued in the next period. (See Supervisor's Communication General Matters / Other Instructions (CI 13.1) No 133).

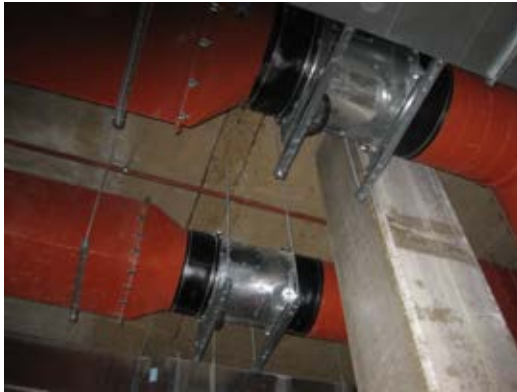
We noted that some fire rated ductwork sections have been damaged during installation. We asked Brookfield to confirm the method for re-coating the painted finishes, integrity test procedure to meet compliance and identification. They have confirmed that the remedial work will be implemented in accordance with the attached method statement. Consequently Supervisor's Communication General Matters / Other Instructions (CI 13.1) No 136 is closed out.

THE REPAIR OF F.F.C. FIRE COATING SHOWING SIGNS OF FLAKING OR PEELING DUE TO IMPROPER APPLICATION IN THE FIRST INSTANCE

- 1) The affected area shall be inspected and any loose material removed using a suitable scraper or a light abrasive material.
- 2) The repair area shall be checked to ensure that it is clean and dry.
- 3) Ensure the area is properly etched and no grease or oil is present.
- 4) The repair material will be Fenland Fire Contracts FFC250 fire rated intumescent coating.
- 5) Brush, roller or spray can be used to apply the FFC250 repair material.
- 6) Minimum recommended application temperature 5°C.
- 7) Care should be taken to ensure that the applied thickness of the repaired coating meets with the requirements of the fire rating of the ductwork system.
- 8) A minimum of 24 hours should be allowed for the repaired area to cure.
- 9) Whilst Curing the repair must be protected from frost.

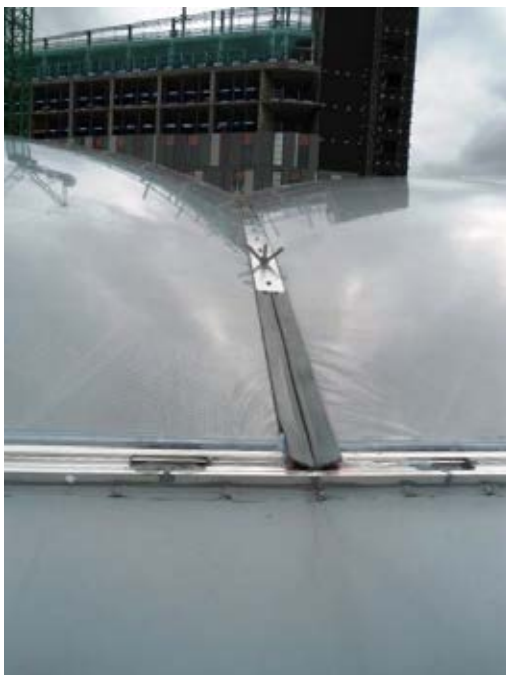
Joint section at Barrel Vaulted Roof.

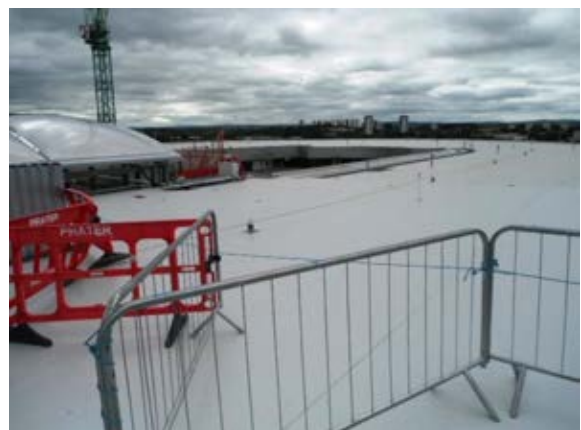
Sarna roof covering nearing completion.

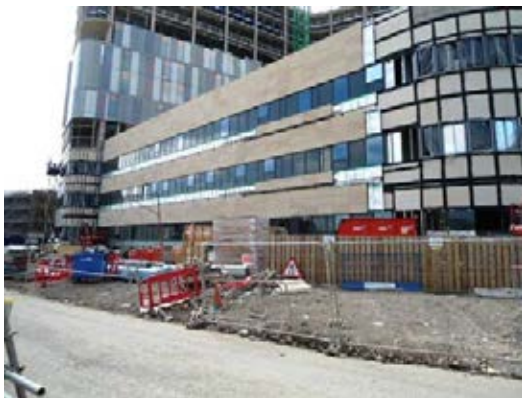
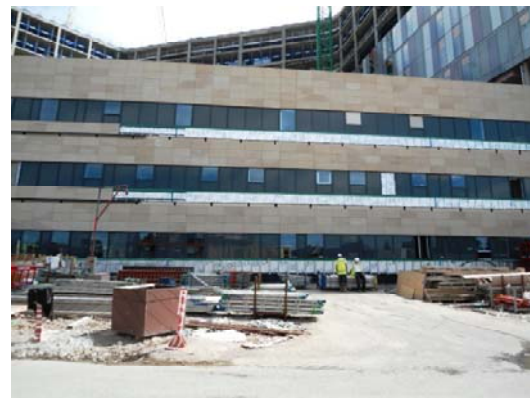
Repairs and painting was carried out to two damaged panels and these were acceptable to the client. Brookfield awaits confirmation from Rukki that their Warranty is not compromised as a result of the repair/repaint. (See Supervisor's Communication General Matters / Other Instructions (CI 13.1) No 103).

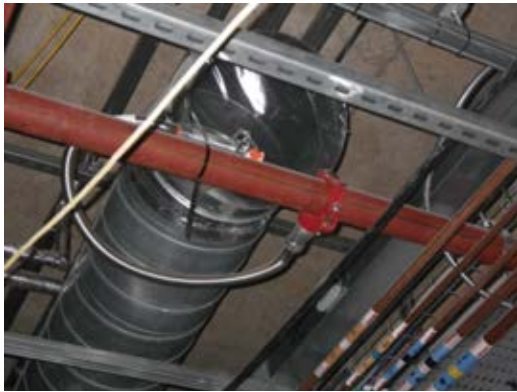
The duct mounted heater battery coil exposed at high level adjacent riser in Area ref CCI 047 has now been suitably protected. Consequently Supervisor's Communication General Matters / Other Instructions (CI 13.1) No 127 is closed out.

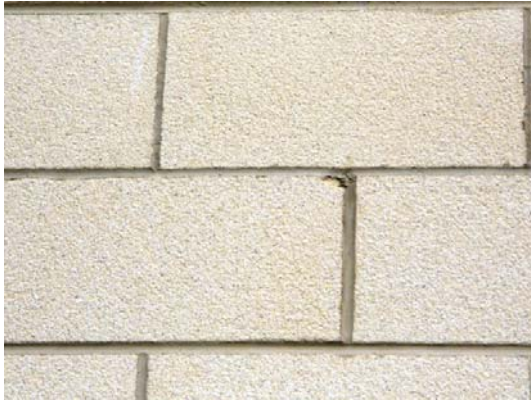
colour difference to some of the blocks. Brookfield has highlighted some of these problems and is subject to an NCR. In addition to our observations about the poor workmanship there are also specific damaged blockwork.

Damaged Corner.

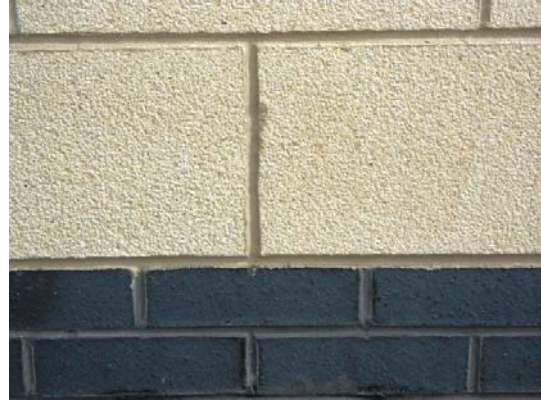
Damaged edge of blockwork at perpend.

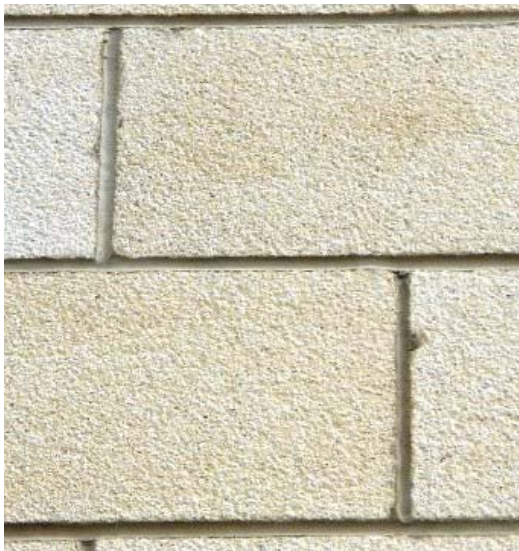
Damaged blockwork and overspill of mortar pointing at edge of blockwork.

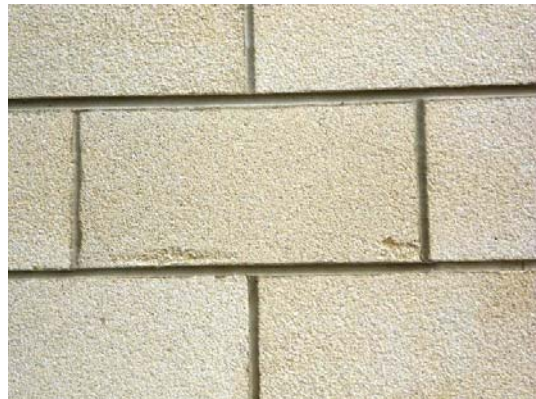
Damaged blockwork and overspill of mortar pointing at edge of blockwork.

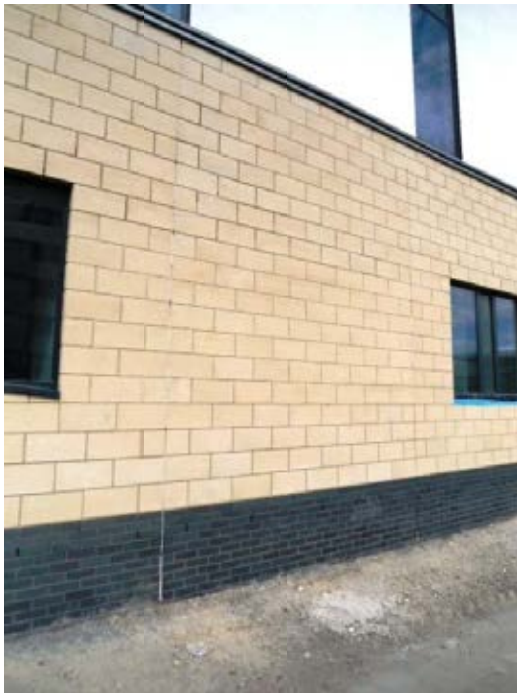
Shading of mortar pointing.

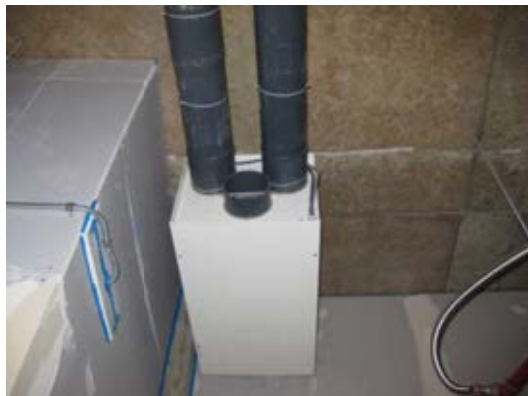
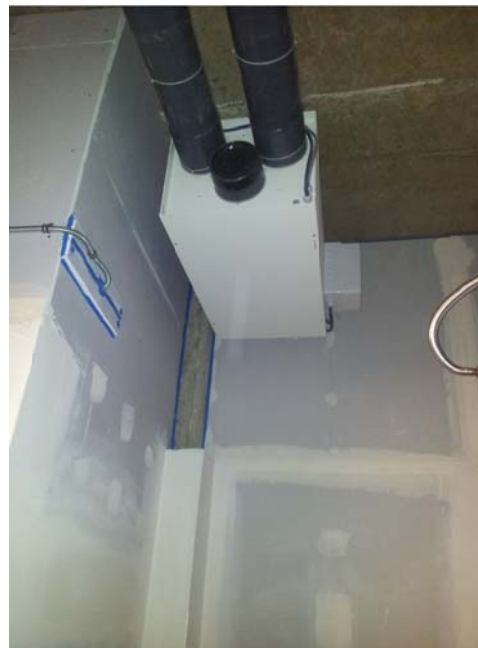
Pneumatic tube box at CCW 073 Bay 1 has an exposed end. The pneumatic tube was left open to allow purging. A temporary cover has now been fitted, consequently Supervisor's Communication General Matters / Other Instructions (CI 13.1) No 130 is closed out.

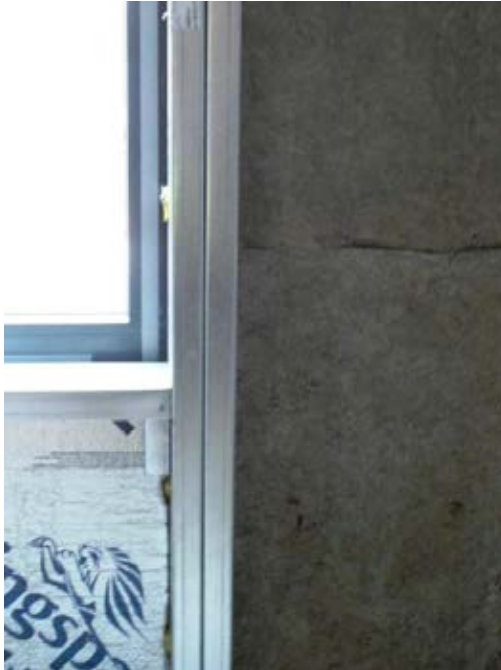
We noted that insulation has not been fitted inside the vertical SFS forming the window openings of the ground floor children's Hospital resulting in cold bridging. Brookfield has confirmed that insulation has been placed within the SFS vertical members. Consequently Supervisor's Communication General Matters / Other Instructions (CI 13.1) No 129 is closed out.

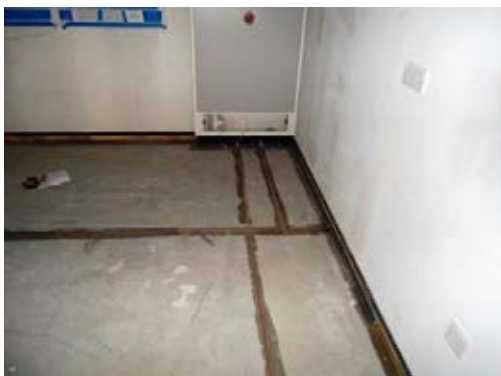
During an inspection with Brookfield on Level 2 Zones F & J we noted that the insulation has not been fitted to the SFS abutting the columns on the west facing elevation and at the double studs on the external radius facades in areas 2-507, 2-530 and 2-533. Consequently we have raised Supervisor's Communication General Matters / Other Instructions (CI 13.1) No 147 asking Brookfield to confirm when this will be been addressed.

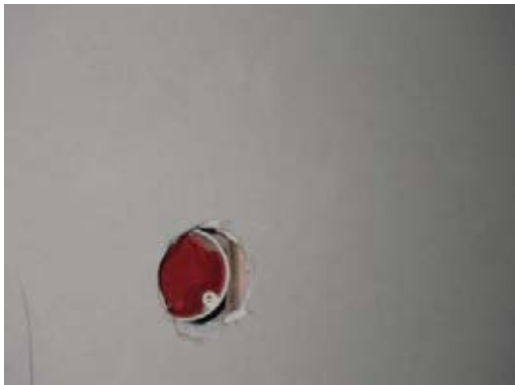
The en-suite circular boxes in Level 0 OBW-023 appears to be recessed too far back and the openings are not cut out properly. This occurs in the en-suite on level 3. We asked Brookfield to confirm that an adequate seal between the boxes and the inner face of the board and around the perimeter can be achieved especially in any fire walls. Brookfield has confirmed that this is being investigated and a formal response will be issued in the next reporting period. (See Supervisor's Communication General Matters / Other Instructions (CI 13.1) No 139).

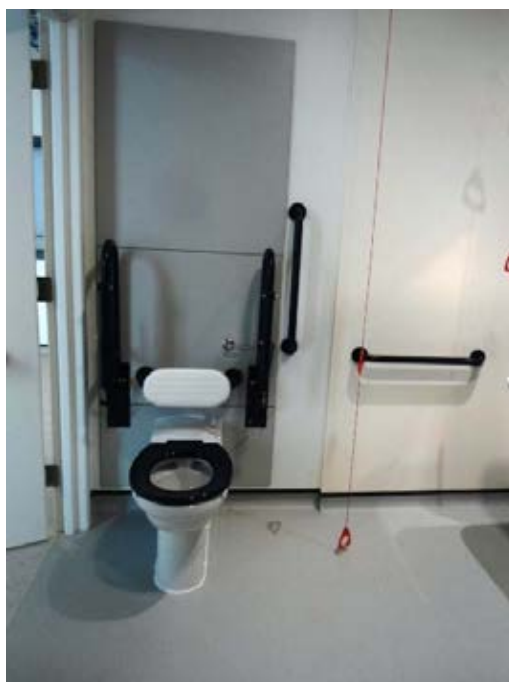
With the exception of room CCU-065 on level 1 1-521 all of the pull cords next to the WC bowls in the en-suites are not in their correct positions. We have asked Brookfield to confirm when they have been relocated. Brookfield has instructed Mercury Floor/Package managers to investigate and advise. (See Supervisor's Communication General Matters / Other Instructions (CI 13.1) No 140).

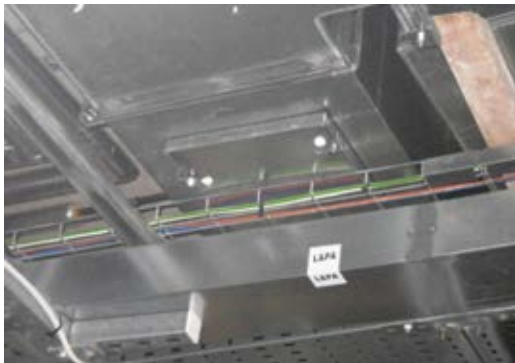
Existing hatch

Duct access hatch which was blocked by chilled water pipework at ground floor area around DB cupboard AAW190 has been resolved by fitting a new hatch. Consequently Supervisor's Communication General Matters / Other Instructions (CI 13.1) No 56 is closed out.

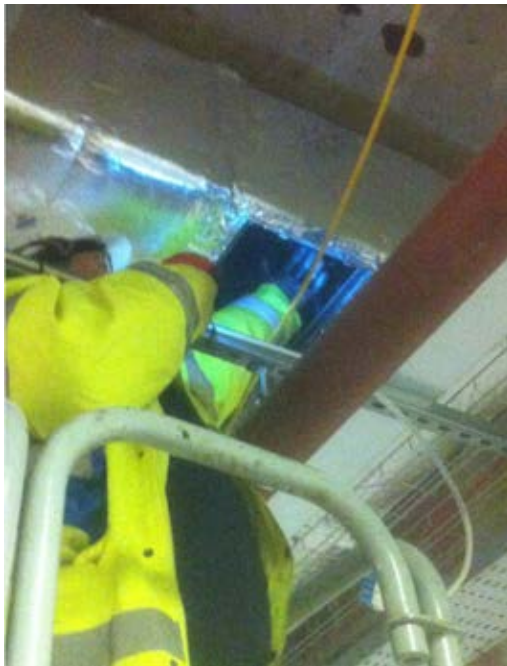
Ductwork obstructed by modular frame Zone H. Mercury has investigated and this was work in progress. All of the systems in the Zone H areas of levels 0 and 1 are now connected. Consequently Supervisor's Notification of Defect (CI 42.2) No 14 is closed out.

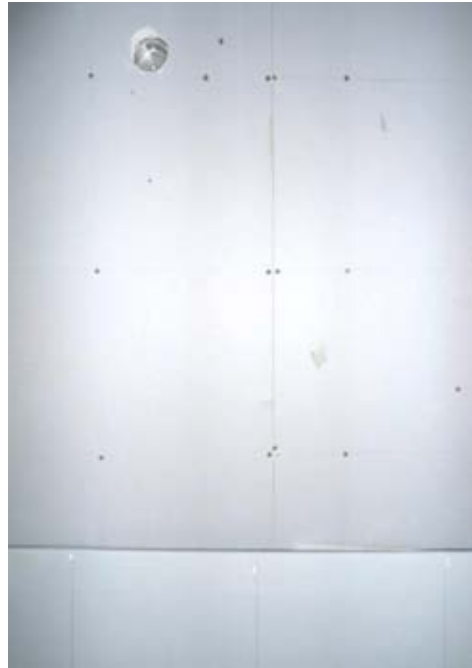
Two access hatches are blocked by containment in the corridor. New access hatches have been located in these and another two identified by Mercury. Consequently Supervisor's Communication General Matters / Other Instructions (CI 13.1) No 53 is closed out.

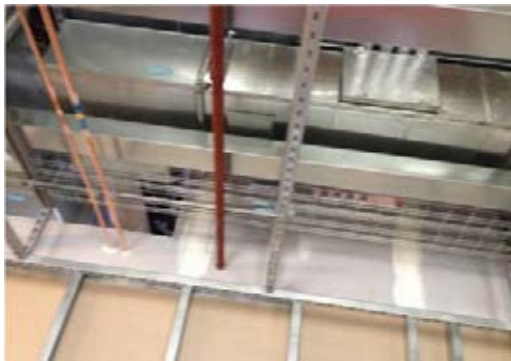
Example of new access hatch formed.

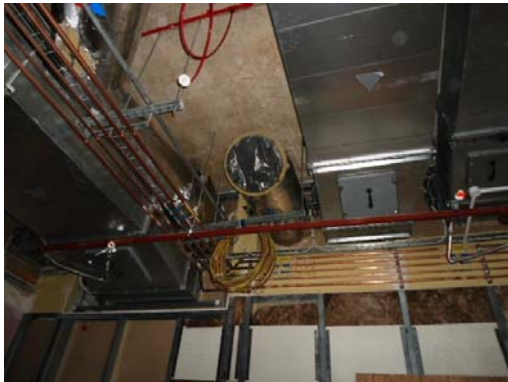
Following an 85 point check to the partition in room THE-137 Store Bulk the floor track did not have sealant in accordance with the specification.

We have asked Brookfield to provide us with a drawing identifying the partitions constructed by the operative/s who constructed the failed partition. We have also asked them to confirm when they will be lifting sections of the floortrack identified on their drawings as part of their checks. Brookfield has confirmed that these rooms have been screeded up to the partitions following the installation of a picture frame of mastic which to eliminate any acoustic issues. Consequently Supervisor's Communication General Matters / Other Instructions (CI 13.1) No 58 is closed out.

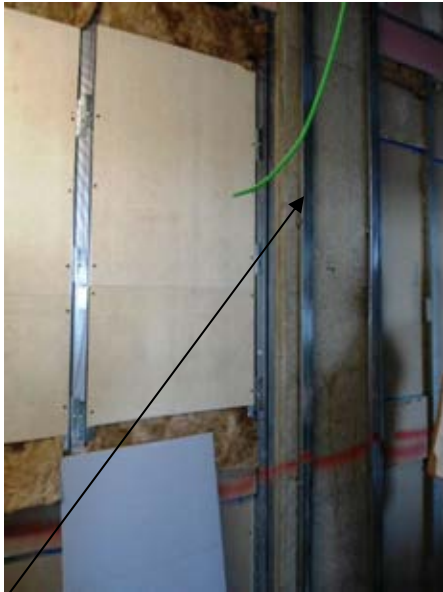
We undertook inspection with Brookfield of all Zones on Level 4 and noted that the works were progressing at varying stages in all Zones. The works are generally to a good industrial standard. However we brought to Brookfield's attention locations where there were double studs without insulation. Brookfield confirmed that they would address this but we will monitor this during further visits.

Double stud resulting failure of insulation qualities of partition.

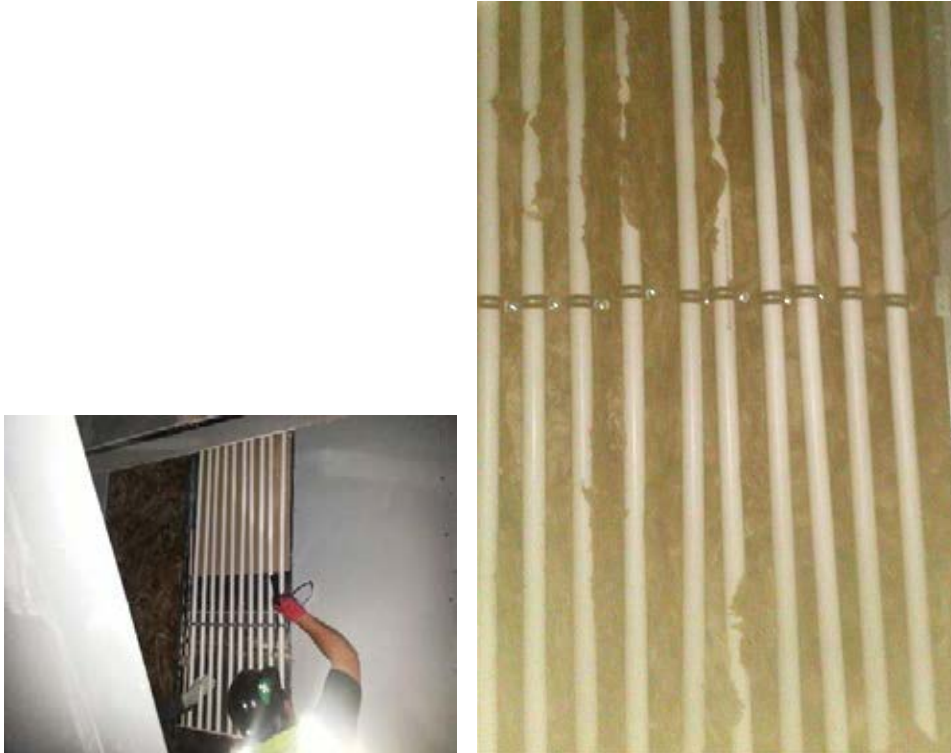
vertical conduits. They immediately addressed this and checked partitions which had not been sheeted in other rooms to ensure the insulation were fitted.

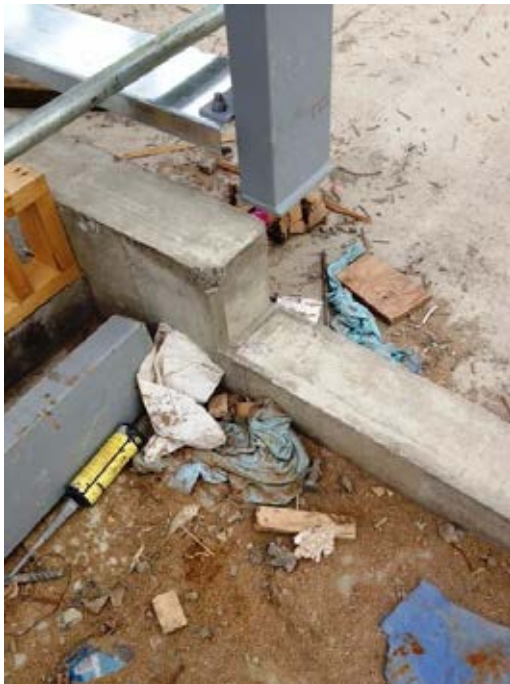
The areas of steelwork in the Children's Hospital Zone B had significant paint damage which is now completed and a joint inspection between Brookfield and Capita is to be arranged. See Supervisor's Communication General Matters / Other Instructions (CI 13.1) No 119.

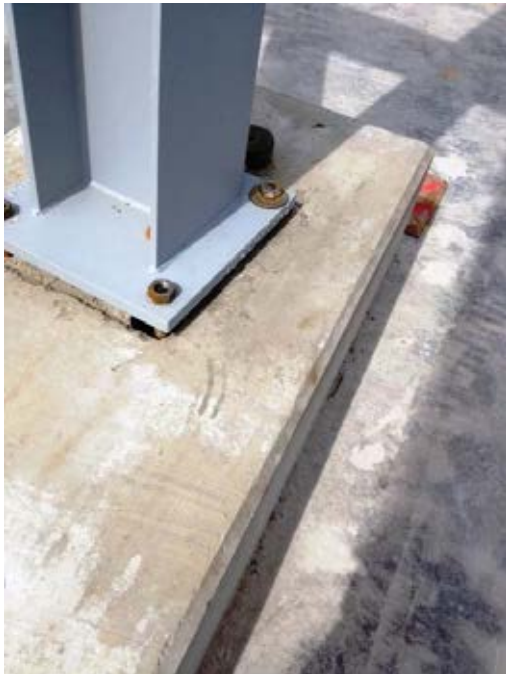
We asked Brookfield to provide technical solutions to various situations on the structural steelwork to the Children's roof where base plates are (floating) edge distances are minimal or miss the concrete base. Cladding rails also prevented HD bolt fixing. WSP has provided a detailed sketch to show remedial work to plinth. We shall inspect this on completion. See Supervisor's Communication General Matters / Other Instructions (CI 13.1) No 141.

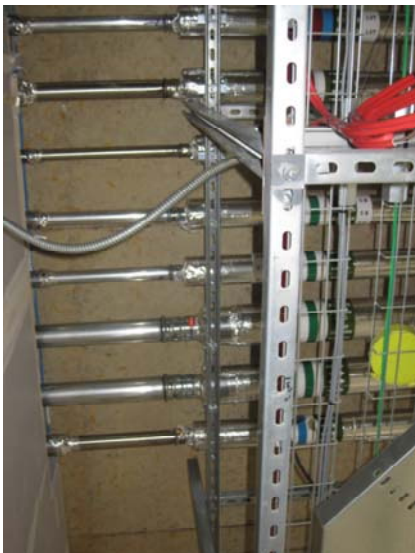
Level 2 Zone H. Pipework connections above line of unistrut. Access appears difficult. We have asked Brookfield to confirm that future access will be available.

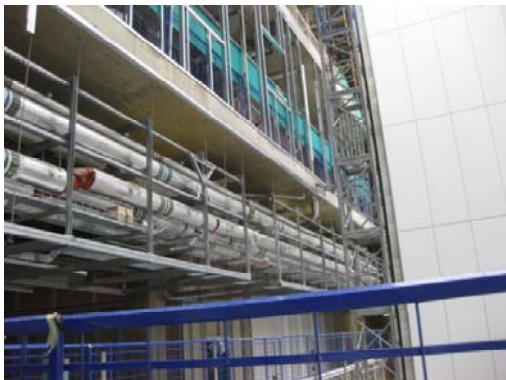
Level 3 / Zone H. Pipe Racks in area shown below have multiple levels of pipe work. We have asked Brookfield to confirm that future access will be available. Brookfield confirmed that access to the 3 areas identified will be accessible for FM in compliance with ER Section 5.13. The access arrangements for this item will be recorded as part of the Access Strategy Tracker which is currently being developed by Brookfield and Mercury. (See Supervisor's Communication General Matters / Other Instructions (CI 13.1) No 126).

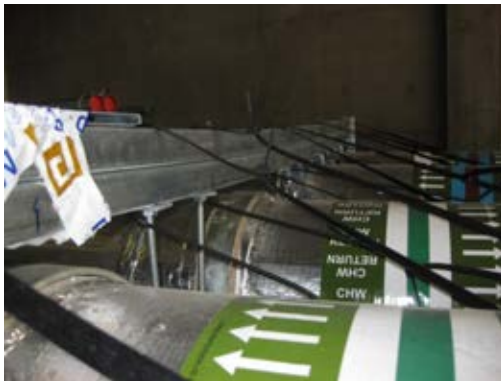
We noted that the unistrut pipework support had visibly bent under weight of pre-fabricated pipework module in Plant room PR31 adjacent sub-station 2A.

This will become more pronounced when pipework is filled with water. We asked Brookfield to confirm that the structural supports utilised are compliant with the design intent. Brookfield has replied that the frames are suitable for their intended function and have provided calculations. They have informed us that this appears to have been mechanical damage and not deformation due to weight of the services. We have not found any fitted modules with bowed frames in this manner. Further investigations are being carried out by Brookfield and Mercury. (See Supervisor's Communication General Matters / Other Instructions (CI 13.1) No 135).

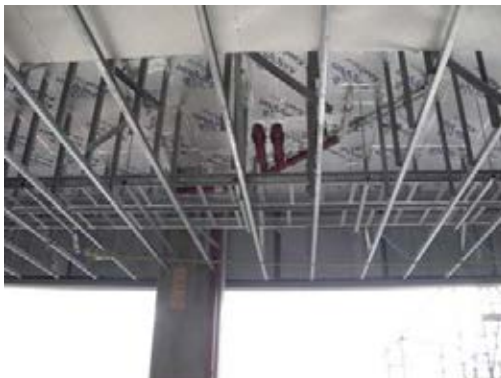
The waste pipes are not insulated to the external soffit area on the underside of Level 4 Zone H and on the underside of Level 1 above the entrance to Accident and Emergency. We have asked Brookfield if insulation is required to these pipes. This Notification has been forwarded to the relative floor manager and is being investigated. (See Supervisor's Communication General Matters / Other Instructions (CI 13.1) No 156).

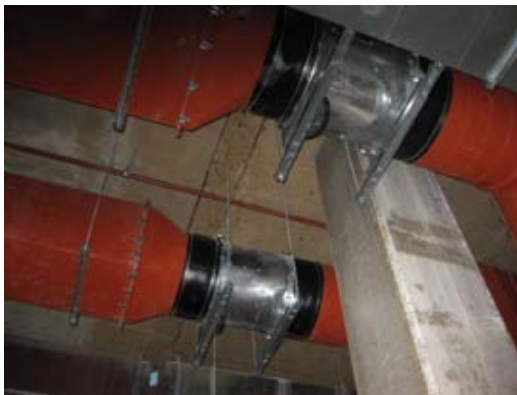
We asked Brookfield to confirm that the fire rating of the flexible connections and supporting system in Plant room PR31 is equivalent to the overall system requirements. The fan is located adjacent to atrium at the west side of building. We have also asked them to confirm fire rating of fans (observed as non-bifurcated type). ZBP has confirmed to Brookfield that fans require to be fire rated and are at technical submittal stage. (See Supervisor's Communication General Matters / Other Instructions (CI 13.1) No 133).

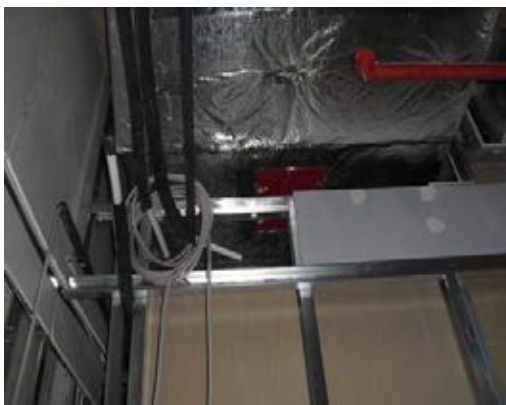
During our inspections on Level 2 we noted that the duct inspection hatch is located above the partition dividing rooms DMW-037 & 038. We have received confirmation that the duct access hatch will be repositioned to allow access to the duct. (See Supervisor's Communication General Matters / Other Instructions (CI 13.1) No 150).

We have asked Brookfield to confirm when the hatch will be accessible.

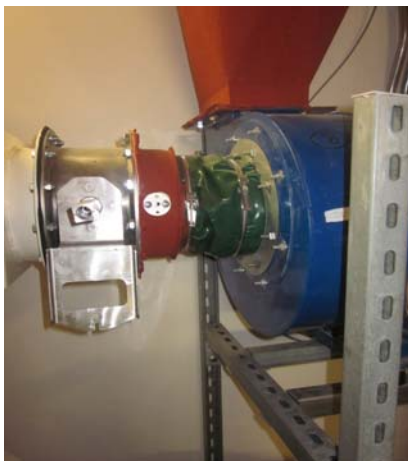
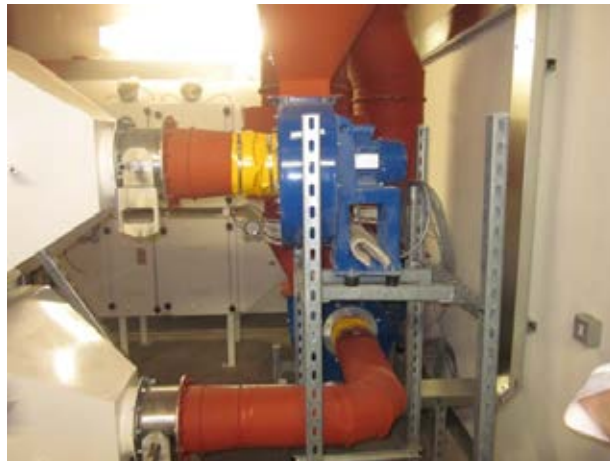
There are multiple types of Isolation ductwork flexible connections used in Plant Room 21, all secured with single jubilee clip at either end. We have asked Brookfield to confirm if these provide an adequate seal against air leakage especially to spiral ductwork?

We have asked Brookfield to confirm if fire integrity is maintained with all types of flexible connection used? This Notification has been forwarded to the relative floor manager and is being investigated. (See Supervisor's Communication General Matters / Other Instructions (CI 13.1) No 155).

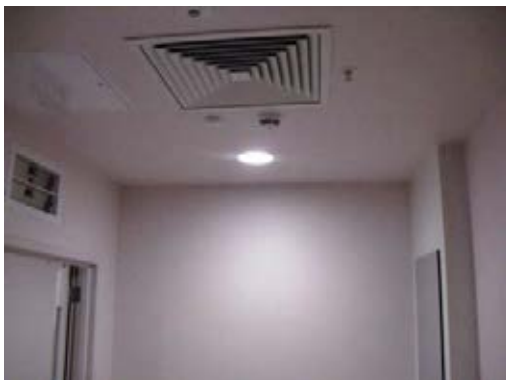
The smoke detector within the lobby on Level 1 Room CCW-049 is within 300mm of the supply grille. We asked Brookfield to confirm when this has been repositioned to the minimum distance of 1metre. (See Supervisor's Communication General Matters / Other Instructions (CI 13.1) No 146).

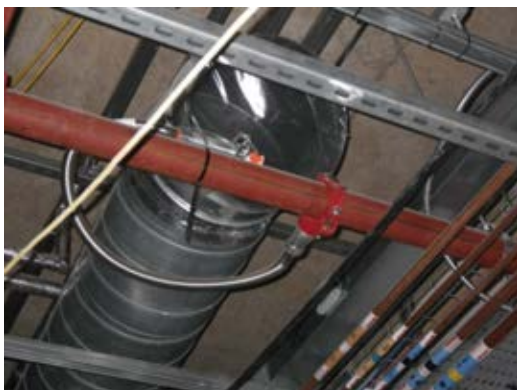
We have asked Brookfield to confirm that the fire damper actuator highlights in room EMC-011 can be accessed on completion of the cold water and ceiling installation. Brookfield has confirmed that the damper actuator will be accessible. The access arrangements for this item will be recorded as part of the Access Strategy Tracker which is being developed. (See Supervisor's Communication General Matters / Other Instructions (CI 13.1) No 92).

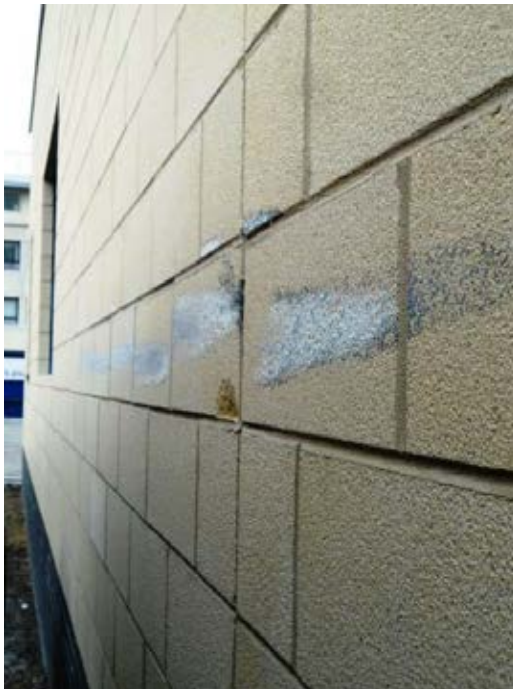
Damaged caused by plant

We have reported since April that the quality and standard of workmanship of the blockwork at the curve of the south west elevations was not to a good industrial standard. There is a variation in shade of the pointing mortar. The pointing is also to a poor quality and the perpends are of variable sizes. There also appears to be a colour difference to some of the blocks. Brookfield has highlighted some of these problems and is subject to an NCR. In addition to our observations about the poor workmanship there are also specific additional damaged blockwork.

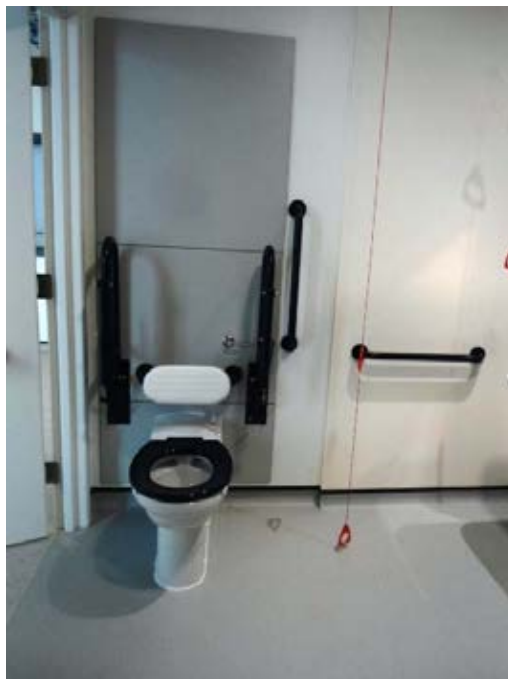
With the exception of room CCU-065 on level 1 1-521 all of the pull cords next to the WC bowls in the en-suites are not in their correct positions. We have asked Brookfield to confirm when they have been relocated. Brookfield has instructed Mercury Floor / Package managers to investigate and advise. (See Supervisor's Communication General Matters / Other Instructions (CI 13.1) No 140).

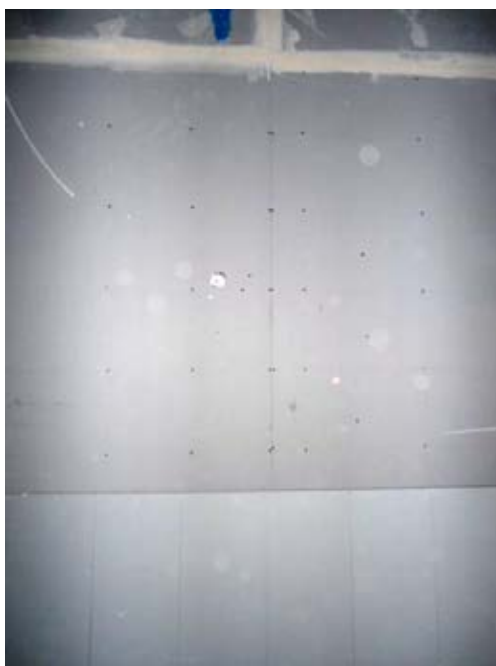
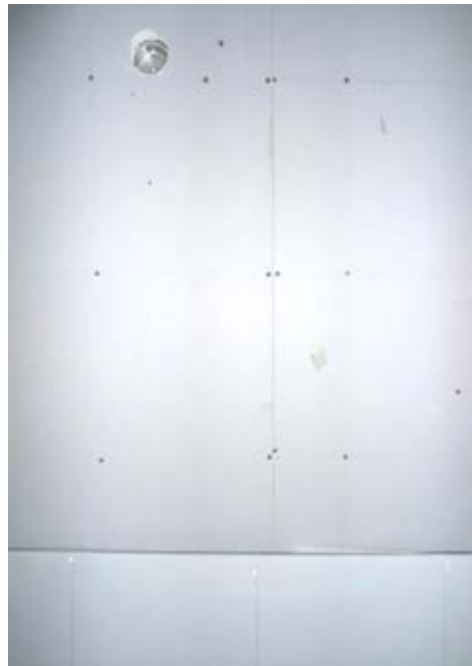
There are partitions on Level 0 Area 529 which have screw fixings that have been fixed too close to the edge of the board. The Knauf/NBS Specification states that screws to be not less than 10mm from edge of board and this is not being achieved in many locations. Brookfield has confirmed that this has been raised at a progress meeting with Astins. The Sub Contractor is currently seeking information from Knauf on this issue. When Brookfield has feedback from Astins they will issue a further response. Brookfield has confirmed however at this stage the integrity and fixing of the boards should not be compromised. (See Supervisor's Communication General Matters / Other Instructions (CI 13.1) No 51).

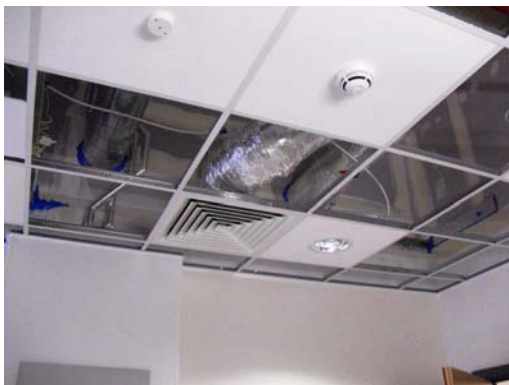
We noted that some smoke detectors were too near to supply grilles in all rooms in area 0-528 with the exception of rooms AAW-260, AAW-263 & AAW-366 which were locked at the time of the inspection. The smoke detectors are recommended to be no less than 1000mm from the supply grille in accordance with BS5839-1:2002+A2: 2008 Clause 22.3 Sub Clause (M). We have received confirmation that this system is designed to this standard.

The recommendation is that any detector sighted next to a forced air inlet should be 1000mm away from the grille unit. At present Scotshield have installed detectors in uniformed positions throughout the project with a measured distance of approximately > 950mm away from ceiling grilles.

In terms of the short fall of approximately 50mm, they have confirmed that this will have no detrimental effect on how the system operates. The technologies used within present day systems are more advanced to monitor all situations therefore reducing the level of false alarms created by previous developed systems. This may require to be recorded as a minor derogation. (See Supervisor's Communication General Matters / Other Instructions (CI 13.1) No 59).

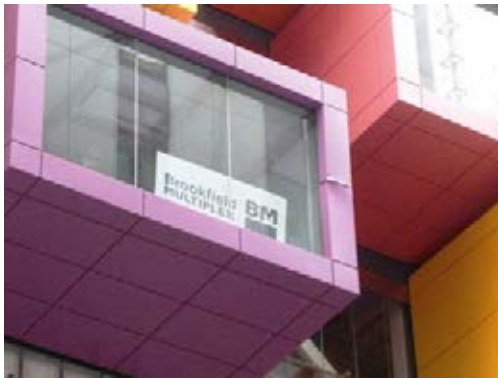
The Pod on the North East corner of the 4th floor Atrium Bridge has sustained damage. We have asked Brookfield to confirm when this has been addressed. (See Supervisor's Communication General Matters / Other Instructions (CI 13.1) No 60).

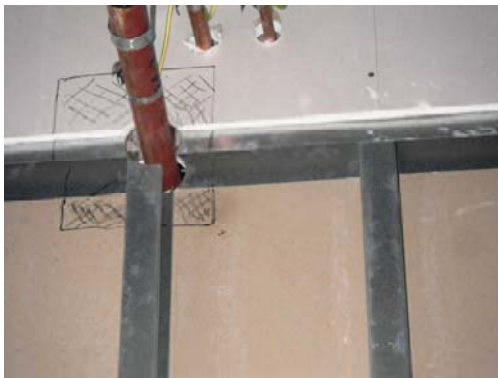
The partition in Room ARU-034 on Level 2 has been cut to allow the sprinkler pipe to pass between rooms resulting in the partition being weakened. Brookfield has passed this to Astins to investigate. (See Supervisor's Communication General Matters / Other Instructions (CI 13.1) No 63).

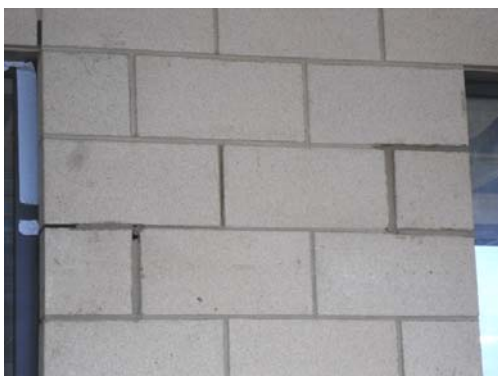
The quality of the workmanship to the blockwork on the West Facing Elevation is poor and requires to be addressed. The widths of perpend varying at various locations on this elevation. This is particularly evident between the windows on the right hand side of the entrance to A&E. See photo below. We have asked Brookfield to confirm when this issue has been addressed. (See Supervisor's Communication General Matters / Other Instructions (CI 13.1) No 64).

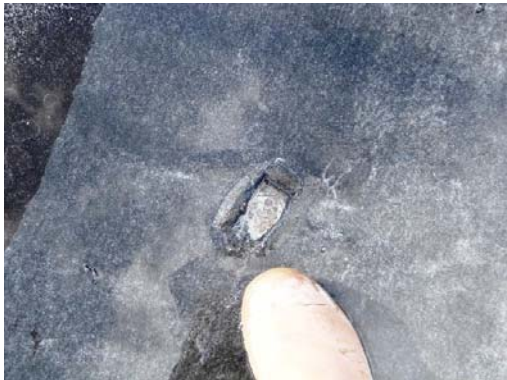
We noted that there were indentations / penetrations through the protective layer of the Level 12 roof and we have asked Brookfield to confirm when these have been addressed to allow for a further inspection. (See Supervisor's notification of Defects (CI 42.2) No 61). Location 1.

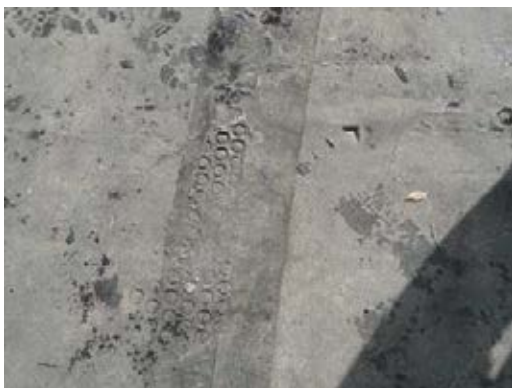
We noted that there were indentations/penetrations through the protective layer of the Level 12 roof and we have asked Brookfield to confirm when these have been addressed to allow for a further inspection. (See Supervisor's notification of Defects (CI 42.2) No 62). Location 2.

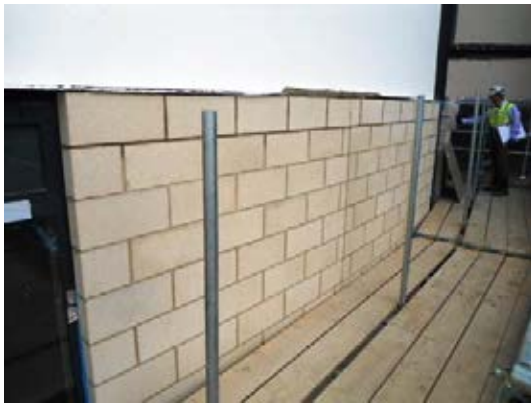
Blockwork at the Children's Hospital.

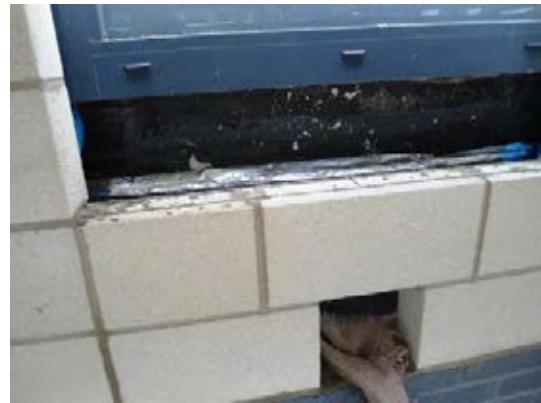
Reinforcing at window.

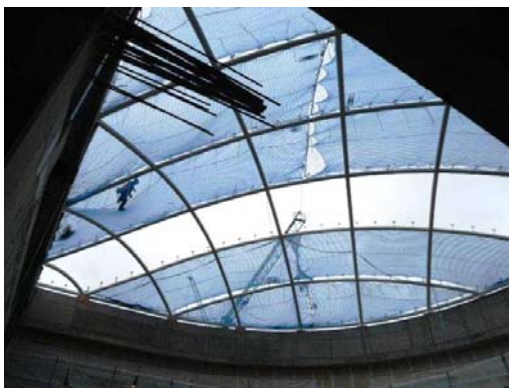
The Main Atrium roof is nearing completion.

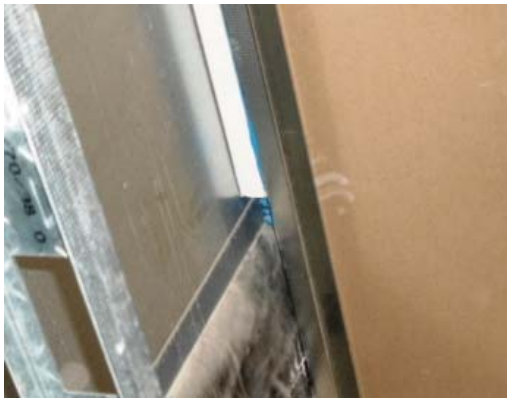
An 85 point check was carried out to a partition in the Children's Hospital which has a 47db rating formed on Level 0 Area 1-515 in rooms OPD-769 and 133. The partition had been constructed in accordance with the specification. A check was also carried out to the junction with the external wall and the partition which was full insulated.

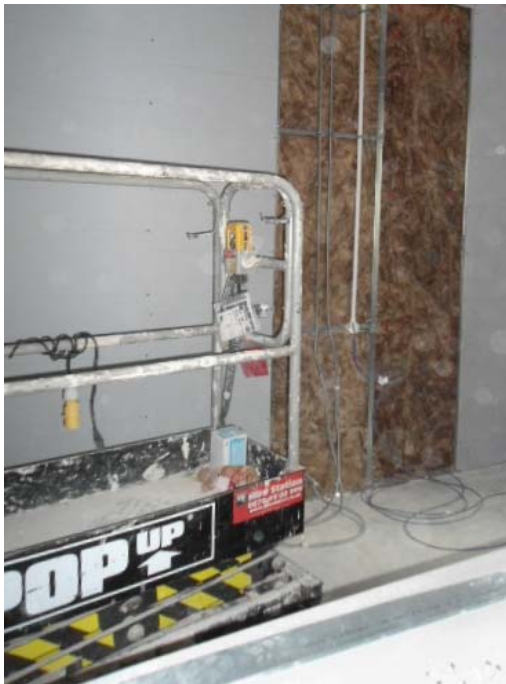
Insulation in partition.

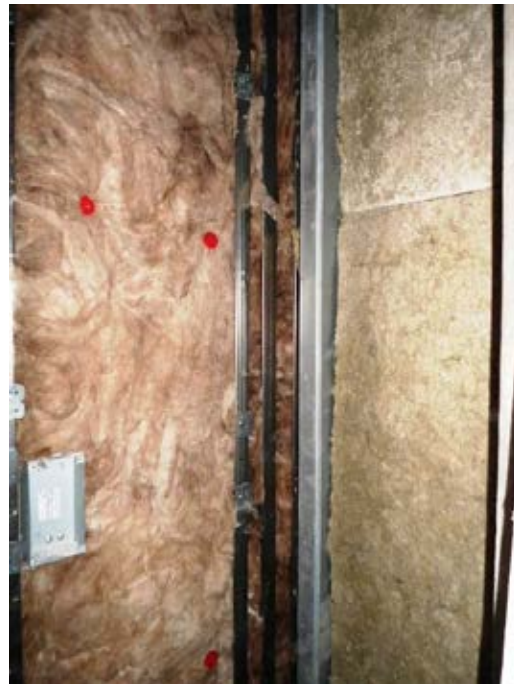
Junction of partition with external wall

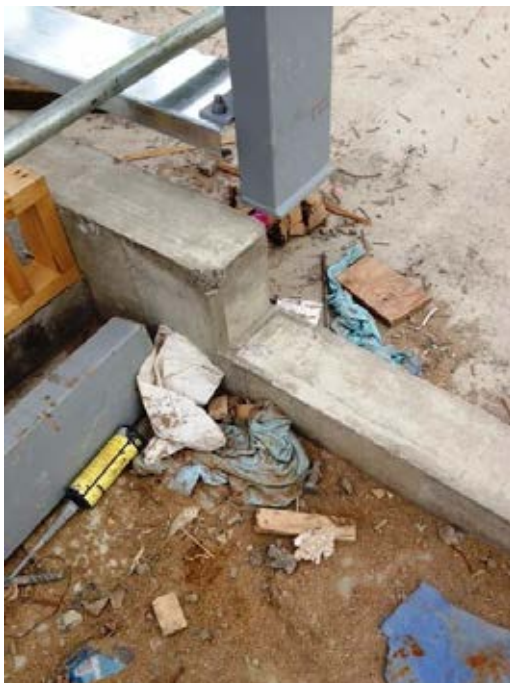
Two internal RHS columns in the Children's Hospital Zone B appear to be held up by adjoining steelwork. Brookfield has informed us that the final detail is a connection to concrete. The concrete works and subsequent bolting up will be undertaken prior to the installation of any cladding. The fitting of additional brackets has been agreed by WSP and we were informed that this would be completed by Monday 19th August. It was our intention to inspect on completion, however the work is still not complete. (See Supervisor's Communication General Matters / Other Instructions (CI 13.1) No 118).

The areas of steelwork in the Children's Hospital Zone B had significant paint damage is now completed and a joint inspection between Brookfield and Capita is to be arranged. (See Supervisor's Communication General Matters / Other Instructions (CI 13.1) No 119).

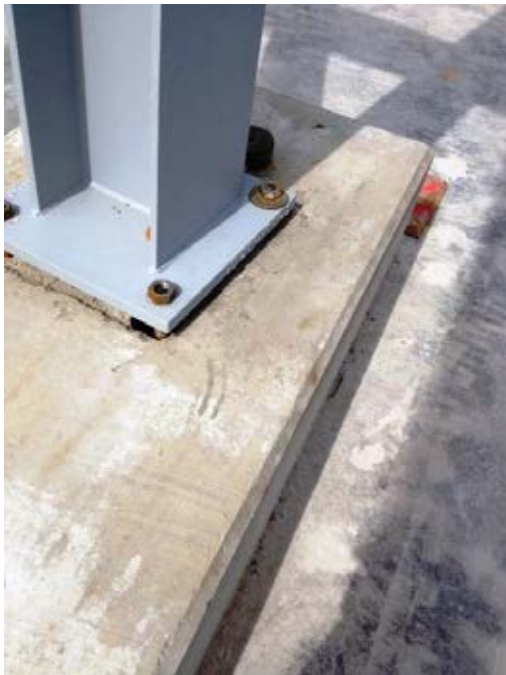
We asked Brookfield to provide technical solutions to various situations on the structural steelwork to the Children's roof where base plates are (floating), edge distances are minimal or miss the concrete base. Cladding rails also prevented HD bolt fixing. WSP has provided a detailed sketch to show remedial work to plinth. We shall inspect this on completion. (See Supervisor's Communication General Matters / Other Instructions (CI 13.1) No 141).

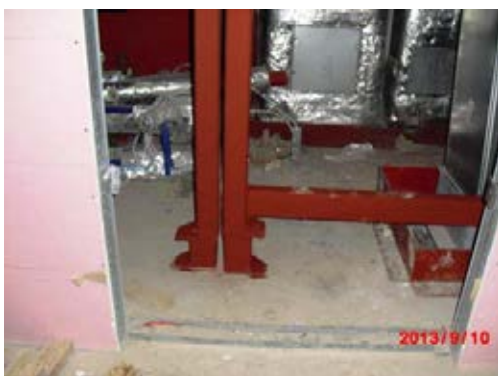
The steel framework in riser on Level 0 ZF Riser M30 has had the legs extended immediately in front of the entrance door. There are other legs which have not been extended yet and we asked Brookfield to confirm when the other legs will be extended. This work is in progress and they will advise when complete. (See Supervisor's Communication General Matters / Other Instructions (CI 13.1) No 162).

Extended legs
