**Bundle of documents for Oral hearings
commencing from 13 May 2025 in relation
to the Queen Elizabeth University Hospital
and the Royal Hospital for Children,
Glasgow**

**Bundle 33
NEC3 Supervisor's Reports and Project
Supervisors Interface Action Notes**

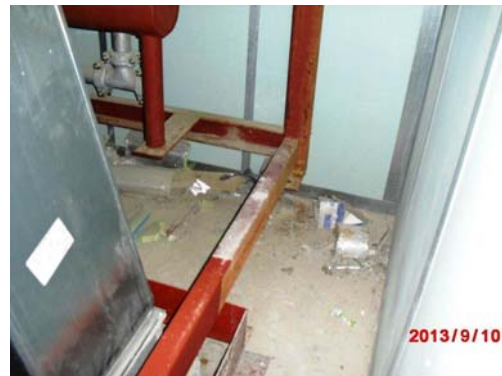
Leg still to be extended.

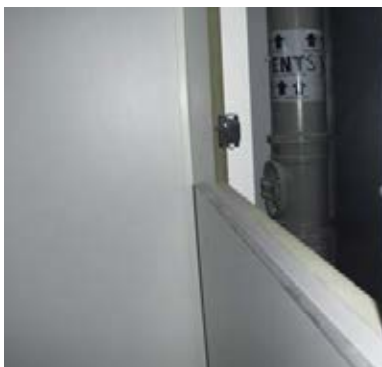
Rodding eye inspection cover facing wrong direction for access. We have asked Brookfield to confirm when this has to be addressed to allow access from behind removable panel within toilet MDU-011. (See Supervisor's Communication General Matters / Other Instructions (CI 13.1) No 164).

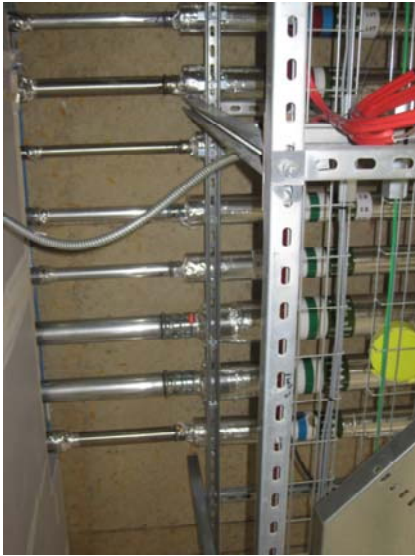
Level 2 Zone H. Pipework connections above line of unistrut. Access appears difficult. We have asked Brookfield to confirm that future access will be available.

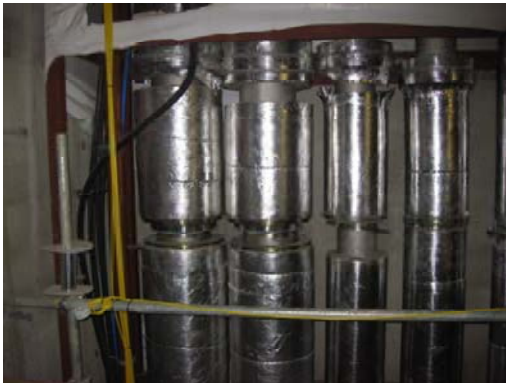
Level 2 / Zone K. Current access to install chilled water riser pipework appears difficult. We have asked Brookfield to confirm that future access will be available once the walls are constructed.

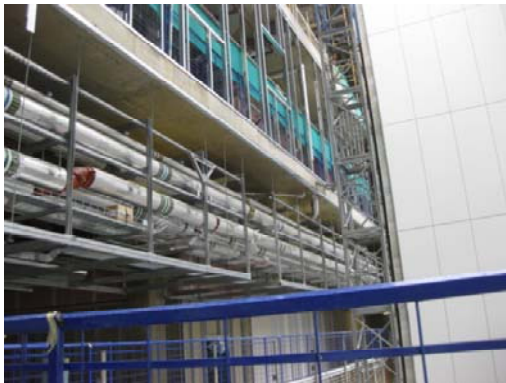
Level 3 / Zone H. Pipe Racks in area shown below have multiple levels of pipe work. We have asked Brookfield to confirm that future access will be available. Brookfield confirmed that access to the 3 areas identified will be accessible for FM in compliance with ER Section 5.13. The access arrangements for this item will be recorded as part of the Access Strategy Tracker which is currently being developed by Brookfield and Mercury. (See Supervisor's Communication General Matters / Other Instructions (CI 13.1) No 126).

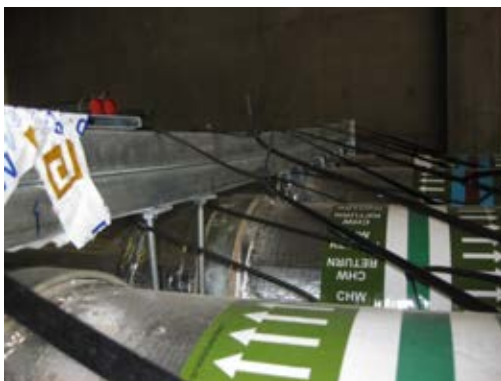
We noted that the unistrut pipework support had visibly bent under weight of pre-fabricated pipework module in Plant room PR31 adjacent sub-station 2A. This will become more pronounced when pipework is filled with water. We asked Brookfield to confirm that the structural supports utilised are compliant with the design intent. Brookfield has replied that the frames are suitable for their intended function and have provided calculations. They have informed us that this appears to have been mechanical damage and not deformation due to weight of the services. We have not found any fitted modules with bowed frames in this manner. Further investigations are being carried out by Brookfield and Mercury. (See Supervisor's Communication General Matters / Other Instructions (CI 13.1) No 135).

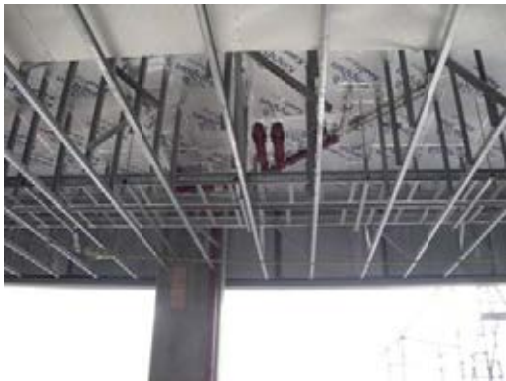
The waste pipes are uninsulated to the external soffit area on the underside of Level 4 Zone H and on the underside of Level 1 above the entrance to Accident and Emergency. We have asked Brookfield if insulation is required to these pipes. This Notification has been forwarded to the relative floor manager and is being investigated. (See Supervisor's Communication General Matters / Other Instructions (CI 13.1) No 156).

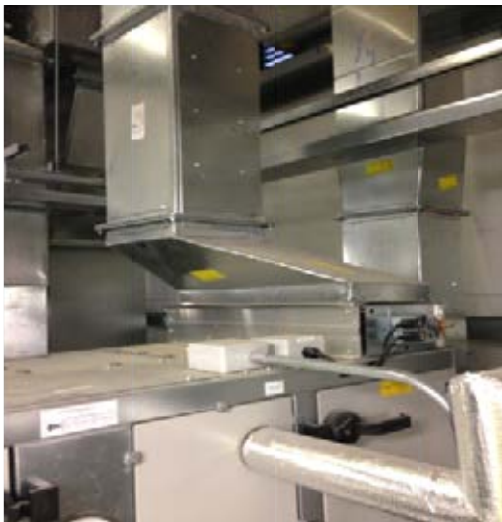
We noted that the air handling unit 21AHU16 supply duct transition does not appear to comply with HVAC DW144 clause 11.6 & 11.7 which could result in high pressure loss.

Brookfield has confirmed that ductwork is not in compliance to drawing/specification and will be replaced. However we await the design philosophy in relation to the proposed remedial measures. (See Supervisor's Communication General Matters / Other Instructions (CI 13.1) No 121).

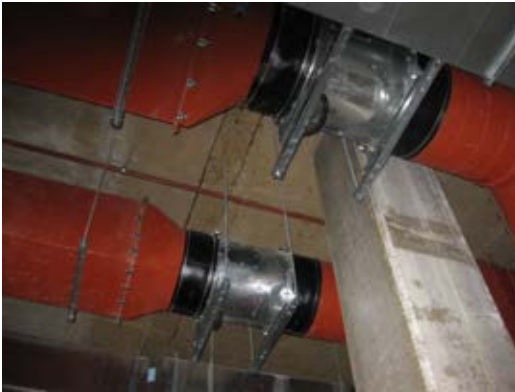
We asked Brookfield to confirm that the fire rating of the flexible connections and supporting system in Plant room PR31 is equivalent to the overall system requirements. The fan is located adjacent to atrium at the west side of building. We have also asked them to confirm fire rating of fans (observed as non-bifurcated type). ZBP has confirmed to Brookfield that fans require to be fire rated and are at technical submittal stage. (See Supervisor's Communication General Matters / Other Instructions (CI 13.1) No 133).

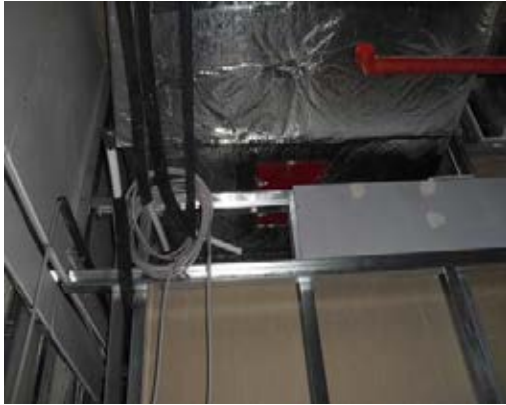
During our inspections on Level 2 we noted that the duct inspection hatch is located above the partition dividing rooms DMW-037 & 038. We have received confirmation

that the duct access hatch will be repositioned to allow access to the duct. We have asked Brookfield to confirm when the hatch will be accessible. (See Supervisor's Communication General Matters / Other Instructions (CI 13.1) No 150).

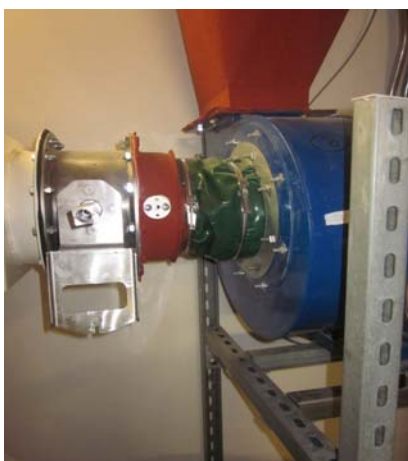
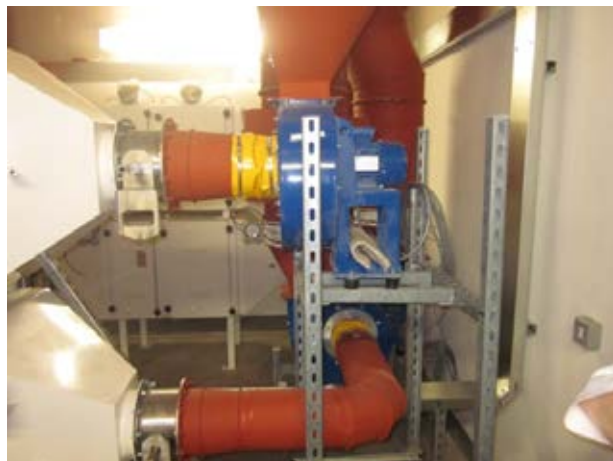
There are multiple types of Isolation ductwork flexible connections used in Plant Room 21, all secured with single jubilee clip at either end. We have asked Brookfield to confirm if these provide an adequate seal against air leakage especially to spiral ductwork.

We have asked Brookfield to confirm if fire integrity is maintained with all types of flexible connection used? This Notification has been forwarded to the relative floor manager and is being investigated. (See Supervisor's Communication General Matters / Other Instructions (CI 13.1) No 155).

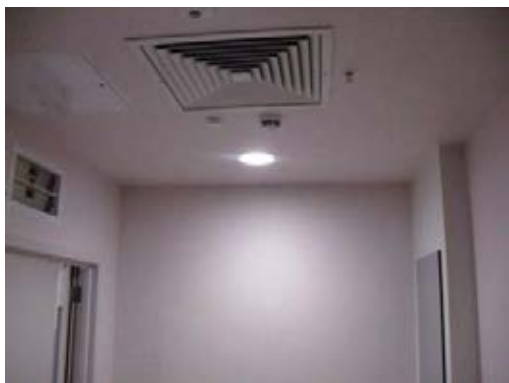
The smoke detector within the lobby on Level 1 Room CCW-049 is within 300mm of the supply grille. We asked Brookfield to confirm when this has been repositioned to the minimum distance of 1metre. (See Supervisor's Communication General Matters / Other Instructions (CI 13.1) No 146).

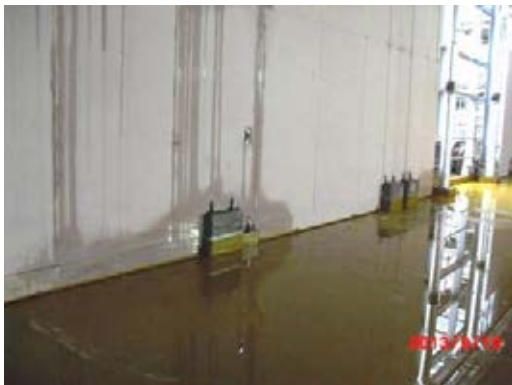
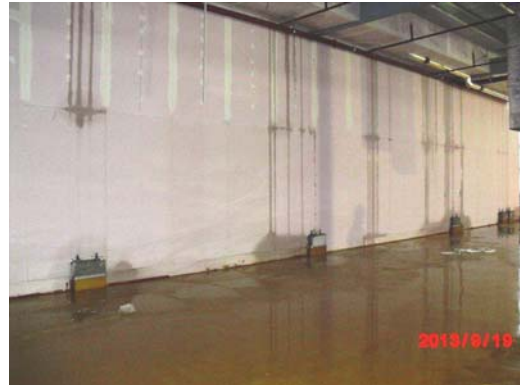
Water damaged boards.

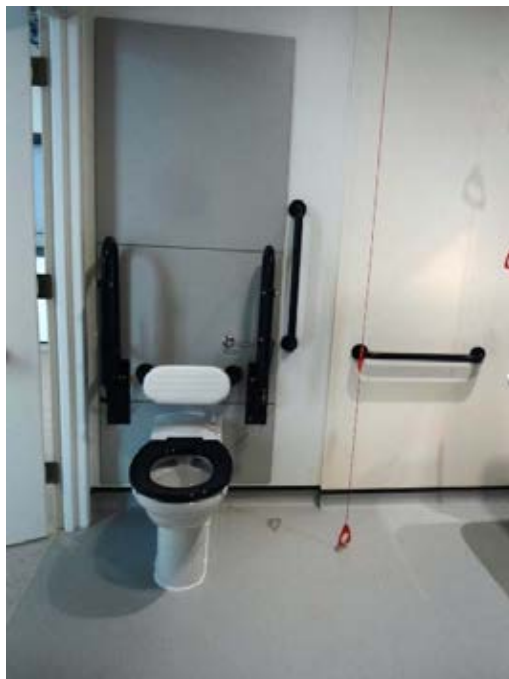
With the exception of room CCU-065 on level 1 1-521 all of the pull cords next to the WC bowls in the en-suites are not in their correct positions. We have asked Brookfield to confirm when they have been relocated. Brookfield has instructed Mercury Floor/Package managers to investigate and advise. (See Supervisor's Communication General Matters / Other Instructions (CI 13.1) No 140).

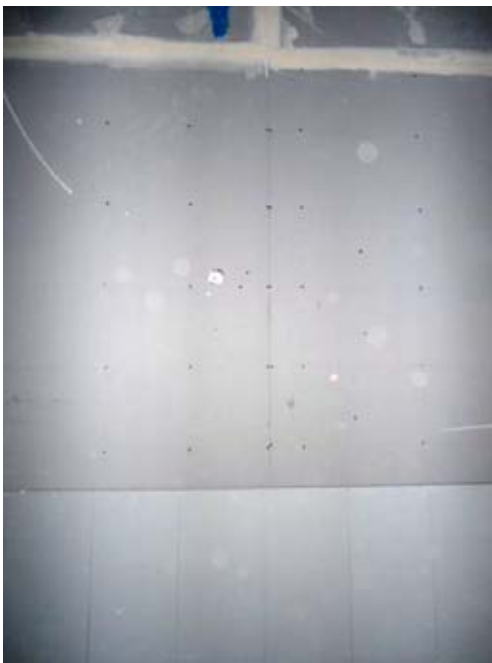
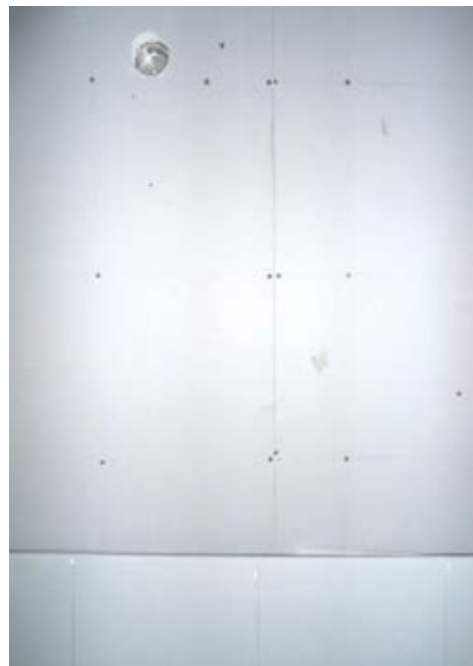
There are partitions on Level 0 Area 529 which have screw fixings that have been fixed too close to the edge of the board. The Knauf/NBS Specification states that screws to be not less than 10mm from edge of board and this is not being achieved in many locations. Brookfield has confirmed that this has been raised at a progress meeting with Astins. The Sub Contractor is currently seeking information from Knauf on this issue. When Brookfield has feedback from Astins they will issue a further response. Brookfield has confirmed however at this stage the integrity and fixing of the boards should not be compromised. (See Supervisor's Communication General Matters / Other Instructions (CI 13.1) No 51).

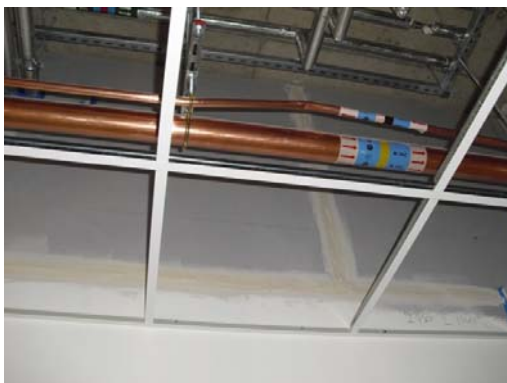
There are damaged medical gas pipes on Level 1 room MDU 012 above the ceiling. We have asked Brookfield to confirm when this has been addressed. (See Supervisor's Communication General Matters / Other Instructions (CI 13.1) No 66).

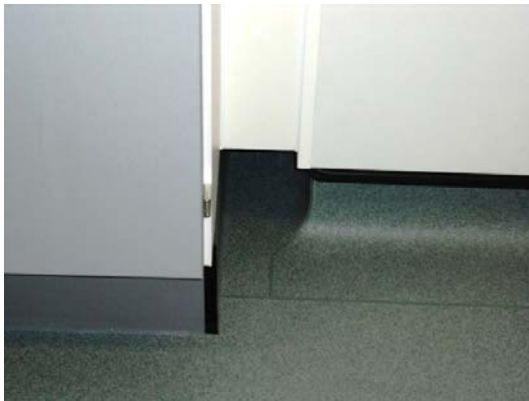
Gap between sink base unit and wall.

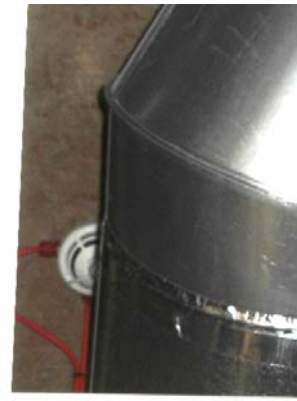
Restricted access to smoke detector.

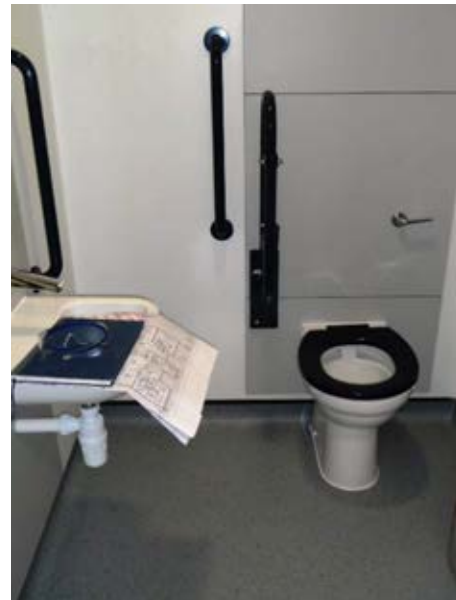
We carried out quality and compliance inspections on Level 0 Areas 0-519 and 0-520. The areas inspected were to a good industrial standard and the defects captured by Brookfield were generally of a minor nature. There were however issues with drop down handrails. One clashed with the wash hand basin and two others were fixed to the IPS boards. There was also one smoke detector which was too close to a vent

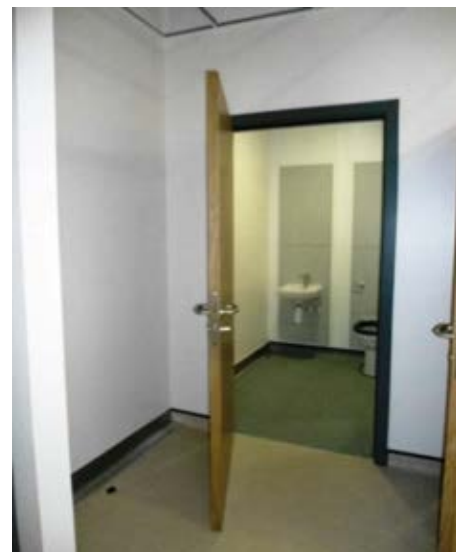
Quality and compliance were carried out on Level 2 Area 2-526. The area inspected was to a good industrial standard with only a few minor defects identified. There was however two doors to toilets which were hung opening in the wrong direction. Brookfield is seeking a contractor's change to maintain the doors in their current position.

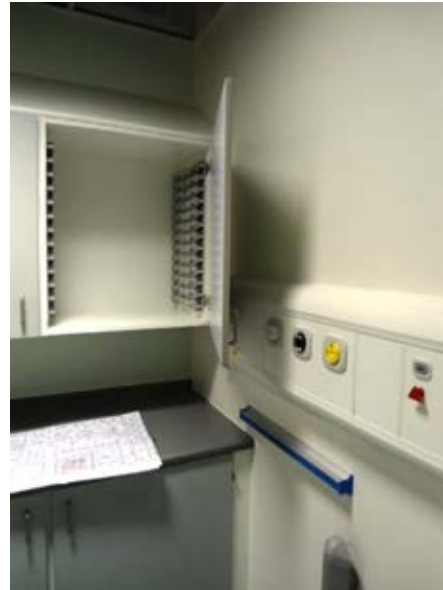
The quality of the finish on Level 0 Area 0-522 was to a high industrial standard with very few defects. However the wall cabinets in the majority of the Generic Assess & Treatment rooms clash with the bed heads.

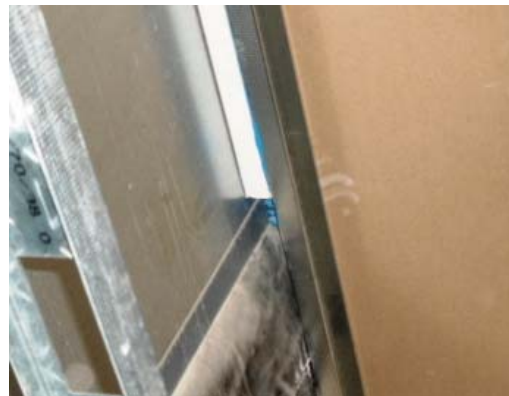
An 85 point inspection of the partition in room RENW-143 on Level 4 Zone E 4-143 and the partition was constructed in accordance with the specification. There was a small step between the concrete upstand and the Unitised Panel which was filled with sealant. This may allow flanking of sound and Brookfield is seeking advice from Nightingales.

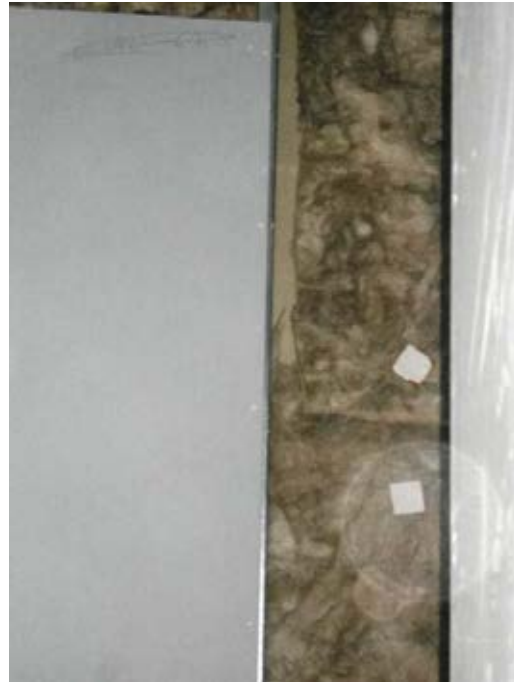
An 85 point check was carried out to a partition in The Tower which has a 47db rating formed on Level 5 Area 5-510 in rooms GEN WC-028. A piece of insulation adjacent the external wall was too narrow resulting in a failure of the acoustic property of the partition.

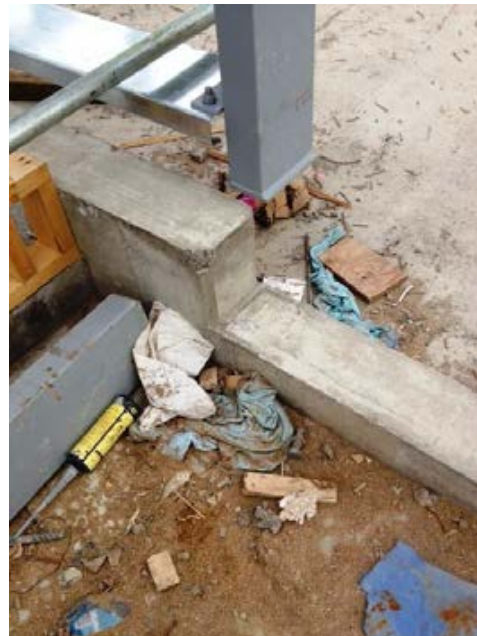
Two internal RHS columns in the Children's Hospital Zone B appear to be held up by adjoining steelwork. Brookfield has informed us that the final detail is a connection to concrete. The concrete works and subsequent bolting up will be undertaken prior to the installation of any cladding. The fitting of additional brackets has been agreed by WSP and we were informed that this would be completed by Monday 19th August. It was our intention to inspect on completion, however the work is still not complete. (See Supervisor's Communication General Matters / Other Instructions (CI 13.1) No 118).

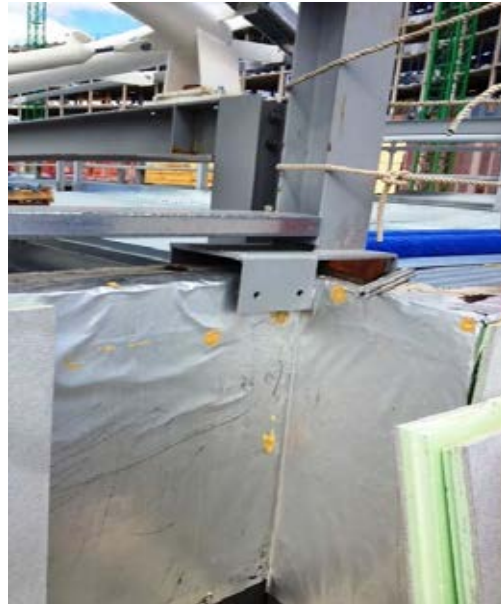
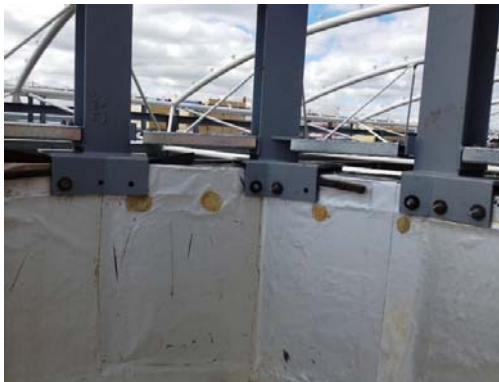
We asked Brookfield to provide proposals to meet the design intent for the Children's Hospital Roof Steelwork Zone A where bolts are missing at the parapet. Brookfield has had discussions with William McColgan WSP during a visit to site. Subsequent to this visit Dunne has provided a detailed sketch which has been approved by WSP. We shall inspect this on completion. Some work has been done in this area and confirmation that it meets the new design and specification intent is awaited. (See Supervisor's Communication General Matters / Other Instructions (CI 13.1) No 128).

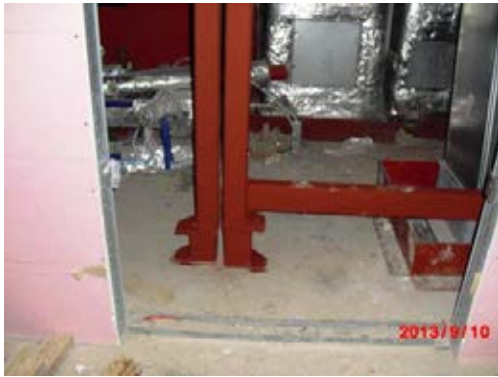
extended yet and we asked Brookfield to confirm when the other legs will be extended. Manufacturer is producing adaptors for the short legs and will be fitted within the next 3 weeks. (See Supervisor's Communication General Matters / Other Instructions (CI 13.1) No 162).

Extended legs

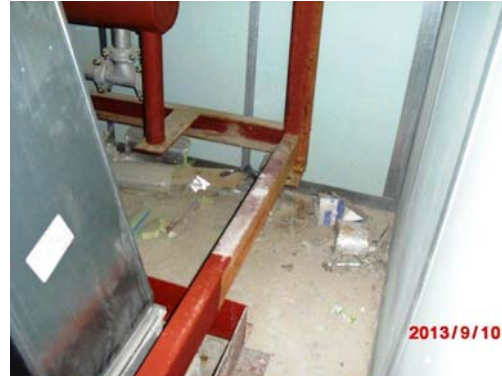
Leg still to be extended.

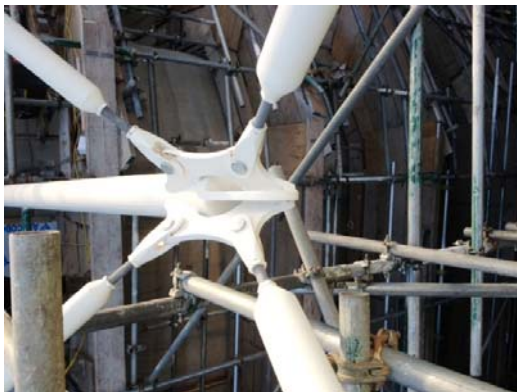
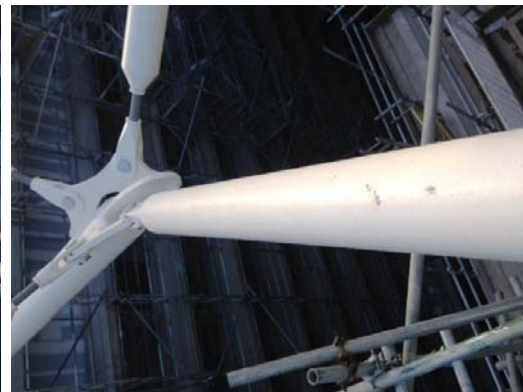
We asked Brookfield to confirm their proposals in respect of attention to rust marks and chipped paintwork to the white roof atrium steelwork. Following a joint inspection on Friday 01/11/13 between ourselves and Brookfield it was agreed that the works had been rectified. However once the scaffold is dropped a further inspection will be carried out from the scaffold below. Supervisor's Communication General Matters / Other Instructions (CI 13.1) No 172 is closed out.

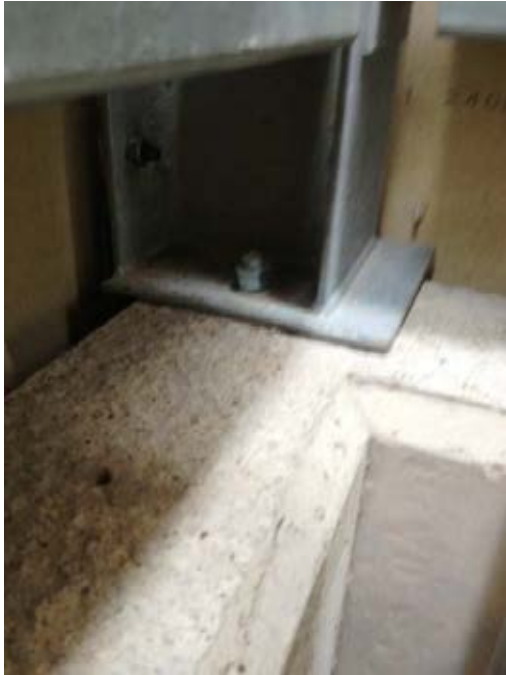
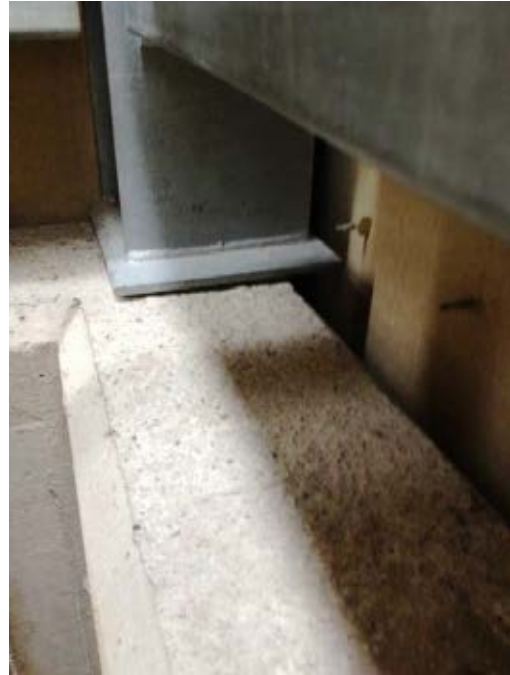
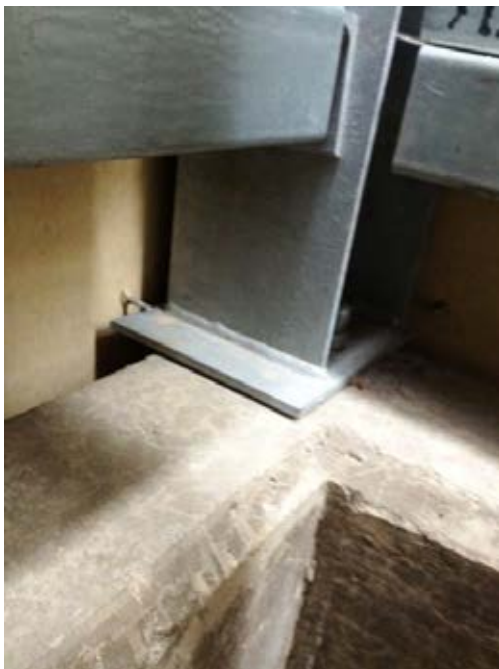
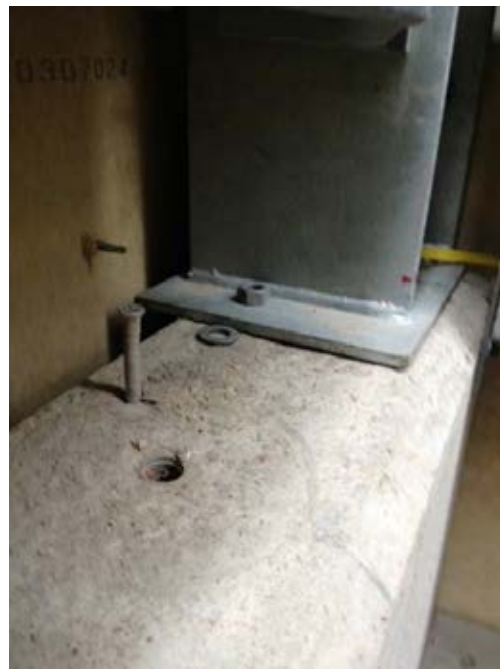
At the southern skylight, Children's 3rd floor podium, there are 4No steel column baseplates which have only 1No bolt connection to the concrete upstand. The position of the other bolt at each of these locations being above the edge chamfer of

the concrete upstand. (For the structure as a whole there are a total of 8No bolts in place but there are 12No bolt holes.)

We asked Brookfield to confirm that this arrangement satisfies the design and specification intent or provide remedial proposals. (The situation is different at the northern skylight where concrete walls extend to the underside of the skylight panels.) A check should also be made on the northern skylight steelwork. (See Supervisor's Communication General Matters / Other Instructions (CI 13.1) No 174).

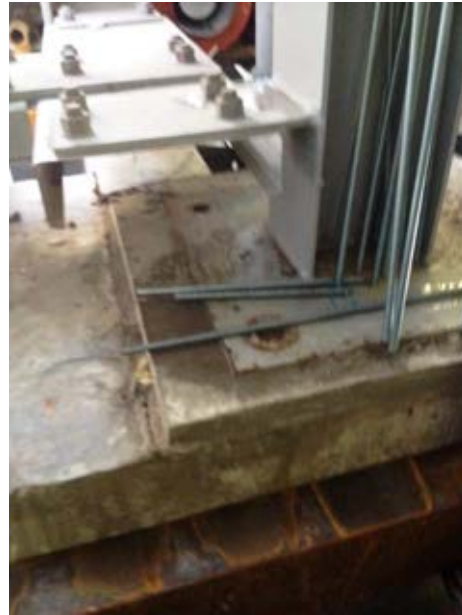
One of the base plates Level 4 Zone B has 2 out of 4 HD bolts either missing or not protruding through the baseplate. We have asked Brookfield to confirm that this satisfies the design and specification intent or provide a remedial solution. (See Supervisor's Communication General Matters / Other Instructions (CI 13.1) No 182).

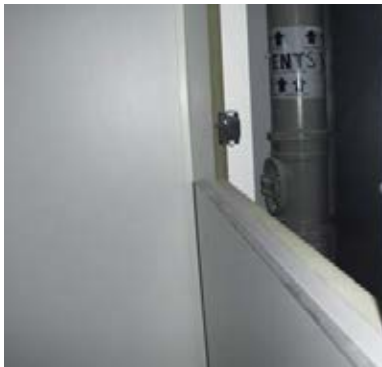
Rodding eye inspection cover facing wrong direction for access. We have asked Brookfield to confirm when this has been addressed to allow access from behind removable panel within toilet MDU-011. This has been rectified and we currently await photographic to confirm this. (See Supervisor's Communication General Matters / Other Instructions (CI 13.1) No 164).

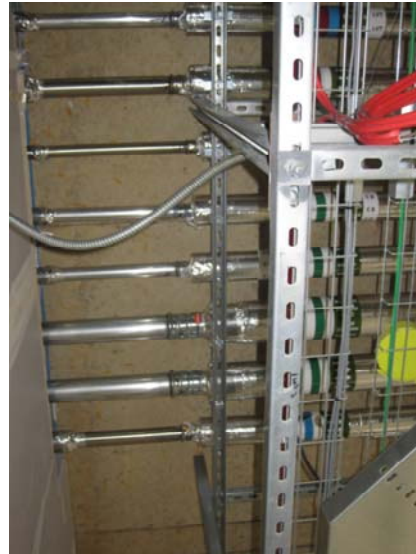
We raised our concerns with Brookfield in relation with the following areas Level 2 Zone H. Pipework connections above line of unistrut. Access appears difficult. We have asked Brookfield to confirm that future access will be available.

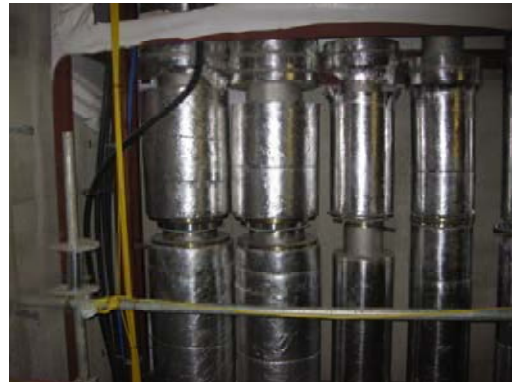
Level 2 / Zone K. Current access to install chilled water riser pipework appears difficult. We have asked Brookfield to confirm that future access will be available once the walls are constructed.

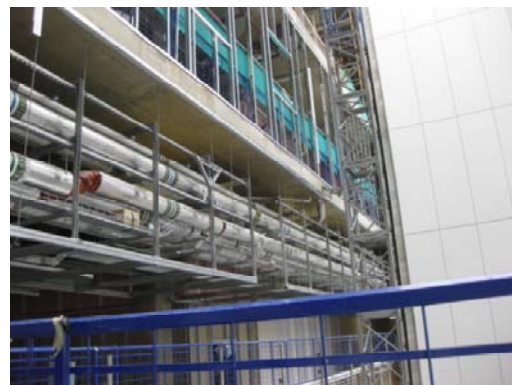
Level 3 / Zone H. Pipe Racks in area shown below have multiple levels of pipe work. We have asked Brookfield to confirm that future access will be available. Brookfield confirmed that access to the 3 areas identified will be accessible for FM in compliance with ER Section 5.13. The access arrangements for this item will be recorded as part of the Access Strategy Tracker which is currently being developed by Brookfield and Mercury. (See Supervisor's Communication General Matters / Other Instructions (CI 13.1) No 126).

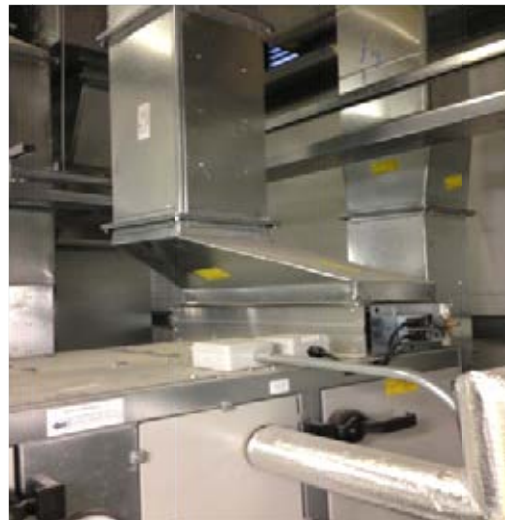
We noted that the air handling unit 21AHU16 supply duct transition does not appear to comply with HVAC DW144 clause 11.6 & 11.7 which could result in high pressure loss.

Brookfield has confirmed that ductwork is not in compliance to drawing/specification and will be replaced. However we await the design philosophy in relation to the proposed remedial measures. (See Supervisor's Communication General Matters / Other Instructions (CI 13.1) No 121).

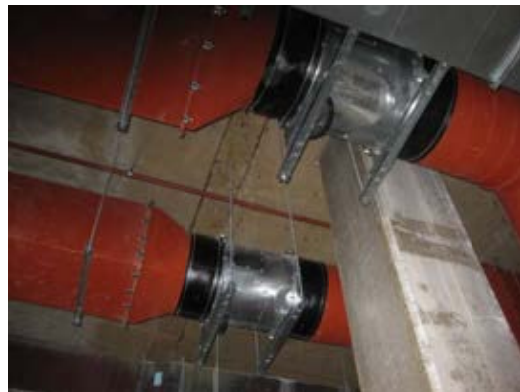
We asked Brookfield to confirm that the fire rating of the flexible connections and supporting system in Plant room PR31 is equivalent to the overall system requirements. The fan is located adjacent to atrium at the west side of building. We have also asked them to confirm fire rating of fans (observed as non-bifurcated type). ZBP has confirmed to Brookfield that fans require to be fire rated and are at technical submittal stage. (See Supervisor's Communication General Matters / Other Instructions (CI 13.1) No 133

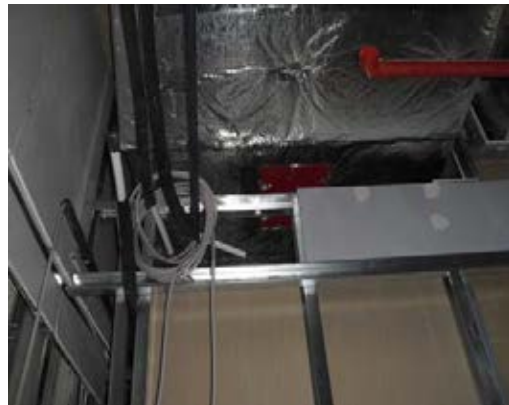
During our inspections on Level 2 we noted that the duct inspection hatch is located above the partition dividing rooms DOPD-037 & 038. We have received confirmation that the duct access hatch will be repositioned to allow access to the duct. We have asked Brookfield to confirm when the hatch will be accessible. (See Supervisor's Communication General Matters / Other Instructions (CI 13.1) No 150)

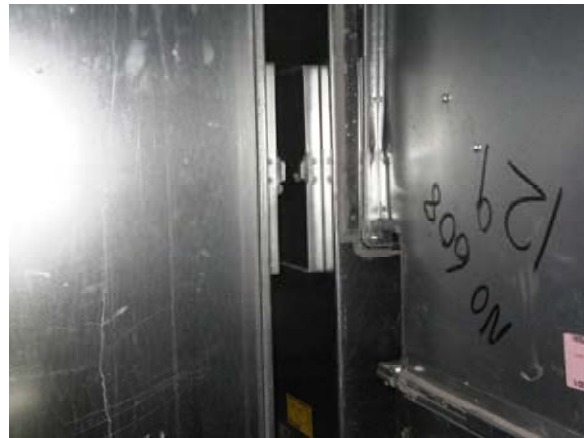
The access hatches in the Plantroom on Level 3 are too close consequently access is not possible. We have asked Brookfield to confirm the remedial measures required to allow access. (See Supervisor's Communication General Matters / Other Instructions (CI 13.1) No 179).

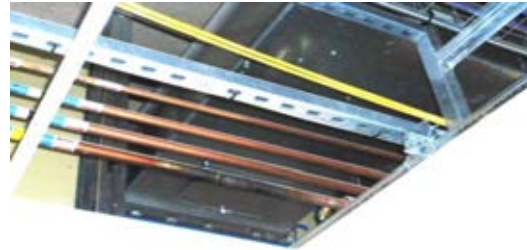
Access to the fire damper between room THE Exit Bay and THE 348 Dirty Utility is restricted. Brookfield to confirm that a new access cleaning hatch has been fitted (not a damper hatch), old hatch will be marked not in use. We will review on site. (See Supervisor's Communication General Matters / Other Instructions (CI 13.1) No 169).

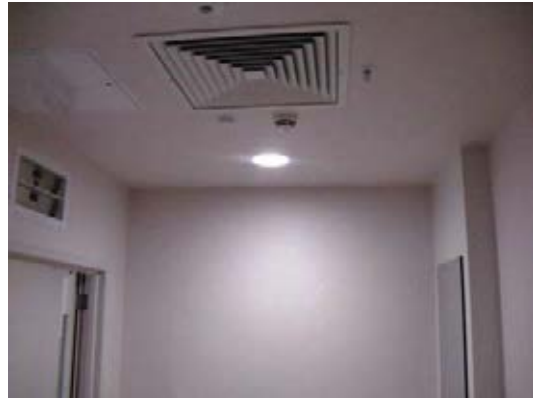
The smoke detector within the lobby on Level 1 Room CCW-049 is within 300mm of the supply grille. We asked Brookfield to confirm when this has been repositioned to the minimum distance of 1metre. Mercury's specialist contractor has confirmed that in terms of BS5839-1 Clause 22.3 Paragraph M minimum spacing cannot be achieved. They state further that given this recommendation and the dimensions of the area in question; along with the finished ceiling layout of third party equipment, they cannot see how you can demonstrate the recommendation without infringing on the minimum distance required to be away from the finished wall surfaces. They have stated that the detector can remain in position as is. We shall review this on site.

(See Supervisor's Communication General Matters / Other Instructions (CI 13.1) No 146)

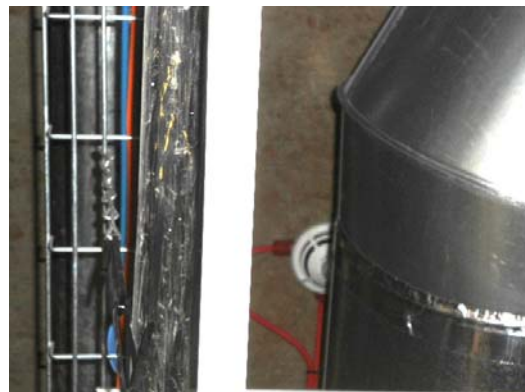
Access to the smoke detector in corridor THE-129 opposite room THE 158 is inaccessible. We have asked Brookfield to confirm the appropriate remedial action to achieve unrestricted access to the smoke detector. Mercury has instructed Scotshield to review this. (See Supervisor's Communication General Matters / Other Instructions (CI 13.1) No 168).

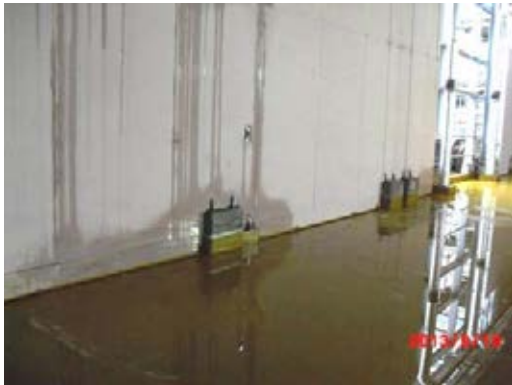
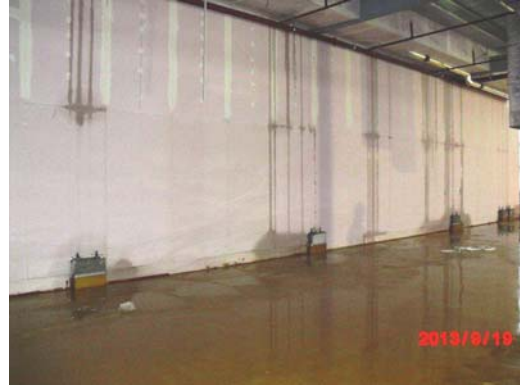
The partition between the east side of the atrium and plant room 41 has been damaged by water ingress. Brookfield to confirm they are aware there has been

some damage, and will replace the boards after they have completed the resin flooring works. (See Supervisor's Communication General Matters / Other Instructions (CI 13.1) No 166).

Water damaged boards.

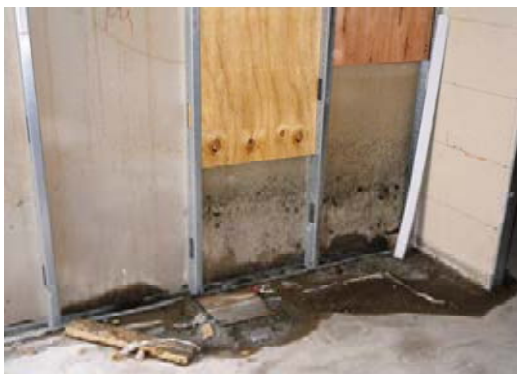
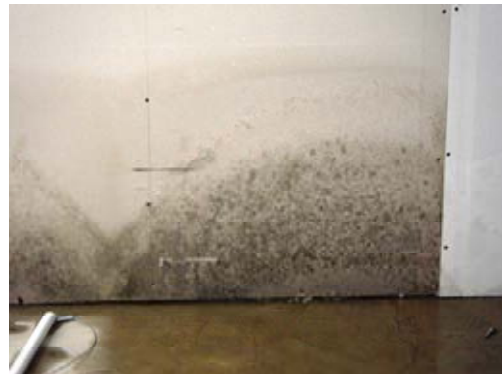
The boards in room SCH-046 Level 2 has water damaged boards. We have asked Brookfield to confirm when the boards are replaced so that a further inspection can be carried out. Brookfield has informed us that Zone C is currently progressing with 1st fix. Their intention would be to complete water damaged boards to this area and below the movement joint between zone B & C at 2nd fix stage. As they are still suffering water ingress from level 4 they have informed us that 2nd fix will be around the 28th October. (See Supervisor's Communication General Matters / Other Instructions (CI 13.1) No 171).

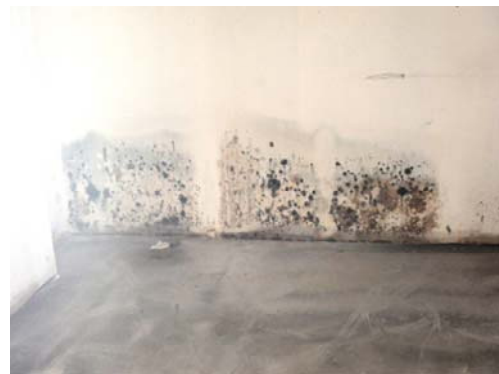
Boards have been damaged by water ingress and we have asked Brookfield to confirm when these have been replaced. (See Supervisor's Communication General Matters / Other Instructions (CI 13.1) No 180).

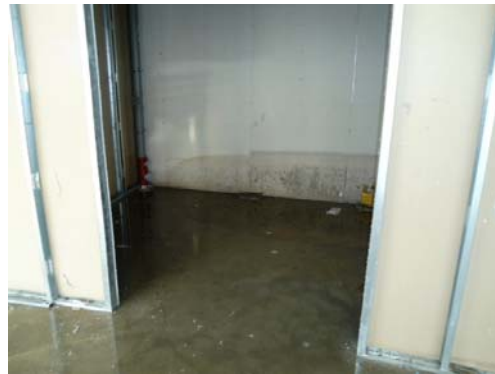
We asked Brookfield to confirm when water damaged boards will be replaced in the rooms between DCFP-010 and DCFP-025 on Level 4. They have confirmed that they will be replaced at second side boarding stage. We will continue to monitor (See Supervisor's Communication General Matters / Other Instructions (CI 13.1) No 181).

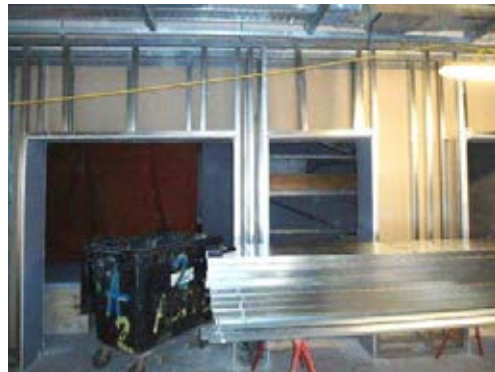
During an inspection of the Atrium Bridge on Level 4 with Brookfield we noted that the lintels to the door openings were not level. This was noted by Brookfield and addressed.

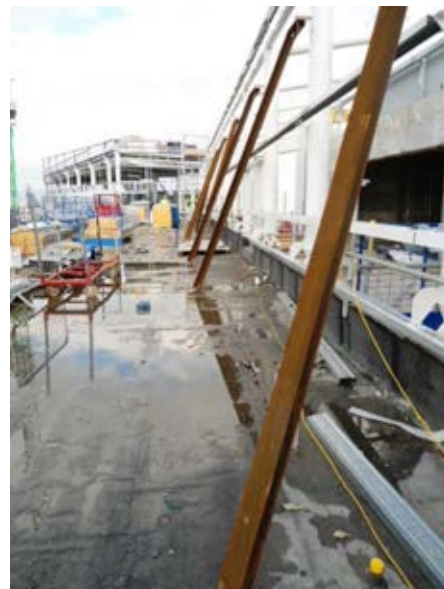
Steel supports are in place to provide temporary supports to the main Atrium Roof. The end of these supports has penetrated the hotmelt roofs on Level 12. Consequently we asked Brookfield to confirm when these areas have been repaired and provide the accompanying QA information. Brookfield has advised that this area will be revisited with remedial works to hot melt. Once remedial works are complete along with the remaining roof slab Prater will carry out the testing and advise accordingly. (See Supervisor's Communication General Matters / Other Instructions (CI 13.1) No 175).

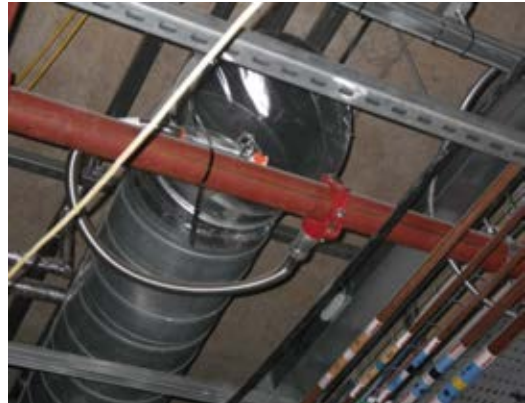
We have asked Brookfield to confirm that the fire damper actuator highlights in room EMC-011 can be accessed on completion of the cold water and ceiling installation. Brookfield has confirmed that the damper actuator will be accessible. The access arrangements for this item will be recorded as part of the Access Strategy Tracker which is being developed. (See Supervisor's Communication General Matters / Other Instructions (CI 13.1) No 92).

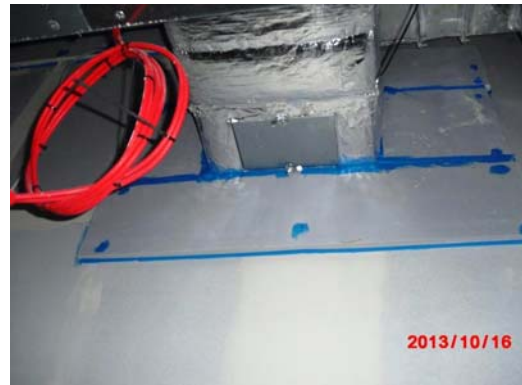
The hatch is too close to the partition between Room RENO-064 and DOPD-037 Level 2, 2-531. Consequently the joint between the hatch and the board is not sealed. We have asked Brookfield to confirm if there is a fire seal between the underside of the trunking and the main partition board. If not Brookfield to confirm if hatch will be moved. This Notification has been forwarded to the relative floor manager and is being investigated. (See Supervisor's Communication General Matters / Other Instructions (CI 13.1) No 177).

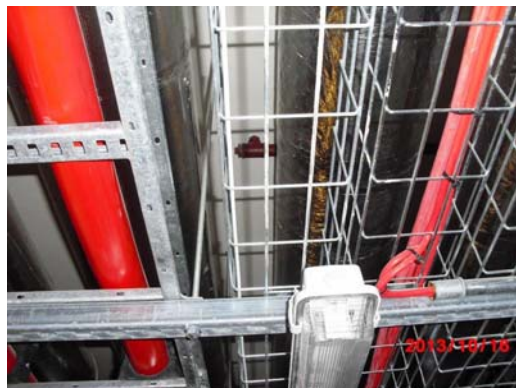
The sprinkler heads on Level 1 Zone K adjacent to Core "A" staircase appear difficult to access for maintenance or replacement. Brookfield confirmed that this is being investigated. (See Supervisor's Communication General Matters / Other Instructions (CI 13.1) No 178.

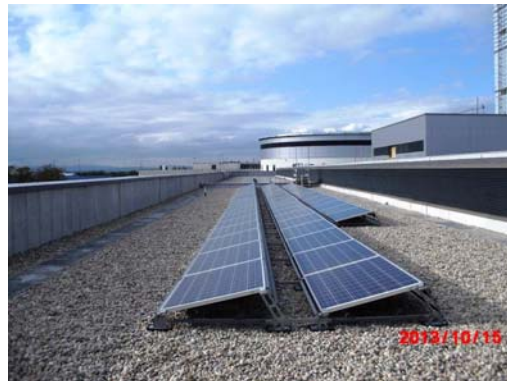
The photovoltaic panels are mounted on frame work with spreader feet which are sitting directly onto ballast. We asked Brookfield to confirm if these require to be fitted on flat slabs. Brookfield confirmed that this was raised at the Mechanical Workshop with Brendan Rooney (Mercury) on 17/10/13. He has come back with information from the PV Design Engineer at Renewables Energy.

They previously responded that there is no issue with having the feet stand on top of gravel or pebbles but would have the manufacturer to confirm this in writing. We have since been informed that the frames are never bolted to the roof nor do they sit on slabs or plinths. They sit directly on the membrane. They have confirmed that pebbles will be removed from underneath feet and units place directly on the membrane.

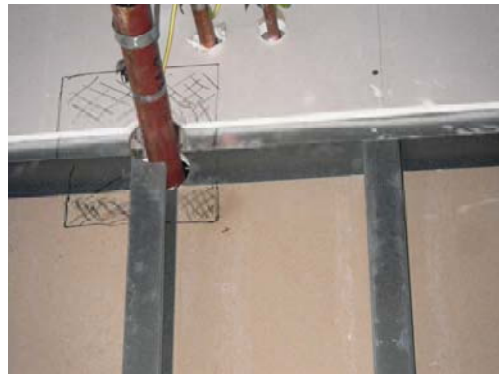
The partition in Room ARU-034 on Level 2 has been cut to allow the sprinkler pipe to pass between rooms resulting in the partition being weakened.

Brookfield has passed this to Astins to investigate. (See Supervisor's Notification of Defect (CI 42.2)) No 63).

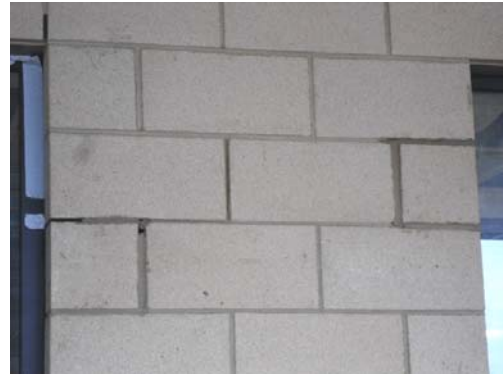
The quality of the workmanship to the blockwork on the West Facing Elevation is poor and requires to be addressed. The widths of perpends varying at various locations on this elevation. This is particularly evident between the windows on the right hand side of the entrance to A&E. See photo. Brookfield has confirmed that the issue has been addressed. We shall carry out a further inspection. (See Supervisor's Communication General Matters / Other Instructions (CI 13.1) No 64).

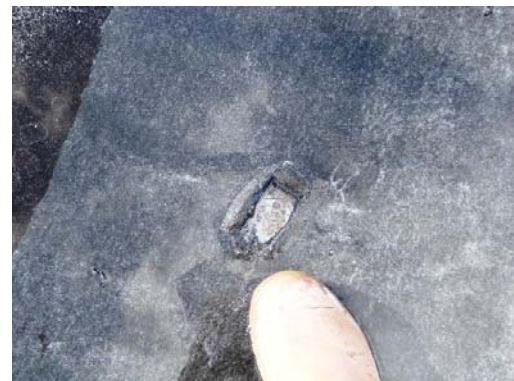
We noted that there were indentations/penetrations through the protective layer of the Level 12 roof and we have asked Brookfield to confirm when these have been addressed to allow for a further inspection. (See Supervisor's Notification of Defect (CI 42.2) No 61).

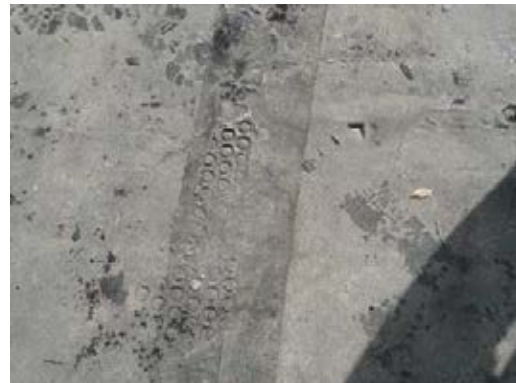
We noted that there were indentations / penetrations through the protective layer of the Level 12 roof and we have asked Brookfield to confirm when these have been addressed to allow for a further inspection. (See Supervisor's Notification of Defects (CI 42.2) No 62).

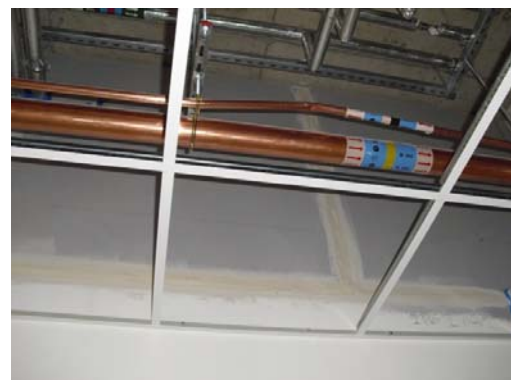
There is a damaged medical gas pipe on Level 1 room MDU 051 above the ceiling. We have asked Brookfield to confirm when this has been addressed. (See Supervisor's Notification of Defect (CI 42.2) No 65).

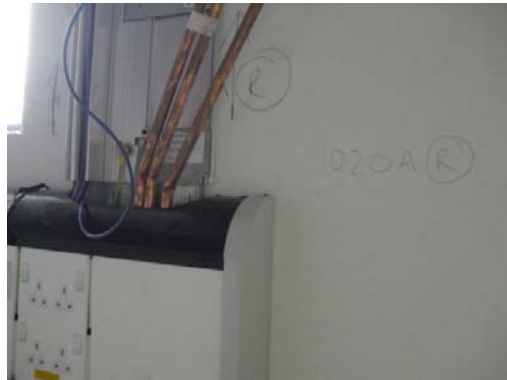
There are damaged medical gas pipes on Level 1 room MDU 012 above the ceiling. We have asked Brookfield to confirm when this has been addressed. (See Supervisor's Notification of Defect (CI 42.2) No 66).

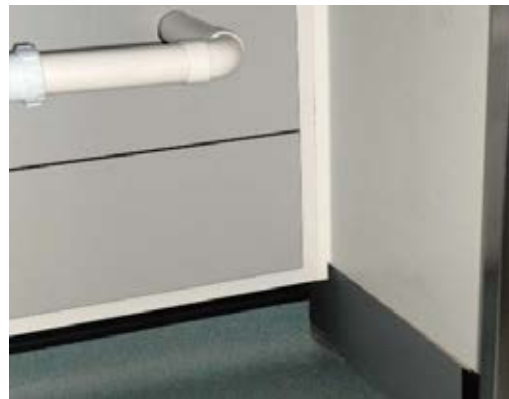
We reported in last month's report that there were gaps between sink bases and walls in Area 2-524. This problem was identified again in Area 2-527. We asked Brookfield to provide a solution to overcome this. Brookfield has reviewed this issue and proposes to infill the gap. This will be achieved by fixing a return to the plinth of the work units, scribing the edge to the contour of the coved skirting and sealing all joints with clear silicon sealant. They have instructed their sub contractor to prepare a sample for inspection and approval. Supervisor's Communication General Matters / Other Instructions (CI 13.1) No 184).

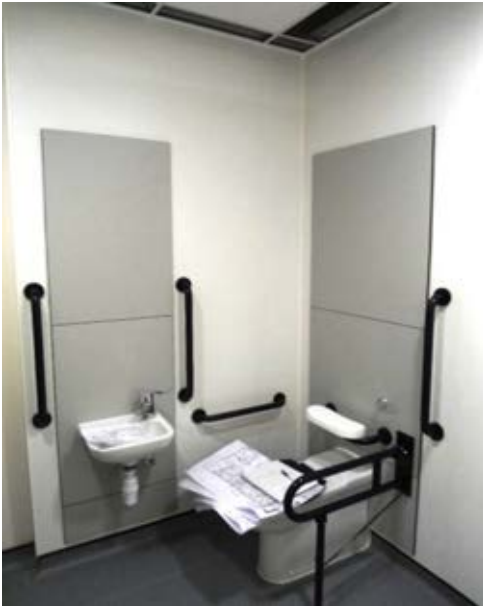
Room AAW-240 a pull cord had not been fitted.

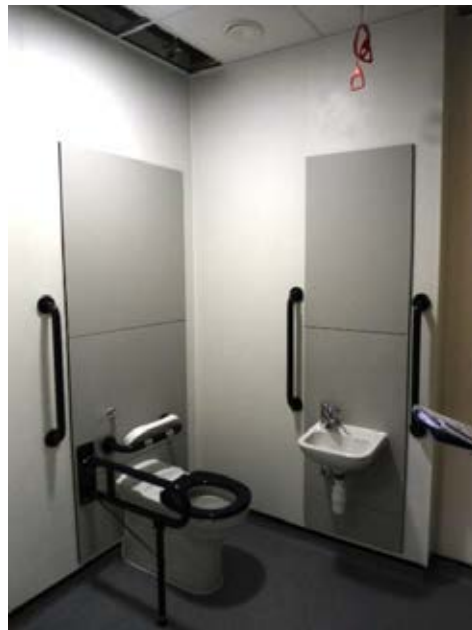
There was a pull cord missing in room THE-028 which Brookfield recorded on to their IDMS.

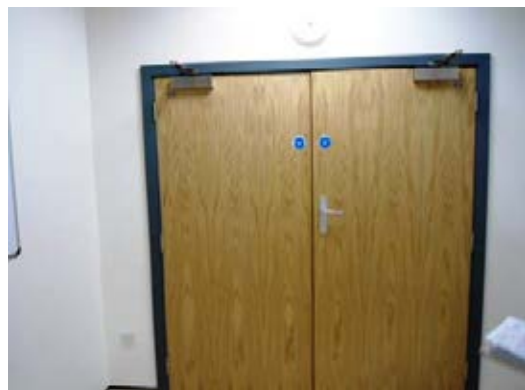
We have asked Brookfield to confirm if a door selector is required to allow the fire doors to room THE-361 Bulk Store to close properly and provide the requisite fire protection. (See Supervisor's Communication General Matters / Other Instructions (CI 13.1) No 183).

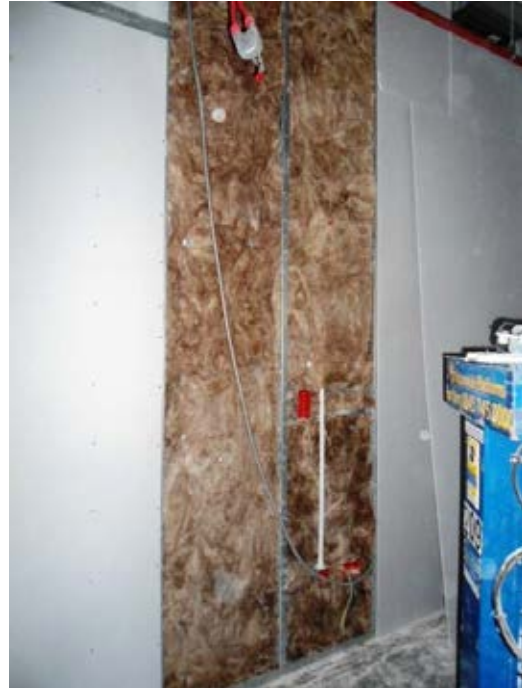
An 85 point check was carried out to a partition in the Children's Hospital Level 5, Area 5-507 room GENWB 028. A strip of insulation approximately 80mm wide was found to be missing. Additional inspections were carried out in other rooms and the insulation was found to be present.
