**Bundle of documents for Oral hearings
commencing from 13 May 2025 in relation
to the Queen Elizabeth University Hospital
and the Royal Hospital for Children,
Glasgow**

**Bundle 33
NEC3 Supervisor's Reports and Project
Supervisors Interface Action Notes**

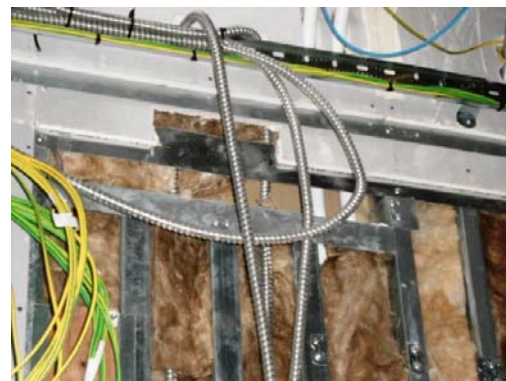
We witnessed an 85 point inspection in room GW3-004 on Level 3, Area 3-507. There was a small area of insulation removed from behind conduits.

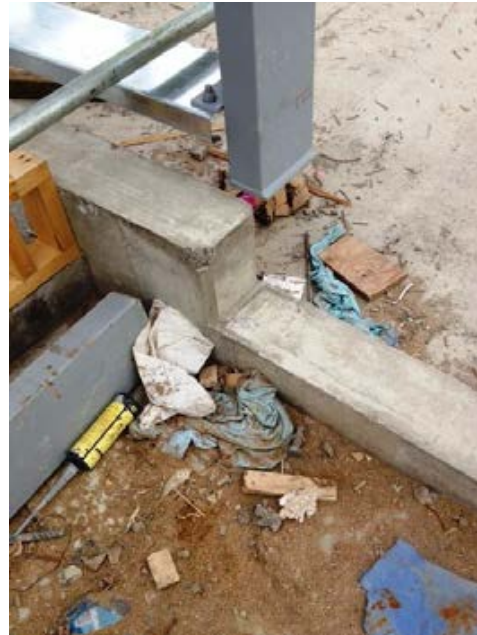
Two internal RHS columns in the Children's Hospital Zone B appear to be held up by adjoining steelwork. Brookfield has informed us that the final detail is a connection to concrete. The concrete works and subsequent bolting up will be undertaken prior to the installation of any cladding. The fitting of additional brackets has been agreed by WSP and we were informed that this would be completed by Monday 19th August. It was our intention to inspect on completion, however the work is still not complete. (See Supervisor's Communication General Matters / Other Instructions (CI 13.1) No 118).

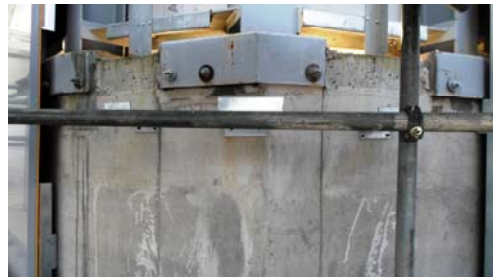
We asked Brookfield to provide proposals to meet the design intent for the Children's Hospital Roof Steelwork Zone A where bolts are missing at the parapet. Brookfield has had discussions with William McColgan WSP during a visit to site. Subsequent to this visit Dunne has provided a detailed sketch which has been approved by WSP. Brookfield has confirmed that the bolts have been completed. See photo opposite. Consequently Supervisor's Communication General Matters / Other Instructions (CI 13.1) No 128 is closed out.

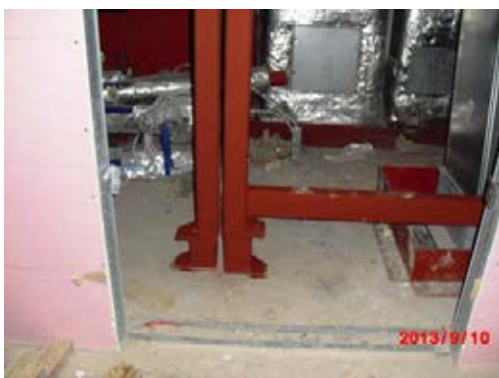
Extended legs

The steel framework in riser on Level 0 ZF Riser M30 has had the legs extended immediately in front of the entrance door. There are other legs which have not been extended yet and we asked Brookfield to confirm when the other legs will be extended. Brookfield has confirmed that these legs are not weight bearing and the weight bearing supports are on Level 01. They also confirmed that the extended legs will be cut back to be completely clear of the ground floor to finish flush with the frame. We have asked for confirmation that the justification for this is based on an analytical assessment, and that the details provided are in accordance with this. (See Supervisor's Communication General Matters / Other Instructions (CI 13.1) No 162).

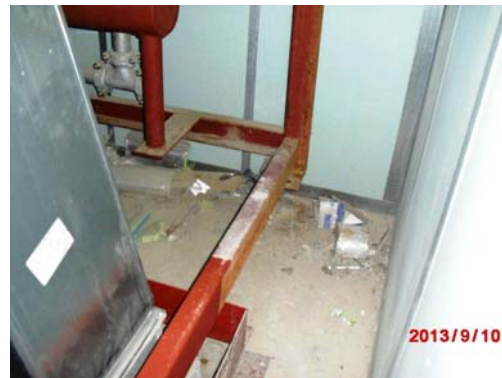
Leg still to be extended.

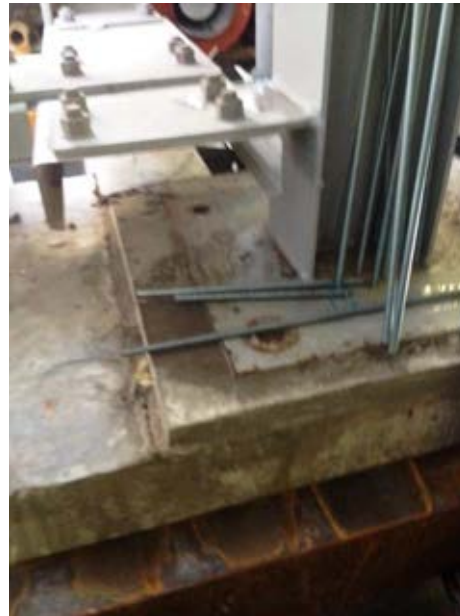
One of the base plates Level 4 Zone B has 2 out of 4 HD bolts either missing or not protruding through the baseplate. We have asked Brookfield to confirm that this satisfies the design and specification intent or provide a remedial solution. (See Supervisor's Communication General Matters / Other Instructions (CI 13.1) No 182).

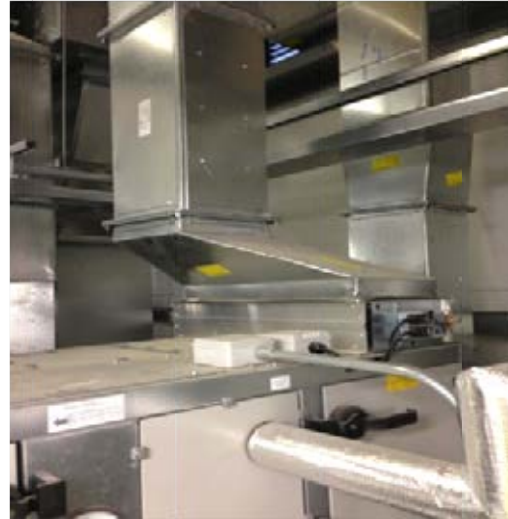
We noted that the air handling unit 21AHU16 supply duct transition does not appear to comply with HVAC DW144 clause 11.6 & 11.7 which could result in high pressure loss.

Brookfield has confirmed that ductwork is not in compliance to drawing/specification and will be replaced. (See Supervisor's Communication General Matters / Other Instructions (CI 13.1) No 121).

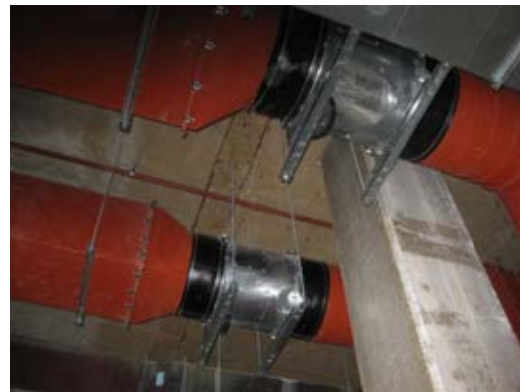
We asked Brookfield to confirm that the fire rating of the flexible connections and supporting system in Plant room PR31 is equivalent to the overall system requirements. The fan is located adjacent to atrium at the west side of building. We have also asked them to confirm fire rating of fans (observed as non-bifurcated type). ZBP has confirmed to Brookfield that fans require to be fire rated and are at technical submittal stage. (See Supervisor's Communication General Matters / Other Instructions (CI 13.1) No 133.

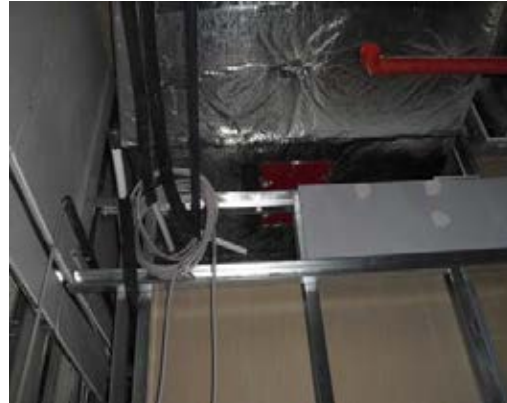
During our inspections on Level 2 we noted that the duct inspection hatch is located above the partition dividing rooms DOPD-037 & 038. We have received confirmation that the duct access hatch will be repositioned to allow access to the duct. We have asked Brookfield to confirm when the hatch will be accessible. (See Supervisor's Communication General Matters / Other Instructions (CI 13.1) No 150).

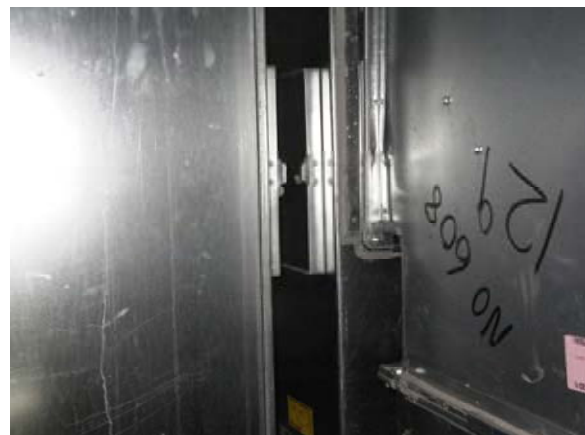
The access hatches in the Plantroom on Level 3 are too close consequently access is not possible. We have asked Brookfield to confirm the remedial measures required to allow access. (See Supervisor's Communication General Matters / Other Instructions (CI 13.1) No 179).

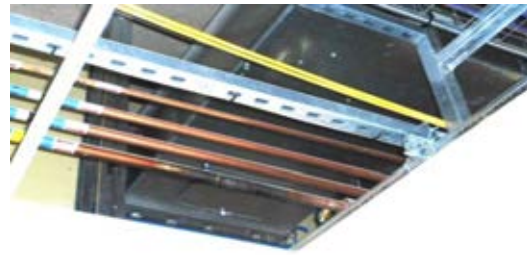
Access to the fire damper between room THE Exit Bay and THE 348 Dirty Utility is restricted. Brookfield has confirmed that a new access cleaning hatch has been fitted and we have inspected this on site. Consequently Supervisor's Communication General Matters / Other Instructions (CI 13.1) No 169 is closed out.

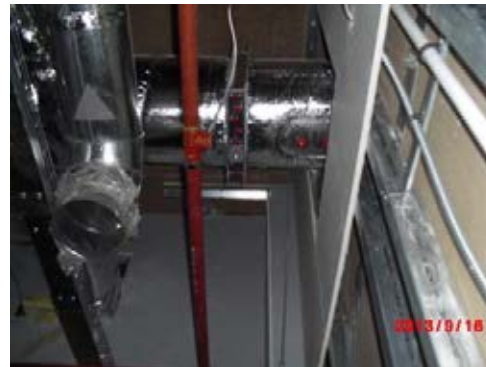
The inspection hatch installed within the adjacent partition in room DMW-004 Therapy Room. We have asked Brookfield to confirm when the hatch has been repositioned. See Supervisor's Communication General Matters / Other Instructions (CI 13.1) No 186).

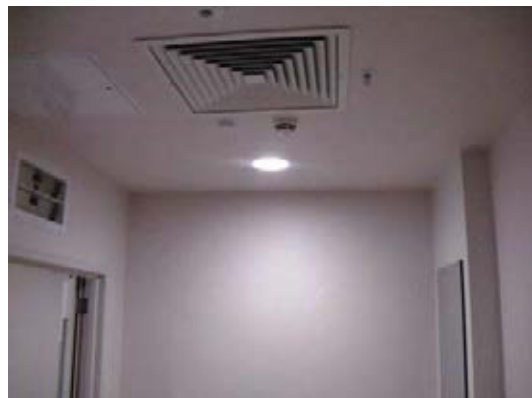
The smoke detector within the lobby on Level 1 Room CCW-049 is within 300mm of the supply grille. We asked Brookfield to confirm when this has been repositioned to the minimum distance of one metre. Mercury's specialist contractor has confirmed that in terms of BS5839-1 Clause 22.3 Paragraph M minimum spacing cannot be achieved. They cannot see how they are able to demonstrate the recommendation without infringing on the minimum distance required to be away from the finished wall surfaces. They state further that due to third party equipment on the ceiling this restricts the position on the smoke detector. Consequently they state that it can remain in position. However we await confirmation that it has been repositioned. (See Supervisor's Communication General Matters / Other Instructions (CI 13.1) No 146)

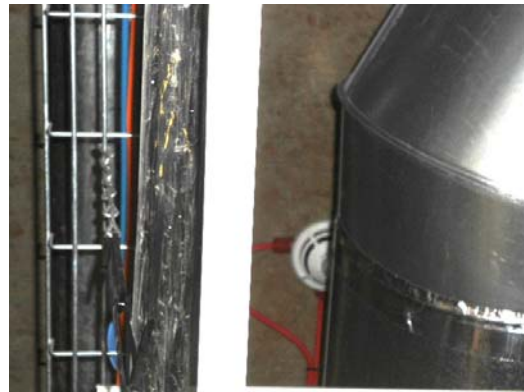
Access to the smoke detector in corridor THE-129 opposite room THE 158 is inaccessible. We have asked Brookfield to confirm the appropriate remedial action to achieve unrestricted access to the smoke detector. Mercury has instructed Scotshield to review this. (See Supervisor's Communication General Matters / Other Instructions (CI 13.1) No 168).

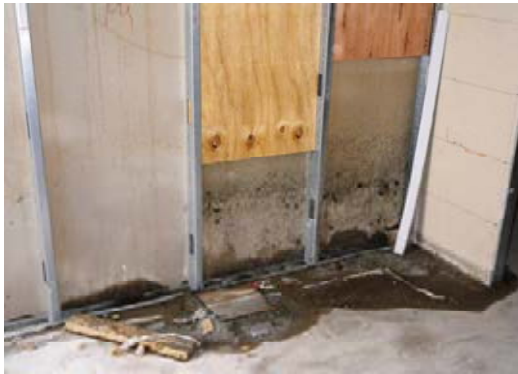
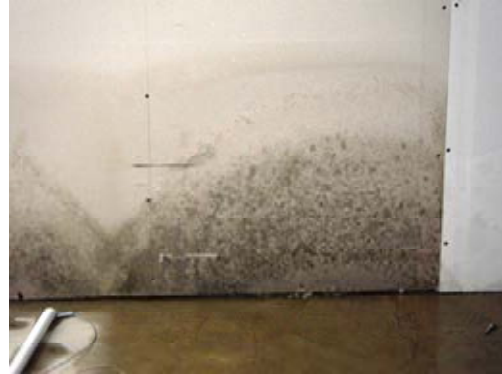
Water damaged boards.

The boards in room SCH-046 Level 2 has water damaged boards. We have asked Brookfield to confirm when the boards are replaced so that a further inspection can be carried out. Brookfield has informed us that Zone C is currently progressing with 1st fix. Their intention would be to complete water damaged boards to this area and below the movement joint between zone B & C at 2nd fix stage. As they are still suffering water ingress from level 4 they have informed us that 2nd fix will be around the 28th October. (See Supervisor's Communication General Matters / Other Instructions (CI 13.1) No 171).

Boards have been damaged by water ingress and we have asked Brookfield to confirm when these have been replaced. (See Supervisor's Communication General Matters / Other Instructions (CI 13.1) No 180).

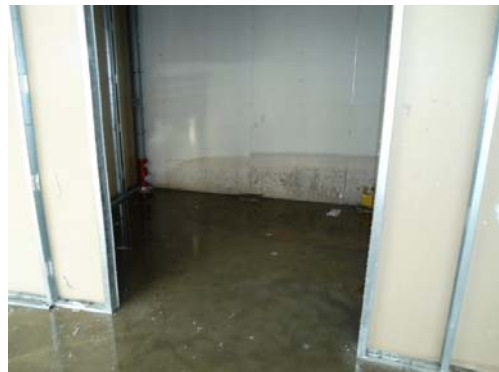
We asked Brookfield to confirm when water damaged boards will be replaced in the rooms between DCFP-010 and DCFP-025 on Level 4. They have confirmed that they will be replaced at second side boarding stage. We will continue to monitor (See Supervisor's Communication General Matters / Other Instructions (CI 13.1) No 181).

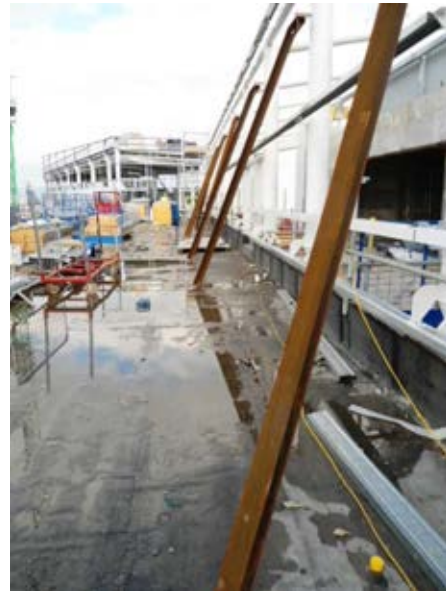
Steel supports are in place to provide temporary supports to the main Atrium Roof. The end of these supports has penetrated the hotmelt roofs on Level 12. Consequently we asked Brookfield to confirm when these areas have been repaired and provide the accompanying QA information. Brookfield has advised that this area will be revisited with remedial works to hot melt. Once remedial works are complete along with the remaining roof slab Prater will carry out the testing and advise accordingly. (See Supervisor's Communication General Matters / Other Instructions (CI 13.1) No 175).

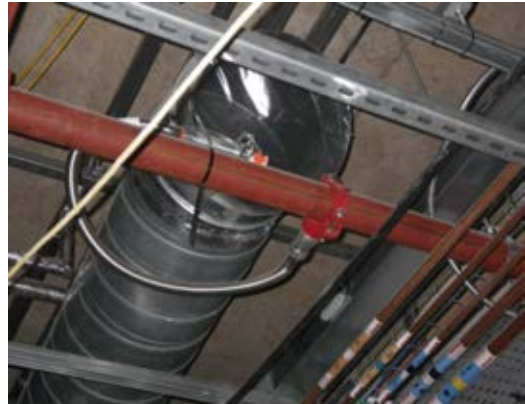
We have asked Brookfield to confirm that the fire damper actuator highlights in room EMC-011 can be accessed on completion of the cold water and ceiling installation. Brookfield has confirmed that the damper actuator will be accessible. The access arrangements for this item will be recorded as part of the Access Strategy Tracker which is being developed. (See Supervisor's Communication General Matters / Other Instructions (CI 13.1) No 92).

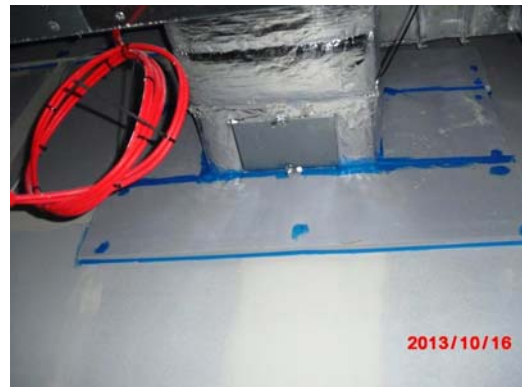
The hatch is too close to the partition between Room RENO-064 and DOPD-037 Level 2, 2-531. Consequently the joint between the hatch and the board is not sealed. We have asked Brookfield to confirm if there is a fire seal between the underside of the trunking and the main partition board. If not Brookfield to confirm if hatch will be moved. This Notification has been forwarded to the relative floor manager and is being investigated. (See Supervisor's Communication General Matters / Other Instructions (CI 13.1) No 177).

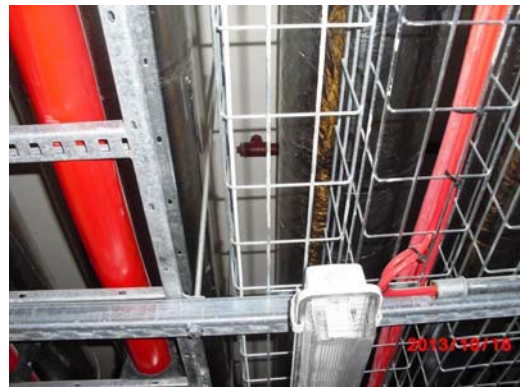
The sprinkler heads on Level -1 Zone K adjacent to Core "A" staircase appear difficult to access for maintenance or replacement. Brookfield confirmed that this is being investigated. (See Supervisor's Communication General Matters / Other Instructions (CI 13.1) No 178.

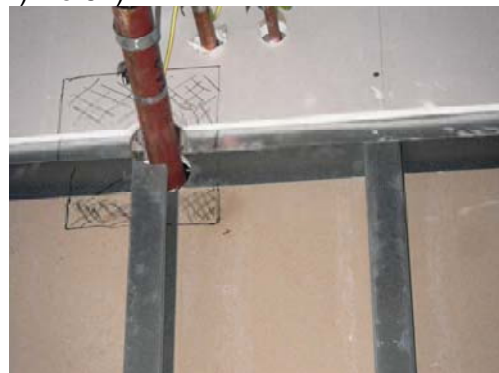
The partition in Room ARU-034 on Level 2 has been cut to allow the sprinkler pipe to pass between rooms resulting in the partition being weakened. Brookfield has passed this to Astins to investigate. (See Supervisor's Notification of Defect (CI 42.2)) No 63).

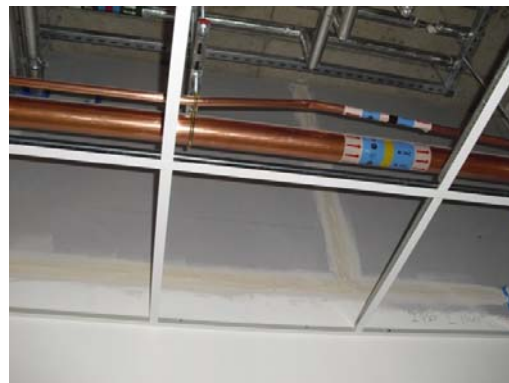
There is a damaged medical gas pipe on Level 1 room MDU 051 on the ceiling. We have asked Brookfield to confirm when this has been addressed. (See Supervisor's Notification of Defect (CI 42.2) No 65).

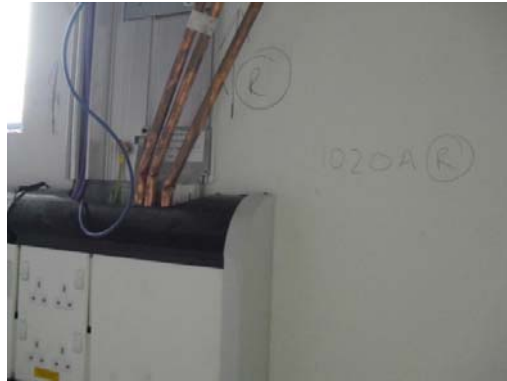
There are damaged medical gas pipes on Level 1 room MDU 012 on the bedhead. We have asked Brookfield to confirm when this has been addressed. (See Supervisor's Notification of Defect (CI 42.2) No 66).

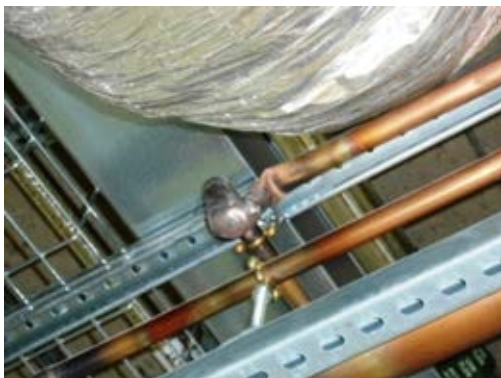
We noted that there is a damaged medical gas pipe above the circulation area adjacent to bay RAF-024. We asked Brookfield to confirm when this would be addressed. They have confirmed that Mercury has replaced the damaged pipe. Consequently Supervisor's Notification of Defect (CI 42.2) No 67 is closed out.

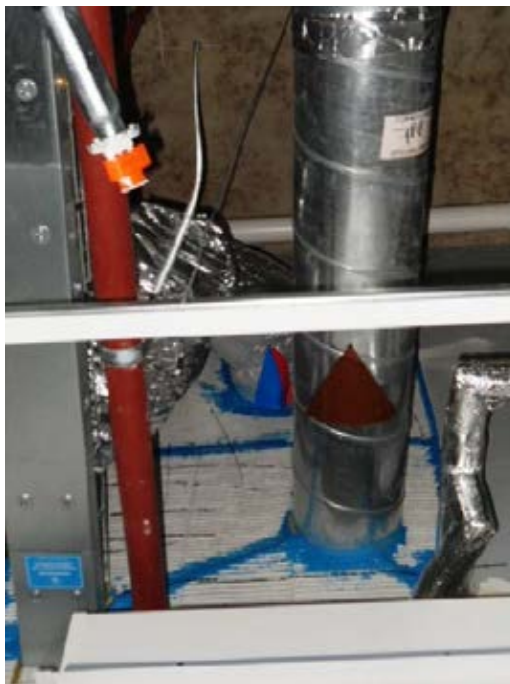
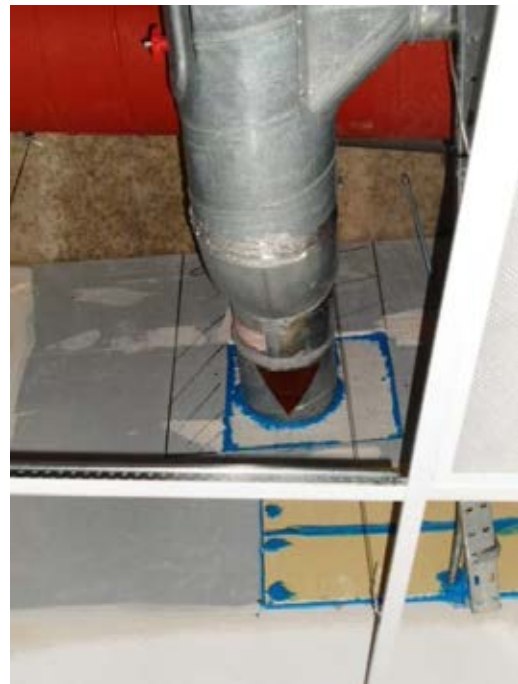
Partitions marked out for the inclusion of new fire dampers.

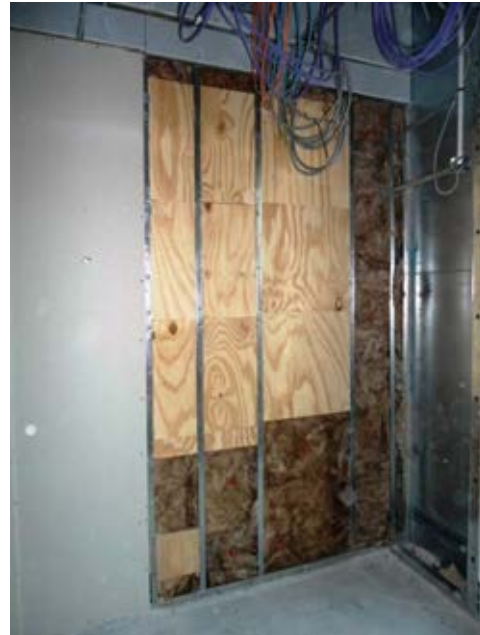
Level 8 Area 8-509 room GENW11-014.

An 85 point check was carried out to a partition in room GEN-W10 and the partition was constructed in accordance with the specification.

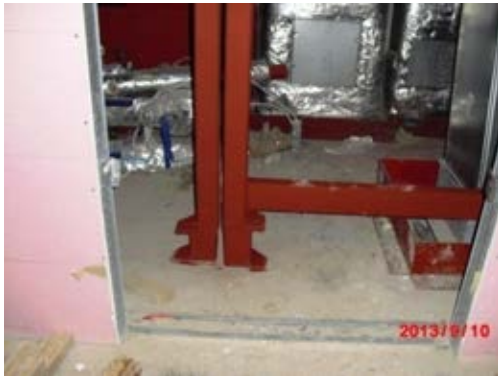
Extended legs

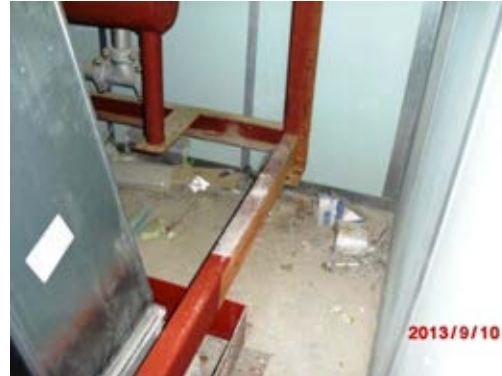
Leg still to be extended.

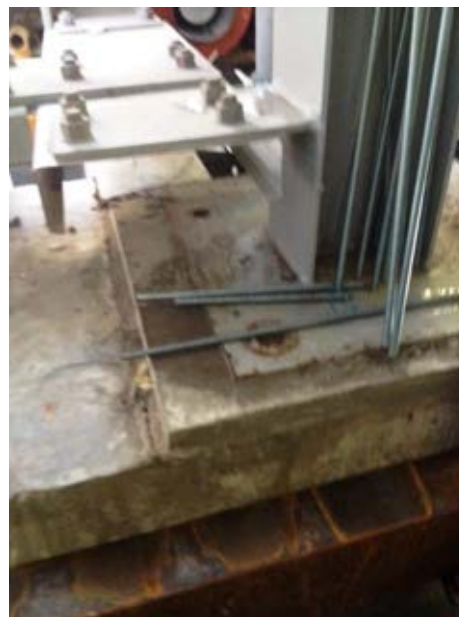
At the southern skylight, Children's 3rd floor podium, there are 4No steel column baseplates which have only 1No bolt connection to the concrete upstand. This communication has been closed out. One of the base plates Level 4 Zone B has 2 out of 4 HD bolts either missing or not protruding through the baseplate. We have asked Brookfield to confirm that this satisfies the design and specification intent or provide a remedial solution. Brookfield have intimated that this will be attended to in the next period. (See Supervisor's Communication General Matters / Other Instructions (CI 13.1) No 182).

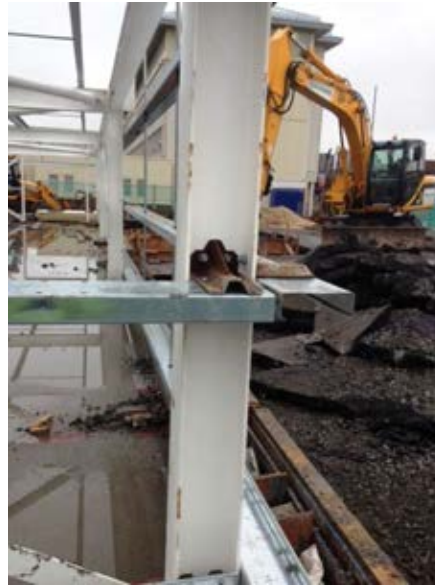
We noted at the VIE Building structure almost all main cleats connecting the galvanised cladding rails to the main fire protected steelwork structure are completely rusted. The fire protected steelwork painting is also chipped with protection incomplete in several places. Brookfield is aware of this and paint is on site ready to carry out the remedials. This will be done when M & S alter the bracing and add the additional trimming to the purlins. See Communication General Matters / Other Instructions (CI 13.1) No 190

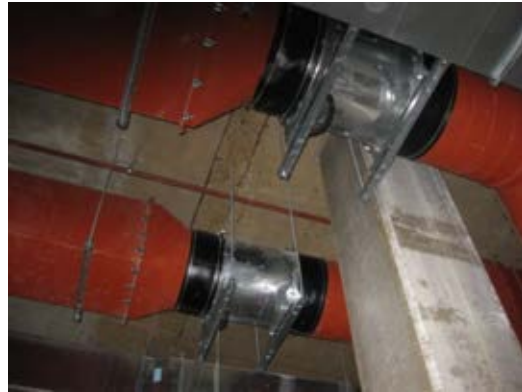
We asked Brookfield to confirm that the fire rating of the flexible connections and supporting system in Plant room PR31 is equivalent to the overall system requirements. The fan is located adjacent to atrium at the west side of building. We have also asked them to confirm fire rating of fans (observed as non-bifurcated type). ZBP has confirmed to Brookfield that fans require to be fire rated and are at technical submittal stage. (See Supervisor's Communication General Matters / Other Instructions (CI 13.1) No 133.

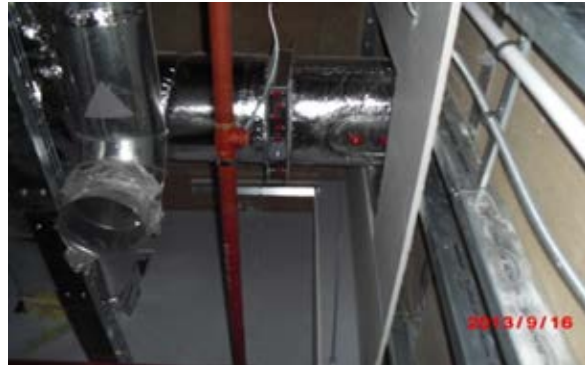
The inspection hatch is installed within the adjacent partition in room DMW-004 Therapy Room. We have received photographic evidence that the hatch has been repositioned. Consequently Supervisor's Communication General Matters / Other Instructions (CI 13.1) No 186 is closed out.

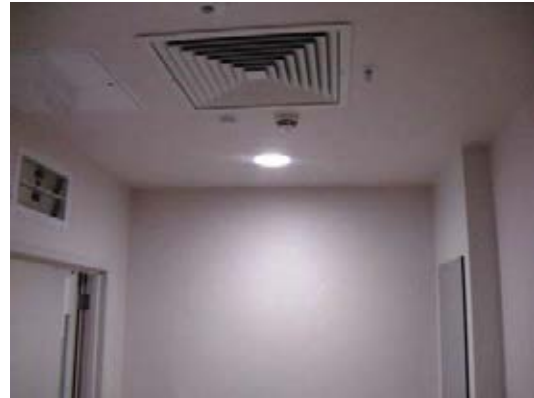
The smoke detector within the lobby on Level 1 Room CCW-049 is within 300mm of the supply grille. We asked Brookfield to confirm when this has been repositioned to the minimum distance of one metre. Mercury's specialist contractor has confirmed that in terms of BS5839-1 Clause 22.3 Paragraph M minimum spacing cannot be achieved. They cannot see how they are able to demonstrate the recommendation without infringing on the minimum distance required to be away from the finished wall surfaces. They state further that due to third party equipment on the ceiling this restricts the position on the smoke detector. They state that it can remain in position. However this will mean that this is not compliant in terms of BS5839-1 Clause 22.3. (See Supervisor's Communication General Matters / Other Instructions (CI 13.1) No 146).

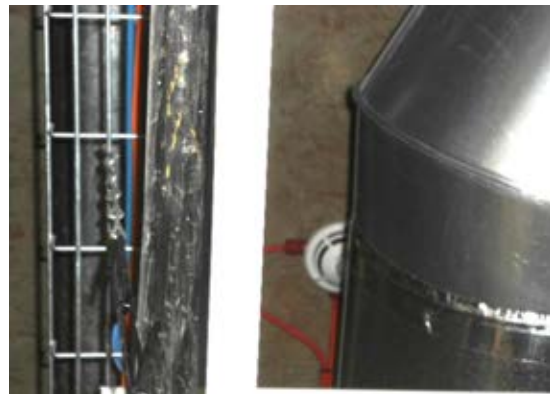
Access to the smoke detector in corridor THE-129 opposite room THE 158 is inaccessible. We asked Brookfield to confirm the appropriate remedial action to achieve unrestricted access to the smoke detector. Brookfield arranged Scotshield to demonstrate that access was available to the smoke detector. We witnessed the successful demonstration. Consequently Supervisor's Communication General Matters / Other Instructions (CI 13.1) No 168 is closed out.

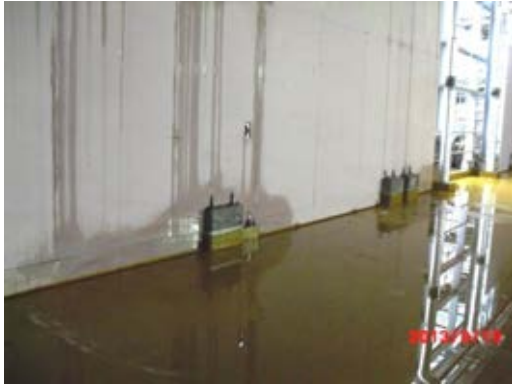
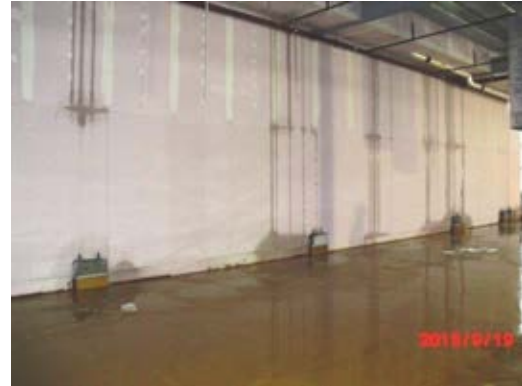
The partition between the east side of the atrium and plant room 41 has been damaged by water ingress. Brookfield to confirm they are aware there has been some damage, and will replace the boards after they have completed the resin flooring works. (See Supervisor's Communication General Matters / Other Instructions (CI 13.1) No 166).

Water damaged boards.

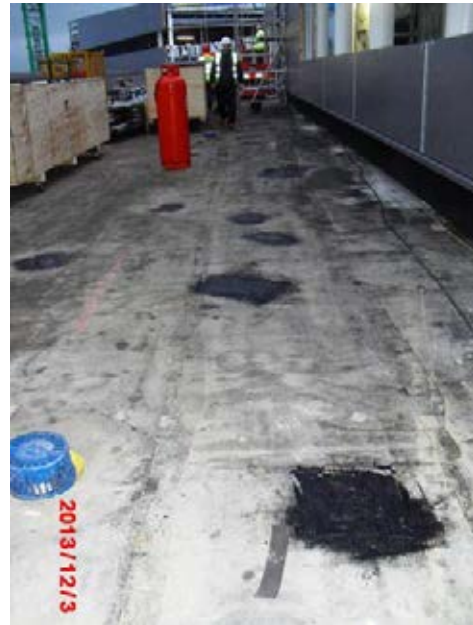
The Steel supports providing temporary supports to the main Atrium Roof have been removed and the penetrated into the hotmelt roofs repaired. Consequently Supervisor's Communication General Matters / Other Instructions (CI 13.1) No 175 is closed out.

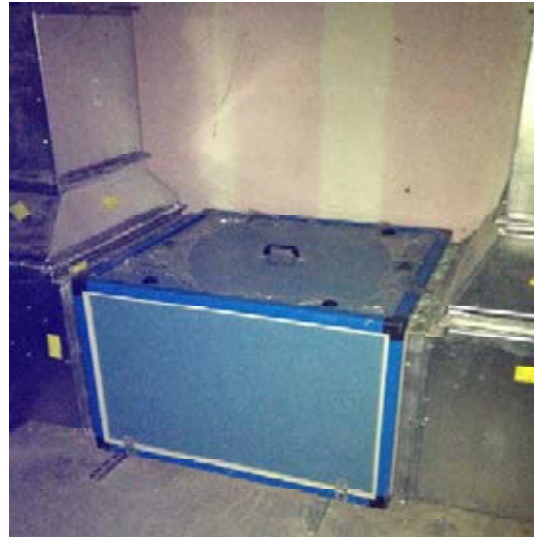
Extract fan on Level L3 PR31 extract fan unit Number 30EF1 has been installed on the floor of the plantroom with the service access on the underside of the unit making servicing impossible. We asked Brookfield confirm that extract fan will be installed in a manner which will allow unrestricted maintenance. Removable Panels have been fitted on 3 fan casings as shown in photographs below to allow unrestricted access. Consequently Supervisor's Communication General Matters / Other Instructions (CI 13.1) No 151 is closed out.

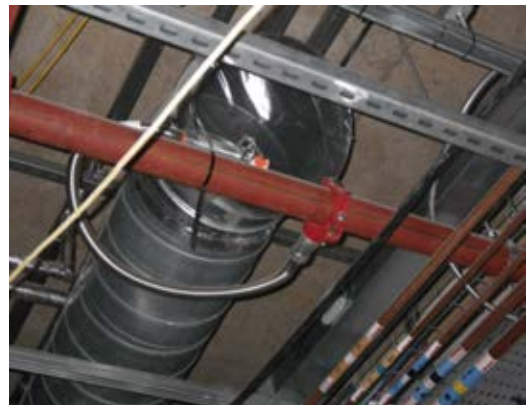
We have asked Brookfield to confirm that the fire damper actuator highlights in room EMC-011 can be accessed on completion of the cold water and ceiling installation. Brookfield has confirmed that the damper actuator will be accessible. The access arrangements for this item will be recorded as part of the Access Strategy Tracker which is being developed. (See Supervisor's Communication General Matters / Other Instructions (CI 13.1) No 92).

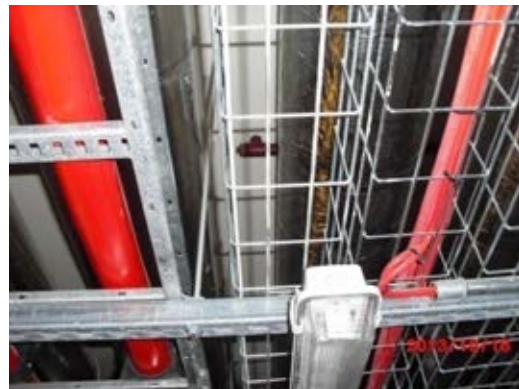
The sprinkler heads on Level -1 Zone K adjacent to Core "A" staircase appear difficult to access for maintenance or replacement. Brookfield together with Mercury has investigated this and confirmed that the basket can be removed in 5 minutes, cables moved to the side to gain access. They have also confirmed that the head only requires maintenance/replacement when it is activated and the ceiling and other services are likely to be replaced should that situation arise. Consequently Supervisor's Communication General Matters / Other Instructions (CI 13.1) No 178 is closed out.

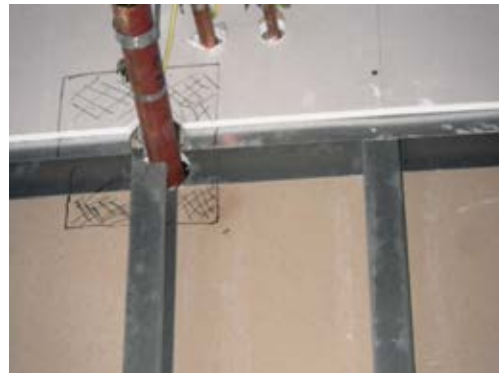
The partition in Room ARU-034 on Level 2 has been cut to allow the sprinkler pipe to pass between rooms resulting in the partition being weakened. Brookfield has confirmed that Astins have rectified this at the 2nd fix stage by introducing a transom. Consequently Supervisor's Notification of Defect (CI 42.2) No 63 is closed out.

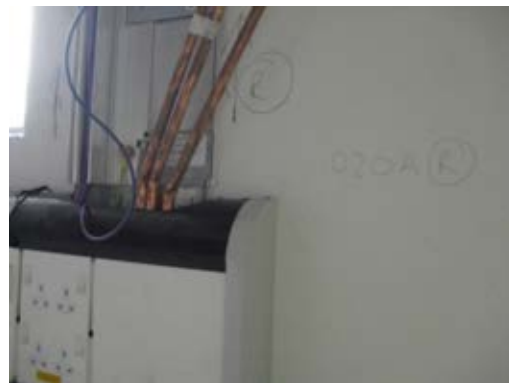
There are damaged medical gas pipes on Level 1 room MDU 012 on the bedhead. We have asked Brookfield to confirm when this has been addressed. (See Supervisor's Notification of Defect (CI 42.2) No 66).

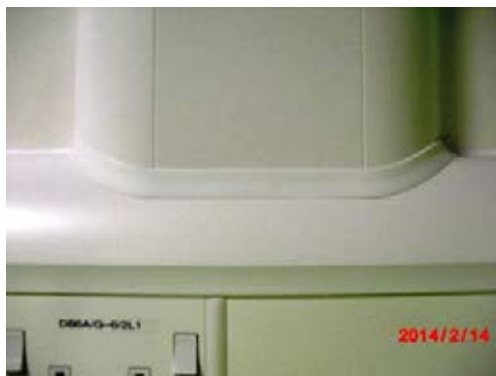
We have also raised a Communication in relation to the lack of seals between the horizontal beadheads and the vertical section asking Brookfield if there has been a change to the specification. (See Supervisor's Communication General Matters / Other Instructions (CI 13.1) No 193).

Bedhead junction at the horizontal

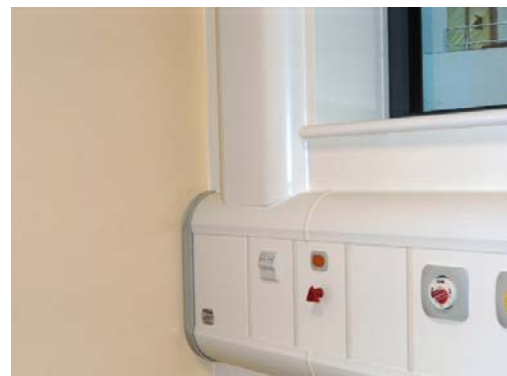
Bedhead junction at the horizontal

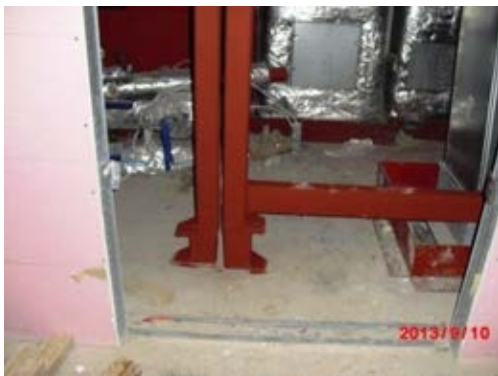
The steel framework in riser on Level 0 ZF Riser M30 has had the legs extended immediately in front of the entrance door. There are other legs which have not been extended yet and we asked Brookfield to confirm when the other legs will be extended. Brookfield has confirmed that these legs are not weight bearing and the weight bearing supports are on Level 01. They also confirmed that the extended legs will be cut back to be completely clear of the ground floor to finish flush with the frame. We asked for confirmation that the justification for this is based on an analytical assessment, and that the details provided are in accordance with this. We have received a further response but not an analytical assessment. We await a further response. (See Supervisor's Communication General Matters / Other Instructions (CI 13.1) No 162).

Extended legs

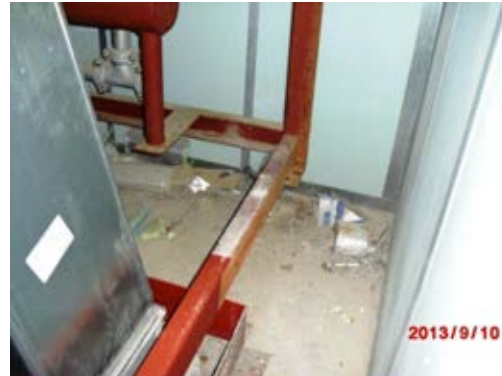
Leg still to be extended.

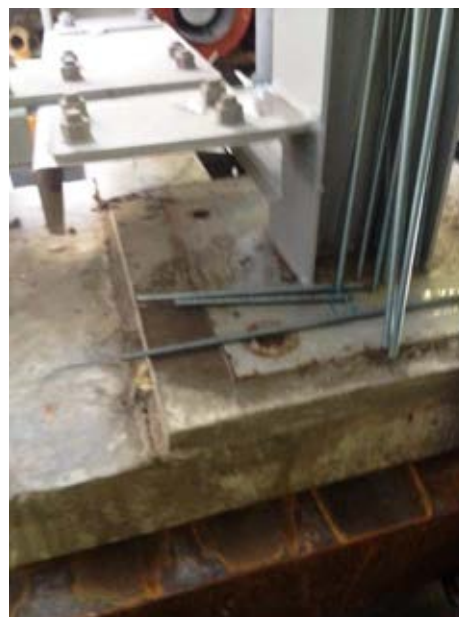
One of the base plates Level 4 Zone B has 2 out of 4 HD bolts either missing or not protruding through the baseplate. We have asked Brookfield to confirm that this satisfies the design and specification intent or provide a remedial solution. Brookfield have intimated that this will be attended to in the next period. (See Supervisor's Communication General Matters / Other Instructions (CI 13.1) No 182).

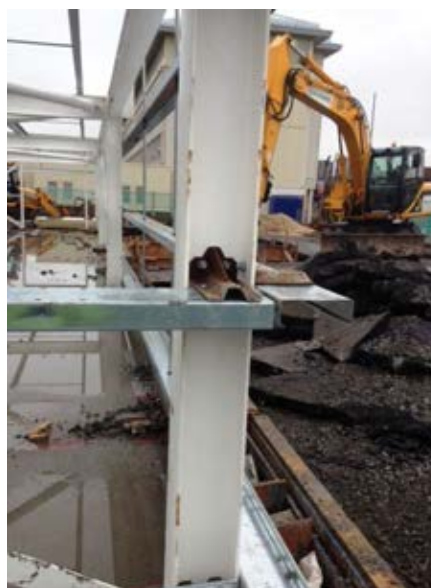
We noted at the VIE Building structure almost all main cleats connecting the galvanised cladding rails to the main fire protected steelwork structure are completely rusted. The fire protected steelwork painting is also chipped with protection incomplete in several places. Brookfield is aware of this and paint is on site ready to carry out the remedials. This will be done when M & S alter the bracing and add the additional trimming to the purlins. Communication General Matters / Other Instructions (CI 13.1) No 190 is closed out.

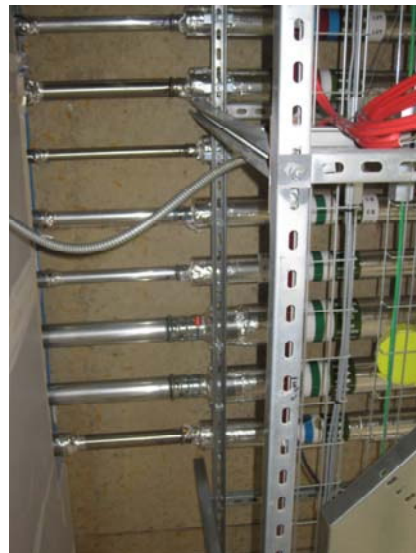
We raised our concerns with Brookfield in relation with the following areas Level 2 Zone H. Pipework connections above line of unistrut. Access appears difficult. We have asked Brookfield to confirm that future access will be available.

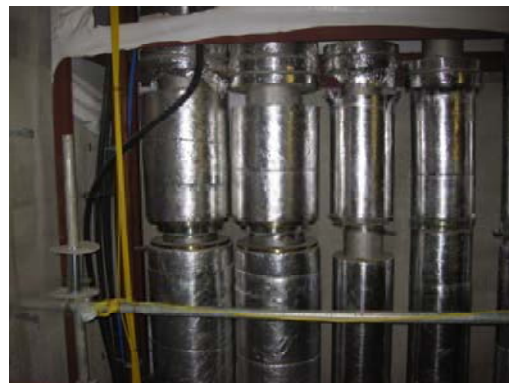
Level 2 / Zone K. Current access to install chilled water riser pipework appears difficult. We have asked Brookfield to confirm that future access will be available once the walls are constructed.

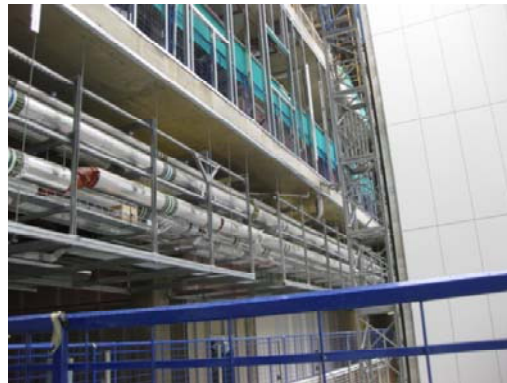
Level 3 / Zone H. Pipe Racks in area shown below have multiple levels of pipe work. We have asked Brookfield to confirm that future access will be available. Brookfield confirmed that access to the 3 areas identified will be accessible for FM in compliance with ER Section 5.13. The access arrangements for this item will be recorded as part of the Access Strategy Tracker which is currently being developed by Brookfield and Mercury. (See Supervisor's Communication General Matters / Other Instructions (CI 13.1) No 126).

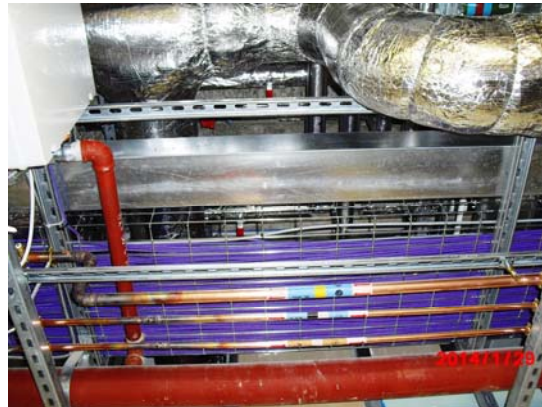
We noted that the service valves on Level 0 Zone C in corridor OPD 024 adjacent OPD 025 are inaccessible within the ceiling space. Please confirm the procedures for access to these valves in accordance with SHTM 2035 Section 5. (See Supervisor's Communication General Matters / Other Instructions (CI 13.1) No 122).

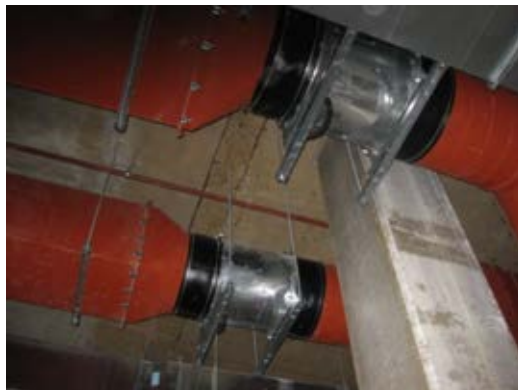
We asked Brookfield to confirm that the fire rating of the flexible connections and supporting system in Plant room PR31 is equivalent to the overall system requirements. The fan is located adjacent to atrium at the west side of building. We also asked them to confirm fire rating of fans (observed as non-bifurcated type). ZBP has confirmed to Brookfield that fans require to be fire rated and are at technical submittal stage. Brookfield has issued an instruction to have the fans replaced. We await comments in relation to the connections. (See Supervisor's Communication General Matters / Other Instructions (CI 13.1)

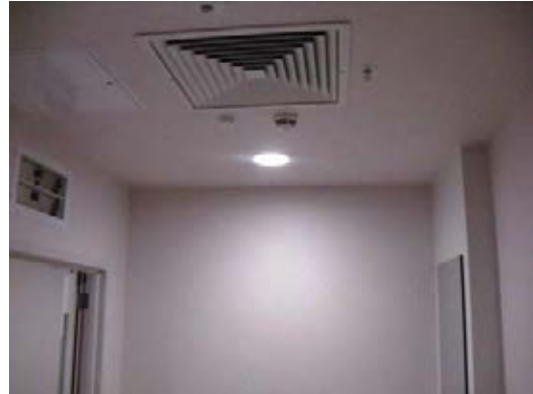
The smoke detector within the lobby on Level 1 Room CCW-049 is within 300mm of the supply grille. We asked Brookfield to confirm when this has been repositioned to the minimum distance of one metre. Mercury's specialist contractor has confirmed that in terms of BS5839-1 Clause 22.3 Paragraph M minimum spacing cannot be achieved. They cannot see how they are able to demonstrate the recommendation without infringing on the minimum distance required to be away from the finished wall surfaces. They state further that due to third party equipment on the ceiling this restricts the position on the smoke detector. They state that it can remain in position. However this will mean that this is not compliant in terms of BS5839-1 Clause 22.3. During joint inspections also identified two other locations where the smoke detectors are too close to the walls and we have asked them to review the requirements of (See Supervisor's Communication General Matters / Other Instructions (CI 13.1) No 146).

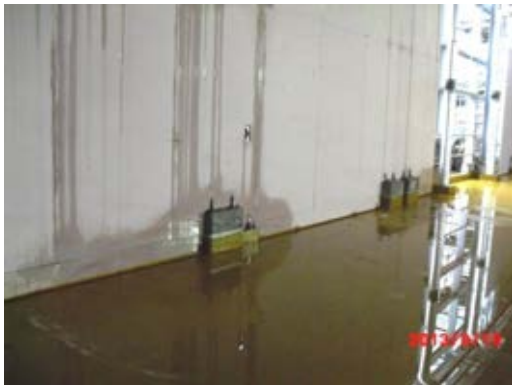
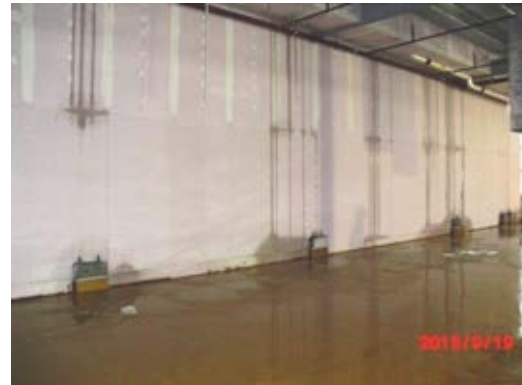
The partition between the east side of the atrium and plant room 41 has been damaged by water ingress. Brookfield to confirm they are aware there has been some damage, and will replace the boards after they have completed the resin flooring works. (See Supervisor's Communication General Matters / Other Instructions (CI 13.1) No 166).

Water damaged boards.

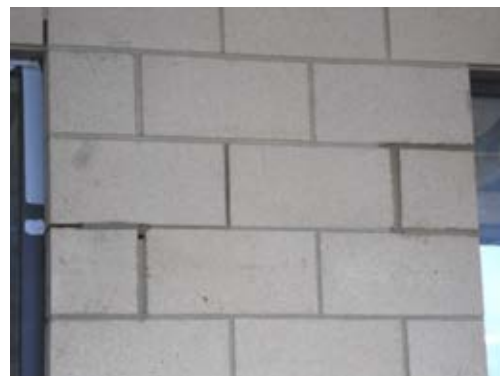
The quality of the workmanship to the blockwork on the West Facing Elevation is poor and requires to be addressed. The widths of perpends varying at various locations on this elevation. This is particularly evident between the windows on the right hand side of the entrance to A&E. See photo. Brookfield has confirmed that the issue has been addressed. We carried out a further inspection and noted that the pointing was still darker than the surrounding joints. (See Supervisor's Communication General Matters / Other Instructions

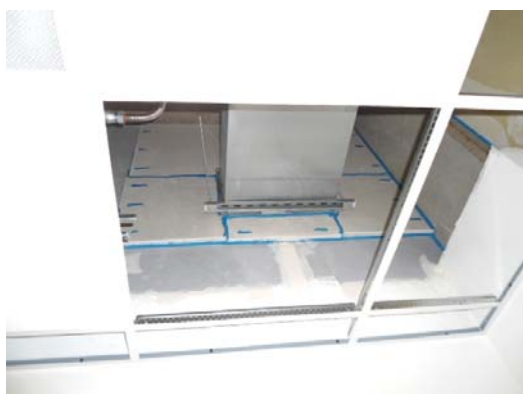
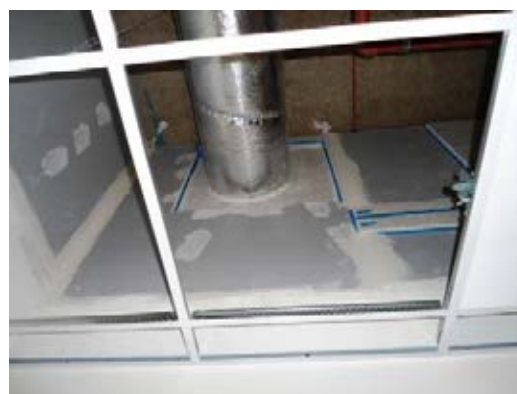
During an inspection on Level 1 Area 1-519 we noted that the ducting passing through partition between the hazard rooms Regen Kitchens CCW-032, Disposal Hold CCW-034 and the Fluid Hold CCW-033 did not appear to have fire dampers and were not fire rated. We have asked Brookfield to confirm that the ducts are to the appropriate fire resistance compatible with the partitions or ensure that the appropriate dampers are fitted to satisfy the integrity of the partitions in compliance with both SHTM 85 and the Scottish Building Standards. Brookfield confirmed that where there were clusters of Hazard Rooms the enclosure of the rooms will be treated as a fire Hazard Room as agreed by Building Control and the NHS Board. Consequently Supervisor's Notification of Defect (CI 42.2) No 69 is closed out.

Photo in Disposal Hold CCW-034 showing ducting passing through in to Regen Kitchens CCW-032.

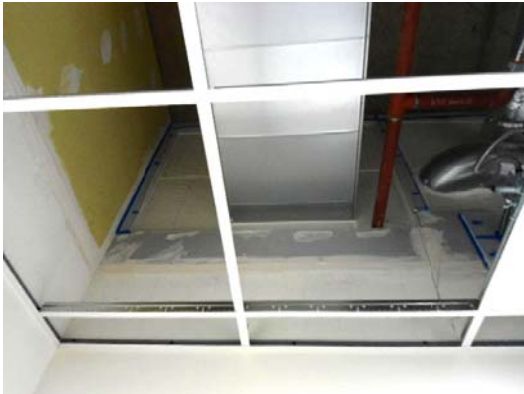
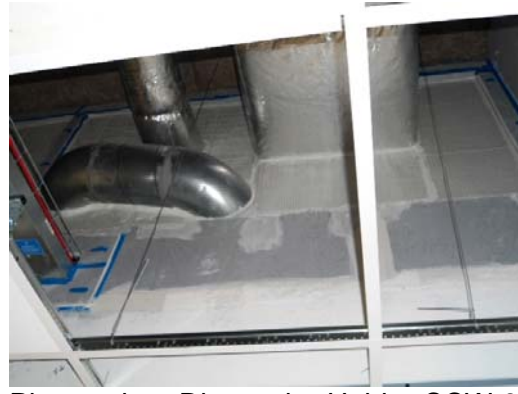
Photo in Disposal Hold CCW-034 showing ducting passing through in to Fluid Hold CCW-033.

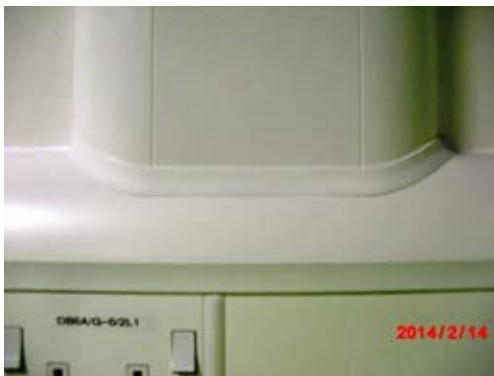
We have also raised a Communication in relation to the lack of seals between the horizontal beadheads and the vertical section asking Brookfield if there has been a change to the specification. (See Supervisor's Communication General Matters / Other Instructions (CI 13.1) No 193). **AWAITING RESPONSE FROM JOHN WALES**

Bedhead junction at the horizontal vertical sections currently fitted on Level 0 showing gasket.

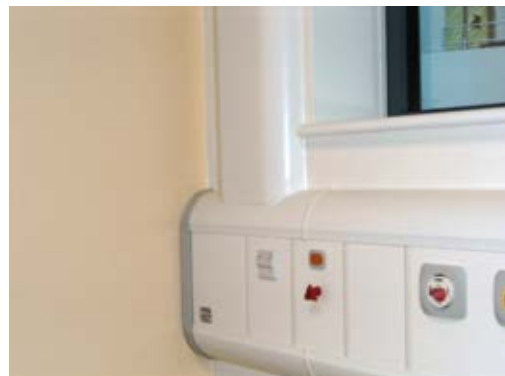
Bedhead junction at the horizontal vertical sections currently fitted on Level 1, Area 1-537 and 1-539 showing sealant.

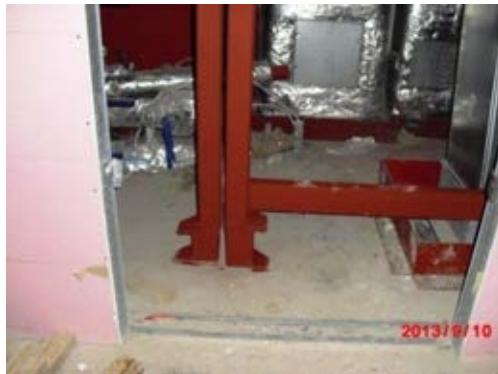
Extended legs

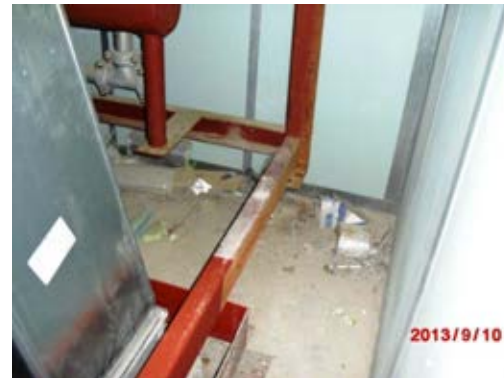
Leg still to be extended.

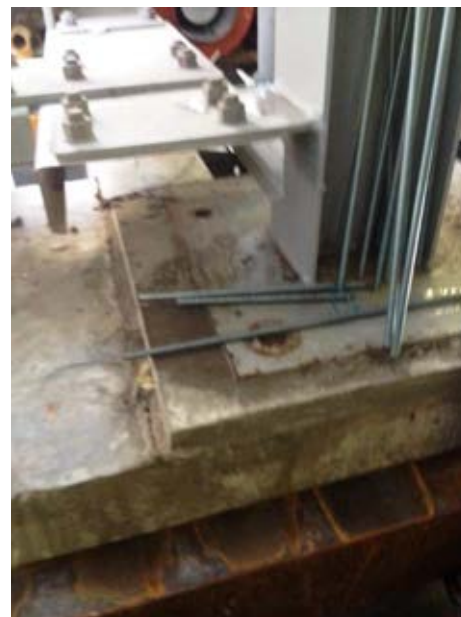
Several fixings to the underside of the roof slab for prefabricated framework supporting services on Level 3 zones E, K & F Zone 3-501 are not as originally intended. We have asked Brookfield to confirm that what has been provided has been designed and that the installation is in accordance with that design.

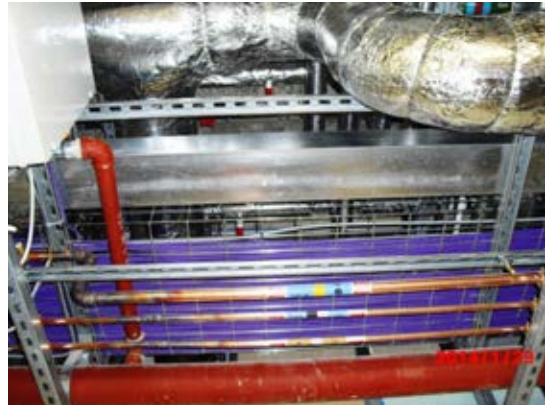
We noted that the service valves on Level 0 Zone C in corridor OPD 024 adjacent OPD 025 are inaccessible within the ceiling space. We vasked Brookfield to confirm the procedures for access to these valves in accordance with SHTM 2035 Section 5. Brookfield has confirmed that a section of unistrut has been removed and a modified 550x550mm MEWP cage would allow access to the valves. Consequently Supervisor's Communication General Matters / Other Instructions (CI 13.1) No 122 is closed out

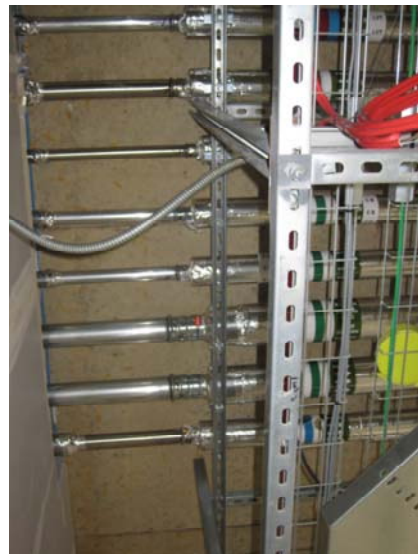
We raised our concerns with Brookfield in relation with the following areas Level 2 Zone H. Pipework connections above line of unistrut. Access appears difficult. We have asked Brookfield to confirm that future access will be available.

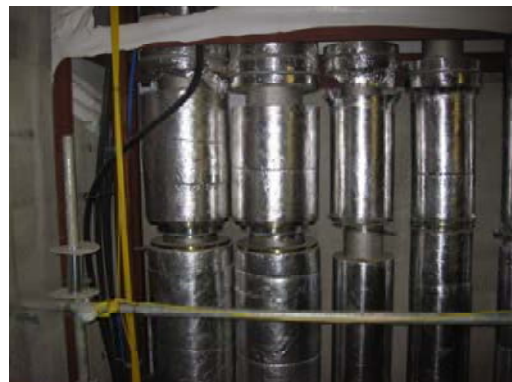
Level 2 / Zone K. Current access to install chilled water riser pipework appears difficult. We have asked Brookfield to confirm that future access will be available once the walls are constructed.
