**Bundle of documents for Oral hearings
commencing from 13 May 2025 in relation
to the Queen Elizabeth University Hospital
and the Royal Hospital for Children,
Glasgow**

**Bundle 33
NEC3 Supervisor's Reports and Project
Supervisors Interface Action Notes**

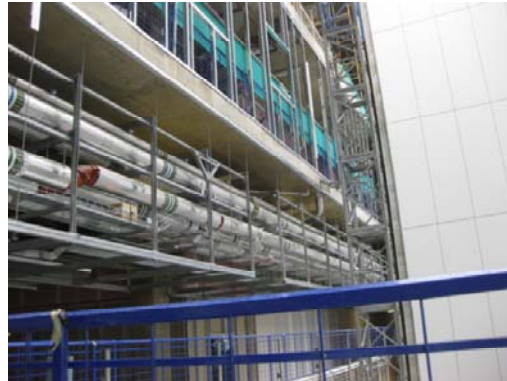
Level 3 / Zone H. Pipe Racks in area shown below have multiple levels of pipe work. We have asked Brookfield to confirm that future access will be available. Brookfield confirmed that access to the 3 areas identified will be accessible for FM in compliance with ER Section 5.13. The access arrangements for this item will be recorded as part of the Access Strategy Tracker which is currently being developed by Brookfield and Mercury. (See Supervisor's Communication General Matters / Other Instructions (CI 13.1) No 126).

We asked Brookfield to confirm that future access will be available to pipework on Level 3 / Zone H and Level 2 Zone K. Brookfield confirmed that access to the areas identified will be by an adapted MEWP 540x 540. This has been recorded on their Access Strategy Tracker. Supervisor's Communication General Matters / Other Instructions (CI 13.1) No 126 is closed out.

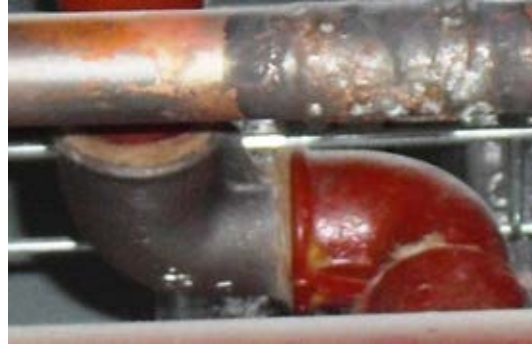
During our Quality and Compliance Inspection of Level 1, 1- 536 and various other areas we noted that fittings i.e. elbows, "T" pieces etc are not being painted after installation in accordance with BS 5306 - section 21.2.1.2.

This states that non-galvanized ferrous pipes for use above ground shall be supplied to site with one external coat of paint or varnish, and fittings shall be coated, and pipes shall be further coated, as soon as practicable after installation.

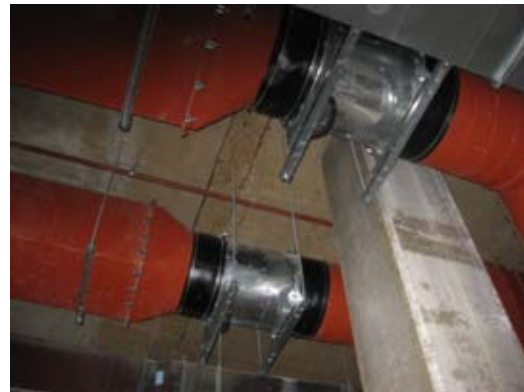
Items 127 to 132 have been closed out				
133	Plant room PR31. Confirm that fire rating of flexible connections and supporting system is equivalent to overall system requirements. Confirm fire rating of fans (observed as non-bifurcated type).	03.07.13	Response received.

We asked Brookfield to confirm that the fire rating of the flexible connections and supporting system in Plant room PR31 is equivalent to the overall system requirements. The fan is located adjacent to atrium at the west side of building. We also asked them to confirm fire rating of fans (observed as non-bifurcated type). ZBP has confirmed to Brookfield that fans require to be fire rated and are at technical submittal stage. Brookfield has issued an instruction to have the fans replaced. We await comments in relation to the connections. (See Supervisor's Communication General Matters / Other Instructions (CI 13.1) No 133. AWAITING RESPONSE FROM JOHN WALES

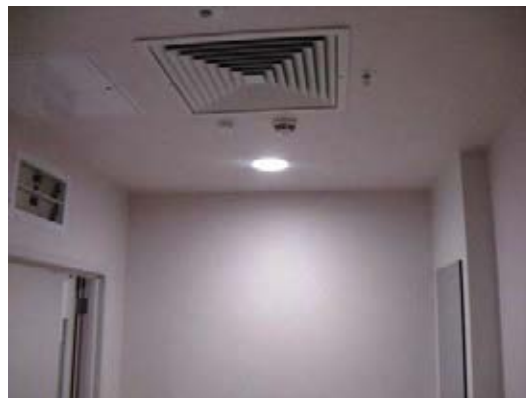
The smoke detector within the lobby on Level 1 Room CCW-049 is within 300mm of the supply grille. We asked Brookfield to confirm when this has been repositioned to the minimum distance of one metre. Mercury's specialist contractor has confirmed that in terms of BS5839-1 Clause 22.3 Paragraph M minimum spacing cannot be achieved. They cannot see how they are able to demonstrate the recommendation without infringing on the minimum distance required to be away from the finished wall surfaces. They state further that due to third party equipment on the ceiling this restricts the position on the smoke detector. They state that it can remain in position. However this will mean that this is not compliant in terms of BS5839-1 Clause 22.3. Supervisor's Communication General Matters / Other Instructions (CI 13.1) No 146 has been closed out and subsequently raised as a defect.

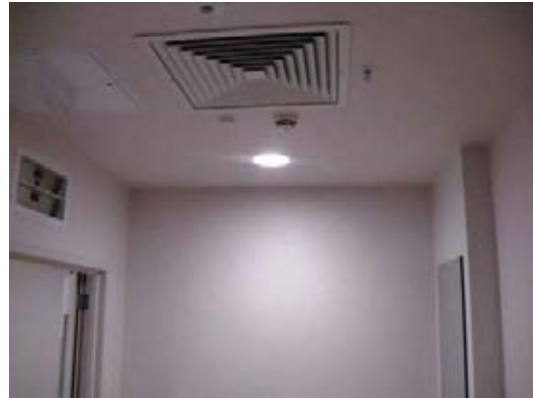
The smoke detector within the lobby on Level 1 Room CCW-049 is within 300mm of the supply grille. We asked Brookfield to confirm when this has been repositioned to the minimum distance of one metre. Mercury's specialist contractor has confirmed that in terms of BS5839-1 Clause 22.3 Paragraph M minimum spacing cannot be achieved. They cannot see how they are able to demonstrate the recommendation without infringing on the minimum distance required to be away from the finished wall surfaces. They state further that due to third party equipment on the ceiling this restricts the position on the smoke detector. They state that it can remain in position. However this will mean that this is not compliant in terms of BS5839-1 Clause 22.3. (See Supervisor's Notification of Defect (CI 42.2) No 74).

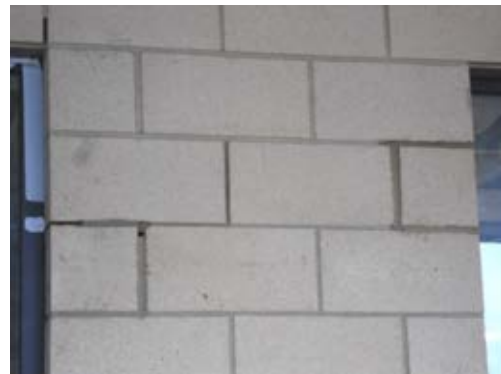
The quality of the workmanship to the blockwork on the West Facing Elevation is poor and requires to be addressed. The widths of perpends varying at various locations on this elevation. This is particularly evident between the windows on the right hand side of the entrance to A&E. See photo. Brookfield has confirmed that the issue has been addressed. We carried out a further inspection and noted that the pointing was still darker than the surrounding joints. (See Supervisor's Communication General Matters / Other Instructions (CI 13.1) No 64.

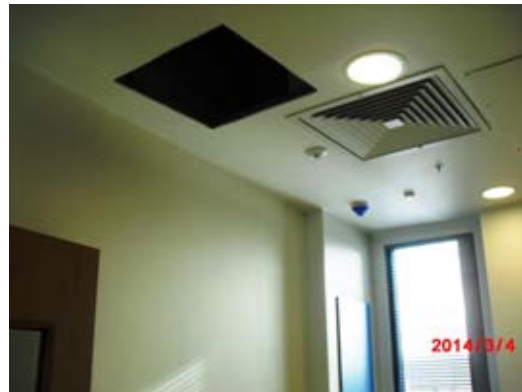
Smoke detectors on Level 1 Areas 1-517 and 1-518 have been fitted too close to the walls in rooms CCW-100 Isolation Ward Lobby and CCW-147 Recess. Consequently these are not compliant with BS5839-1 Clause 22.3 which states that smoke detectors should not be within 500mm of any walls, partitions or obstructions to flow of hot gases. We have asked Brookfield to confirm when the above smoke detectors have been repositioned. (See Supervisor's Notification of Defect (CI 42.2) No 70).

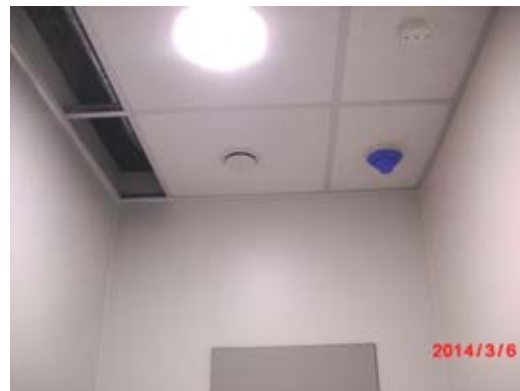
Smoke detectors have been fitted too close to the walls in rooms MP-018 Staff WC, MP-017 Staff WC, MP-002 Reception and MP-013 Cleaners. They are not compliant with BS5839-1 Clause 22.3 which states that smoke detectors should not be within 500mm of any walls, partitions or obstructions to flow of hot gases. We have asked Brookfield to confirm when the above smoke detectors have been repositioned. (See Supervisor's Notification of Defect (CI 42.2) No 71).

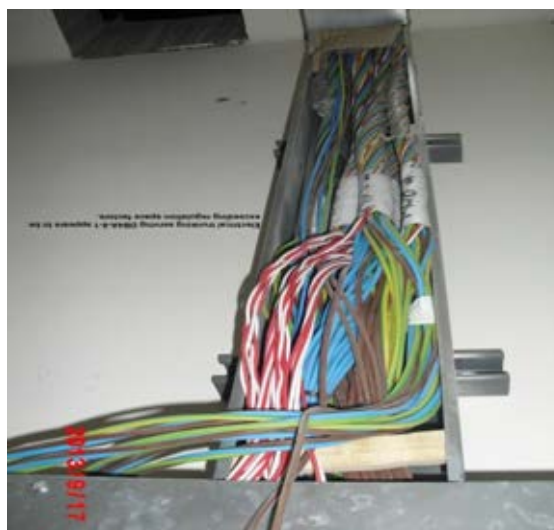
The wiring installed within the trunking at DB 4A-5-1 exceeds the regulated space factor for wiring installations as per section 4.5.3 of the 17th Edition of the IEE Regulations concerning cable capacities in conduits and trunkings. Confirm when this has been addressed.

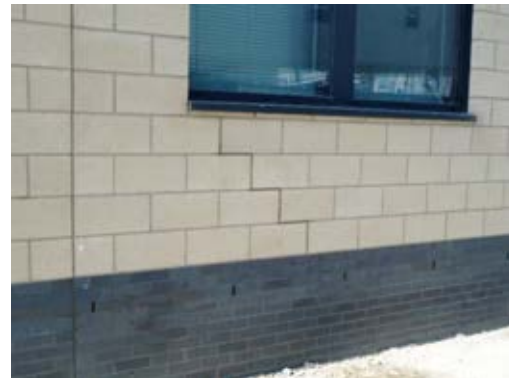
We carried out an inspection of the blockwork with Brookfield on the south and east elevation. The pointing in some areas is darker than the specified pointing. Brookfield intends to tint a sample area to demonstrate that a uniform colour can be attained to the pointing.

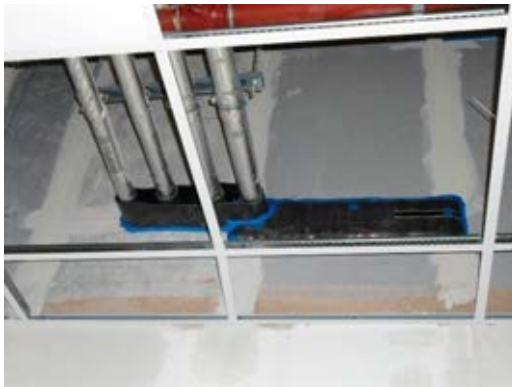
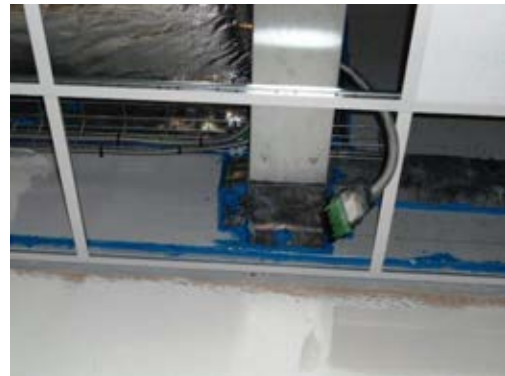
We await details of the lead protection to ducts and penetrations passing through walls above the ceilings within Radiology. Brookfield has confirmed that drawing No AST-XX-XX-DT-252-112 from Astins has been given status B by both NHS and Brookfield with over marked comments. Brookfield discussed this with Astins and a test of rooms is planned for 1st May in specific areas on the ground floor. The results of these tests will confirm if the detail is satisfactory. (See Supervisor's Communication General Matters / Other Instructions (CI 13.1) No 163.

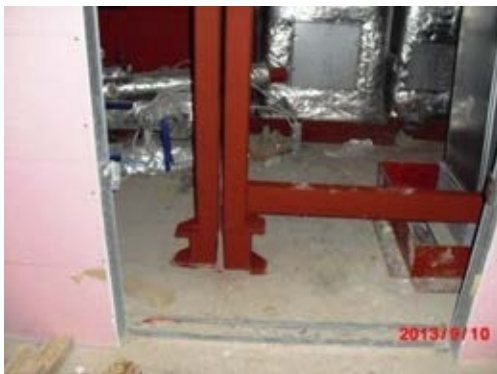
The steel framework in riser on Level 0 ZF Riser M30 has had the legs extended immediately in front of the entrance door. There are other legs which have not been extended yet and we asked Brookfield to confirm when the other legs will be extended. Brookfield has confirmed that these legs are not weight bearing and the weight bearing supports are on Level 01. They also confirmed that the extended legs will be cut back to be completely clear of the ground floor to finish flush with the frame. We asked for confirmation that the justification for this is based on an analytical assessment, and that the details provided are in accordance with this. We have received a further response but not an analytical assessment. We await a further response. (See Supervisor's Communication General Matters / Other Instructions (CI 13.1) No 162).

Extended legs

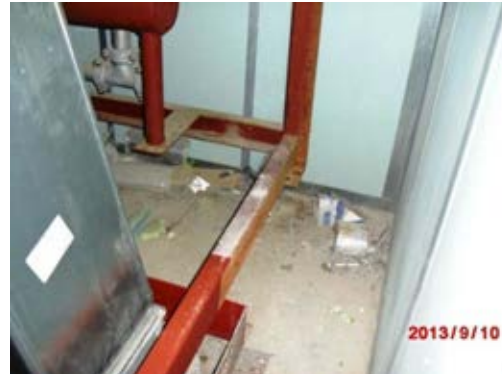
Leg still to be extended.

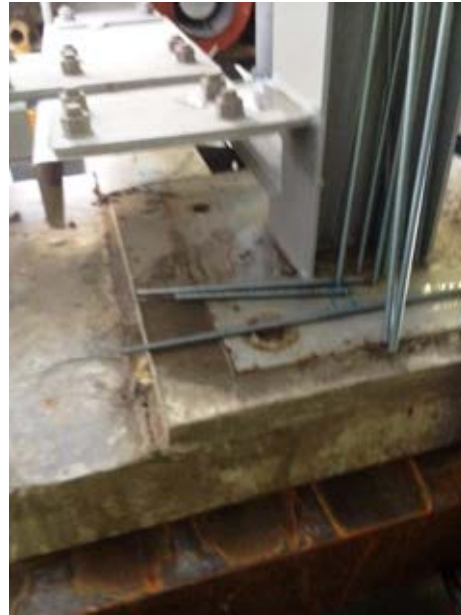
One of the base plates Level 4 Zone B has 2 out of 4 HD bolts either missing or not protruding through the baseplate. Brookfield has confirmed that post fixed anchors were installed and we will inspect this during our next site visit. (See Supervisor's Communication General Matters / Other Instructions (CI 13.1) No 182).

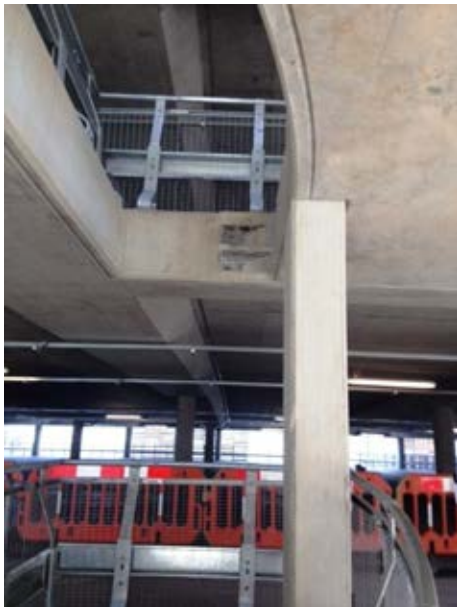
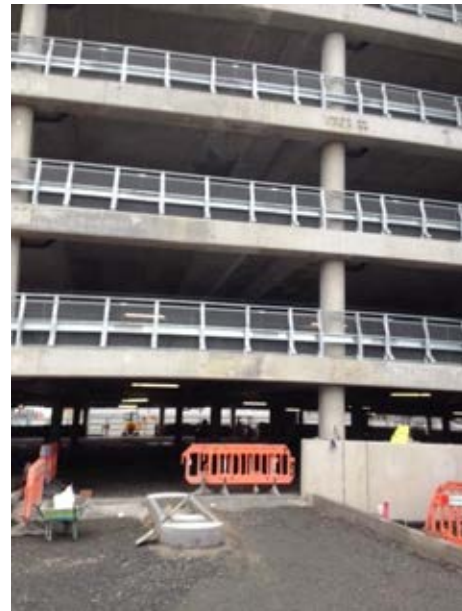
Several areas of the external slab still require some finishing attention, particularly at the prestressing positions. See attached photograph. We asked Brookfield to advise how and when these areas will be addressed. They have informed us that Dunnes currently have operatives working on the inside of the ramps (photo 1) and should be complete by 9th May. They will access the areas above the car park access road using the cladding scissor lift which is due once the tower crane comes down. They expect this to be completed by 16th May. (See Supervisor's Communication General Matters / Other Instructions (CI 13.1) No 205).

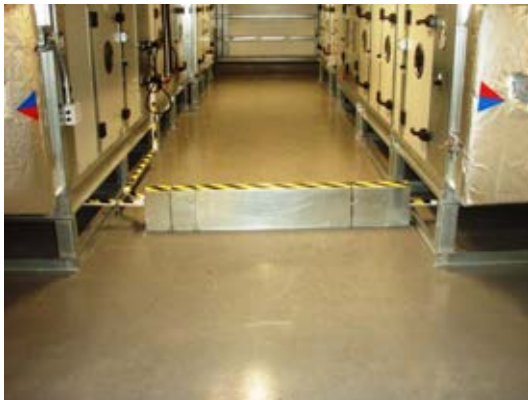
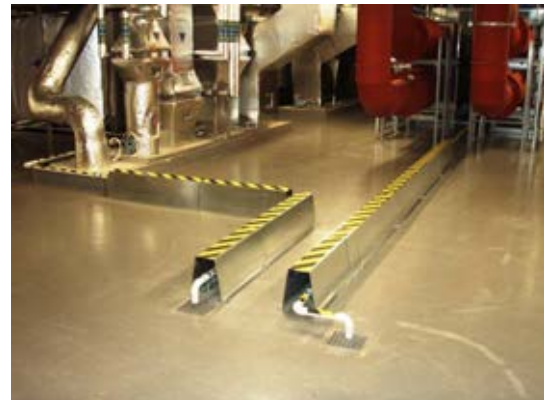
During our inspections in Plant Room 21, we noted that all AHU condensate discharges are routed to gullies via low level unprotected plastic pipework. This is a potential trip hazard. Below are photographs which show the solution to the problem and Brookfield has reported that this has been agreed to by NHS Board. Consequently Supervisor's Communication General Matters / Other Instructions (CI 13.1) No 122 is closed out.

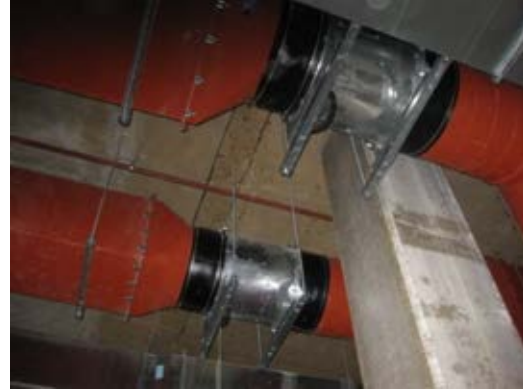
We asked Brookfield to confirm that the fire rating of the flexible connections and supporting system in Plant room PR31 is equivalent to the overall system requirements. The fan is located adjacent to atrium at the west side of building. We also asked them to confirm fire rating of fans (observed as non-bifurcated type). ZBP has confirmed to Brookfield that fans require to be fire rated and are at technical submittal stage. Brookfield has issued an instruction to have the fans replaced. Brookfield has confirmed that the neck pieces are flame retardant to BS 7837:1996. Consequently Supervisor's Communication General Matters / Other Instructions (CI 13.1) No 133 is closed out.

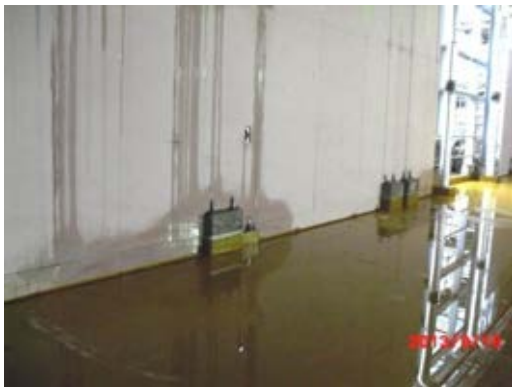
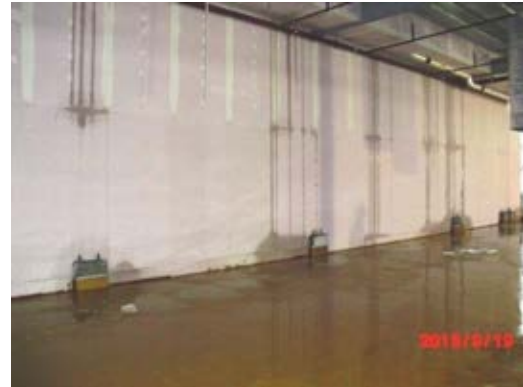
The partition between the east side of the atrium and plant room 41 has been damaged by water ingress. Brookfield to confirm they are aware there has been some damage, and will replace the boards after they have completed the resin flooring works. (See Supervisor's Communication General Matters / Other Instructions (CI 13.1) No 166).

Water damaged boards.

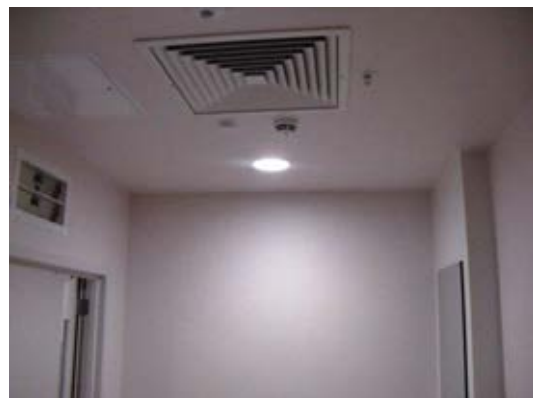
The smoke detector within the lobby on Level 1 Room CCW-049 is within 300mm of the supply grille. We asked Brookfield to confirm when this has been repositioned to the minimum distance of one metre. Mercury's specialist contractor has confirmed that In terms of BS5839-1 Clause 22.3 Paragraph M minimum spacing cannot be achieved. They cannot see how they are able to demonstrate the recommendation without infringing on

the minimum distance required to be away from the finished wall surfaces. They state further that due to third party equipment on the ceiling this restricts the position on the smoke detector. They state that it can remain in position. However this will mean that this is not compliant in terms of BS5839-1 Clause 22.3. Mercury together with their specialist fire systems installers is currently reviewing the position of the detectors. (See Supervisor's Notification of Defect (CI 42.2) No 74).

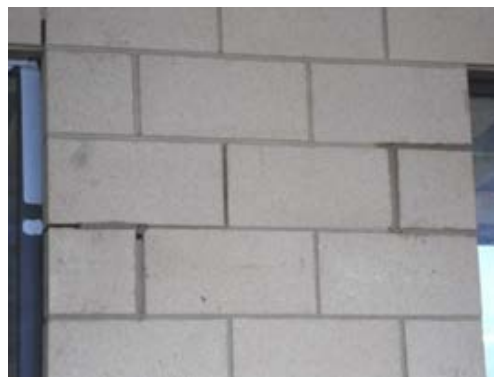
The quality of the workmanship to the blockwork on the West Facing Elevation is poor and requires to be addressed. The widths of perpends varying at various locations on this elevation. This is particularly evident between the windows on the right hand side of the entrance to A&E. See photo. Brookfield has confirmed that the issue has been addressed. We carried out a further inspection and noted that the pointing was still darker than the surrounding joints. (See Supervisor's Communication General Matters / Other Instructions (CI 13.1) No 64).

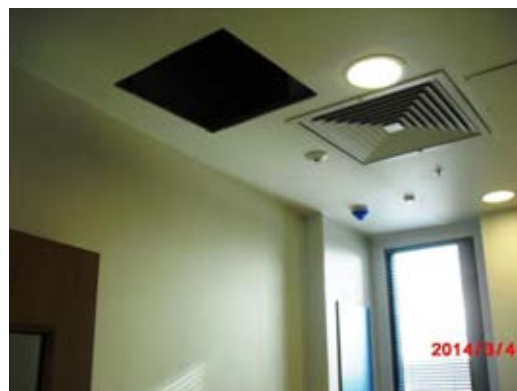
**CCW-100**

Smoke detectors on Level 1 Areas 1-517 and 1-518 have been fitted too close to the walls in rooms CCW-100 Isolation Ward Lobby and CCW-147 Recess. Consequently these are not compliant with BS5839-1 Clause 22.3 which states that smoke detectors should not be within 500mm of any walls, partitions or obstructions to flow of hot gases. We asked Brookfield to confirm when the above smoke detectors have been repositioned. Brookfield has informed us that following a response from their specialist fire system installers the

positions of the detectors have been reviewed. They have informed us that the detector positions in room CCW-100 will remain unchanged. They claim they are in the best positions. This still remains a defect.

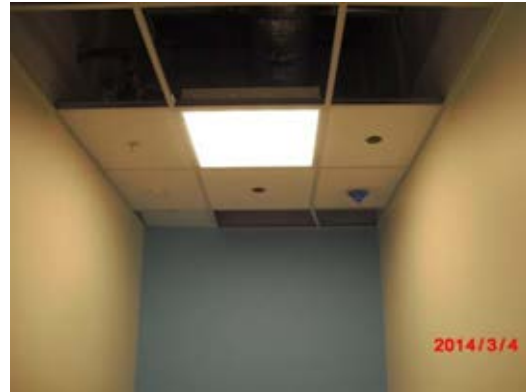
In room CCW-047 Brookfield's Sub Contractor Mercury together with their specialist fire systems installers is currently reviewing the position of the detectors. (See Supervisor's Notification of Defect (CI 42.2) No 70).

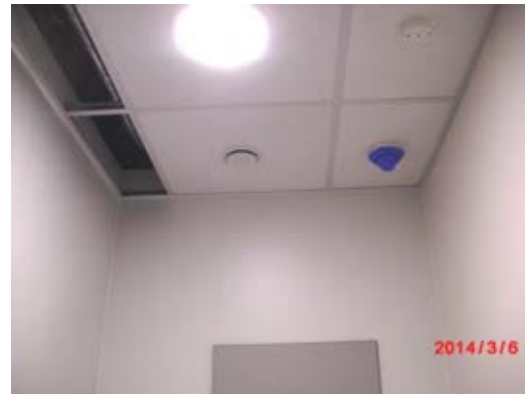
Smoke detectors have been fitted too close to the walls in rooms MP-018 Staff WC, MP-017 Staff WC, MP-002 Reception and MP-013 Cleaners. They are not compliant with BS5839-1 Clause 22.3 which states that smoke detectors should not be within 500mm of any walls, partitions or obstructions to flow of hot gases. We asked Brookfield to confirm when the above smoke detectors have been repositioned. Brookfield's Sub Contractor Mercury together with their specialist fire systems installers is currently reviewing the position of the detectors. (See Supervisor's Notification of Defect (CI 42.2) No 71).

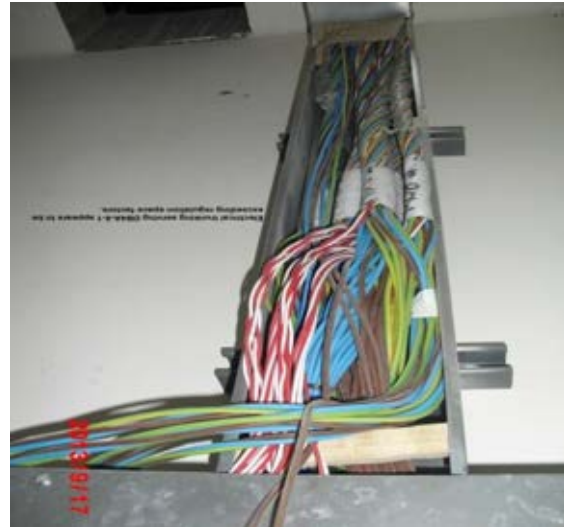
The wiring installed within the trunking at DB 4A-5-1 exceeds the regulated space factor for wiring installations as per section 4.5.3 of the 17th Edition of the IEE Regulations concerning cable capacities in conduits and trunkings. Confirm when this has been addressed. We have revisited the completed installation and are satisfied that the cables have now been posited properly within the trunking. Consequently Supervisor's Notification of Defect (CI 42.2) No 73 is closed out.

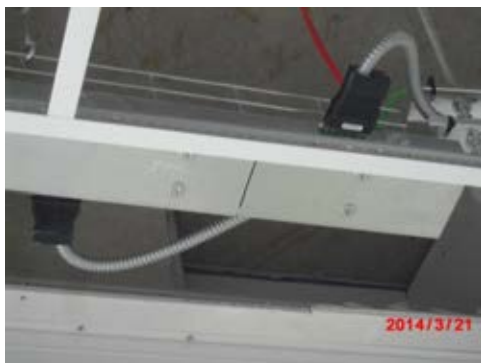
On Level 5 Zone J ward No GENW 006 a Metaflex type wiring system is being used to serve the power outlets in the bed head units. See photos. The cable is plugged into the Wago trunking in the ceiling void via a manufactured plug and drops down the vertical bed head trunking to the socket outlets. In other parts of the hospital installation (Level 1) the Metaflex cable is glanded into a metal box above the bed head dropper and then run within the trunking to the outlets.

Room GENW 006 Cable plugged into Wago power outlet.

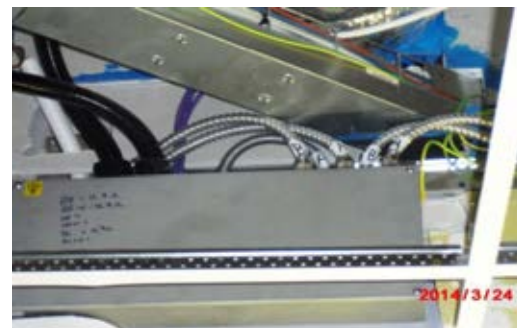
Level 1 Cable glanded properly into bedhead box trunking.

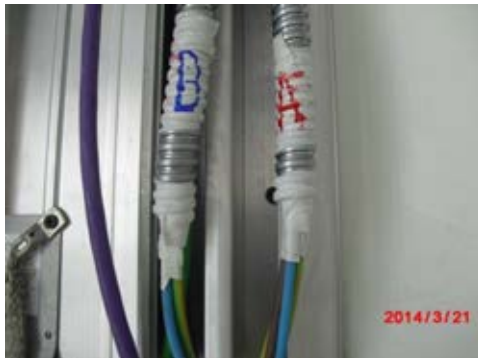
In GENW 006 the Metaflex cables enters the trunking via an open end and run down the inside of the trunking with the end of the Metaflex cable bound with PVC tape. This is not a recognised practice for terminating this type of cable as it leaves a sharp ragged edge which can cause damage to either the cable conductors themselves or neighbouring cables. This practice is not confined to this area alone and is evident on other floors. We asked Brookfield to confirm when the cables are installed correctly in this and other locations where this is evident. Mercury has consulted with the manufacturer and has fitted an anti shorting bush to prevent damage. We have reviewed a sample and the modification appears to resolve the issue. Supervisor's Notification of Defect (CI 42.2) No 76 is closed out but we will continue to monitor the installation.

Metaflex cable incorrectly installed with PVC tape.

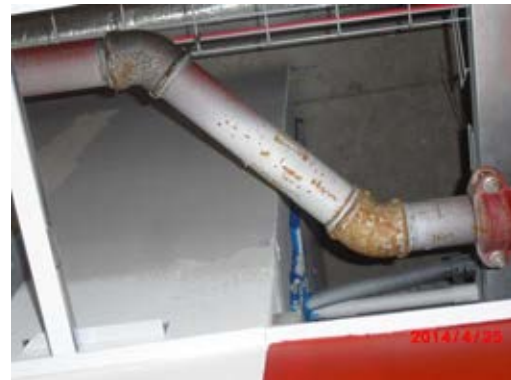
The sprinkler pipes on Level 2, Zone J, Area 2-532 are rusty. We asked Brookfield to confirm the treatment to prevent further rusting of these pipes and confirm when this will be carried out and completed. They have informed us that the defect notification has been forwarded to sprinkler specialist for their action. (See Supervisor's Notification of Defect (CI 42.2) No 77).

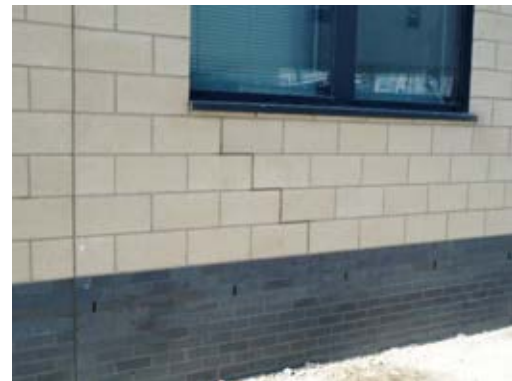
We carried out an inspection of the blockwork with Brookfield on the south and east elevation. The pointing in some areas is darker than the specified pointing. Brookfield tinted a sample area to demonstrate that a uniform colour can be attained to the pointing. The tinting inspected was an improvement to the original finish. A further joint inspection is to be carried with the NHS. See Supervisor's Communication General Matters / Other Instructions (CI 13.1) No 165).

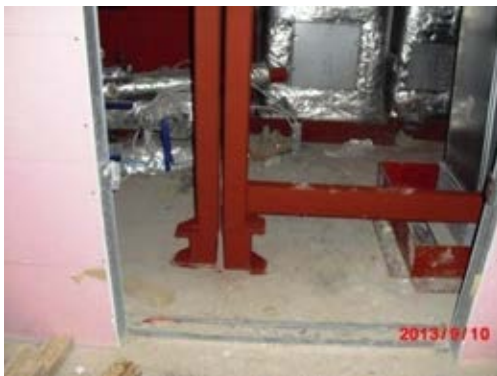
The steel framework in riser on Level 0 ZF Riser M30 has had the legs extended immediately in front of the entrance door. There are other legs which have not been extended yet and we asked Brookfield to confirm when the other legs will be extended. Brookfield informed us that Mercury removed the feet on the framing having it suspended from the soffit of the floor above. Brookfield has consulted with WSP re the allowable load on the slab edge around the risers. The design line load around the riser slab edges is based upon 0.8kN/m height/sq.m plan area. The calculations submitted by Mercury show a load of 0.99kN/m/sq.m which exceeds the design criteria therefore the legs will require extending to provide support from the lower floor. Mercury has been informed to replace/ extend the feet. (See Supervisor's Communication General Matters / Other Instructions (CI 13.1) No 162).

Extended legs

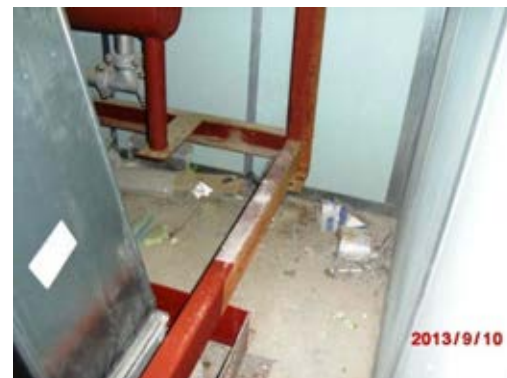
Leg still to be extended.

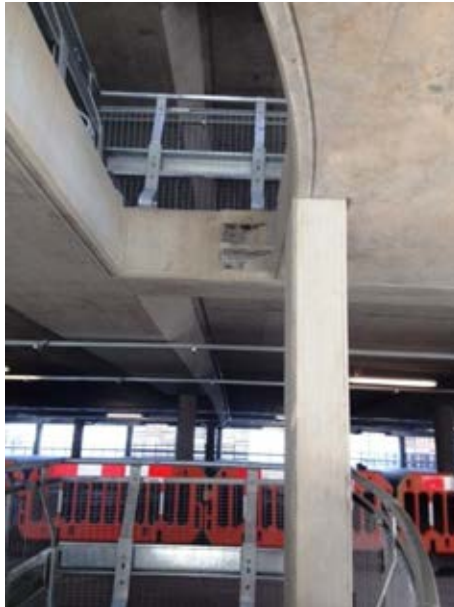
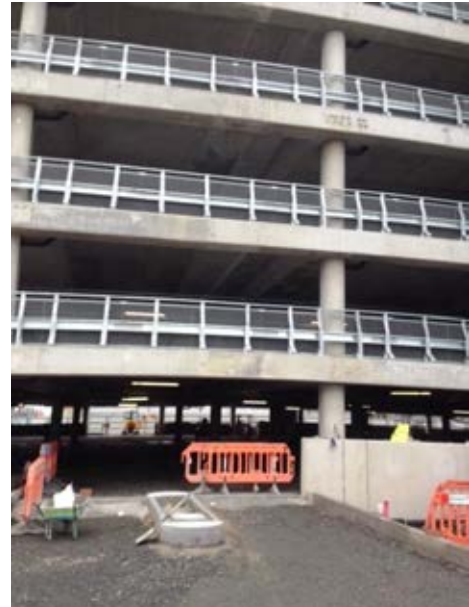
Several areas of the external slab still require some finishing attention, particularly at the prestressing positions. See attached photograph. We asked Brookfield to advise how and when these areas will be addressed. They have informed us that Dunnes currently have operatives working on the inside of the ramps (photo 1) and should be complete by 9th May. They will access the areas above the car park access road using the cladding scissor lift which is due once the tower crane comes down. They expect this to be completed by 16th May. (See Supervisor's Communication General Matters / Other Instructions (CI 13.1) No 205).

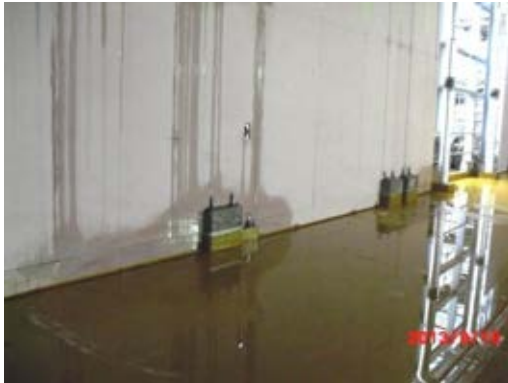
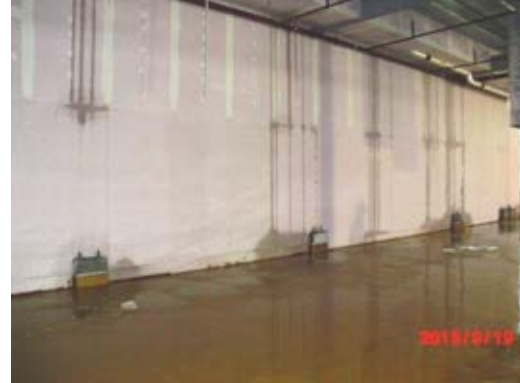
The partition between the east side of the atrium and plant room 41 has been damaged by water ingress. Brookfield to confirm they are aware there has been

some damage, and will replace the boards after they have completed the resin flooring works. (See Supervisor's Communication General Matters / Other Instructions (CI 13.1) No 166).

Water damaged boards.

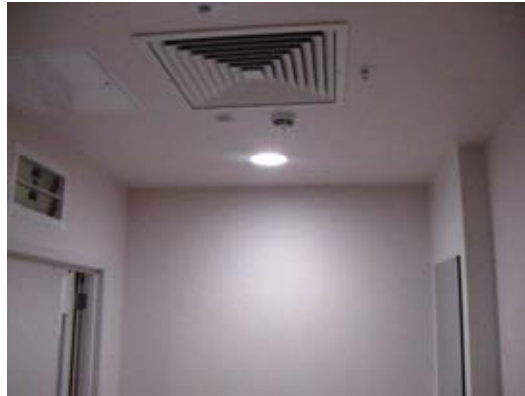
The smoke detector within the lobby on Level 1 Room CCW-049 is within 300mm of the supply grille. Due to restrictions on the ceiling the smoke detector has been fitted in its best location, consequently Supervisor's Notification of Defect (CI 42.2) No 74 is closed out.

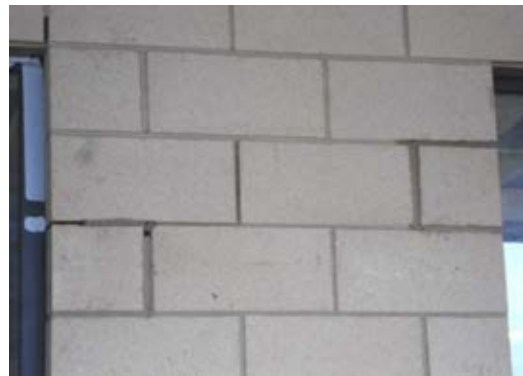
The quality of the workmanship to the blockwork on the West Facing Elevation was poor and required to be addressed. The above area was re-inspected on Friday 16/05/14 with Brookfield, Prater Sub Contractor JB Brickwork and ourselves. The remedial work had been carried out, consequently Supervisor's Communication General Matters / Other Instructions (CI 13.1) No 64 is closed out.

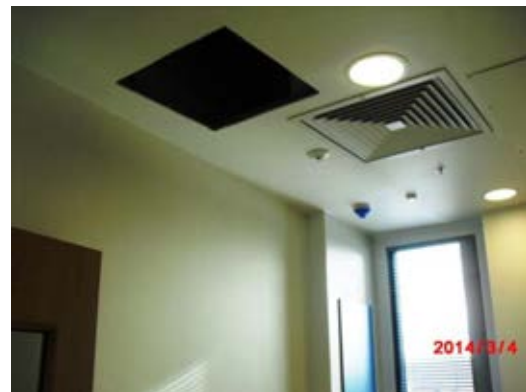
Smoke detectors on Level 1 Areas 1-517 and 1-518 have been fitted too close to the walls in rooms CCW-100 Isolation Ward Lobby and CCW-147 Recess. Mercury has reviewed the positioning of the detectors and can advise as follows. In 1-517 the detector holes have been cut in the best location possible with the constraints limiting positioning within the room. The devices will be fitted in the holes as cut. In 1-518 the detector would be better positioned further away from the wall to the full tile adjacent to the light fitting. They will advise when the work is completed in 1-518. See Supervisor's Notification of Defect (CI 42.2) No 70).

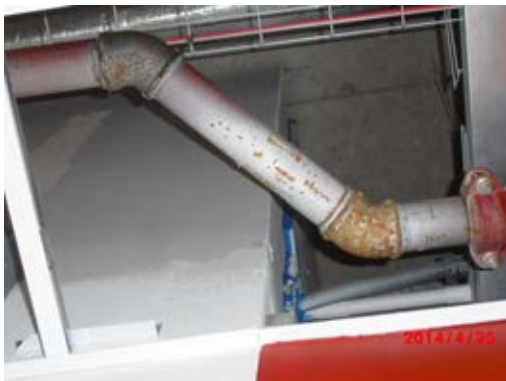
**Before**

The sprinkler pipes on Level 2, Zone J, and Area 2-532 became rusty during the installation of sprinkler pipe when the building was not water tight. The affected pipework has now been cleaned with a wire brush and re-painted as shown in photograph below. Similar work would take place should any other pipework be subjected to similar conditions that require cleaning and repainting. Supervisor's Notification of Defect (CI 42.2) No 77 is closed out.

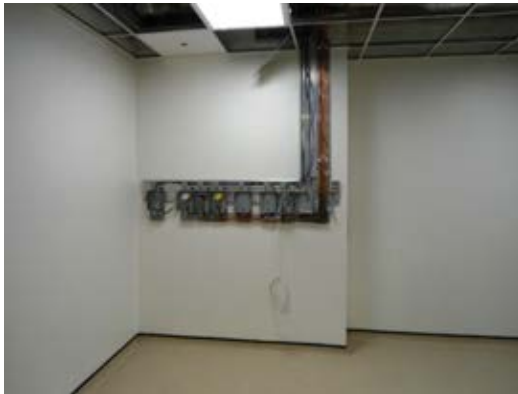
Room OPD 047 Medical trunking incomplete

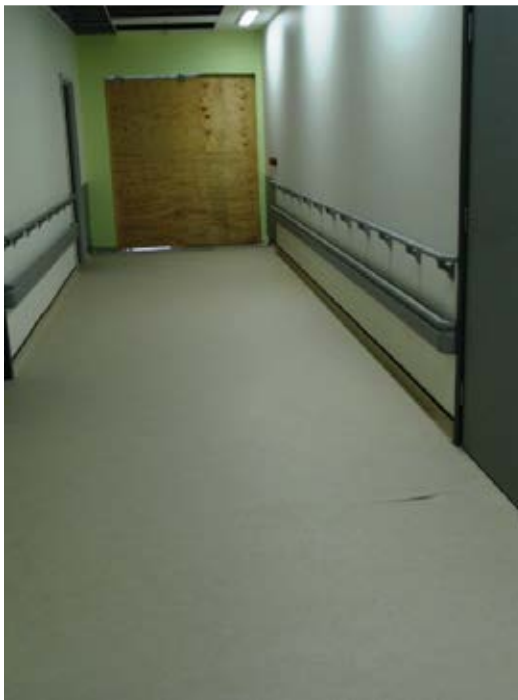
Corridors available for inspection with vinyl weld incomplete.

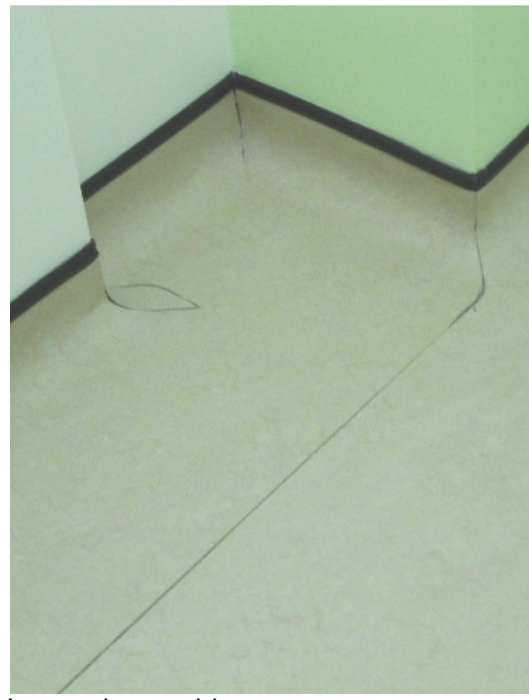
Incomplete welds.

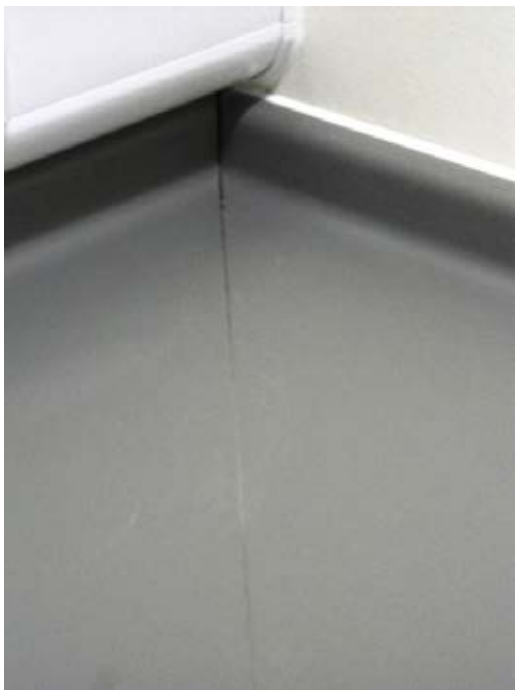
Poorly fitted joint to worktop recorded on Brookfield's IDMS

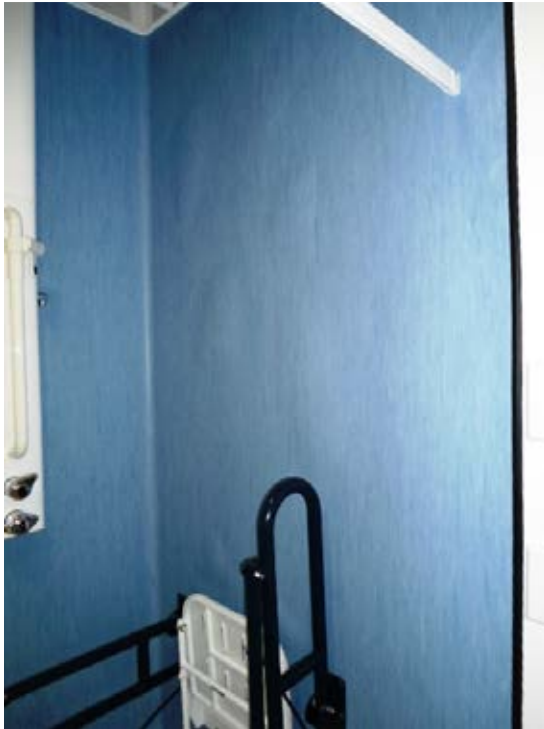
Vinyl becoming detached from the wall.

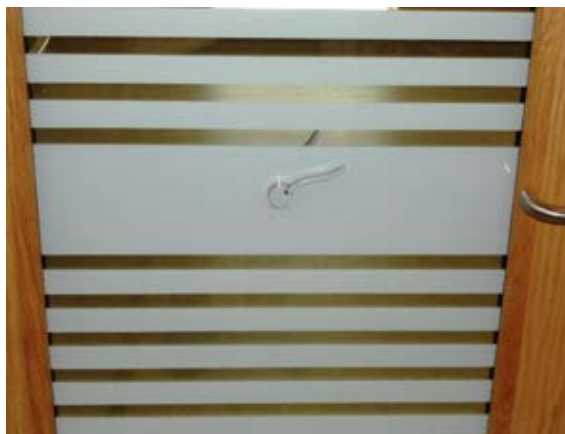
Handle to vision screen loose.

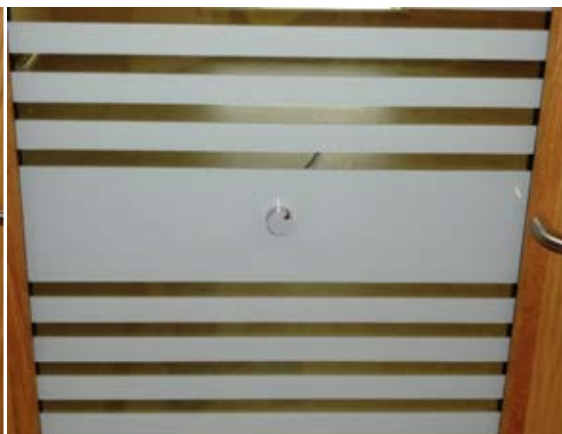
Handle to vision screen detached.

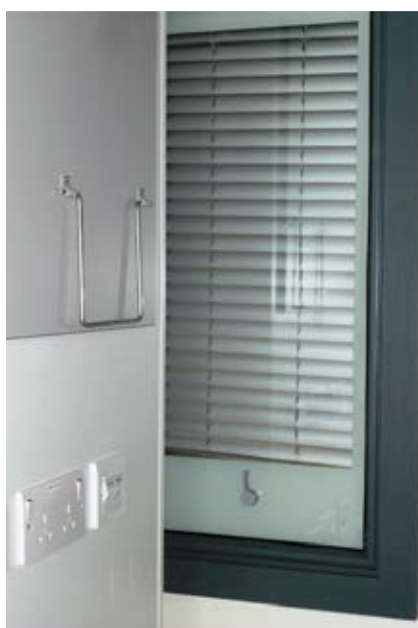
Blinds not level

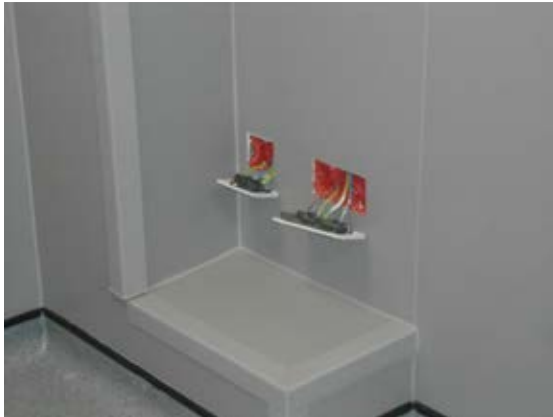
Fire putty present behind cover plate.

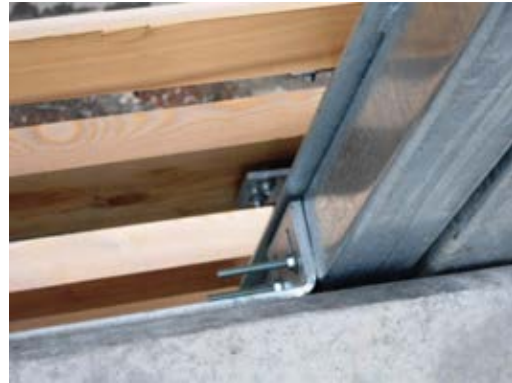
We carried out an inspection of the Car Park with Brookfield and the work is progressing to completion. There were only a few issues raised and these were, the edge of the ramp is too steep and some of the horizontal timber board were not fitted tight against the metal backplates. Brookfield confirmed that these would be remedied. We shall continue to monitor the works.

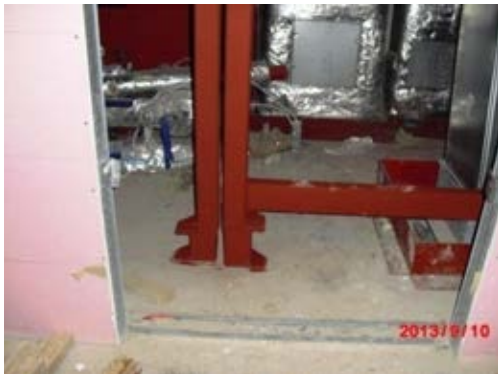
Extended legs

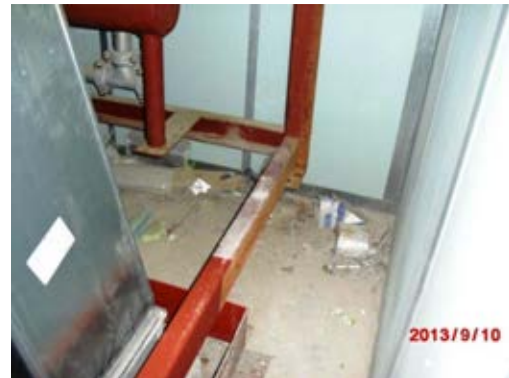
Leg still to be extended.

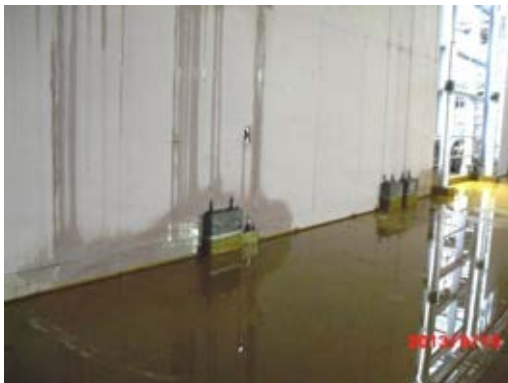
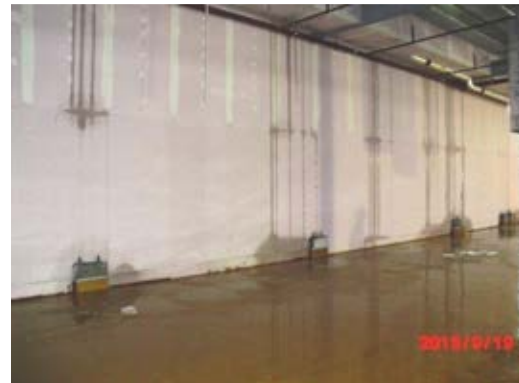
The partition between the east side of the atrium and plant room 41 has been damaged by water ingress. Brookfield to confirm they are aware there has been some damage, and will replace the boards after they have completed the resin flooring works. (See Supervisor's Communication General Matters / Other Instructions (CI 13.1) No 166).

Water damaged boards.

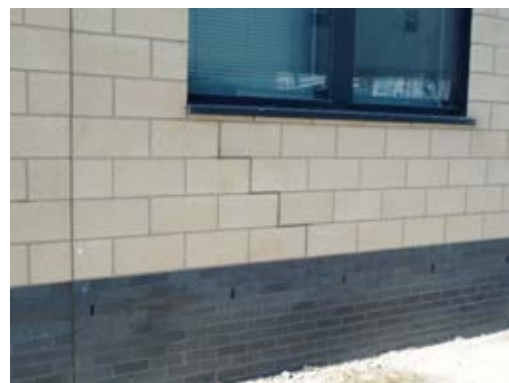
We carried out an inspection of the blockwork with Brookfield on the south and east elevation. The pointing in some areas is darker than the specified pointing. Brookfield tinted a sample area to demonstrate that a uniform colour can be attained to the pointing. The tinting inspected was an improvement to the original finish. A further joint inspection was carried with the NHS and it was agreed that the tinting was acceptable. Consequently Supervisor's Communication General Matters / Other Instructions (CI 13.1) No 165 is closed out.

Tinting of the dark pointing has not commenced yet but Brookfield has informed us that this will be done when the formation of the roads and paths are completed.

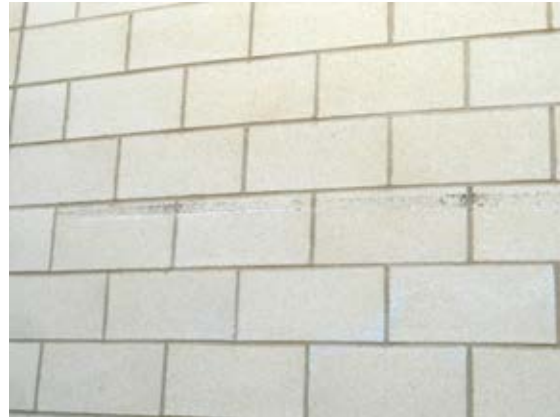
We have asked Brookfield to confirm when the damaged external blockwork on the curve of Area 2-513 in the Children's will be replaced. See Supervisor's Notification of Defect (CI 42.2) No 80.

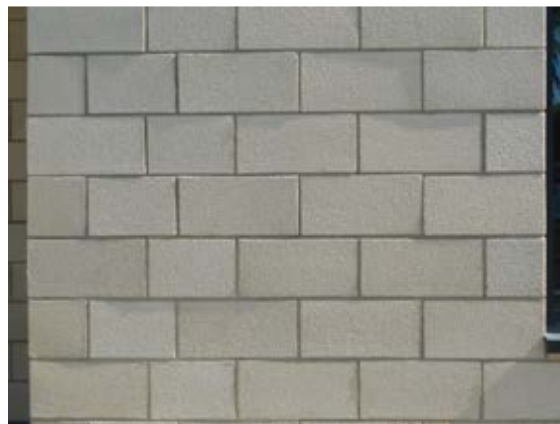
The blockwork at the right hand side of the Children's A&E entrance on the external wall of room EMC-009 is poor quality workmanship. The mortar beds vary in thickness and blocks have not been laid level. We have asked Brookfield when this will be addressed. See Supervisor's Notification of Defect (CI 42.2) No 79.

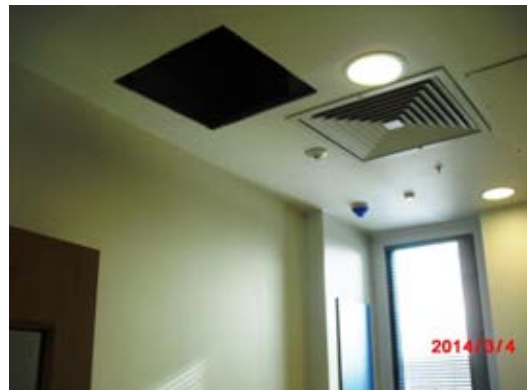
Smoke detectors on Level 1 Areas 1-517 and 1-518 have been fitted too close to the walls in rooms CCW-100 Isolation Ward Lobby and CCW-147 Recess. Mercury has reviewed the positioning of the detectors and can advise as follows. In 1-517 the detector holes have been cut in the best location possible with the constraints limiting positioning within the room. The devices will be fitted in the holes as cut. In 1-518 the detector would be better positioned further away from the wall to the full tile adjacent to the light fitting. They will advise when the work is completed in 1-518. See Supervisor's Notification of Defect (CI 42.2) No 70).

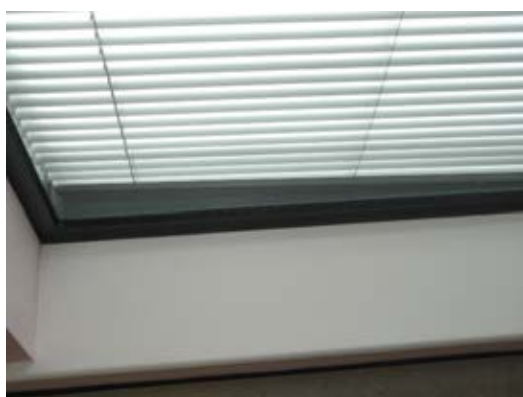
Blind not fitted in the window properly.

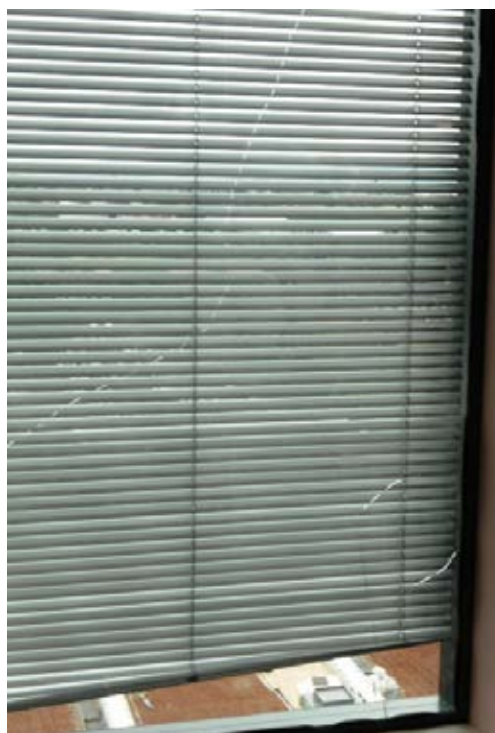
Broken pane of glass.

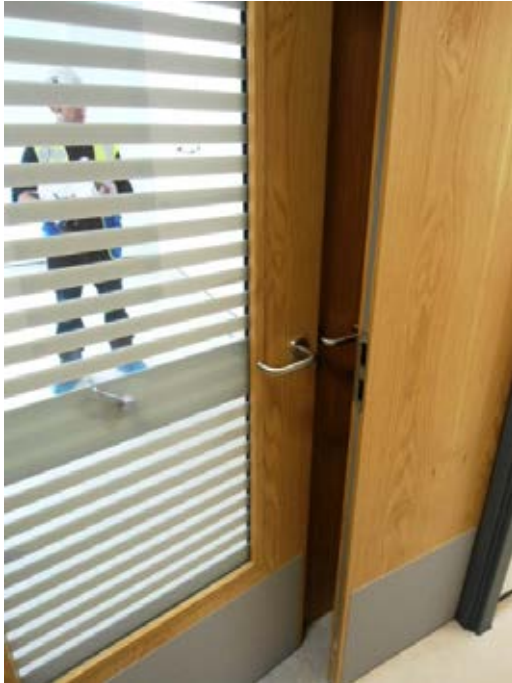
minor defects which Brookfield recorded onto their IDMS. We also noted that the door leading into room GEN WS-065 clashed with en-suite door but is in accordance with the 400 series drawings. This affects rooms in Zone E Area 512 on all areas.

Entrance door clashing with en-suite door.

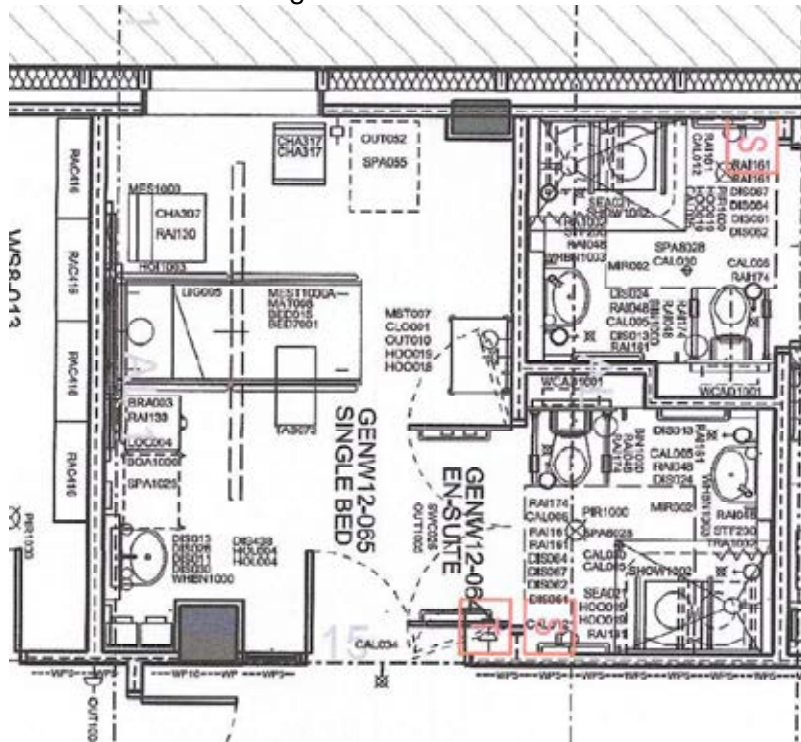
400 series drawing showing clash.

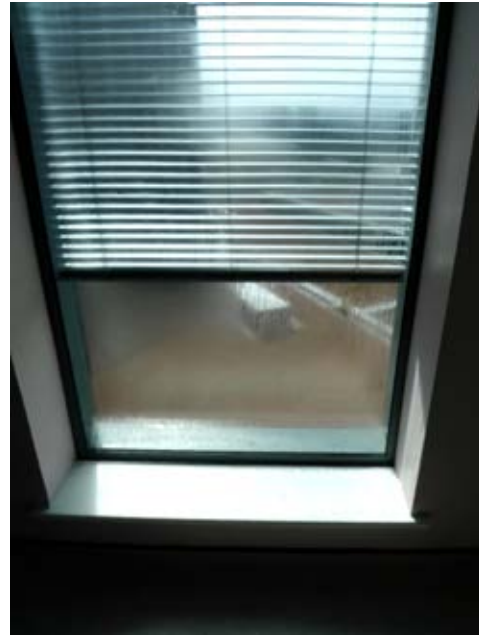
Quality & Compliance Inspection were carried on Level 8, 8-512, 8-513 and 8-514 with Brookfield and the quality of the work inspected was to a good standard. Brookfield recorded defects which we identified on their IDMS. We noted that there was some glass panes were dirty on the inside surface of the pane within the room and some panes had condensation within the cavity between the glass panes.

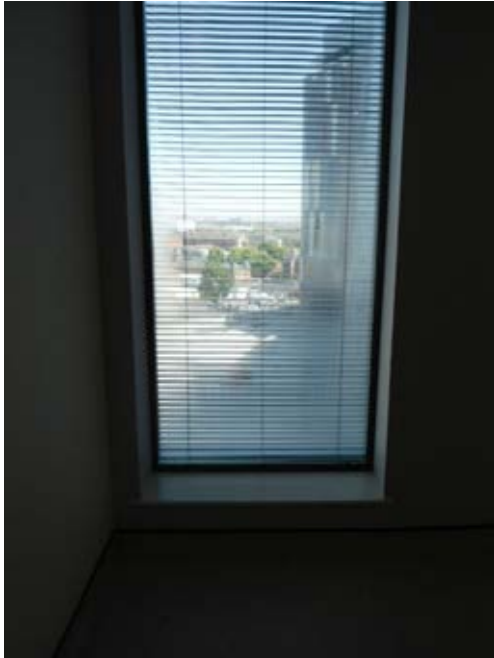
Condensation inside the inner pane of glass.

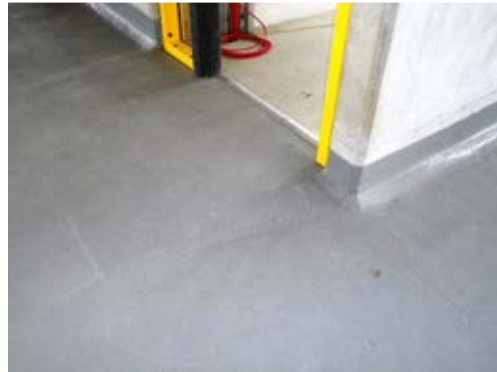
The ramped floor on levels 2, 3, 4, 5 and 6 leading from the car park to the main stairwell is ramped and part of the ramp has a steep gradient which does not appear to be DDA compliant and is also a trip risk. We have asked Brookfield to confirm what remedial work will be undertaken to remove this risk. (See Supervisor's Communication General Matters / Other Instructions (CI 13.1) No 208.
