**Bundle of documents for Oral hearings
commencing from 13 May 2025 in relation
to the Queen Elizabeth University Hospital
and the Royal Hospital for Children,
Glasgow**

**Bundle 33
NEC3 Supervisor's Reports and Project
Supervisors Interface Action Notes**

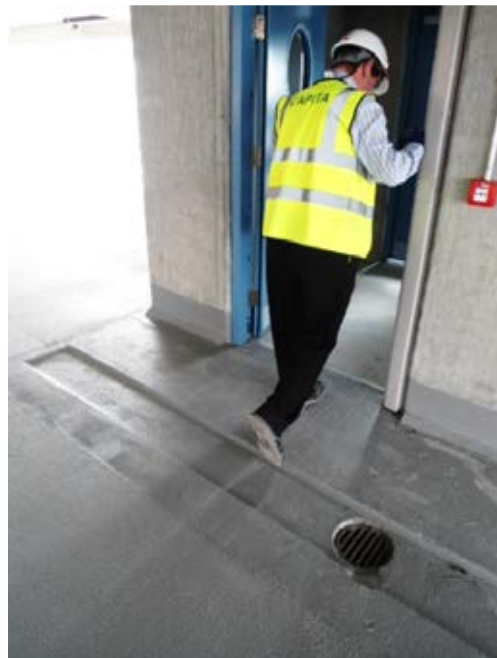
The car park floors on levels 3, 4, 5 and 6 have recessed channels which are less than a metre from the stairwell doors on the Hardgate Rd elevation. The channel is a potential trip hazard. We have asked Brookfield to confirm what remedial work will be undertaken to remove this risk. (See Supervisor's Communication General Matters / Other Instructions (CI 13.1) No 209.

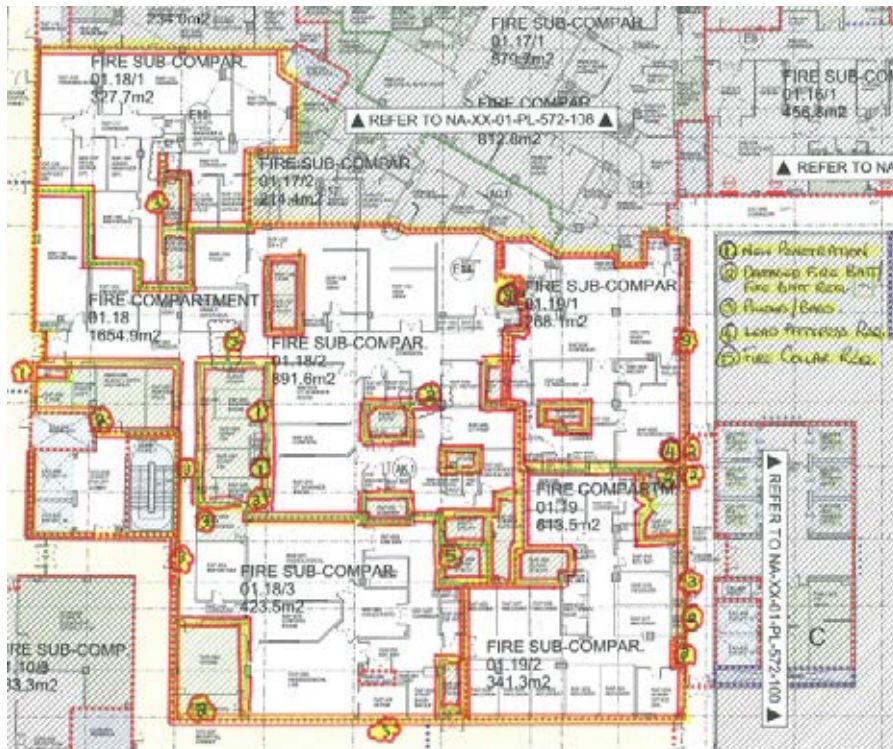
Marked up drawing showing remedial fire stopping work above ceiling Area 2-528.

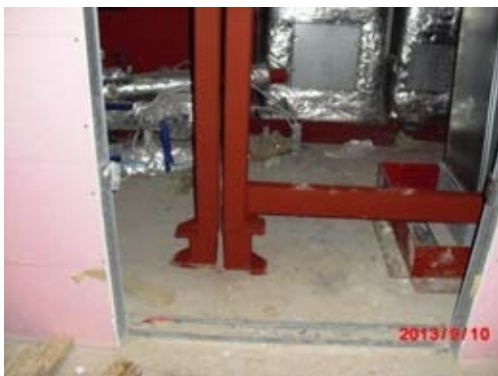
The steel framework in riser on Level 0 ZF Riser M30 has had the legs extended immediately in front of the entrance door. There are other legs which have not been extended yet and we asked Brookfield to confirm when the other legs will be extended. Brookfield informed us that Mercury removed the feet on the framing having it suspended from the soffit of the floor above. Brookfield has consulted with WSP re the allowable load on the slab edge around the risers. The design line load around the riser slab edges is based upon 0.8kN/m height/sq.m plan area. The calculations submitted by Mercury show a load of 0.99kN/m/sq.m which exceeds the design criteria therefore the legs will require extending to provide support from the lower floor. Mercury has been informed to replace/ extend the feet. (See Supervisor's Communication General Matters / Other Instructions (CI 13.1) No 162).

Extended legs

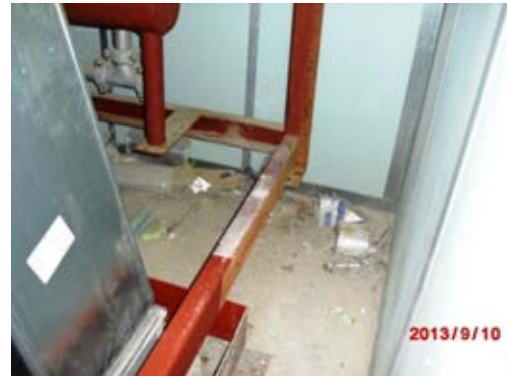
Leg still to be extended.

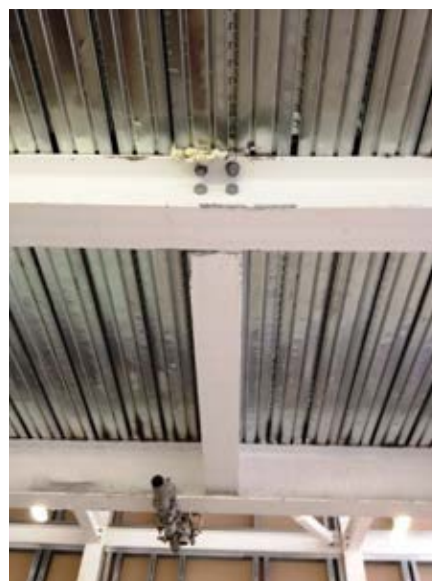
Some areas of intumescent painting to the steelwork on the 1st Floor Podium on the East Side of the Main Atrium appear to be chipped. We asked Brookfield to confirm that this will be addressed as required to ensure overall compatibility with the specification. They have confirmed any areas of the intumescent fire protection on the steelwork that has been damaged will be rectified and that we would be invited to inspect prior to any closing up of the areas. (See Supervisor's Communication General Matters / Other Instructions (CI 13.1) No 210).

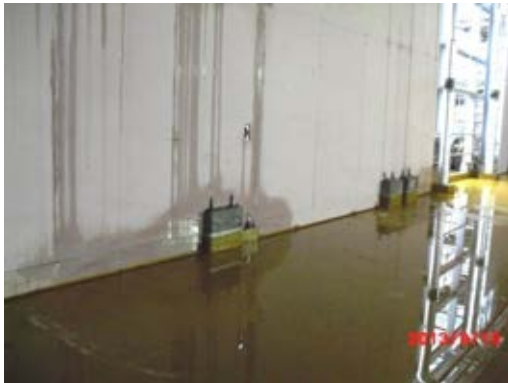
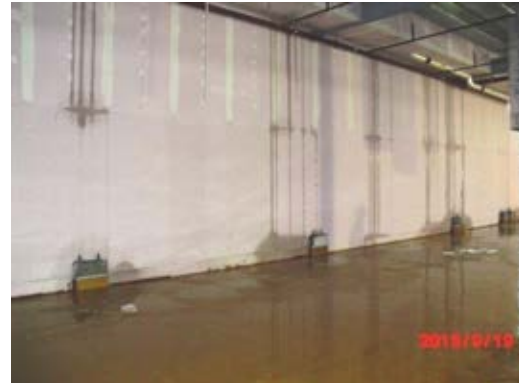
The partition between the east side of the atrium and plant room 41 has been damaged by water ingress. Brookfield to confirm they are aware there has been some damage, and will replace the boards after they have completed the resin flooring works. (See Supervisor's Communication General Matters / Other Instructions (CI 13.1) No 166).

Water damaged boards.

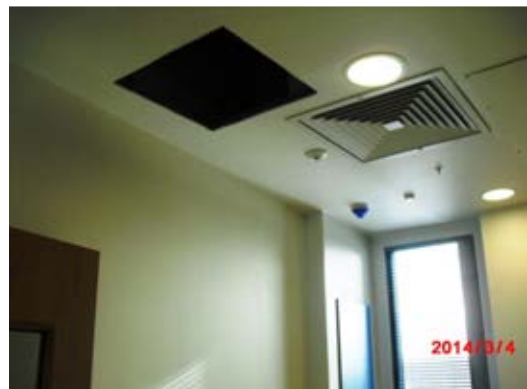
Smoke detectors on Level 1 Areas 1-517 and 1-518 have been fitted too close to the walls in rooms CCW-100 Isolation Ward Lobby and CCW-147 Recess. Mercury has reviewed the positioning of the detectors and can advise as follows. In 1-517 the detector holes have been cut in the best location possible with the constraints limiting positioning within the room. The devices will be fitted in the holes as cut. In 1-518 the detector would be better positioned further away from the wall to the full tile adjacent to the light fitting. They will advise when the work is completed in 1-518. See Supervisor's Notification of Defect (CI 42.2) No 70).

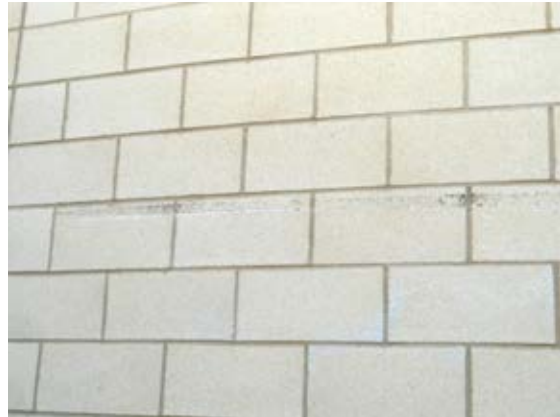
We asked Brookfield to confirm when the damaged external blockwork on the curve of Area 2-513 in the Children's will be replaced. Brookfield confirmed that the damage shown on the defect notice has been noted by Prater and the damage reported to Brookfield. It is the subject of CEN which an instruction is awaited. Brookfield has intimated that it is intended that these works will be completed at a time to be agreed with them but before 31 August 14. See Supervisor's Notification of Defect (CI 42.2) No 80.

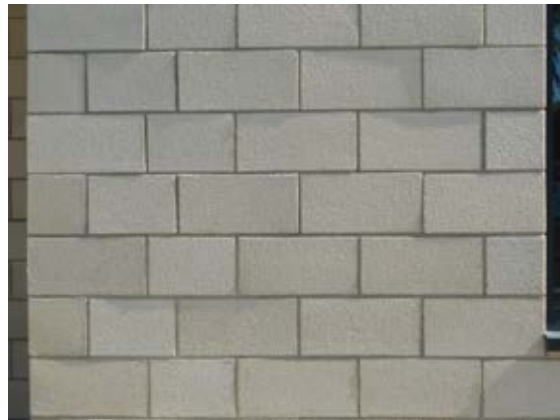
The blockwork at the right hand side of the Children's A&E entrance on the external wall of room EMC-009 is poor quality workmanship. The mortar beds vary in thickness and blocks have not been laid level. We asked Brookfield when this will be addressed. They confirmed that the blockwork panel was inspected by the installer and accepted that the quality is not at the standard required. The panel will be taken down and rebuilt at a time to be agreed with BMCE, but before end of August 2014.

In respect of the mortar beds, these will be tinted to match the adjacent blockwork at the time when the remaining remedials are being carried out.

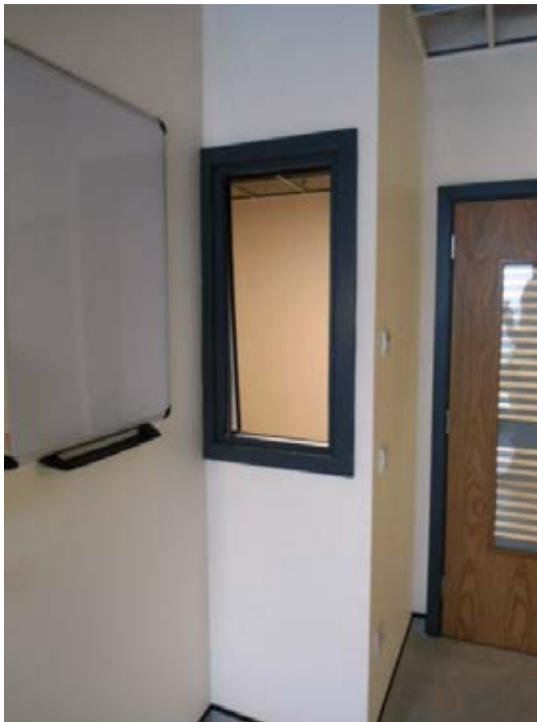
Window to be fitted.

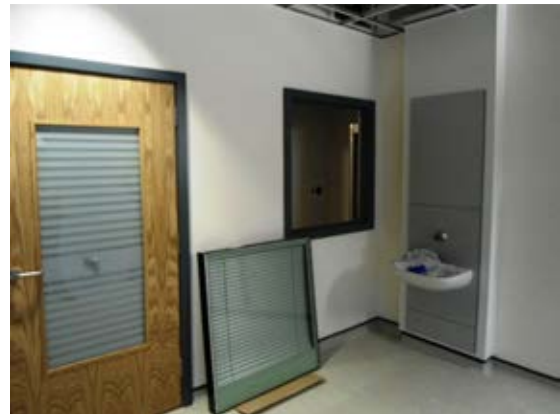
Window to be fitted.

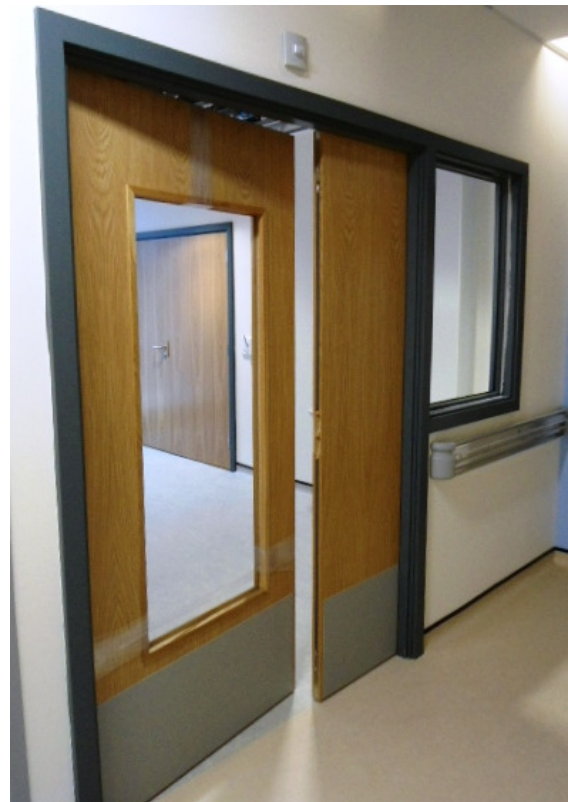
Door ironmongery to be fitted.

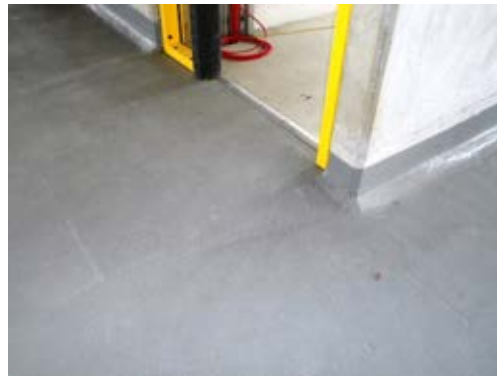
The ramped floor on levels 2, 3, 4, 5 and 6 leading from the car park to the main stairwell is ramped and part of the ramp has a steep gradient which does not appear to be DDA compliant and is also a trip risk. We asked Brookfield to confirm what remedial work would be undertaken to remove this risk. They have confirmed that they have been in contact with the Architect and Engineer. A handrail will be installed at the door jamb, preventing stepping onto the corner section of ramp. Consequently Supervisor's Communication General Matters / Other Instructions (CI 13.1) No 208 is closed out.

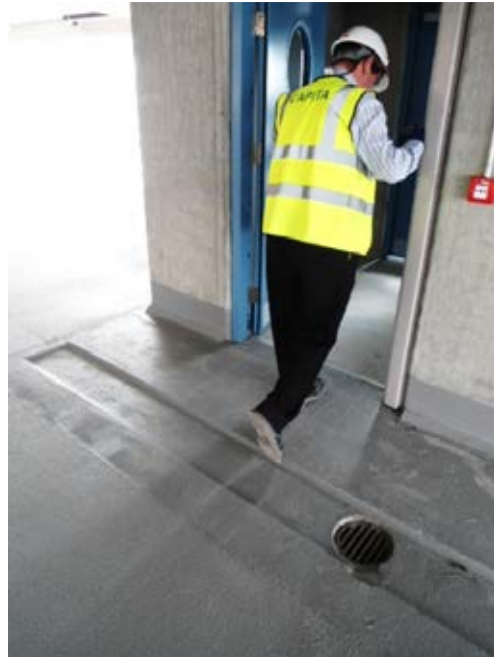
The car park floors on levels 3, 4, 5 and 6 have recessed channels which are less than a metre from the stairwell doors on the Hardgate Rd elevation. The channel is a potential trip hazard. We asked Brookfield to confirm what remedial work would be undertaken to remove this risk. They have confirmed that they are in discussion with Architect and will install a grill in the Channel to avoid the potential trip hazard. Consequently Supervisor's Communication General Matters / Other Instructions (CI 13.1) No 209 is closed out.

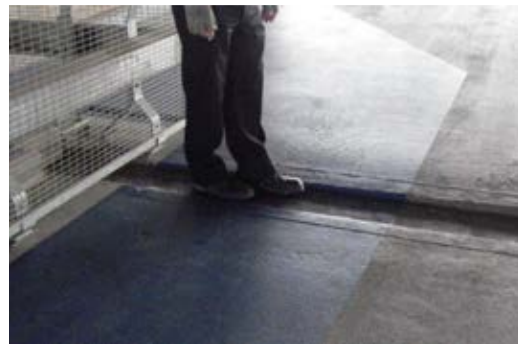
The car park floors on levels 1, 2, 3, 4, 5 and 6 have recessed channels which are a potential trip hazard. We asked Brookfield to confirm what remedial work would be undertaken to remove this risk. They have confirmed that they are in discussion with Architect and will install a grill in the Channel to avoid the potential trip hazard. Consequently Supervisor's Communication General Matters / Other Instructions (CI 13.1) No 11 is closed out.

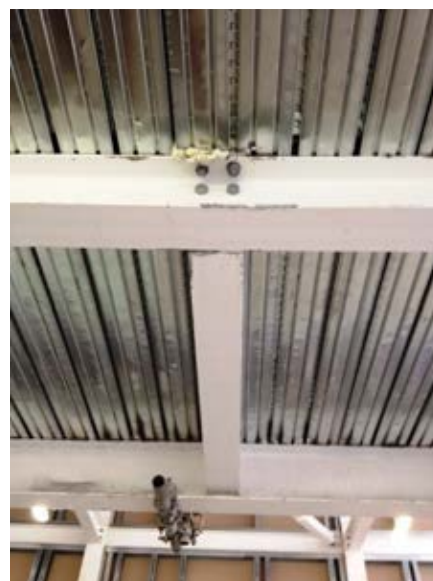
Some areas of intumescent painting to the steelwork on the 1st Floor Podium on the East Side of the Main Atrium appear to be chipped. We asked Brookfield to confirm that this will be addressed as required to ensure overall compatibility with the specification. They have confirmed any areas of the intumescent fire protection on the steelwork that has been damaged will be rectified and that we would be invited to inspect prior to any closing up of the areas. (See Supervisor's Communication General Matters / Other Instructions (CI 13.1) No 210).

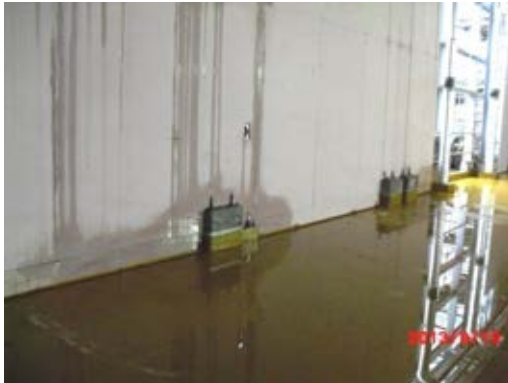
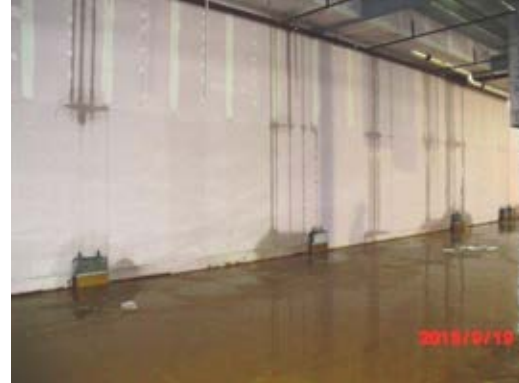
The partition between the east side of the atrium and plant room 41 has been damaged by water ingress. Brookfield to confirm that they are aware there has been

some damage, and will replace the boards after they have completed the resin flooring works. (See Supervisor's Communication General Matters / Other Instructions (CI 13.1) No 166).

Water damaged boards.

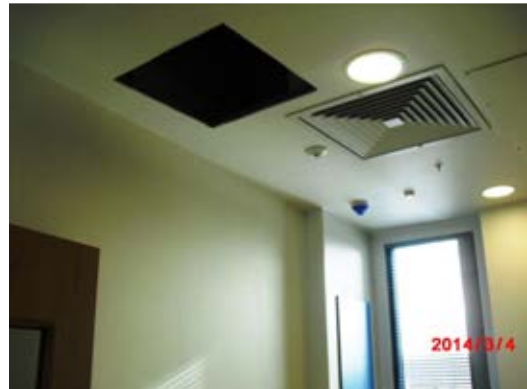
Smoke detectors on Level 1 Areas 1-517 and 1-518 have been fitted too close to the walls in rooms CCW-100 Isolation Ward Lobby and CCW-147 Recess. Mercury has reviewed the positioning of the detectors and can advise as follows. In 1-517 the detector holes have been cut in the best location possible with the constraints limiting positioning within the room. The devices will be fitted in the holes as cut. In 1-518 the detector would be better positioned further away from the wall to the full tile adjacent to the light fitting. They will advise when the work is completed in 1-518. See Supervisor's Notification of Defect (CI 42.2) No 70).

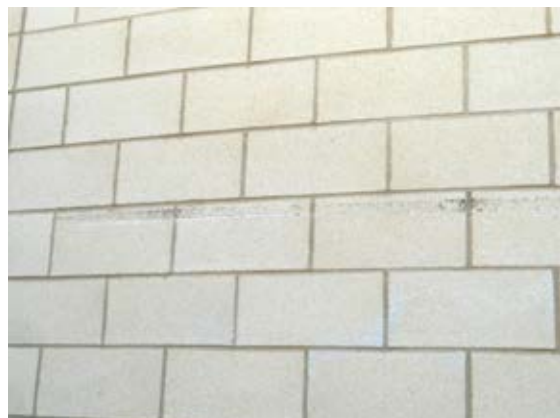
We asked Brookfield to confirm when the damaged external blockwork on the curve of Area 2-513 in the Children's will be replaced. They have confirmed that works to the external damaged blockwork on the curve have been completed. See Supervisor's Notification of Defect (CI 42.2) No 80.

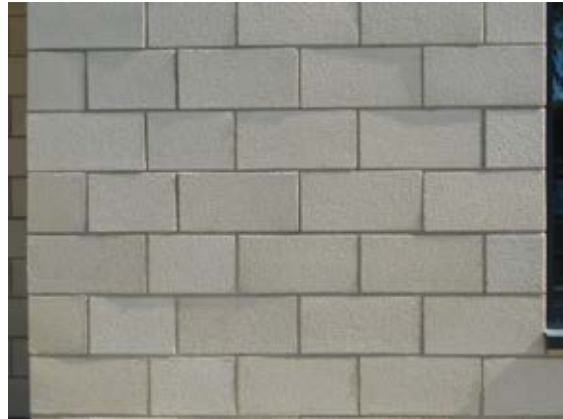
The blockwork at the right hand side of the Children's A&E entrance on the external wall of room EMC-009 is poor quality workmanship. The mortar beds vary in thickness and blocks have not been laid level. We asked Brookfield when this would be addressed. An inspection of the poorly laid blockwork was carried out with Brookfield and the work carried out was generally satisfactory, however one block still requires to be replaced. See Supervisor's Notification of Defect (CI 42.2) No 79.

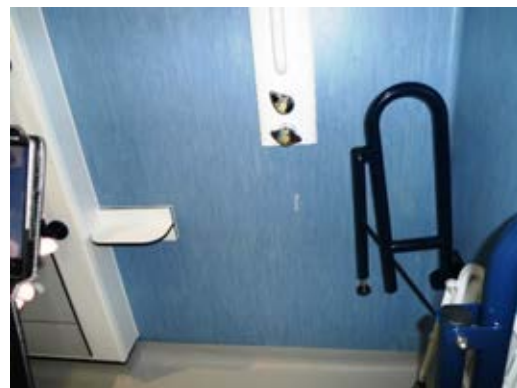
Gouge mark in vinyl

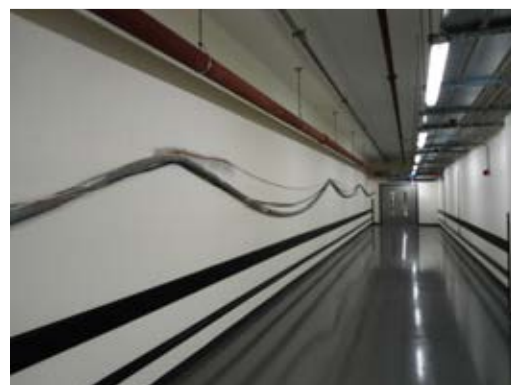
We carried out a Quality & Compliance Inspection in previously excluded rooms in the Basement with Brookfield and the quality of the work inspected was generally to a good standard. We did however note a few minor defects which Brookfield recorded on their IDMS. There were a number of temporary cables which required to be removed and the walls repaired and repainted.

Temporary cables to be removed.

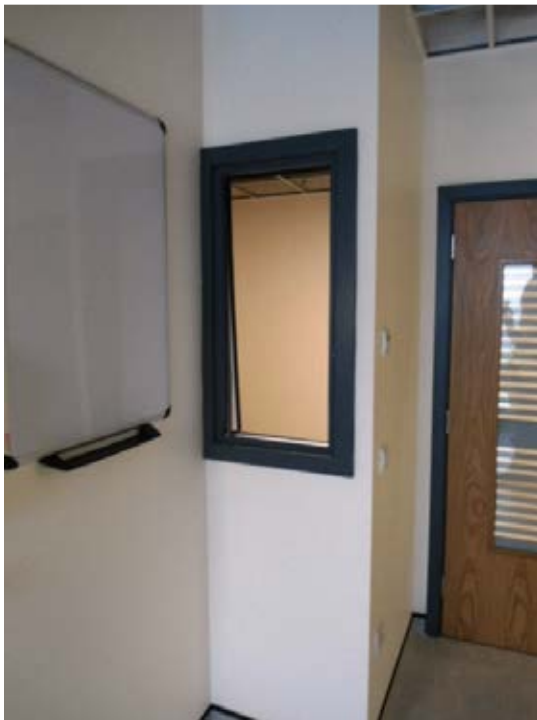
Window to be fitted.

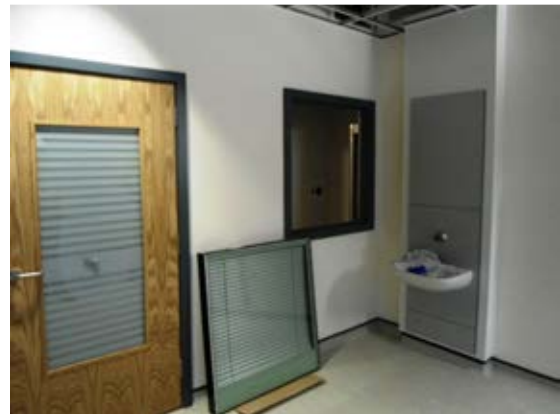
Window to be fitted.

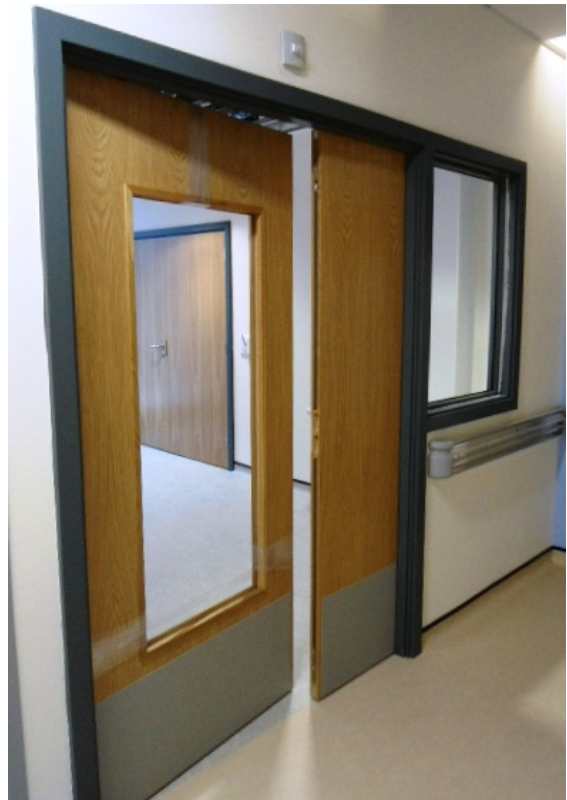
Door ironmongery to be fitted.

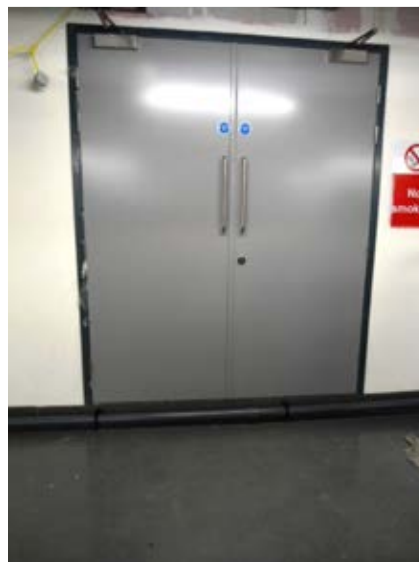
Unprotected pipe at fire escape threshold.

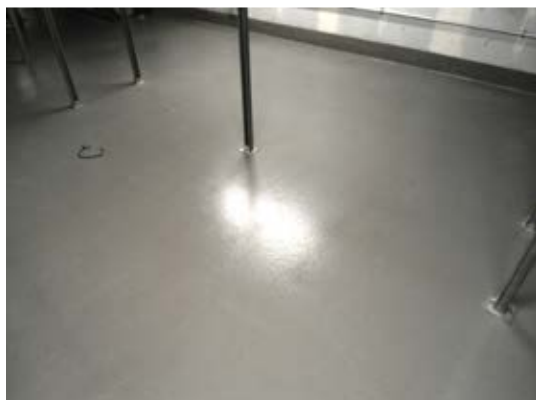
Area of good quality floor cover

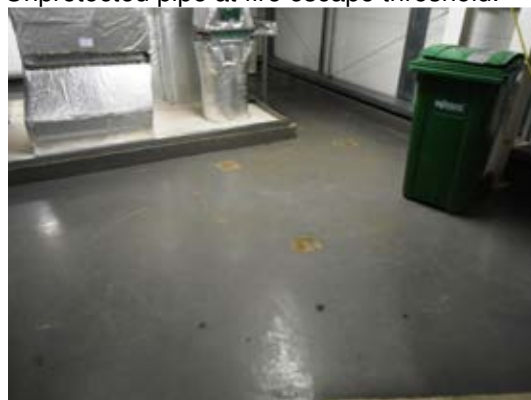
Scuffs, scrapes and damaged areas of floor.

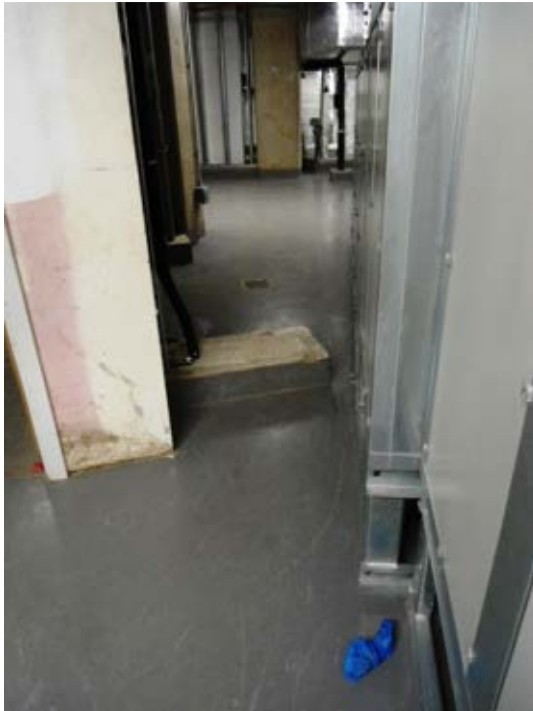
Potential trip hazard.

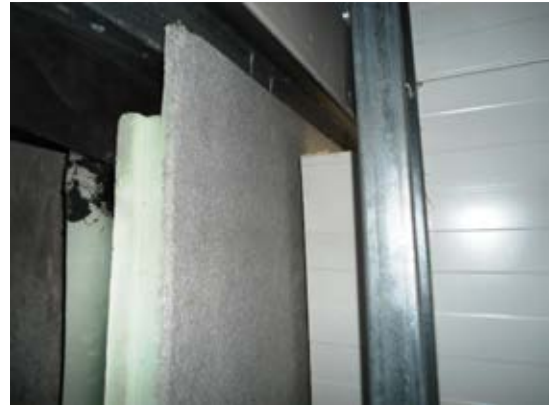
Gap between the outside at flat room level and the Plant Room.

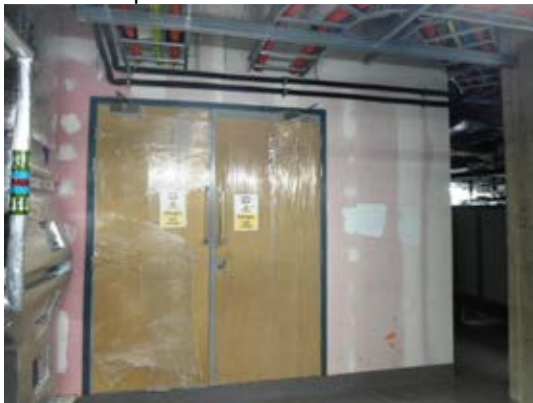
Work in progress.

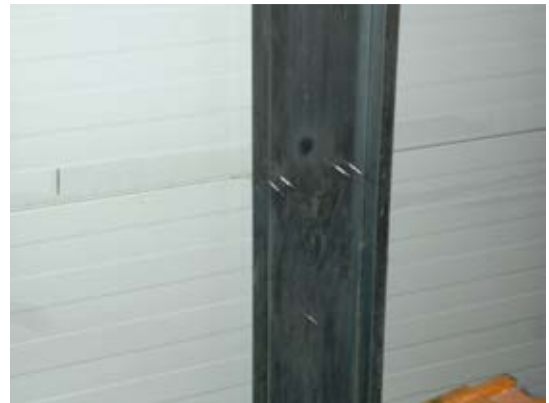
Unprotected screws.

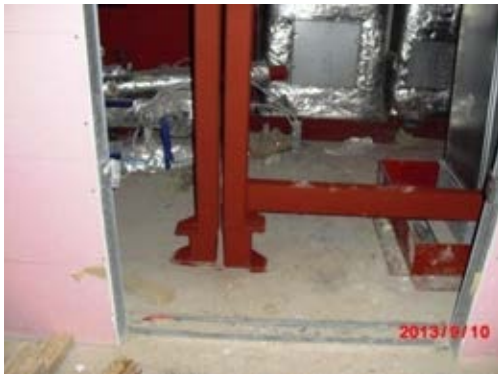
extended yet and we asked Brookfield to confirm when the other legs will be extended. Brookfield informed us that Mercury removed the feet on the framing having it suspended from the soffit of the floor above. Brookfield has consulted with WSP re the allowable load on the slab edge around the risers. The design line load around the riser slab edges is based upon 0.8kN/m height/sq.m plan area. The calculations submitted by Mercury show a load of 0.99kN/m/sq.m which exceeds the design criteria therefore the legs will require extending to provide support from the lower floor. Mercury has been informed to replace/ extend the feet. (See Supervisor's Communication General Matters / Other Instructions (CI 13.1) No 162).

Extended legs

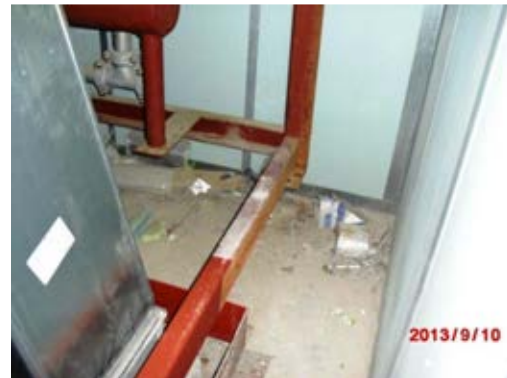
Leg still to be extended.

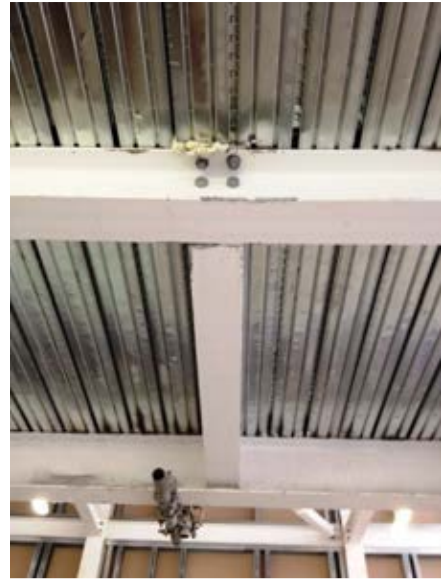
Some areas of intumescent painting to the steelwork on the 1st Floor Podium on the East Side of the Main Atrium appear to be chipped. We asked Brookfield to confirm that this will be addressed as required to ensure overall compatibility with the specification. They have confirmed any areas of the intumescent fire protection on the steelwork that has been damaged will be rectified and that we would be invited to inspect prior to any closing up of the areas. (See Supervisor's Communication General Matters / Other Instructions (CI 13.1) No 210).

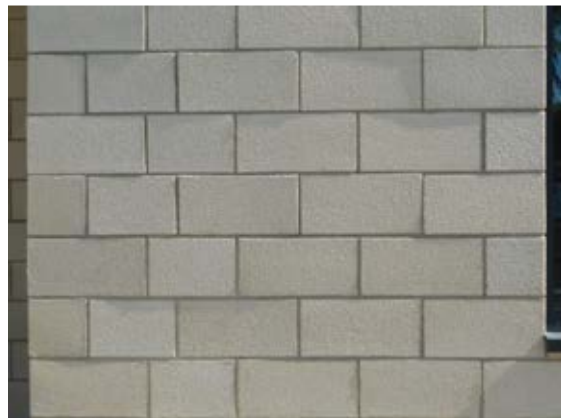
The blockwork at the right hand side of the Children's A&E entrance on the external wall of room EMC-009 is poor quality workmanship. The mortar beds vary in thickness and blocks have not been laid level. We asked Brookfield when this would be addressed. An inspection of the poorly laid blockwork was carried out with Brookfield and the work carried out was generally satisfactory, however one block still requires to be replaced. See Supervisor's Notification of Defect (CI 42.2) No 79.

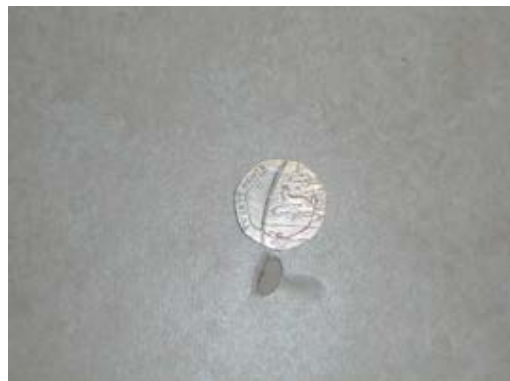
We carried out a Quality & Compliance Inspection to Level 5 Atrium Link Bridge with Brookfield and the quality of the work inspected was generally to a good standard. We did however note defects which Brookfield recorded on their IDMS. There were a few walls which required some attention to decoration. Vinyl had been patched at double doors which are a different shade from the vinyl laid previously. The vinyl had sustained damage across the full length of the Atrium Bridge. There was also a cubical door which had a few millimetres

clearance with the wc bowl.

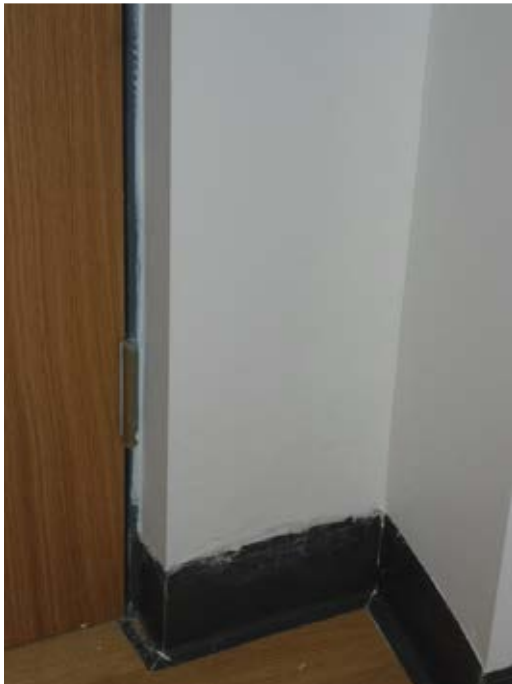
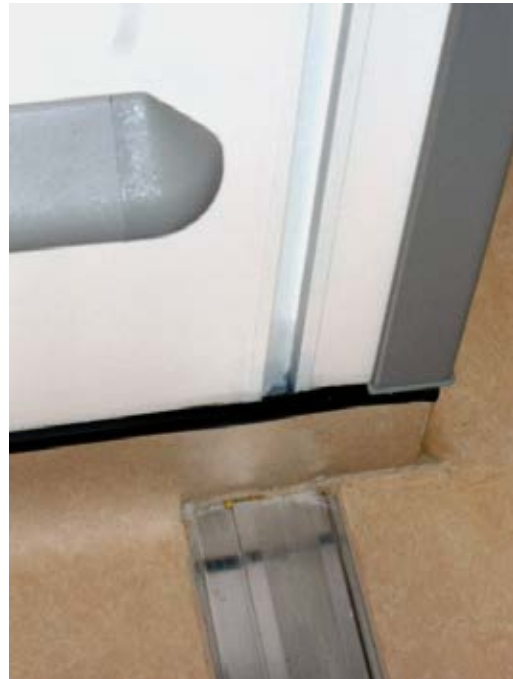
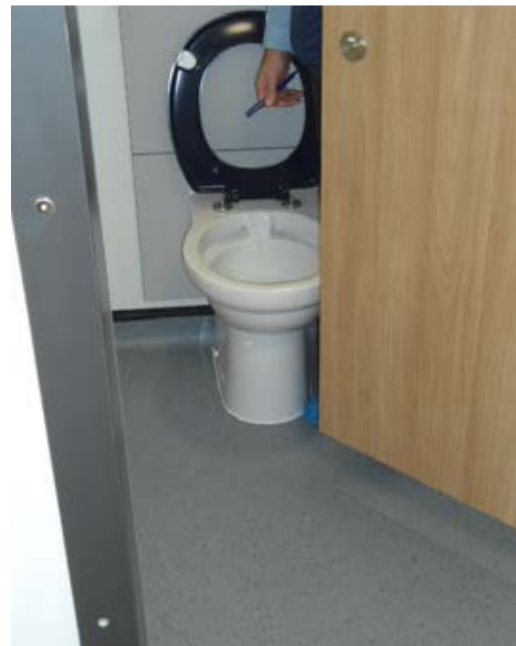
We note that there was insufficient activity space in front of the WC bowl in the room WS5-020 on Level 5 Atrium Bridge. We asked Brookfield to confirm their action to address this issue. Brookfield has confirmed that the toilet layout has been constructed and the WC installed as the NA 400 Series drawing which has been approved by NHS Board. See Supervisor's Communication General Matters / Other Instructions (CI 13.1) No 217

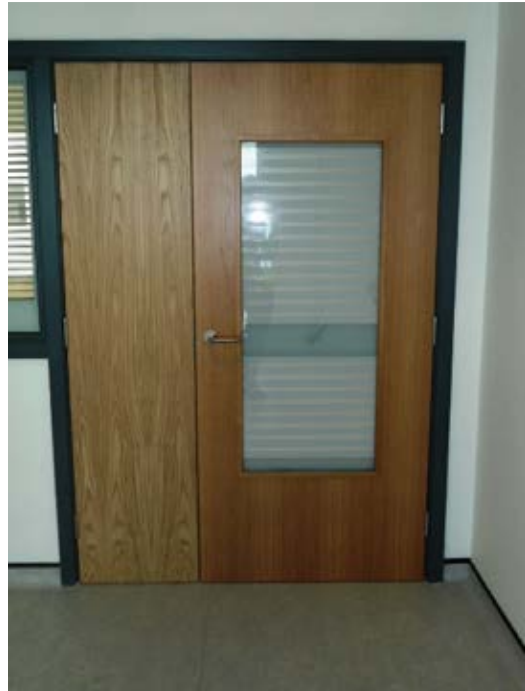
Following recent inspection on site we noted that there were door set which had veneers that did not match. This poor quality of finish occurs in isolated locations throughout the Hospital. We asked Brookfield to confirm that a review of the doors has been carried out on all levels and that door sets are matched where there are dissimilar veneers. Brookfield is currently in discussion with the Sub Contractor TDSL with a view to rectifying this discrepancy. (See Supervisor's Communication General Matters / Other Instructions (CI 13.1) No 221).

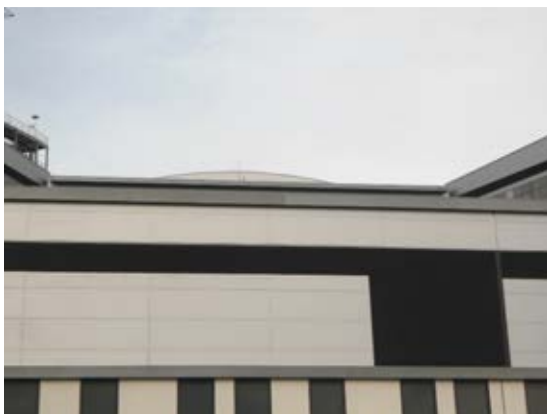
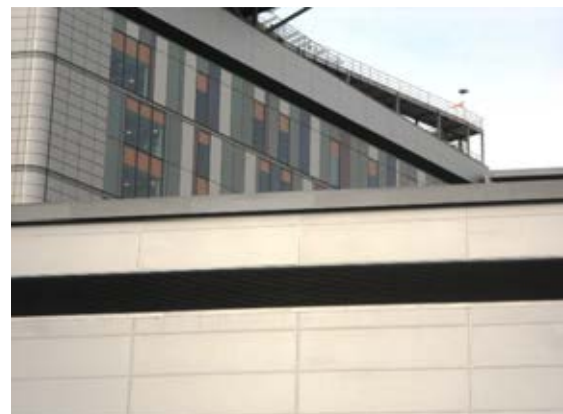
We carried out roof inspections to the Roof R4-009, R3-001 and R3-021 and R2-005. Generally Brookfield has captured all the snags/defects. However we did note that some of the capping pieces on Level 3 south elevation are a different shade from the others. Consequently we have raised Supervisor's Communication General Matters / Other Instructions (CI 13.1) No 213 We asked Brookfield if the different shaded capping pieces have been recorded in the IDMS as a snag/defect and that further remedial action will be undertaken. Brookfield advised that regrettably, Prater advises them that the issue raised is not a defect but a consequence of using a metallic paint finish on multiple pieces of metal. The angles of the metallic flecks differ when applied to individual components which sometimes create an apparent difference in appearance depending on the light conditions when viewed from distance.

Prater will supply test samples of the specified RAL colour and demonstrate that the components are the same colour.

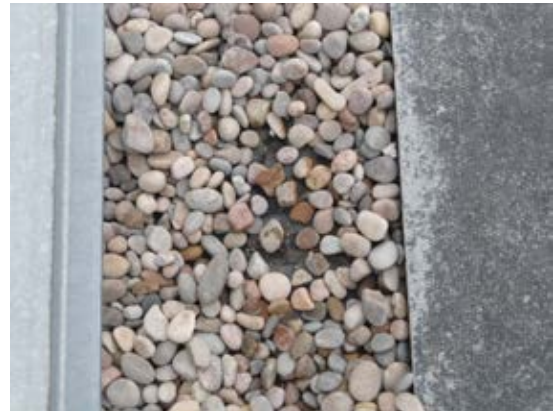
An inspection of the roofs at each finger on Level 12 was carried out with Brookfield and only minor snags / defects were noted by Brookfield. We did note that there were a few areas which required ballast in addition to areas already highlighted by Brookfield.

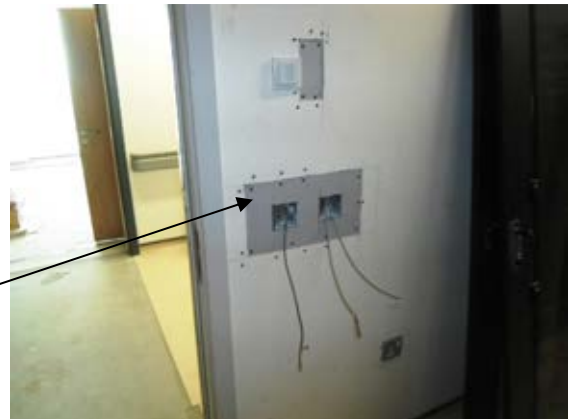
Above ceiling inspections were carried out on Level 5 Zone H and the majority of the fire stopping had been captured by Brookfield. We did however highlight a few areas which required attention.

Fire putty missing

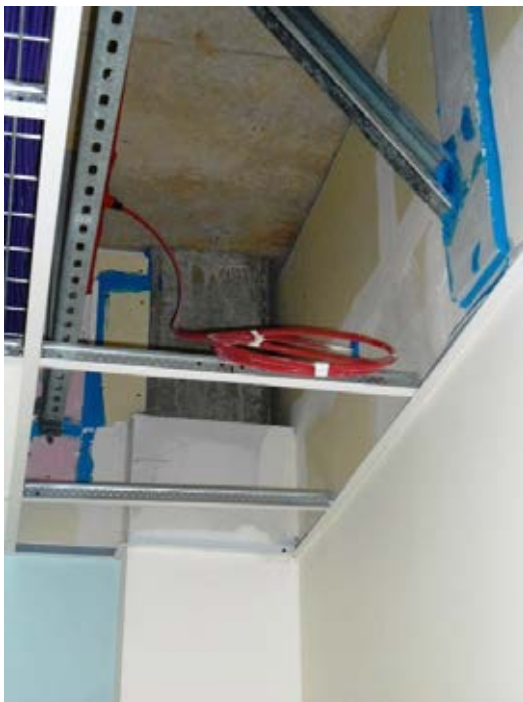
Opening between column and partition.

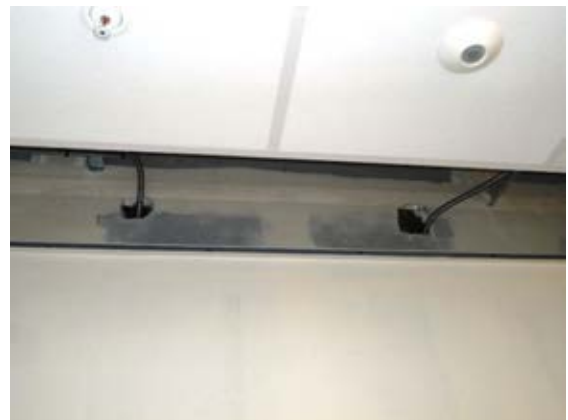
Penitrations through partitions.

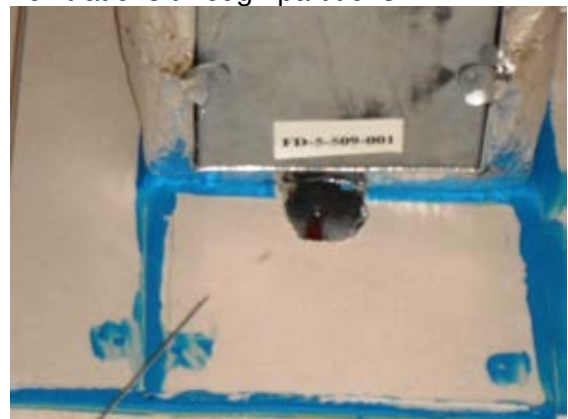
Open area around damper bulb.

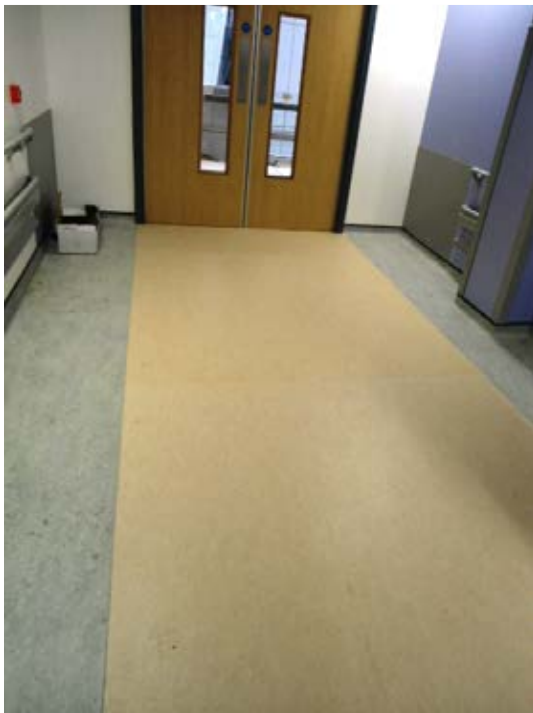
We carried out inspections with Brookfield of vinyl floor covering in some corridor areas on Level 0, 1 and 2. We noted that recently laid vinyl had darker shading than the adjacent vinyl. However we noted another area where the vinyl had been laid later than the surrounding floor but had been down for over two months and had lightened to match the surrounding vinyl.

Shading on newly fitted vinyl.

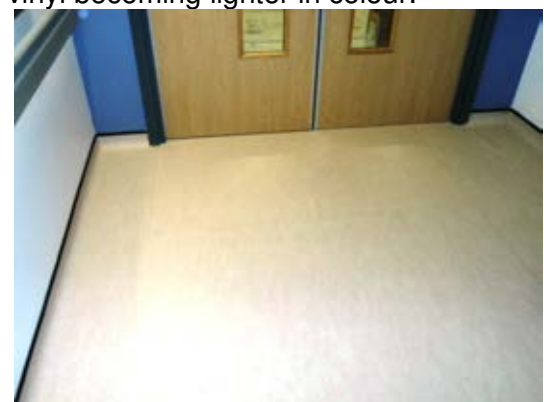
We noted the vinyl fitted at the double doors in corridor AAW-203 has been laid as a patch repair. We asked Brookfield to confirm that a new piece of vinyl will be laid continuously from the skirting to the existing welded joint. Brookfield has reviewed doors on level 4 yesterday and agreed that some of these require to be changed. This is to ensure line of weld is continuous and taken to coving or 100mm from coving to give an aesthetically pleasing finish. They have been done like this in zone F on level 4. ACF have been advised

that going forward if patches are being done to doors they have to be done to keep weld continuous and go to the skirting or just off or to ensure symmetry with surrounding vinyl.
Supervisor's Communication General Matters / Other Instructions (CI 13.1)
No 218 is closed out.

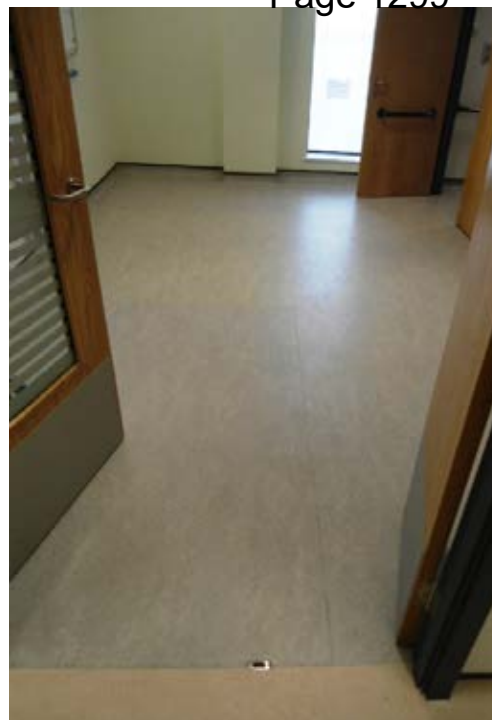
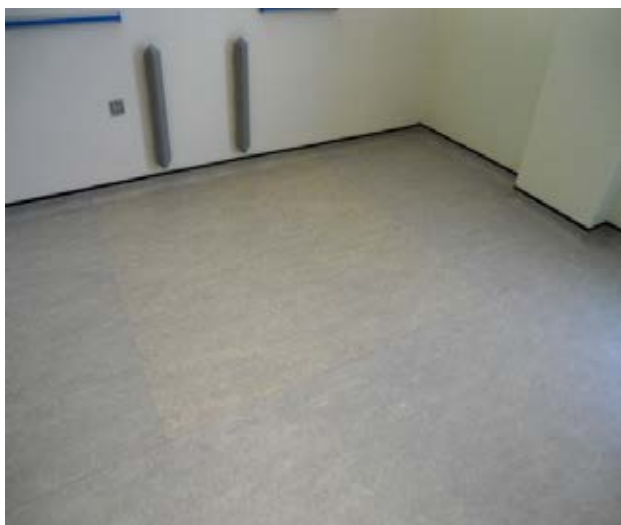
Following our inspection with Brookfield of vinyl in Room CENWC-028 (Room 69). We have asked Brookfield to confirm that the three vinyl panels between the door and the window will be replaced with one length of vinyl. This is also to include bubbled areas. Brookfield has replaced the small damage area approximately 10mm circle and ACF have replaced a section approx 2.0m x 1.8m (as is standard practice) to ensure this does not look like a small patch. When the colour matches this would not be noticeable. ACF/Brookfield will monitor and if colour match does not occur we will replace the full length of vinyl.

Brookfield has provided technical literature regarding drying room yellowing of marmoleum products received from Forbo via AC Flooring. Brookfield has also reviewed doors on level 4 and agreed with us that some of these require to be changed, to ensure line of weld is continuous and taken to coving or 100mm from coving to give an aesthetically pleasing finish. They have been done like this in zone F on level 4. ACF have been advised that going forward if patches are being done to doors they have to be done to keep weld continuous and go to the skirting or just off. Supervisor's Communication General Matters / Other Instructions (CI 13.1).

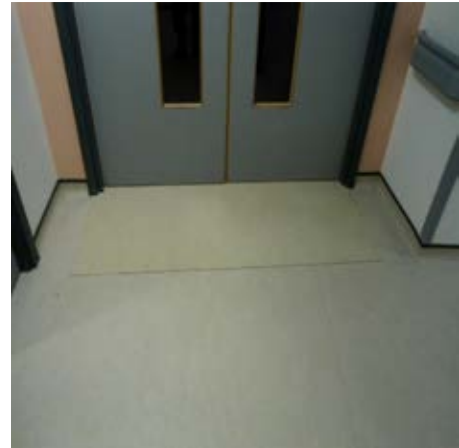
Following a recent inspection on Level 4 we noted that the vinyl floor beneath the double doors adjacent to Core had been patched at a more recent date than the surrounding vinyl. We asked Brookfield to confirm that this will be removed and a new piece fitted to follow the same formation with no broken welds. Brookfield has reviewed doors on level 4. They agreed that some of these require to be changed, to ensure line of weld is continuous and taken to coving or 100mm from coving to give an aesthetically pleasing finish. They have been done like this in zone F on level 4.

This poor quality of finish occurs on other floors. We have asked them to confirm that these will be addressed to ensure continuity of the floor covering. Supervisor's Communication General Matters / Other Instructions (CI 13.1) No 220 is closed out.

ACF have been advised that going forward if patches are being done to doors they have to be done to keep weld continuous and go to the skirting or just off or to ensure symmetry with surrounding vinyl.

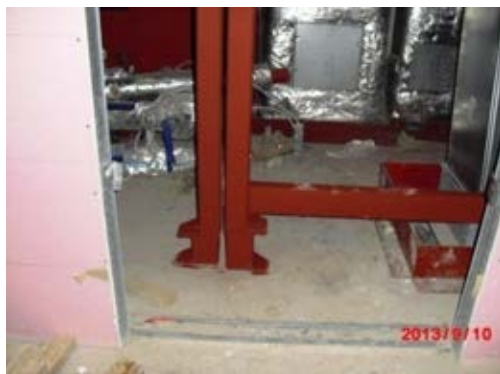
The steel framework in riser on Level 0 ZF Riser M30 has had the legs extended immediately in front of the entrance door. There are other legs which have not been extended yet and we asked Brookfield to confirm when the other legs will be extended. Brookfield informed us that Mercury removed the feet on the framing having it suspended from the soffit of the floor above. Brookfield has consulted with WSP re the allowable load on the slab edge around the risers. The design line load around the riser slab edges is based upon 0.8kN/m height/sq.m plan area. The calculations submitted by Mercury show a load of 0.99kN/m/sq.m which exceeds the design criteria therefore the legs will require extending to provide support from the lower floor. Mercury has been informed to replace/ extend the feet. (See Supervisor's Communication General Matters / Other Instructions (CI 13.1) No 162).

Extended legs

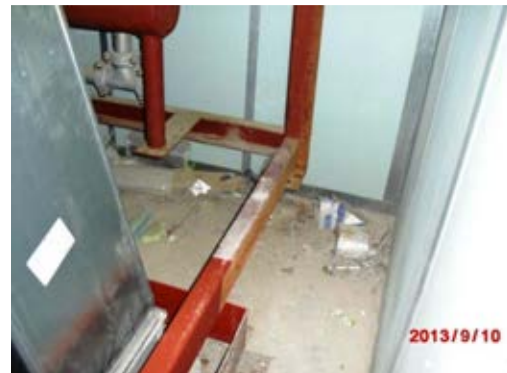
Leg still to be extended.

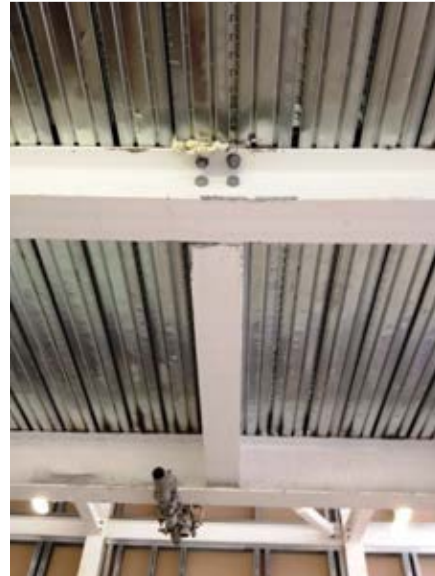
Some areas of intumescent painting to the steelwork on the 1st Floor Podium on the East Side of the Main Atrium appear to be chipped. We asked Brookfield to confirm that this will be addressed as required to ensure overall compatibility with the specification. They have confirmed any areas of the intumescent fire protection on the steelwork that has been damaged will be rectified and that we would be invited to inspect prior to any closing up of the areas. (See Supervisor's Communication General Matters / Other Instructions (CI 13.1) No 210).

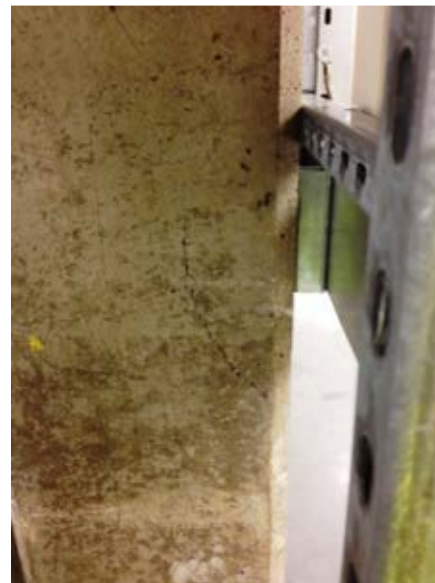
We noted a distribution board fixing has caused the concrete column to crack on Level 2 Plant Room 22. Following discussions with Brookfield and they intend to carry out a localised repair using high strength, low shrinkage (Cementitious with polymers) R4 repair mortar. We asked Brookfield to confirm that they have inspected all plant rooms to identify and repair similar cracked concrete as shown in the photo. Brookfield confirmed that they will carry out localised repairs using high strength, low shrinkage (Cementitious with polymers) R4 repair mortar. All plant rooms will be checked for similar cracked concrete as shown on Capita photo. (See Supervisor's Communication General Matters / Other Instructions (CI 13.1) No 222).

Installation of M&E equipment has been causing concrete spalling to some columns (e.g. in plant room 22) and column bases (e.g. roof level) where bolt fixing has been attempted. Brookfield is aware of this and will address these items.

221	Confirm that a review of the doors has been carried out on all levels and that door sets match.	29.10.14	Response received.	
222	Confirm that all the plant rooms have been inspected to identify and repair cracks to concrete behind distribution boards.	29.10.14	Response received.

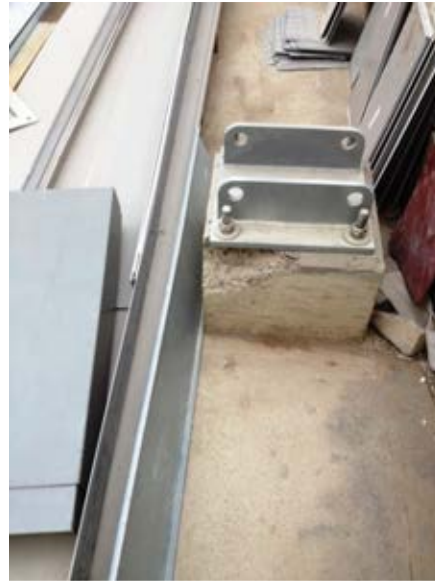
We also noted at roof level of the ACH that the support bases to the columns are spalling. Brookfield confirmed that they would use the R4 repair mortar to effect a repair.

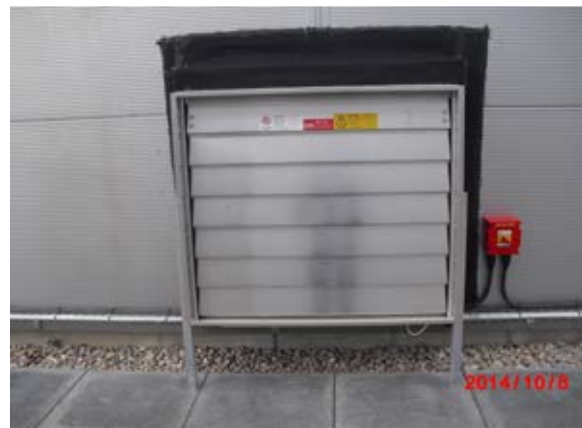
The fan has a local actuator fitted, but there is no local means of isolating the 240 volt actuator. There are four similar fans also on the third floor which are in the process of being similarly installed. We asked Brookfield to confirm how access will be provided to the fan for future maintenance without cutting into the weatherproof membrane.

Brookfield responded by informing us that each fan has an isolator switch which is located adjacent to the ventilator and is shown in the

photograph. The power to the fans and ventilators is taken from the Atrium Control Panel which is also has its own isolator.

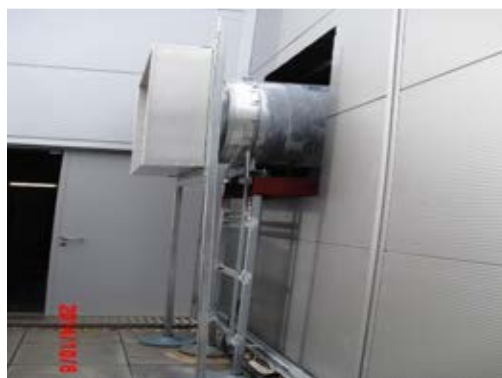
The east door clashes with one of the fans on Level 3 Core H link corridor. We have asked Brookfield to confirm their action to resolve this clash. (See Supervisor's Communication General Matters / Other Instructions (CI 13.1) No 215).

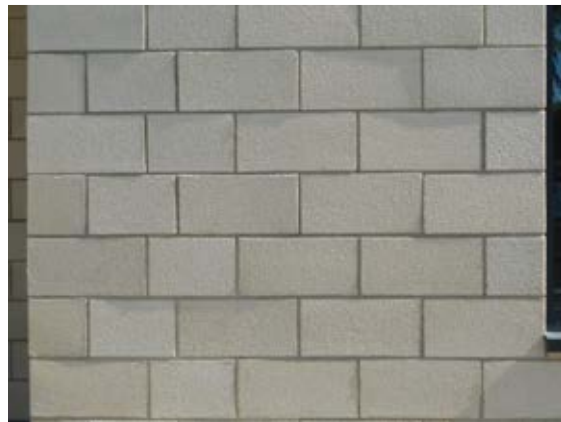
The blockwork at the right hand side of the Children's A&E entrance on the external wall of room EMC-009 is poor quality workmanship. The mortar beds vary in thickness and blocks have not been laid level. We asked Brookfield when this would be addressed. An inspection of the poorly laid blockwork was carried out with Brookfield and the work carried out was generally satisfactory, however one block still requires to be replaced. See Supervisor's Notification of Defect (CI 42.2) No 79.
