**Bundle of documents for Oral hearings
commencing from 13 May 2025 in relation
to the Queen Elizabeth University Hospital
and the Royal Hospital for Children,
Glasgow**

**Bundle 33
NEC3 Supervisor's Reports and Project
Supervisors Interface Action Notes**

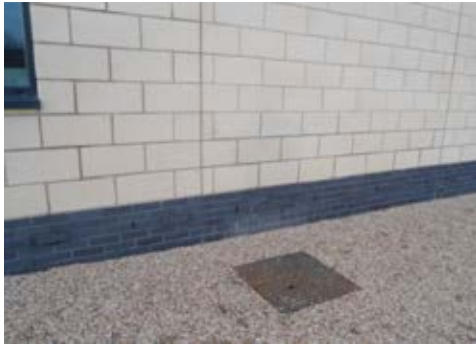
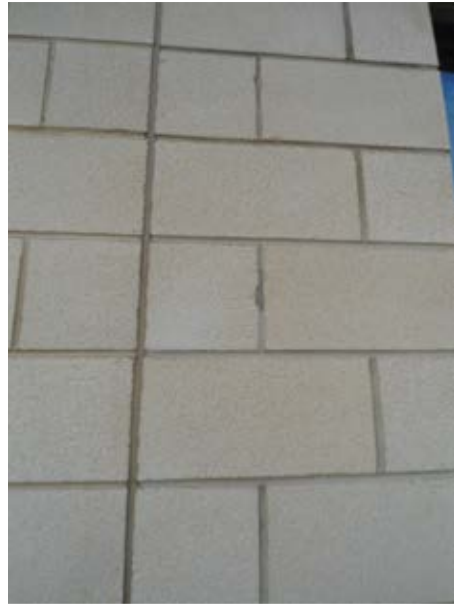
Although some work has been carried out to improve the quality the pointing on the external blockwork on the south and east elevations. Some of the blockwork does not reflect the quality of the pointing on the blockwork benchmark sample. Consequently we have raised Supervisor's Notification of Defect (CI 42.2) No 81.

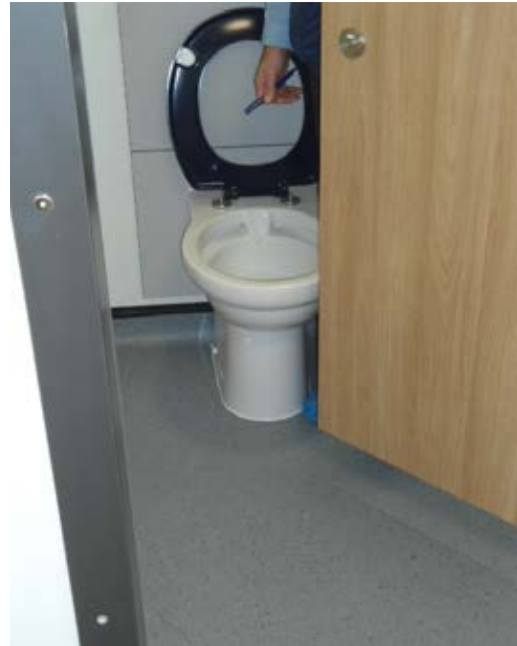
We note that there was insufficient activity space in front of the WC bowl in the room WS5-020 on Level 5 Atrium Bridge. We asked Brookfield to confirm their action to address this issue. Brookfield confirmed that the toilet layout has been constructed and the WC installed as the NA 400 Series drawing which has been approved by NHS Board. However they carried further investigations in Levels 9 and 5 in the male toilet of the male changing room. The doors have been installed larger than required resulting in the activity space being reduced. These two toilet doors will be reduced to allow the required 450mm activity space for access. See Supervisor's Communication General Matters / Other Instructions (CI 13.1) No 217

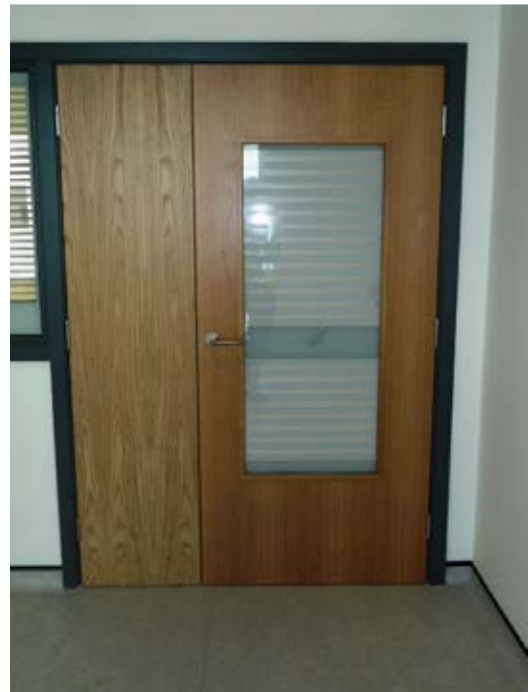
Following recent inspection on site we noted that there were door sets which had veneers that did not match. This poor quality of finish occurs in isolated locations throughout the Hospital. We asked Brookfield to confirm that a review of the doors has been carried out on all levels and that door sets are matched where there are dissimilar veneers. Brookfield is currently in discussion with the Sub Contractor TDSL with a view to rectifying this discrepancy. (See Supervisor's Communication General Matters / Other Instructions (CI 13.1) No 221).

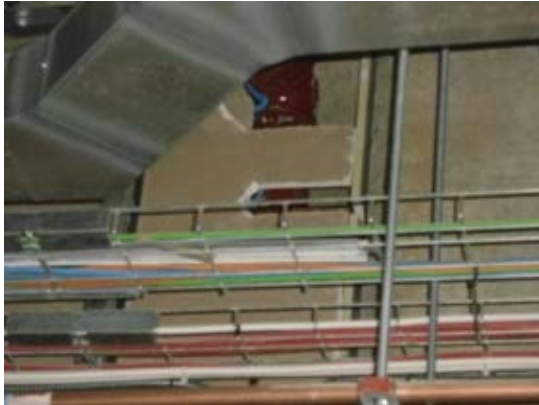
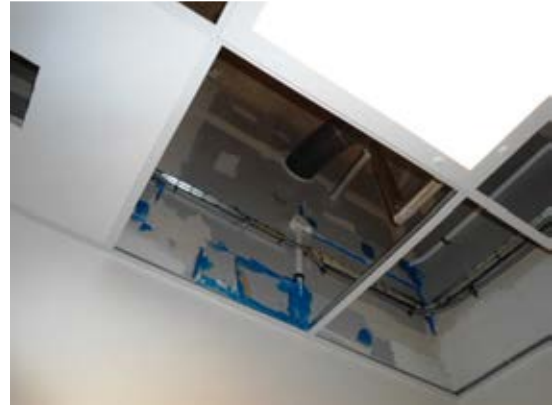
We carried out an inspection with Brookfield of the above ceiling fire stopping on Level Areas 0-531 0-532 0-533 and 0-534. We identified 10 fire stopping issues which required attention prior to the inspection of Building Control inspection.

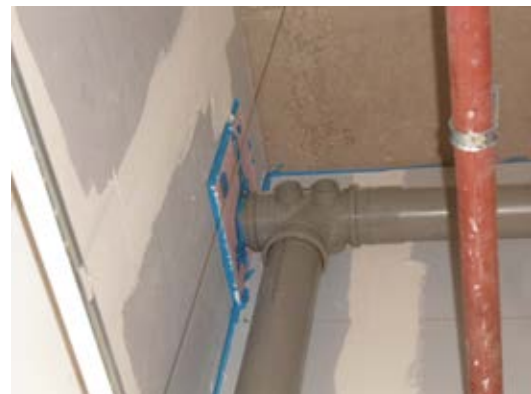
No sleeve visible.

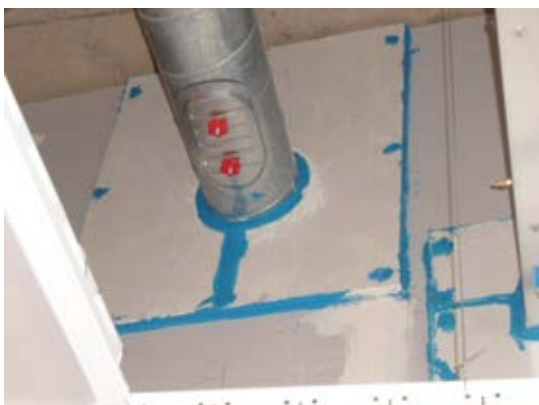
No damper indicator bulb visible.

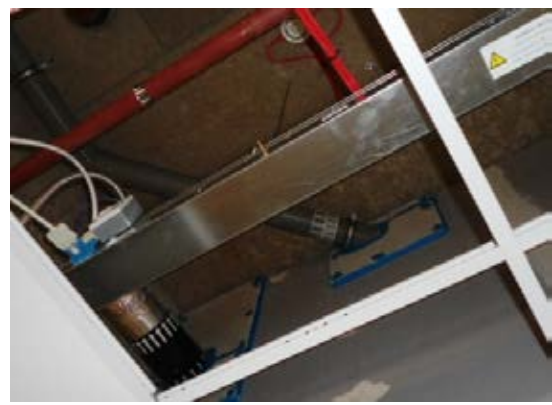
No sleeve visible.

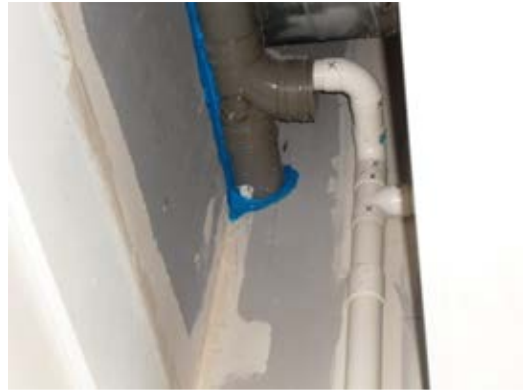
We carried out above ceiling inspections of fire stopping in the Adult Hospital on Level 2 Areas 2-505 3-506 and 3-507. Generally the fire stopping had been carried out satisfactorily to the areas which were available for inspection. However we did identify a pvc pipe without a sleeve.

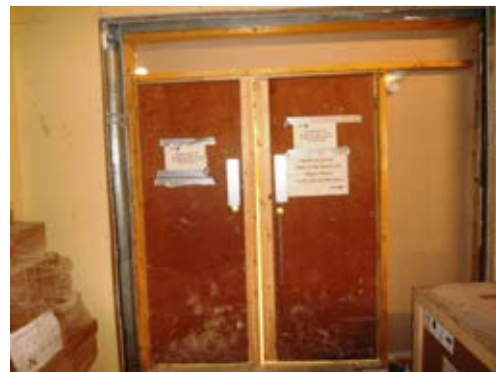
We asked Brookfield to confirm if they will be fitting temporary doors or a section of partition at the break out area in room RCF-024 to provide a 60 minutes fire rating. The break out area must be in accordance with the fire strategy, the existing partition and satisfy Building Control. They confirmed that this room is to be fitted out by NHS. The current date for fit out is beyond the Project Completion date. They will therefore remove the break out panels and reinstate the 60 minutes fire integrity of the partition at the existing break out area. In addition the service penetrations at high level through fire walls will be fire stopped. Supervisor's Communication General Matters / Other Instructions (CI 13.1) No 225 is closed out.

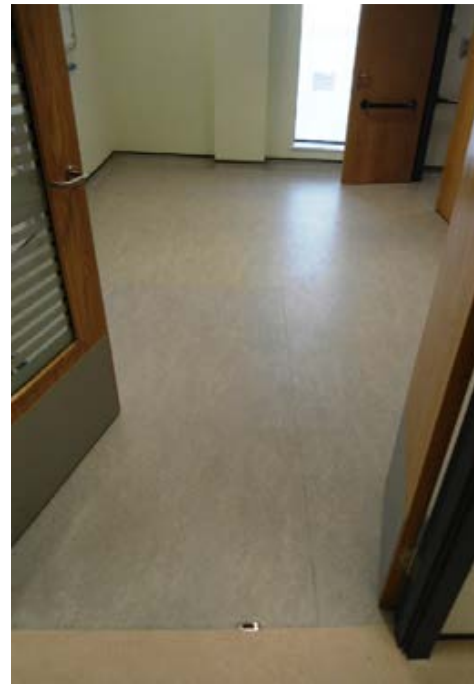
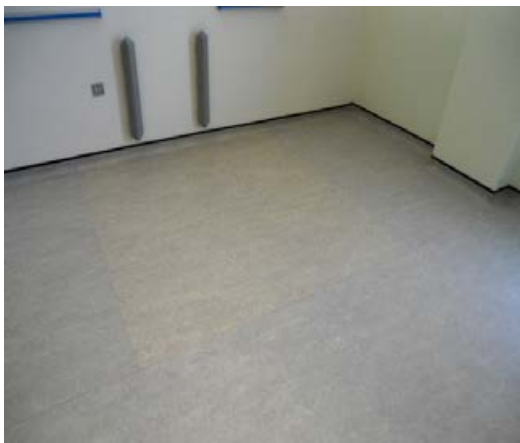
Following our inspection with Brookfield of vinyl in Room CENWC-028 (Room 69). We asked Brookfield to confirm that the three vinyl panels between the door and the window will be replaced with one length of vinyl. This is also to include bubbled areas. Brookfield has confirmed that following the NHS use of this room within the 5H section they will replace the damaged vinyl in Room CENWC-028 (Room 69). To allow this replacement vinyl to be installed they require the NHS to remove their equipment from the room. Supervisor's Communication General Matters / Other Instructions (CI 13.1) No 219 is closed out.

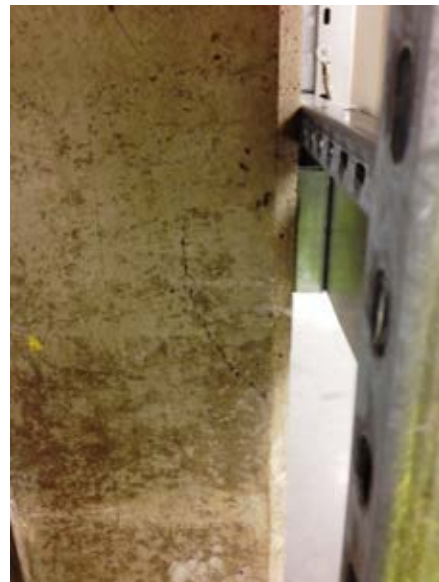
We noted a distribution board fixing has caused the concrete column to crack on Level 2 Plant Room 22. Following discussions with Brookfield and they intend to carry out a localised repair using high strength, low shrinkage (Cementitious with polymers) R4 repair mortar. We asked Brookfield to confirm that they have inspected all plant rooms to identify and repair similar cracked concrete as shown in the photo. Brookfield confirmed that they will carry out localised repairs using high strength, low shrinkage (Cementitious with polymers) R4 repair mortar. All plant rooms will be checked for similar cracked concrete as shown on Capita photo. (See Supervisor's Communication General Matters / Other Instructions (CI 13.1) No 222).

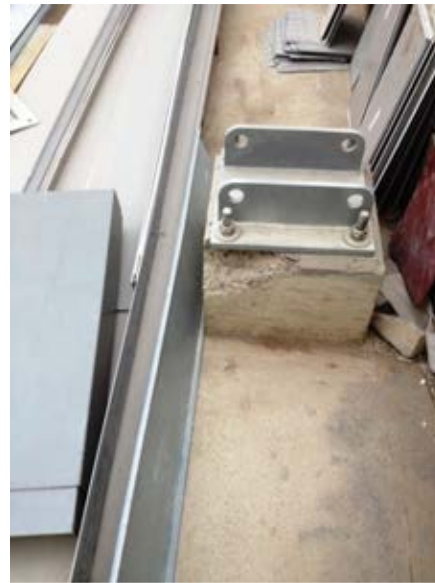
We also noted at roof level of the ACH that the support bases to the columns are spalling. Brookfield confirmed that they would use the R4 repair mortar to effect a repair.

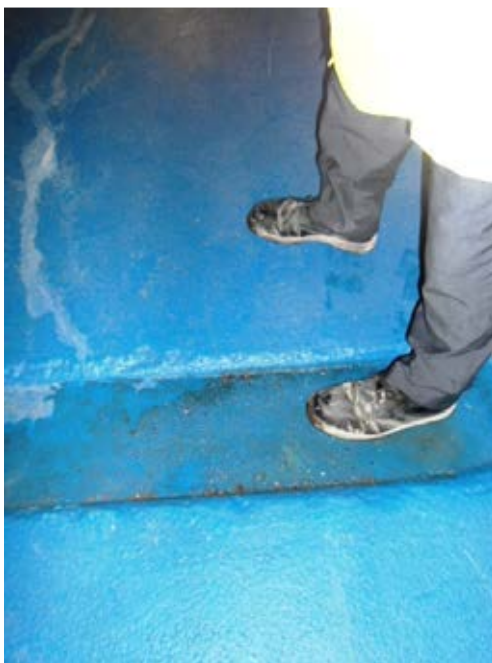
Level 5

The car park floors on levels 1, 2, 3, 4, and 5 adjacent to the stair on the east elevation have recessed channels which cross the pedestrian walkway similar to the potential trip hazards identified in Communication No 209. Some of the channels are in excess of 30mm. We have asked Brookfield to confirm if the same solution which is being considered to resolve Communication No 209 (installation of grills) will be considered. (See Supervisor's Communication General Matters / Other Instructions (CI 13.1) No 224).

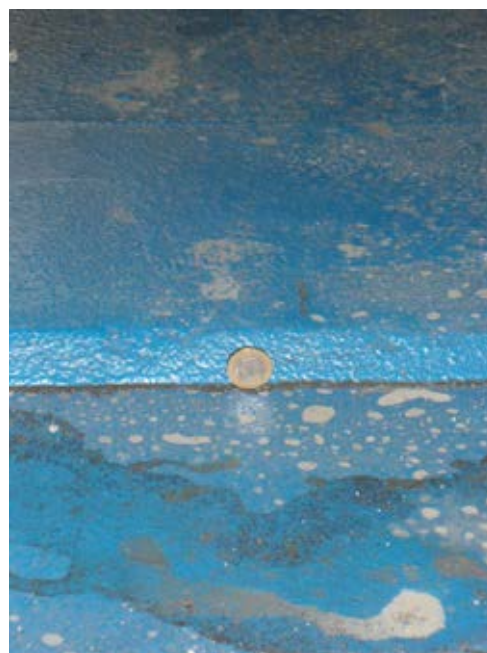
Level 3: Channel exceeds 30mm deep.

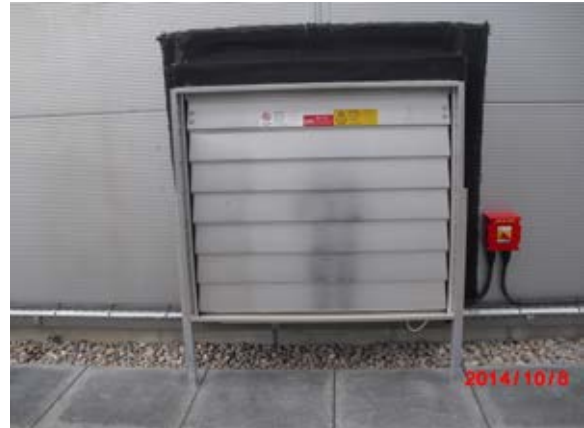
The three high level smoke extract fans on Level 4 Zone C appear to be complete with the fans and actuator totally enclosed with no access for maintenance.

The fan has a local actuator fitted, but there is no local means of isolating the 240 volt actuator. There are four similar fans also on the third floor which are in the process of being similarly installed. We asked Brookfield to confirm how access will be provided to the fan for future maintenance without cutting into the weatherproof membrane.

Brookfield responded by informing us that each fan has an isolator switch which is located adjacent to the ventilator and is shown in the photograph. The power to the fans and ventilators is taken from the Atrium Control Panel which is also has its own isolator.

They also intimated that the ventilator has a top removable blade as shown in the photograph which allows access to its actuator. We have asked Brookfield to demonstrate how access can be gained to the actuator. We are of the view that there is no means to isolate the damper actuator locally to allow safe work.

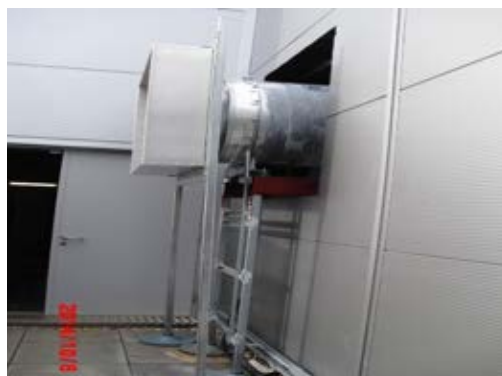
The east door clashes with one of the fans on Level 3 Core H link corridor. We have asked Brookfield to confirm their action to resolve this clash. (See Supervisor's Communication General Matters / Other Instructions (CI 13.1) No 215).

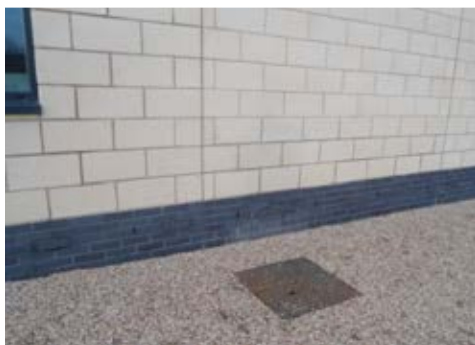
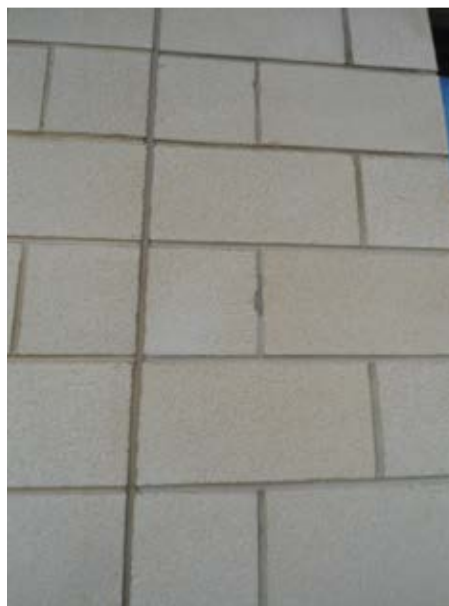
Although some work has been carried out to improve the quality the pointing on the external blockwork on the south and east elevations. Some of the blockwork does not reflect the quality of the pointing on the blockwork benchmark sample. Consequently we have raised Supervisor's Notification of Defect (CI 42.2) No 81.

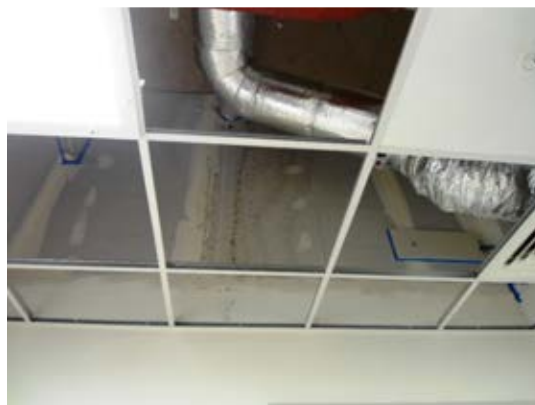
The plasterboard above the ceiling in Room has mould growth. Brookfield has confirmed that all plasterboard in this area affected by mould growth has been brushed, washed and cleaned of any mould in compliance with European Commission for Health & Environmental Alliance protocols. Consequently Supervisor's Notification of Defect (CI 42.2) No 82 is closed out.

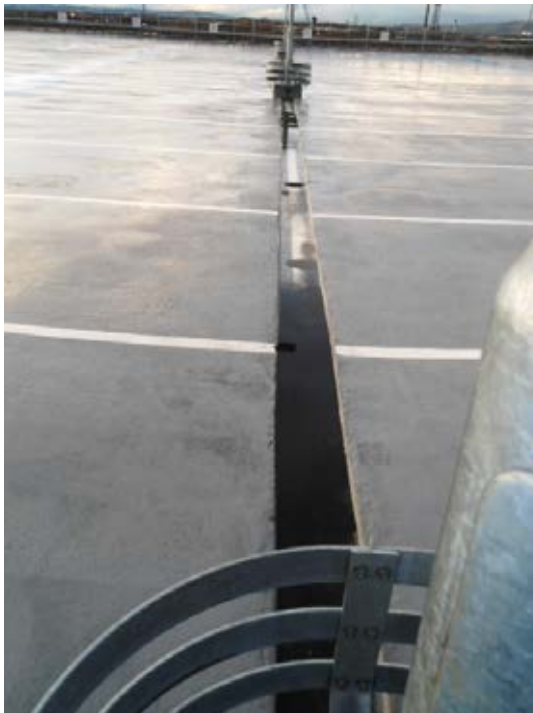
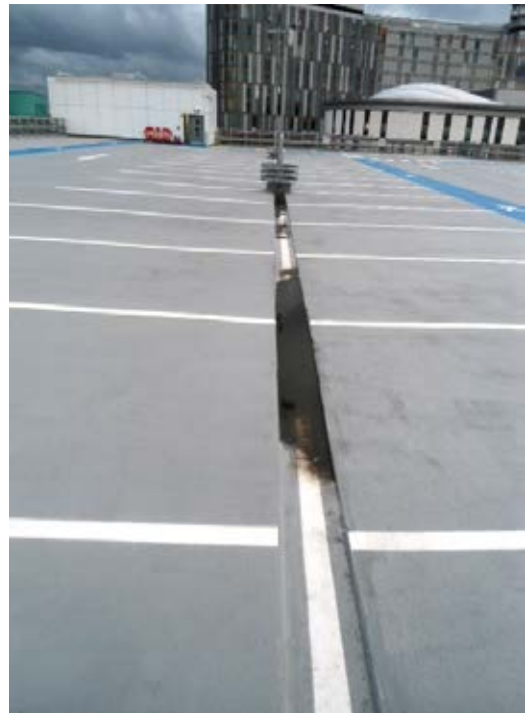
Some of the outlets taking the rainwater from the top level of the Car park are too high consequently water is ponding in the recessed channels.

We have asked Brookfield to confirm what remedial work will be undertaken to resolve this issue and confirm when the work is complete. See Supervisor's Notification of Defect (CI 42.2) No 83.

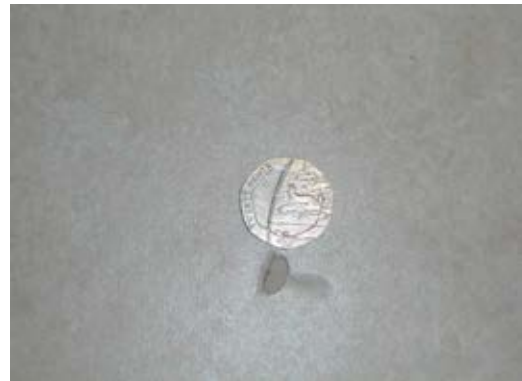
The vinyl had sustained damaged across the full length of the Atrium Bridge. We have asked to confirm that the vinyl floor covering will be replaced across the full width of the bridge to match the benchmark floor on Level 4 Link Bridge. See Supervisor's Notification of Defect (CI 42.2) No 84.

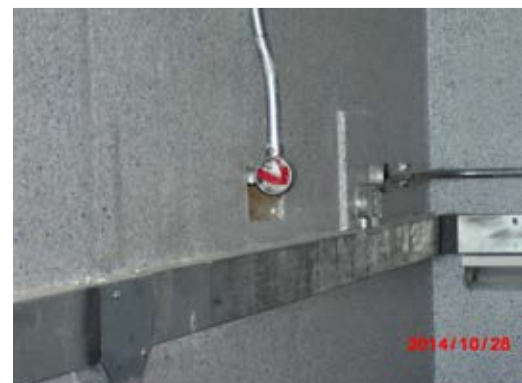
Cables used in the fire alarm installation have been forced into conduits boxes on Level 12 stair core G which is not in accordance with the manufacturer's recommendations. This was previously raised through Supervisors Defect Notification No 68 regarding the stress caused to FP and was addressed. We have asked Brookfield to confirm when this defect has been addressed. See Supervisor's Notification of Defect (CI 42.2) No 85.

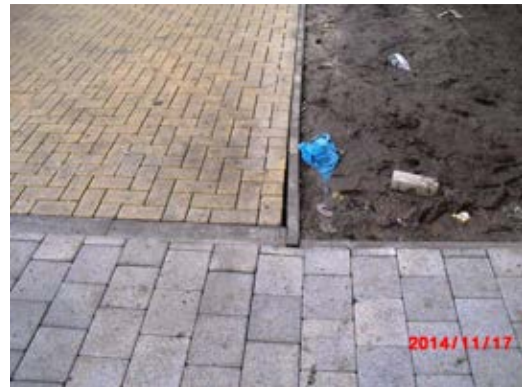
The edging kerb near the south west corner of the Children's Hospital has been poorly laid. We have asked Brookfield to confirm when this has been addressed. See Supervisor's Notification of Defect (CI 42.2) No 86.

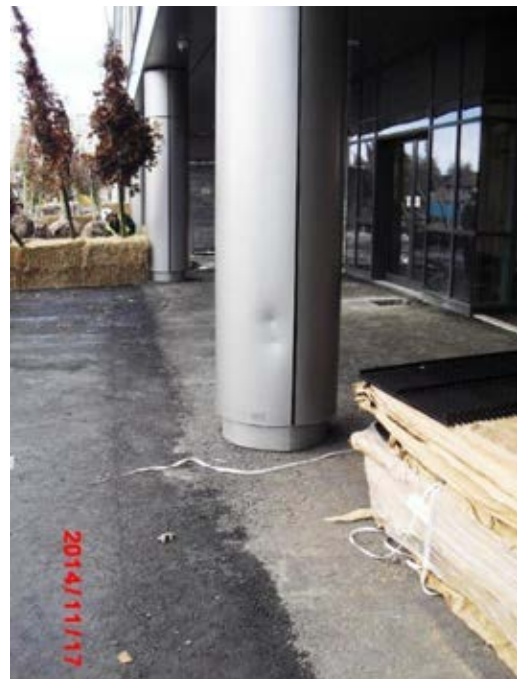
The cladding to the column on the South Elevation of the Adult Hospital is damaged. We asked Brookfield to confirm when this has been addressed. They have confirmed that the damage has been noted by their sub contractor and replacement cladding panel has been put on order. This will be replaced when the new section has been received. See Supervisor's Notification of Defect (CI 42.2) No 87.

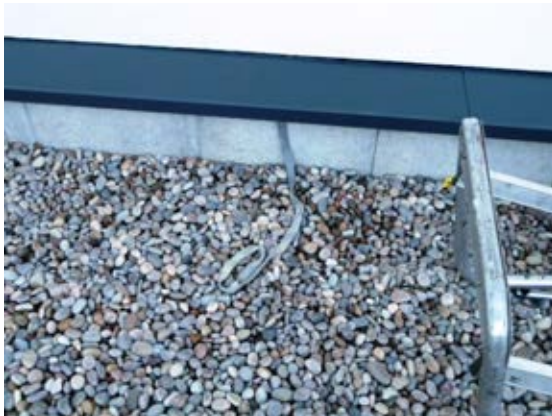
Lightning conductor tape not fitted.

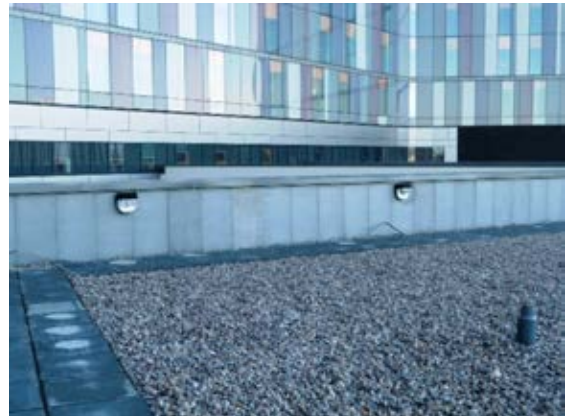
Roof R5-005: Roof lighting lightning still to be wired and conductor tape still to be fitted.

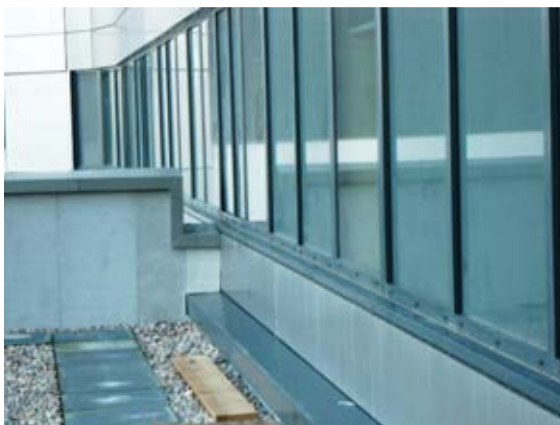
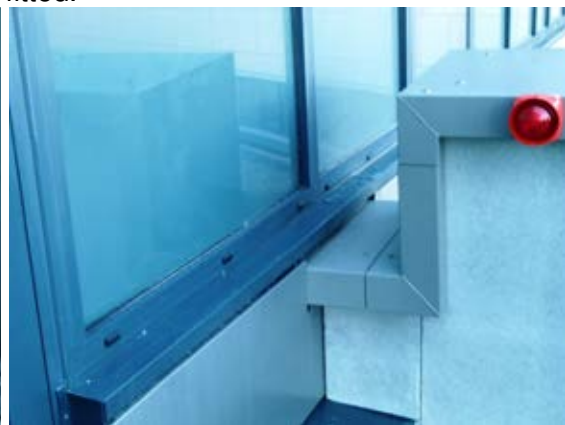
Roof R3-004: Boundary rail still to be fitted to fill gap.

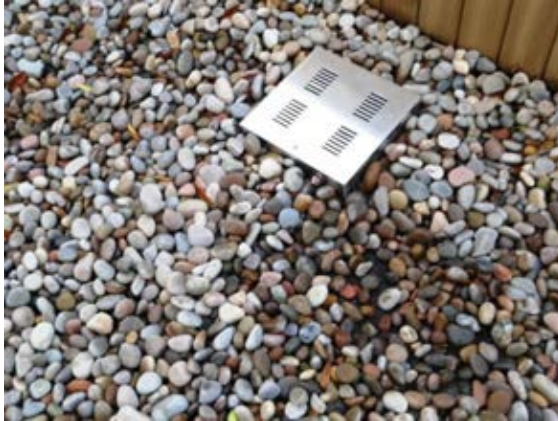
R1-003: Ballast not to the correct depth of 50mm.

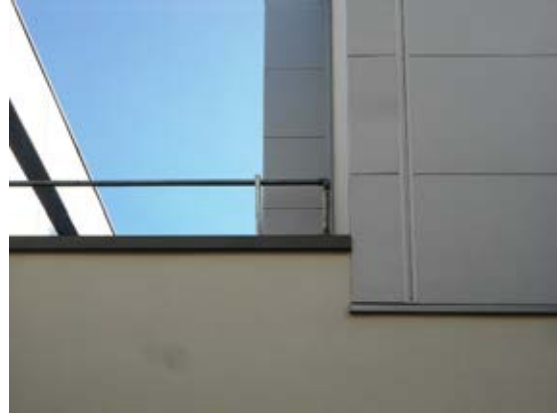
R2-004: Gap between handrail and wall.

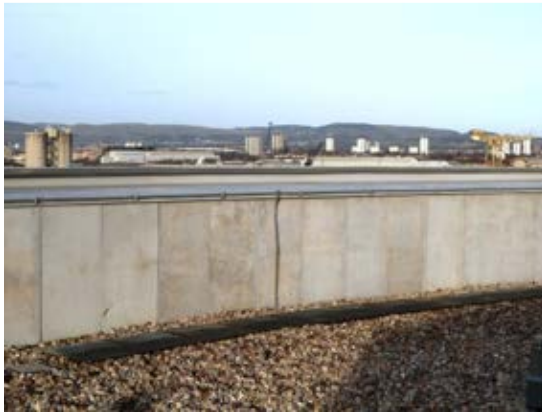
R5-005: Lightning conductor tape still to be clipped.

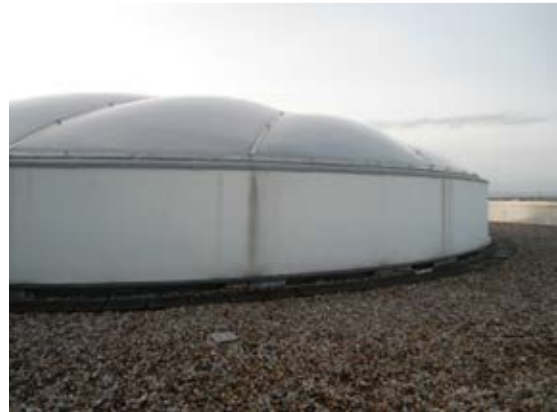
Staining of sto from rainwater from roof.

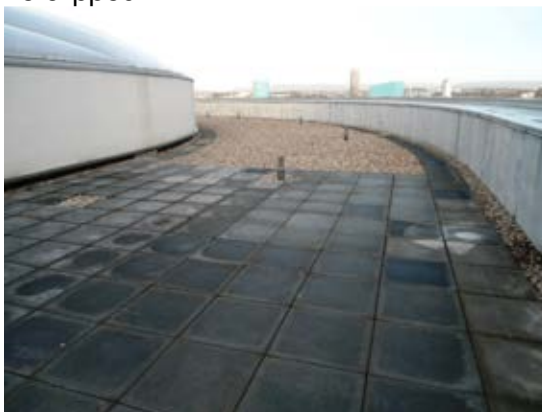
R5-005: Slab to be lifted and roof outlet created.

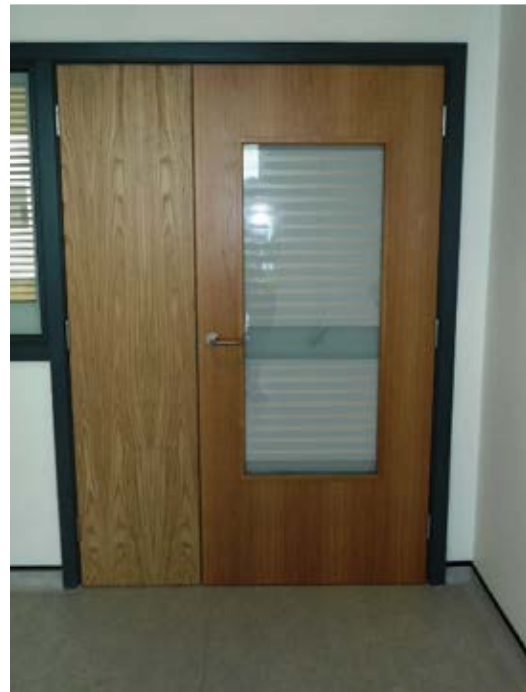
Following recent inspection on site we noted that there were door sets which had veneers that did not match. This poor quality of finish occurs in isolated locations throughout the Hospital. We asked Brookfield to confirm that a review of the doors has been carried out on all levels and that door sets are matched where there are dissimilar veneers. Brookfield is currently in discussion with the Sub Contractor TDSL with a view to rectifying this discrepancy. (See Supervisor's Communication General Matters / Other Instructions (CI 13.1) No 221).

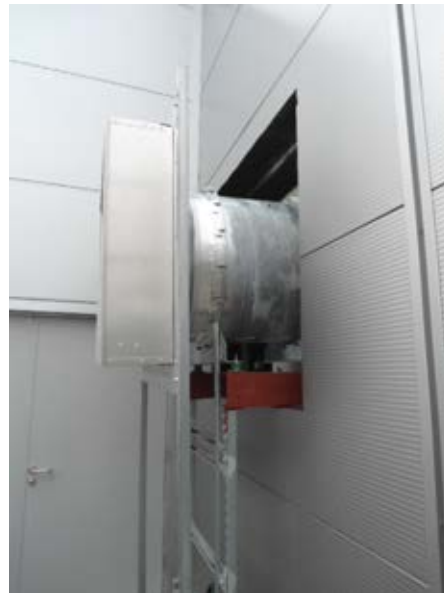
We have asked Brookfield to provide the waterproofing detail for the smoke extract fans. Supervisor's Communication General Matters / Other Instructions (CI 13.1) No 226.

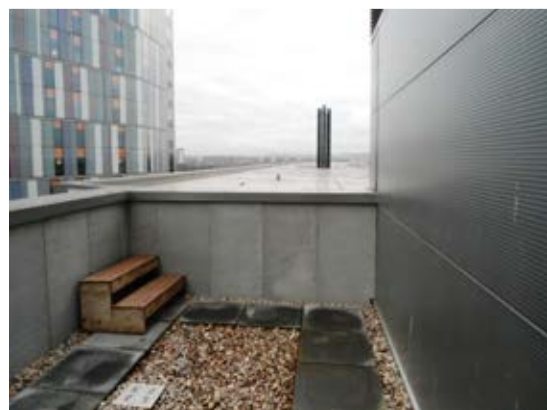
Drawing No NA-XX-05-PL-252-150 for the 5th floor show an access ladder between two roofs on the south elevation adjacent to Plantroom 41A. However this has not been fitted. We have asked Brookfield to confirm when this will be fitted or confirmation that it is an omission. Supervisor's Communication General Matters / Other Instructions (CI 13.1) No 227.

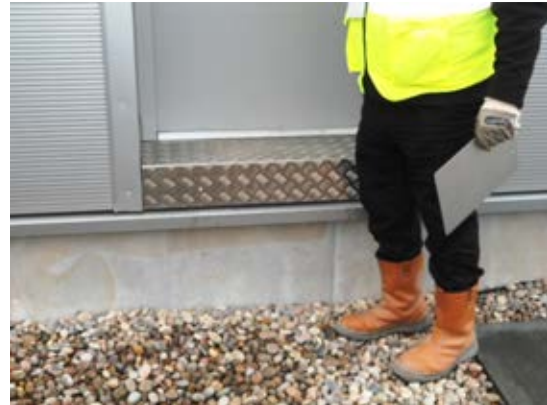
There are two door thresholds providing access and egress from Plantroom 41A which are too high. These are located on the north and west elevations of the Plantroom. There is an access stairs shown on drawings NA-XX-05-PL-252-150 and NA-XX-05-PL-572-010. We have asked Brookfield to confirm when stairs/steps will be fitted. Supervisor's Communication General Matters / Other Instructions (CI 13.1) No 227.

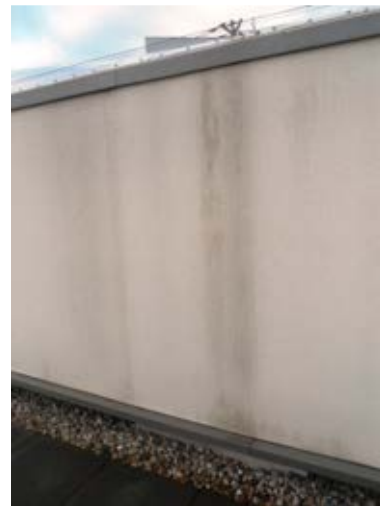
There is staining, slight erosion and cracking to some parts of the semi circular Sto covered wall above the Atrium at the entrance to the Children's Hospital. Please confirm your measures to address these issues. Supervisor's Communication General Matters / Other Instructions (CI 13.1) No 227.

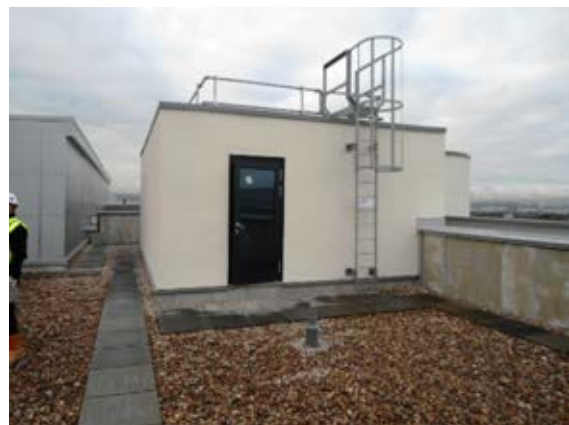
The glassed door leading into Core L from the roof does not appear to be fire rated consequently does not provide fire integrity of the compartmental wall. There is also an opening between the room at the top of the core and the area above the top landing. Confirm if the existing door and door frame is 60 minutes fire rated or if a new door is required. Supervisor's Communication General Matters / Other Instructions (CI 13.1) No 227.

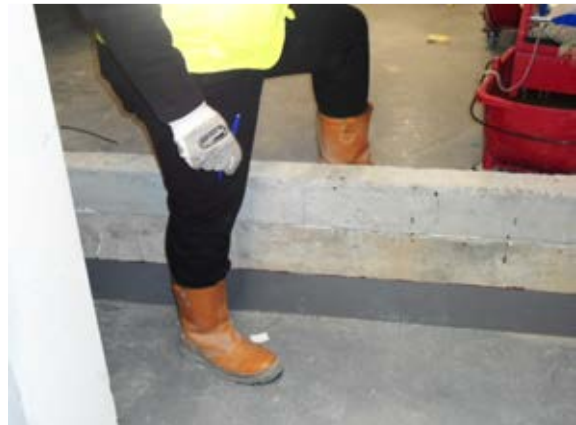
There is an excessive drop between the fire doors leading to Core K on Level 5 and the floor in Plantroom 41A. We have asked Brookfield to confirm measures to address this taking into account that this is a fire exit route. Supervisor's Communication General Matters / Other Instructions (CI 13.1) No 228.

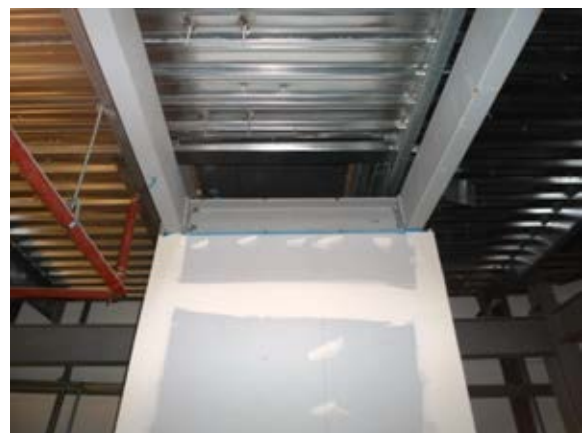
Level 5 Plantroom 41A.

The partitions forming fire protection to the fire vent on the roof between the two fire doors in plantroom 41A leading to Core K is incomplete.

There is a gap between the underside of the roof and the top of the partitions and the steelwork has not been painted with intumescent paint. Please confirm when the area is fully fire protected.

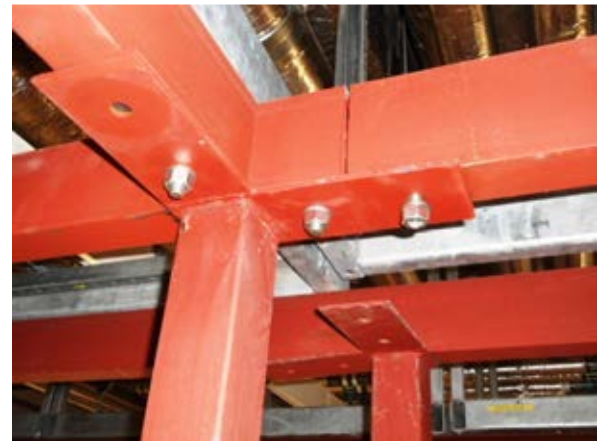
The ramp which serves the Computer Room in Plantroom 41 does not have a handrail or protections to the edge of the ramp and platt to prevent a fall. The do not comply with current Building Regulations. Confirm when this has been addressed. Supervisor's Communication General Matters / Other Instructions (CI 13.1) No 231.

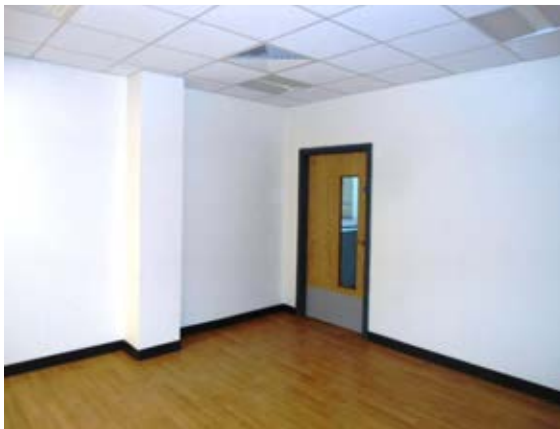
Room THE-067: Door between THE-076 and THE-067.

Room's THE-070 and THE-076 both share the same floor space. There is no light switch on the wall next to the pass door leading from room THE-076 into THE-067. We have asked Brookfield to confirm if lighting should be controlled in room THE-067 when accessing and egressing between rooms' THE-076 and THE-067. Supervisor's Communication General Matters / Other Instructions (CI 13.1) No 233.

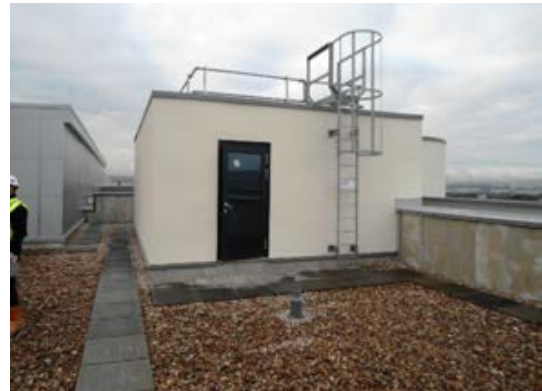
Drawing No NA-XX-05-PL-252-150 for the 5th floor Roof between Plantroom 41A and Core L shows an access cat ladder. However this has not been fitted. We have asked Brookfield to confirm when this will be fitted or if this has been omitted from the contract. Supervisor's Communication General Matters / Other Instructions (CI 13.1) No 234.

Access cat ladder should be fitted to this elevation.

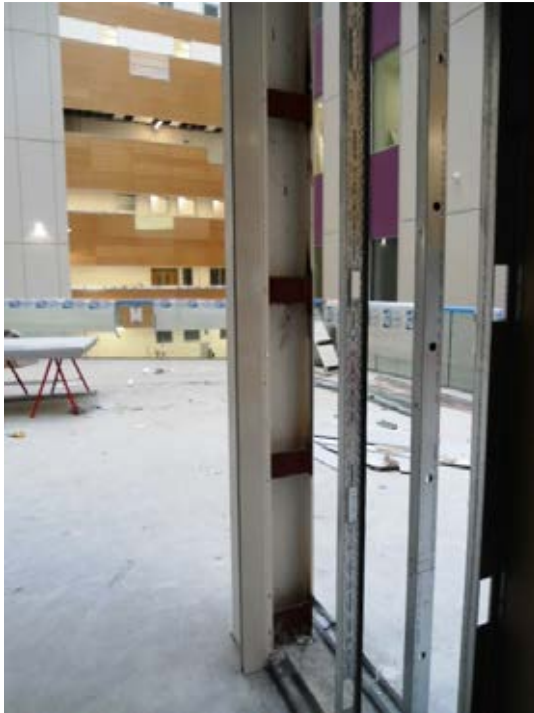
When we walked level 1 on 27/11/14, we highlighted to Brookfield that the intumescent previously noted as damaged together with the additional cleats required fire protection prior to closing up the columns and ceiling. Brookfield attended to this timeously.

Steel cleats without intumescent paint.

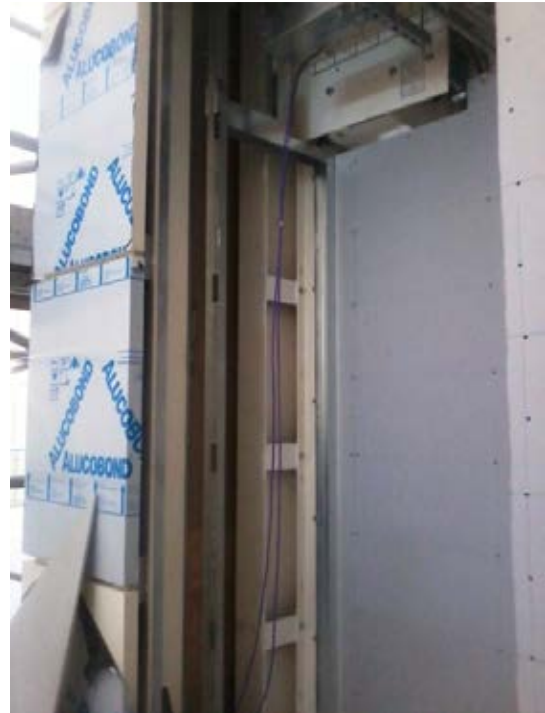
Cleats painted with intumescent paint.

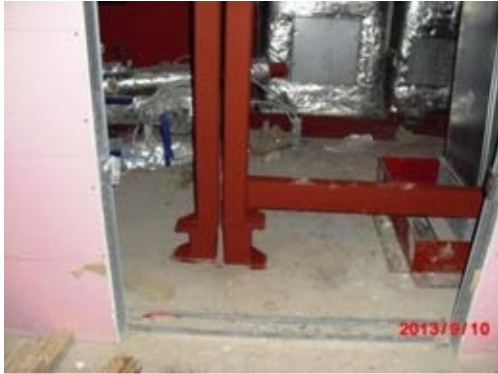
around the riser slab edges is based upon 0.8kN/m height/sq.m plan area. The calculations submitted by Mercury show a load of 0.99kN/m/sq.m which exceeds the design criteria therefore the legs will require extending to provide support from the lower floor. Mercury has been informed to replace/ extend the feet. (See Supervisor's Communication General Matters / Other Instructions (CI 13.1) No 162).

Extended legs

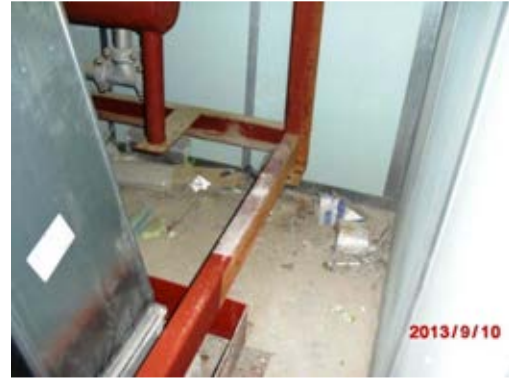
Leg still to be extended.

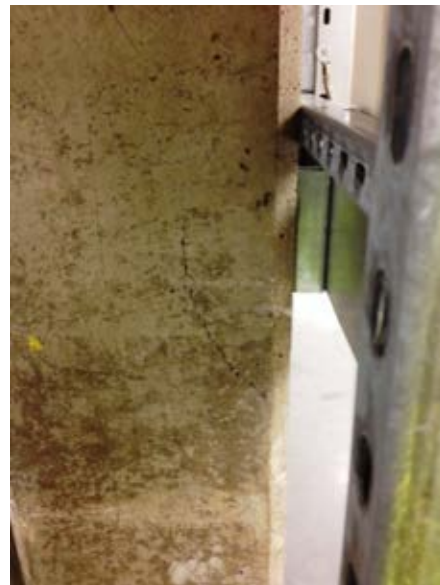
We noted a distribution board fixing has caused the concrete column to crack on Level 2 Plant Room 22. Following discussions with Brookfield and they intend to carry out a localised repair using high strength, low shrinkage (Cementitious with polymers) R4 repair mortar. We asked Brookfield to confirm that they have inspected all plant rooms to identify and repair similar cracked concrete as shown in the photo. Brookfield confirmed that they will carry out localised repairs using high strength, low shrinkage (Cementitious with polymers) R4 repair mortar. All plant rooms will be checked for similar cracked concrete as shown on Capita photo. (See Supervisor's Communication General Matters / Other Instructions (CI 13.1) No 222).

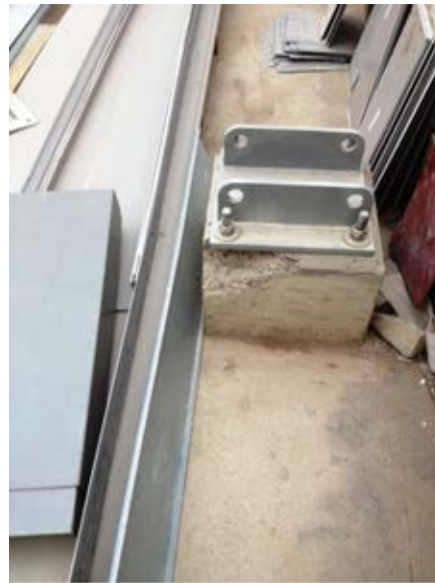
We also noted at roof level of the ACH that the support bases to the columns

are spalling. Brookfield confirmed that they would use the R4 repair mortar to effect a repair.

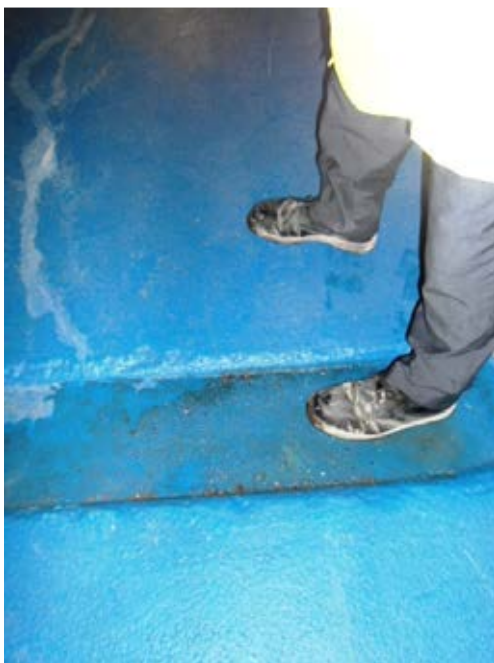
Level 5

The car park floors on levels 1, 2, 3, 4, and 5 adjacent to the stair on the east elevation have recessed channels which cross the pedestrian walkway similar to the potential trip hazards identified in Communication No 209. Some of the channels are in excess of 30mm. We have asked Brookfield to confirm if the same solution which is being considered to resolve Communication No 209 (installation of grills) will be considered. (See Supervisor's Communication General Matters / Other Instructions (CI 13.1) No 224).

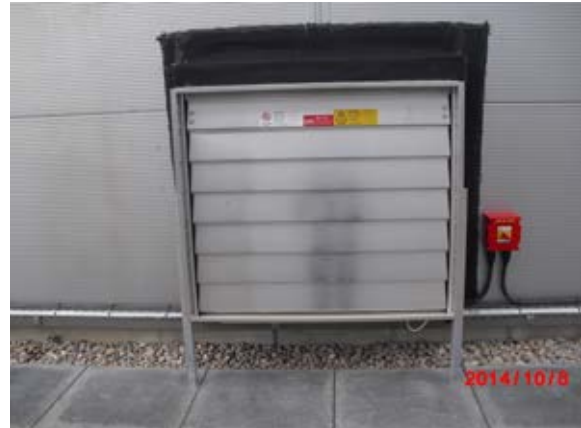
The three high level smoke extract fans on Level 4 Zone C appear to be complete with the fans and actuator totally enclosed with no access for maintenance.

The fan has a local actuator fitted, but there is no local means of isolating the 240 volt actuator. There are four similar fans also on the third floor which are in the process of being similarly installed. We asked Brookfield to confirm how access will be provided to the fan for future maintenance without cutting into the weatherproof membrane.

Brookfield responded by informing us that each fan has an isolator switch which is located adjacent to the ventilator and is shown in the photograph. The power to the fans and ventilators is taken from the Atrium Control Panel which is also has its own isolator.

They also intimated that the ventilator has a top removable blade as shown in the photograph which allows access to its actuator. We have asked Brookfield to demonstrate this to us. We are of the view that there is no means to isolate the damper actuator locally to allow safe work.

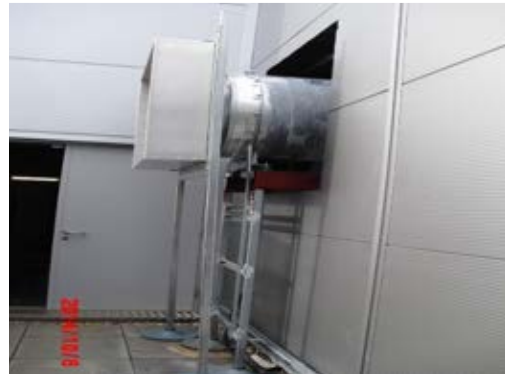
The east door clashes with one of the fans on Level 3 Core H link corridor. We have asked Brookfield to confirm their action to resolve this clash. (See Supervisor's Communication General Matters / Other Instructions (CI 13.1) No 215).

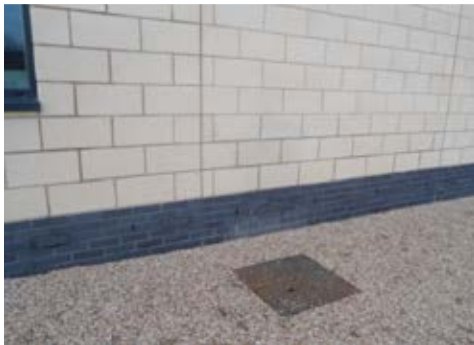
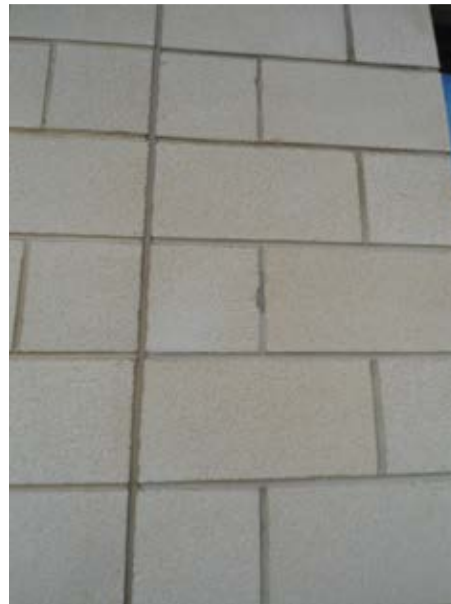
Although some work has been carried out to improve the quality the pointing on the external blockwork on the south and east elevations. Some of the blockwork does not reflect the quality of the pointing on the blockwork benchmark sample. Consequently we have raised Supervisor's Notification of Defect (CI 42.2) No 81.

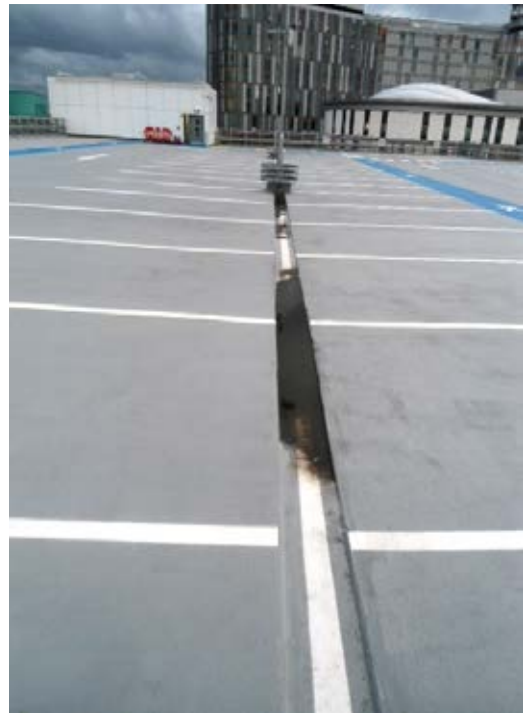
Some of the outlets taking the rainwater from the top level of the Car park are too high consequently water is ponding in the recessed channels.

We have asked Brookfield to confirm what remedial work will be undertaken to resolve this issue and confirm when the work is complete. See Supervisor's Notification of Defect (CI 42.2) No 83.

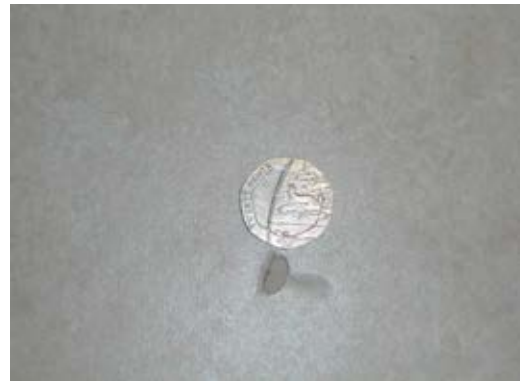
The vinyl across the full length of the Atrium Bridge had sustained damaged. We asked Brookfield to confirm that the vinyl floor covering will be replaced across the full width of the bridge to match the benchmark floor on Level 4 Link Bridge. Following an inspection with Peter Moir a solution to replace the vinyl was agreed. See Supervisor's Notification of Defect (CI 42.2) No 84.

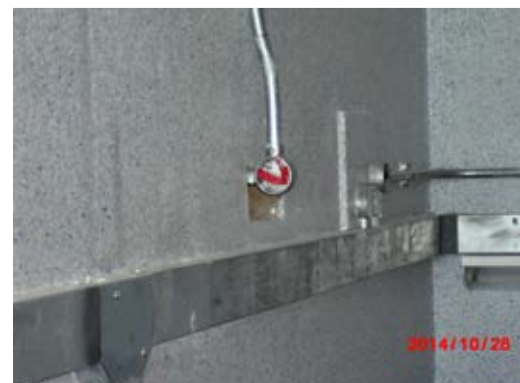
Cables used in the fire alarm installation have been forced into conduits boxes on Level 12 stair core G which is not in accordance with the manufacturer's recommendations. This was previously raised through Supervisors Defect Notification No 68 regarding the stress caused to FP and was addressed. We have asked Brookfield to confirm when this defect has been addressed. See Supervisor's Notification of Defect (CI 42.2) No 85.

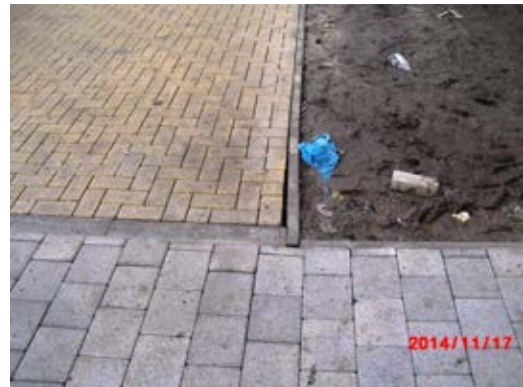
The edging kerb near the south west corner of the Children's Hospital has been poorly laid. We have asked Brookfield to confirm when this has been addressed. See Supervisor's Notification of Defect (CI 42.2) No 86.

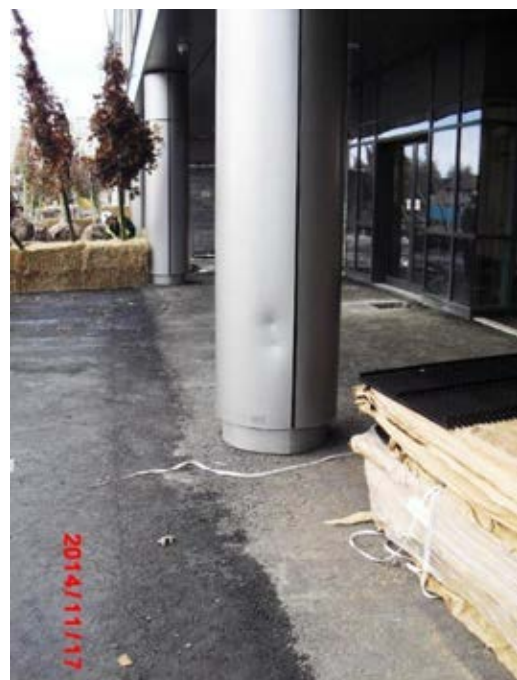
The cladding to the column on the South Elevation of the Adult Hospital is damaged. We asked Brookfield to confirm when this has been addressed. They have confirmed that the damage has been noted by their sub contractor and replacement cladding panel has been put on order. This will be replaced when the new section has been received. See Supervisor's Notification of Defect (CI 42.2) No 87.

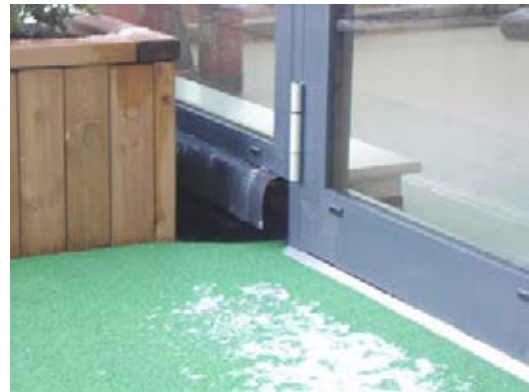
We asked Brookfield to confirm the finish below the glazed frame to prevent water penetrating adjacent to the door into corridor CC4-054. They have issued this to their Package manager who will liaise with the sub contractor to resolve and complete this detail.

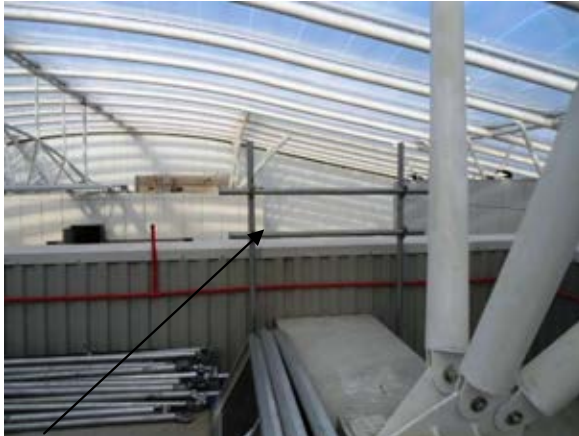
There is temporary scaffolding providing perimeter protection at concrete floor beams above the cores accessed from Level 12. We have asked Brookfield to confirm if permanent perimeter protection is to be fitted. See Supervisor's Communication General Matters / Other Instructions (CI 13.1) No 242.

Temporary scaffolding providing perimeter protection.

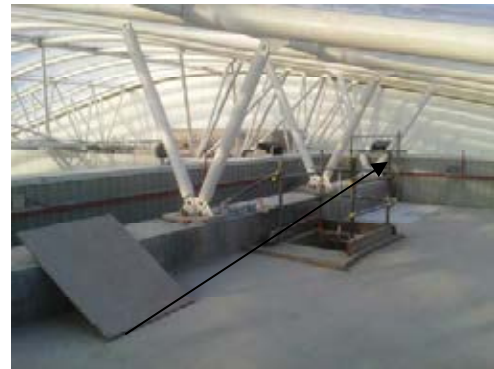
Temporary scaffolding providing perimeter protection.

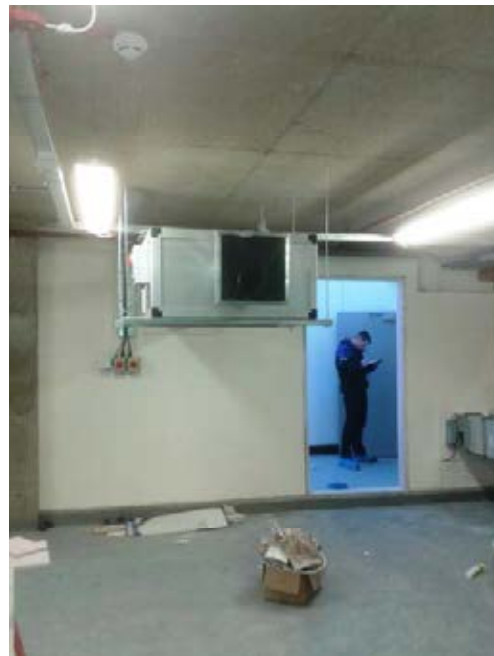
The opening at Core D plantroom adjacent to the FM lift does not have a door and the adjacent fire door shown on drawing NA-XX-12-252-150 has been moved closer to the double doors at the FM lift. We have asked Brookfield if the plantroom shown on the drawing below should have a fire door. Brookfield has confirmed that in accordance with the Fire strategy drawings, NA-XX-12-PL-572-100 and NA-XX-12-PL-572-101. The wall has been built in the correct position. No door (or partition) is shown as being required. Consequently Supervisor's Communication General Matters / Other Instructions (CI 13.1) No 243 is closed out.
