**Bundle of documents for Oral hearings
commencing from 13 May 2025 in relation
to the Queen Elizabeth University Hospital
and the Royal Hospital for Children,
Glasgow**

**Bundle 33
NEC3 Supervisor's Reports and Project
Supervisors Interface Action Notes**

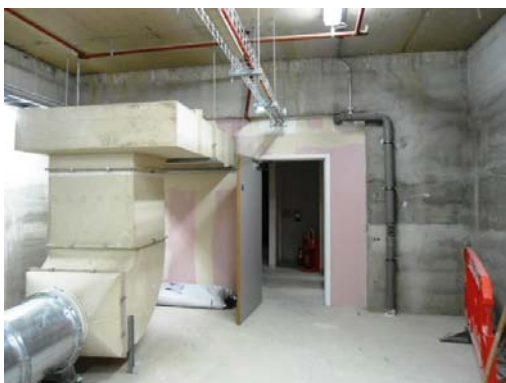
Level 12 Core A incomplete work.

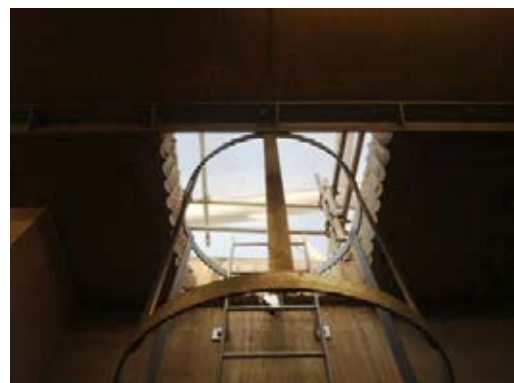
Hatch required to Cat ladder in room

CA12-015.

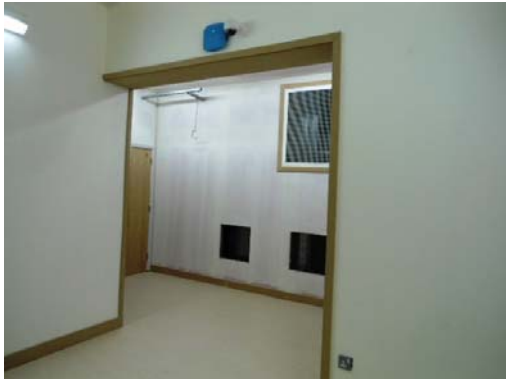
Some snagging work, painterwork and hatches required.

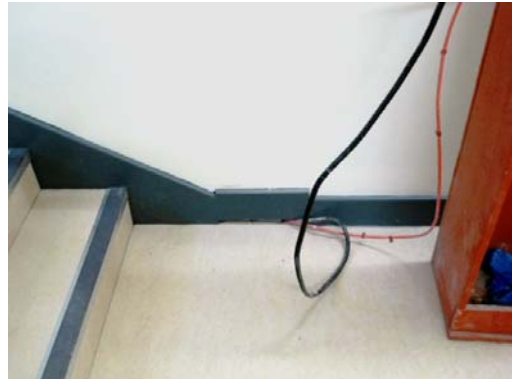
Site alarm system requires to be removed from some floors and skirting fitted.

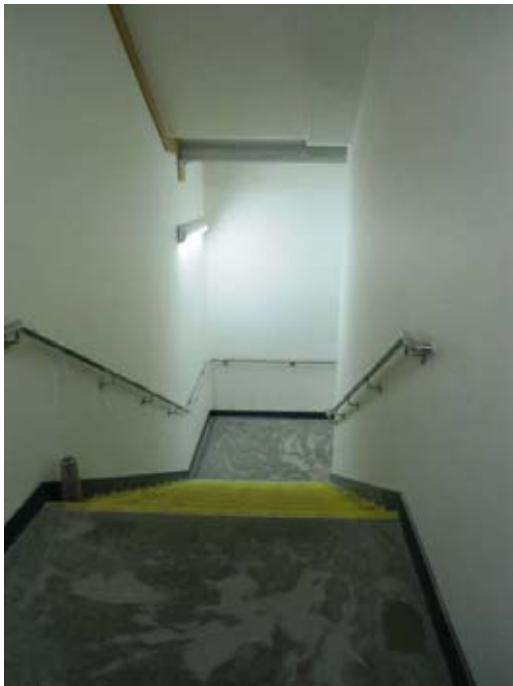
Cores A & B Level 1 to Level 0 incomplete work and snagging.

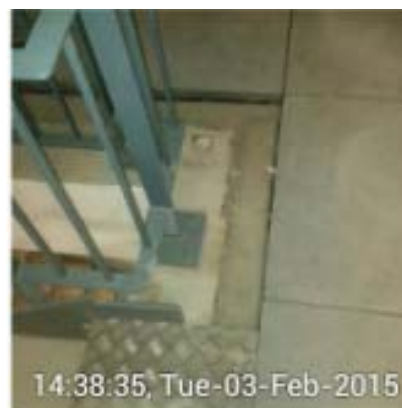
Edge of slab too high.

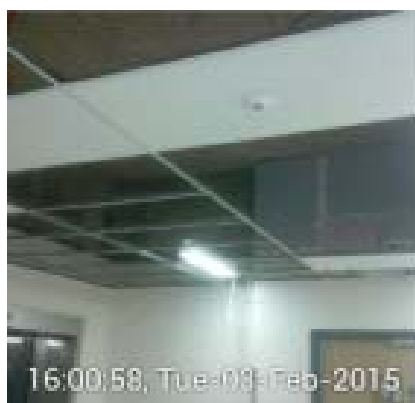
Incomplete ceilings

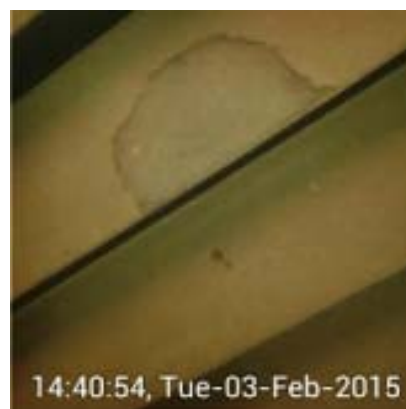
Damaged tread. There were other treads requiring repairs to lifting eyes.

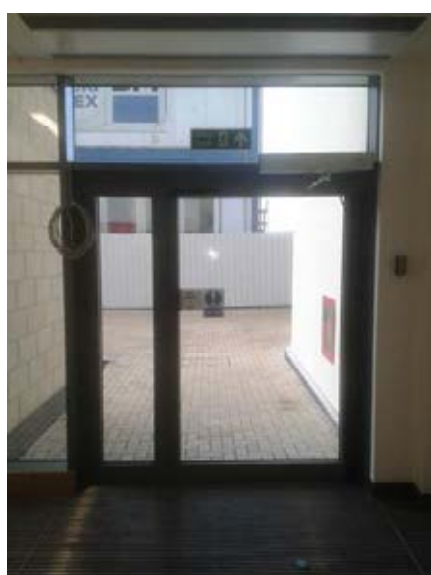
Push button not installed.

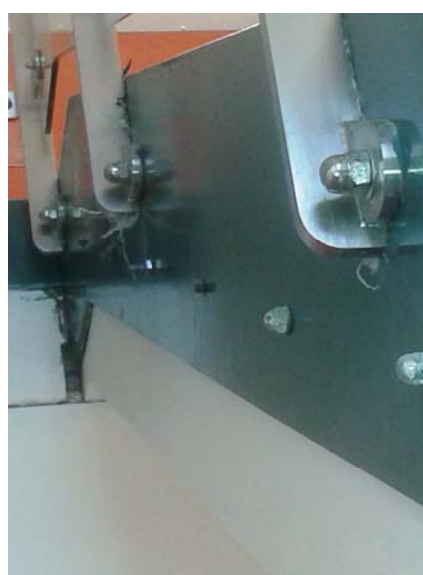
Nuts still to be cropped and fitted

to steel stringer.

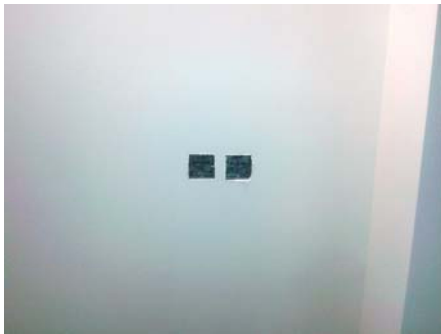
Redundant sockets.

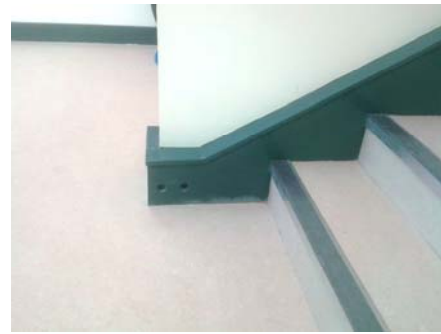
Holes to be filled in metal stringer.

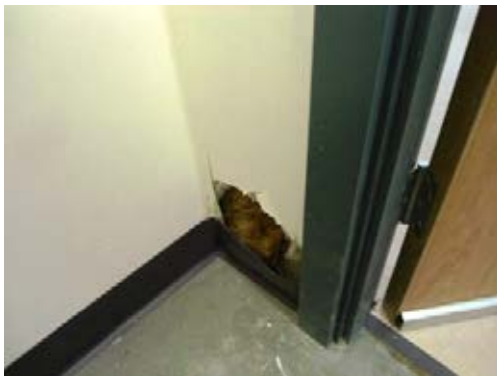
Plasterboard damaged in room GEN21-086

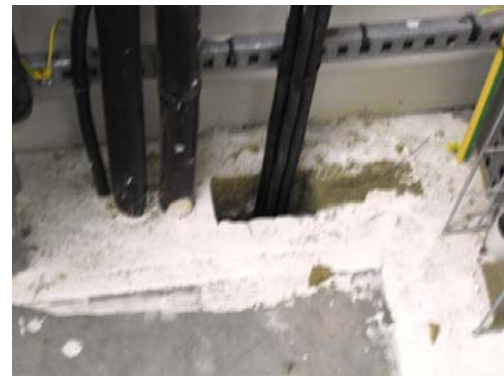
Gap in the fire bat in room GEN21-054

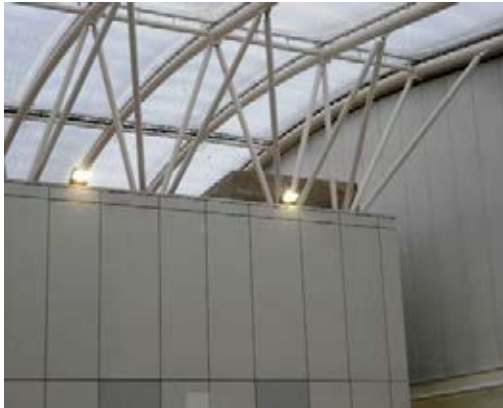
The concrete top of the lift enclosure in Core D is visible.

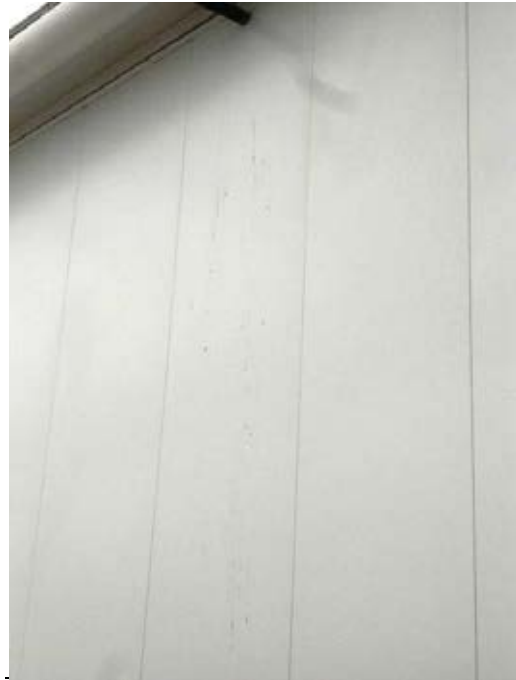
Pigeon droppings on cladding of Core B

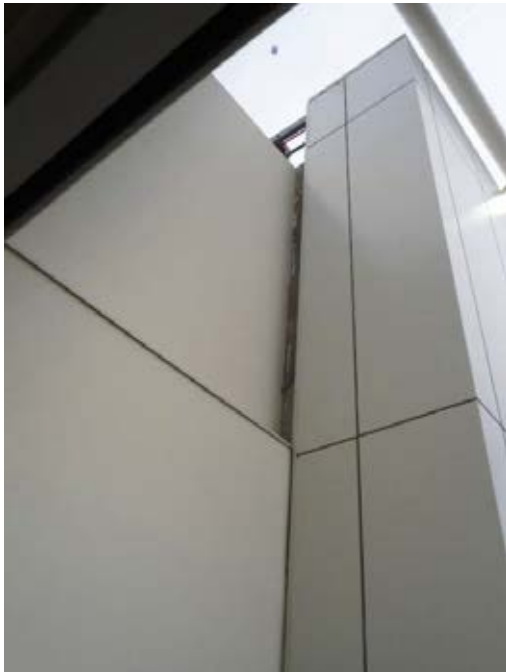
Exposed concrete visible from Level 11 corridor.

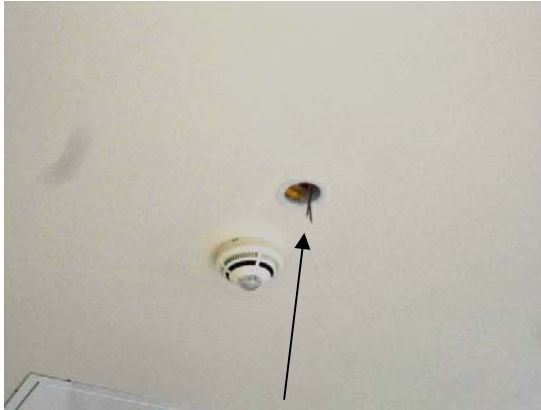
Remote LED to be completed

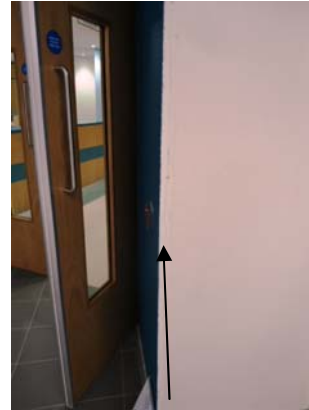
Damaged corner bead

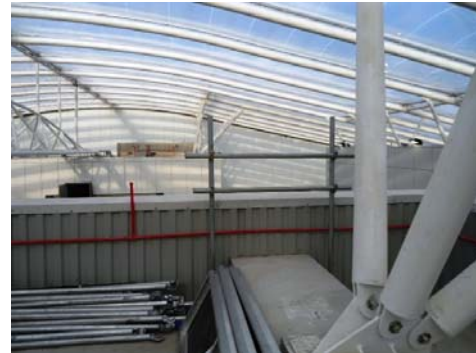
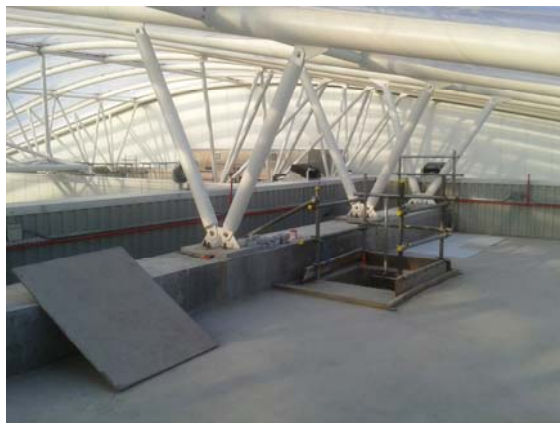
There is temporary scaffolding providing perimeter protection at concrete floor beams above the cores accessed from Level 12. We have asked Brookfield to confirm if permanent perimeter protection is to be fitted. See Supervisor's Communication General Matters / Other Instructions (CI 13.1) No 242.

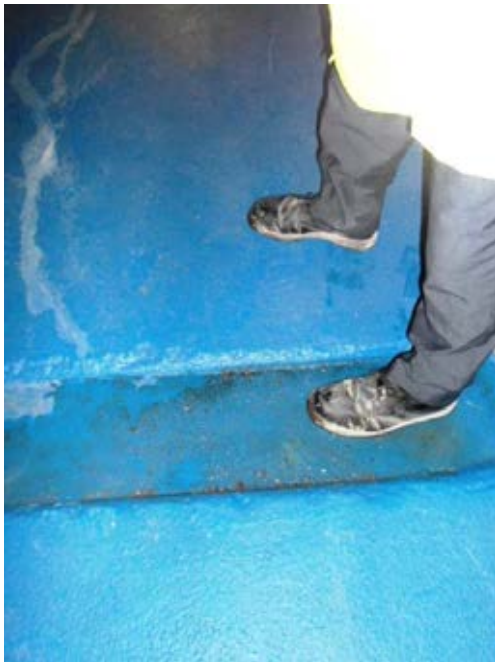
Level 5

The car park floors on levels 1, 2, 3, 4, and 5 adjacent to the stair on the east elevation have recessed channels which cross the pedestrian walkway similar to the potential trip hazards identified in Communication No 209. Brookfield has confirmed that IFT is to infill the channels with coloured screed on the walkways. They have intimated that these locations do not interfere with the water flow as they are the opposite end to the outlet gulley. (See Supervisor's Communication General Matters / Other Instructions (CI 13.1) No 224).

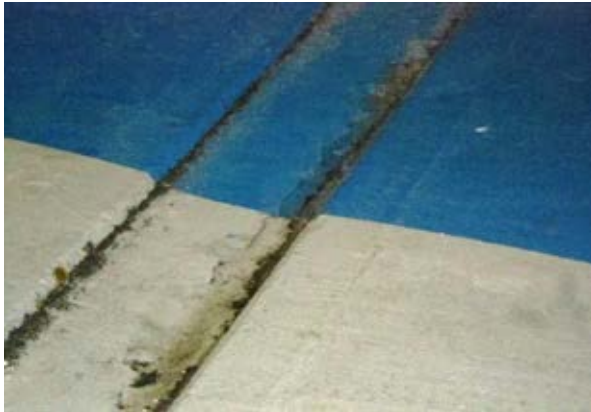
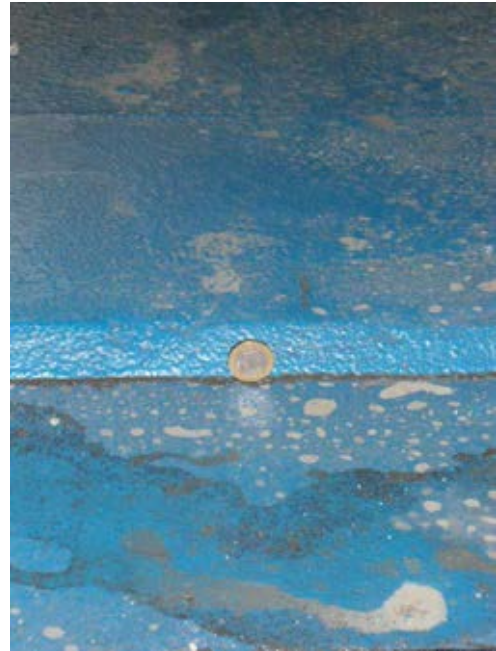
Level 3: Channel exceeds 30mm deep.

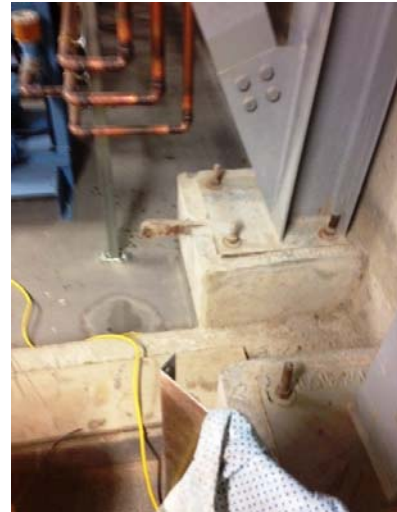
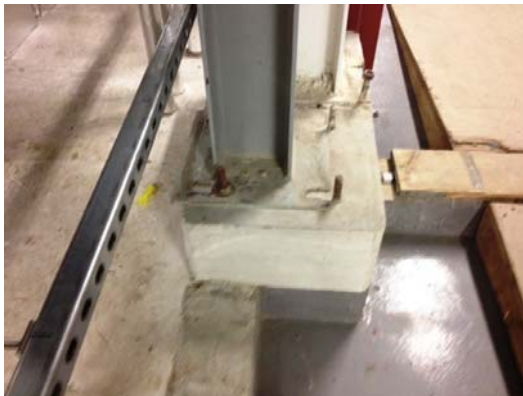
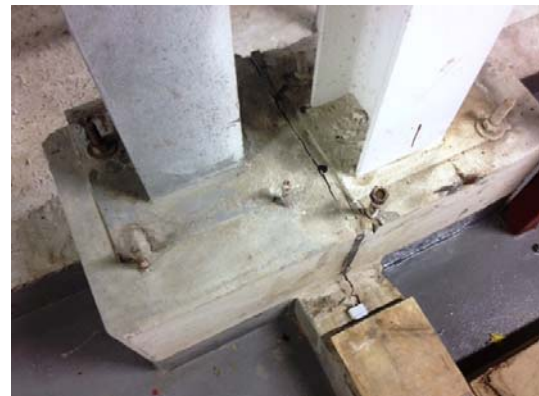
Clearing up in plant rooms has revealed some steel column base plate issues in the Children's area 4th floor – Brookfield are aware of this and are pursuing the matter.

We have asked Brookfield to confirm that the existing base detail as shown on the attached photographs in the Children's 4th floor plant room area is capable of safely resisting the loads which may be applied to it and that it conforms to the design intent. Brookfield confirmed that the steelwork installed by JD Pierce is adequate and capable of safely resisting the loads that have been applied to it and JD Pierce have issued a letter of conformity for all works. Consequently, Supervisor's Communication General Matters / Other Instructions (CI 13.1) No 235 is closed out.

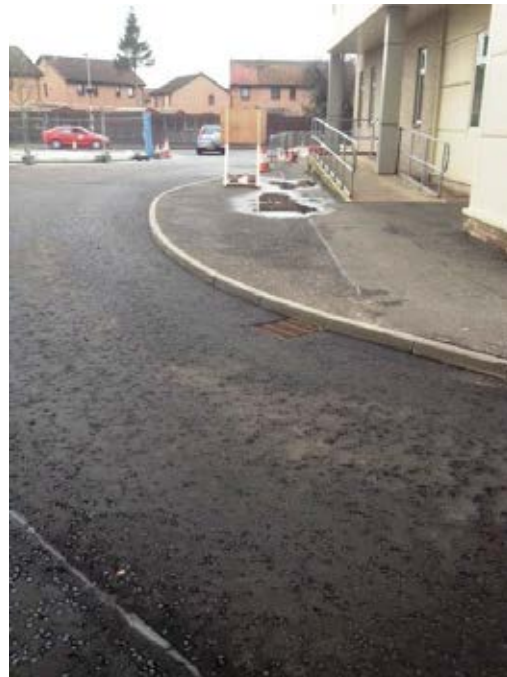
We advised the Brookfield team on 16th December that ponding on the new extended footpath to the east side of the maternity unit has the potential to be a significant slip hazard in cold weather. We asked them to confirm their action to address this hazard. Brookfield has confirmed that Land Engineering have been instructed to lift the full width of tar and re-lay with a fall from the ramp to the new road kerb.

Ponding at the extended footpath area on the east side of the maternity unit, and potential specification non-compliance on sections of the footpath to the dual carriageway just north of the energy centre.

Brookfield is waiting on confirmation of when their tar squad is returning/available to carry out the works. (See Supervisor's Communication General Matters / Other Instructions (CI 13.1) No 237).

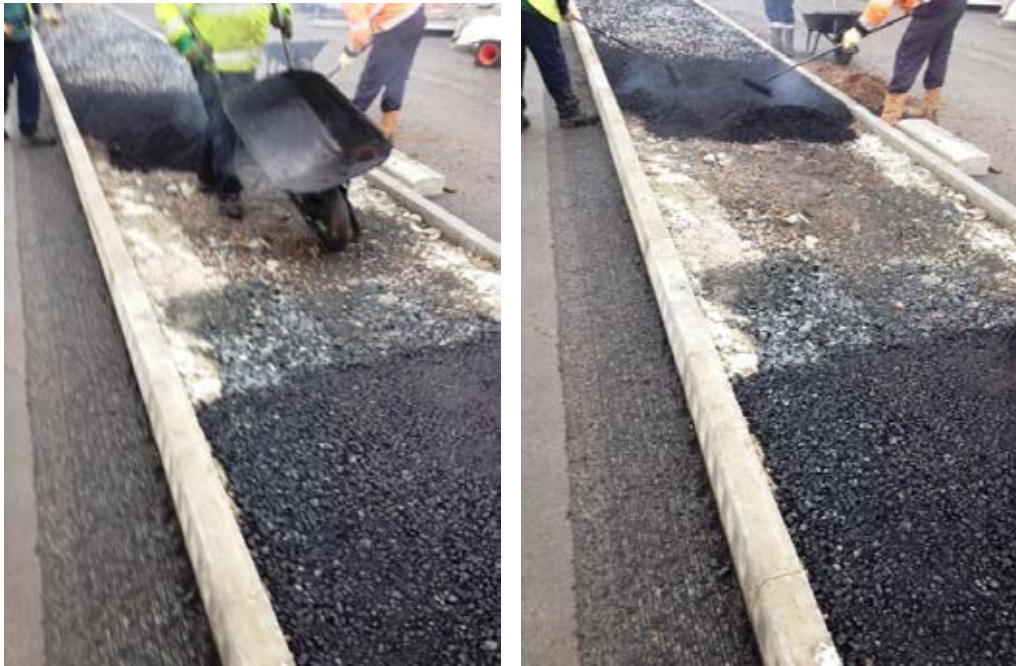
We asked Brookfield to confirm that the footpath make up to the dual carriageway just north of the energy centre complies with the specification (See photos below) Brookfield has confirmed that Land Engineering are to remove section of non complying asphalt and replace with specified material and layers. Land Engineering are to provide photo commentary showing removal and replacement in correct layers alongside delivery tickets evidencing material installed. Consequently Supervisor's Communication General Matters / Other Instructions (CI 13.1) No 236 is closed out.

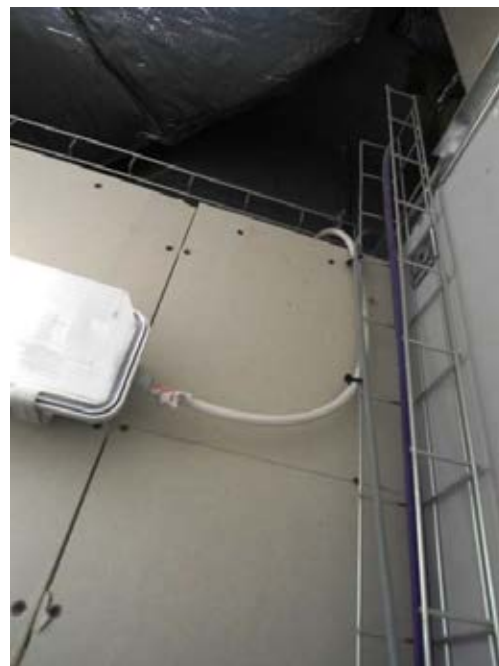
The fire rated partitions between the corridor and the Electrical Riser CCW-126 has incomplete fire stopping. The steelwork does not have intumescent paint. We asked Brookfield to confirm when this work has been completed. They have confirmed intumescent batt/firestopping was completed around the steelwork 26th Feb 2015. They are awaiting confirmation from the designers regarding requirements for intumescent paint. See Supervisor's Notification of Defect (CI 42.2) No 98.

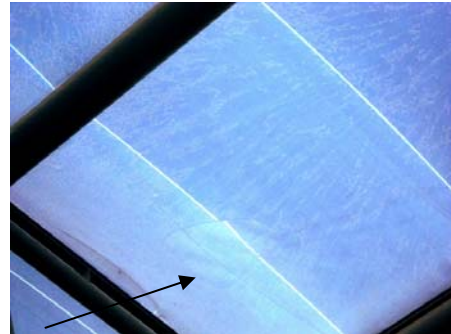
Water ponding on inner skin.

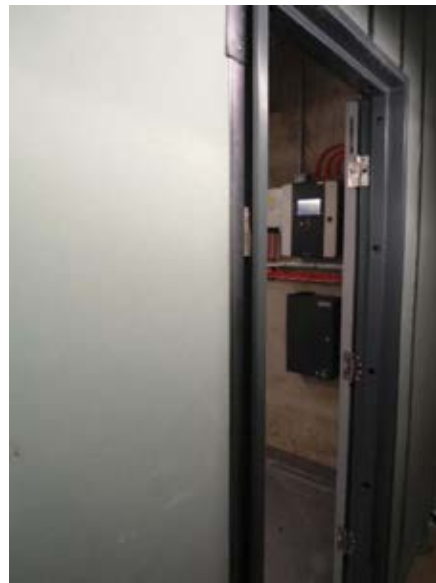
There is no fire stopping around the fire door on Level 12, Plantroom 121, Door M25-A. We asked Brookfield to confirm when the fire stopping has been completed. They have confirmed that this defect has been issued to TDSL to complete the fire stopping. They will confirm when completed. See Supervisor's Notification of Defect (CI 42.2) No 102.

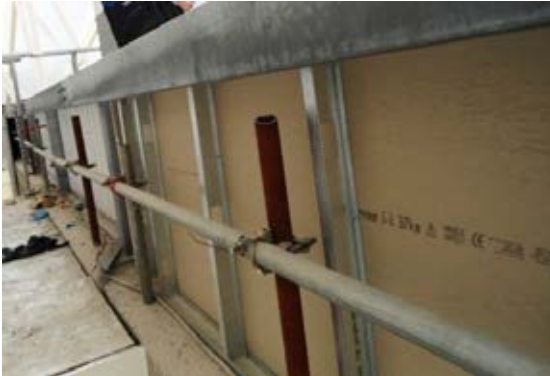
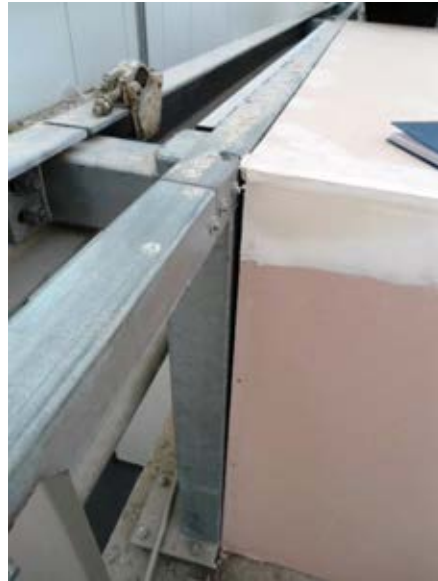
The fire stopping is incomplete to the Fire Enclosure in Core C above Level 12. We have asked Brookfield to confirm when this is complete. They intimated that this defect is being investigated by their Package Managers and a further response to follow. See Supervisor's Notification of Defect (CI 42.2) No 103.

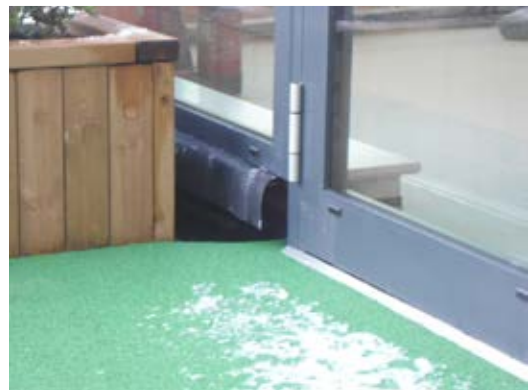
We asked Brookfield to confirm the finish below the glazed frame to prevent water penetrating adjacent to the door into corridor CC4-054. They have issued this to their Package manager who will liaise with the sub contractor to resolve and complete this detail.

See Supervisor's Communication General Matters / Other Instructions (CI 13.1) No 240.

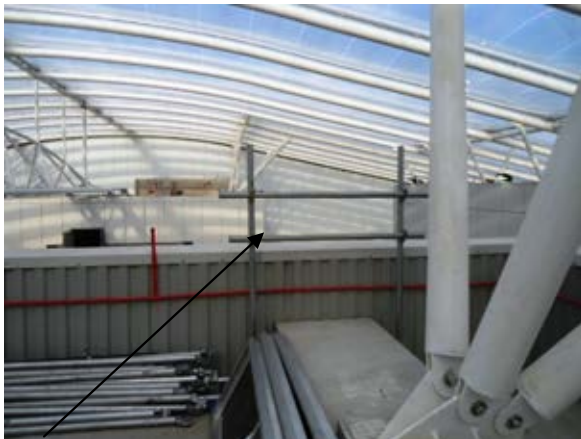
There is temporary scaffolding providing perimeter protection at concrete floor beams above the cores accessed from Level 12. We have asked Brookfield to confirm if permanent perimeter protection is to be fitted. See Supervisor's Communication General Matters / Other Instructions (CI 13.1) No 242.

Temporary scaffolding providing perimeter protection.

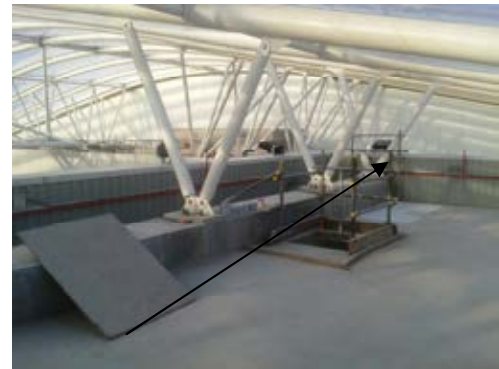
Temporary scaffolding providing perimeter protection.

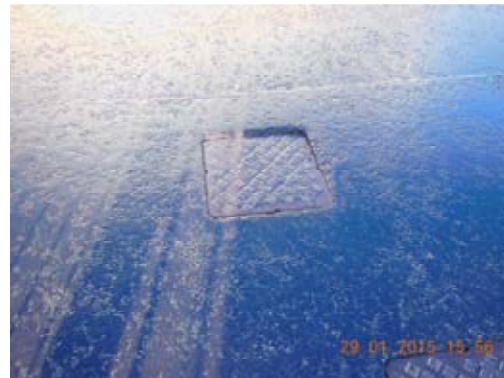
We reviewed Brookfield's NCR Tracker and noted the issues raised by the Package Managers. Brookfield confirmed that the tinting to the blockwork is complete to the pointing on the south and east elevations. An NCR has also been raised in relation to manholes which are below the level of the surrounding tar. (See photo opposite.)

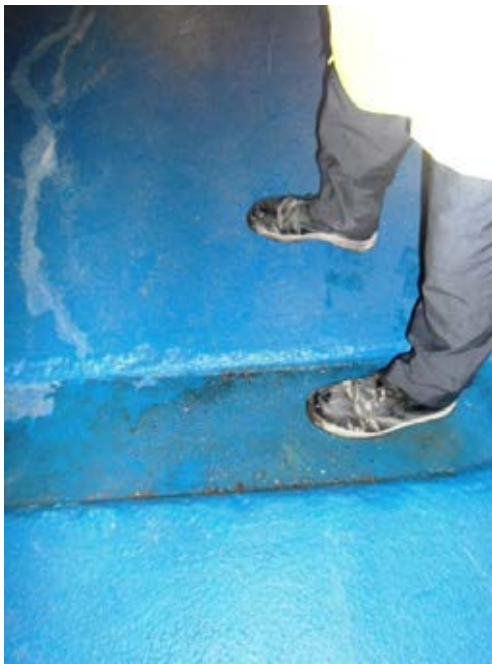
Level 5

The car park floors on levels 1, 2, 3, 4, and 5 adjacent to the stair on the east elevation have recessed channels which cross the pedestrian walkway similar to the potential trip hazards identified in Communication No 209. Brookfield has confirmed that IFT is to infill the channels with coloured screed on the walkways. They have intimated that these locations do not interfere with the water flow as they are the opposite end to the outlet gully. (See Supervisor's Communication General Matters / Other Instructions (CI 13.1) No 224).

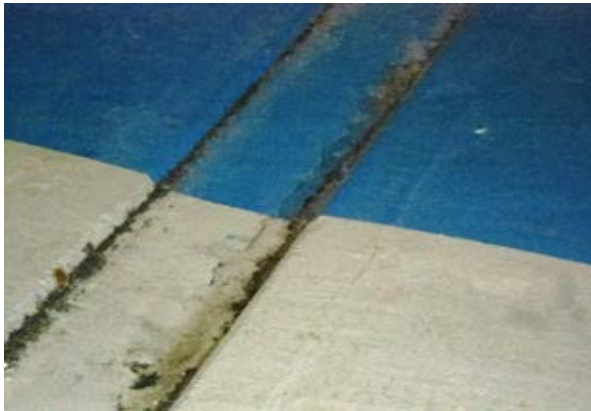
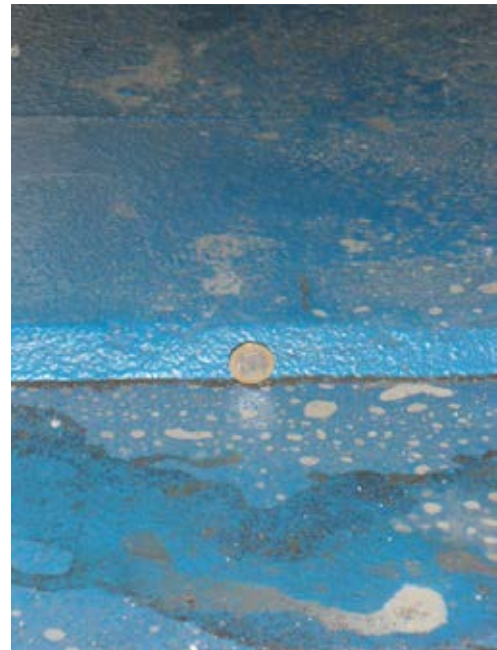
Level 3: Channel exceeds 30mm deep.

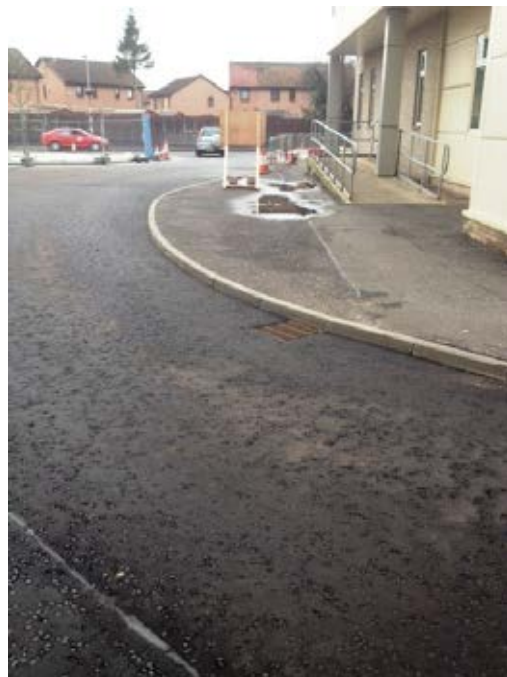
We advised the Brookfield team on 16th December that ponding on the new extended footpath to the east side of the maternity unit has the potential to be a significant slip hazard in cold weather. We asked them to confirm their action to address this hazard. Brookfield has confirmed that Land Engineering have been instructed to lift the full width of tar and re-lay with a fall from the ramp to the new road kerb.

Footpath to the east side of the maternity unit.

Brookfield has confirmed that work will commence week beginning 13th April (See Supervisor's Communication General Matters / Other Instructions (CI 13.1) No 237).

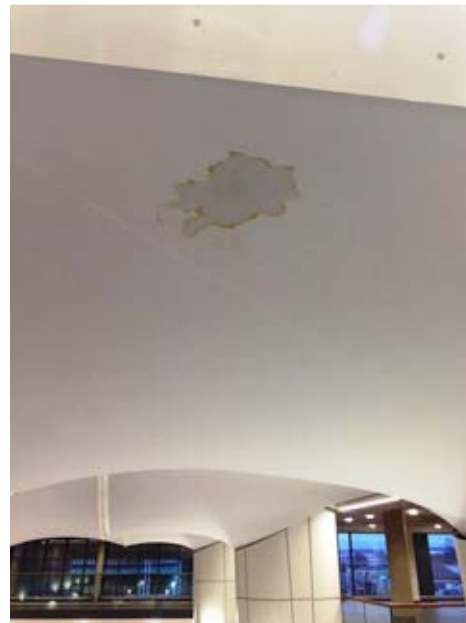
There is a water stain on the fabric ceiling. We asked Brookfield to confirm when they have located the source of the water ingress and when they have carried out the appropriate remedial action. We have also asked them to confirm if the fabric is to be replaced or the stain removed. Brookfield confirmed that this defect was immediately issued to Mercury, who are currently investigating and a response is awaited See Supervisor's Notification of Defect (CI 42.2) No 95

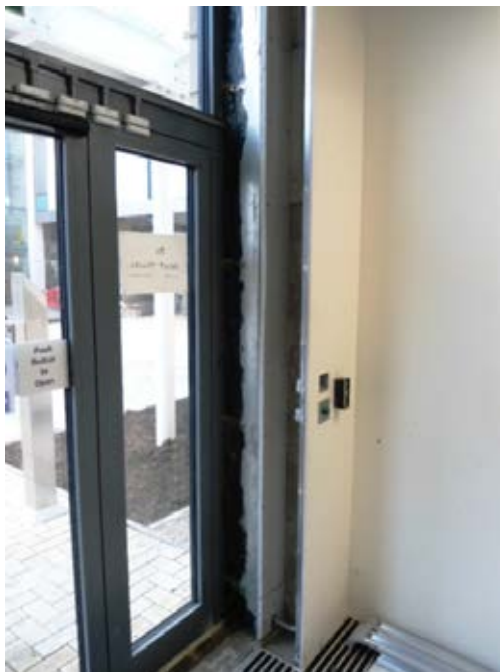
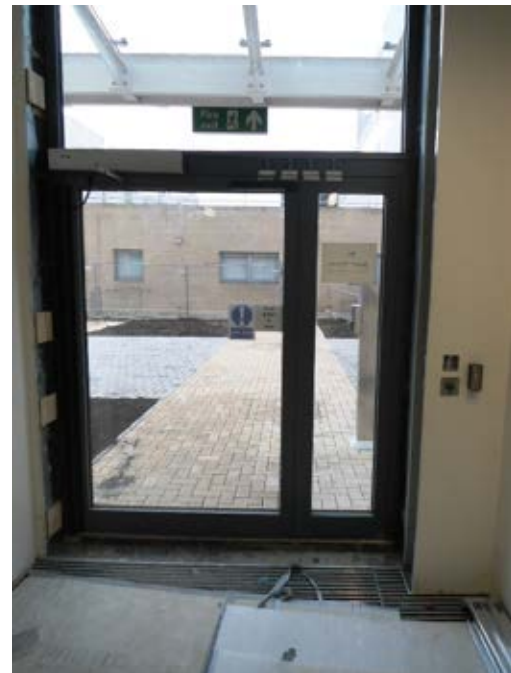
The fire exit door on the West Elevation of the Children's Hospital adjacent to the Disposal Hold OBW-082 is not operational and the works are incomplete.

We asked Brookfield to confirm when the works to the fire exit door are complete and the door is functional as a fire exit. They have confirmed that this has been issued to both Mercury for electrical and BMCE managers to complete the door jambs etc. We had been previously made aware that the keys had been issued to NHS who left it on 'locked' position for security.

See Supervisor's Notification of Defect (CI 42.2) No 96.

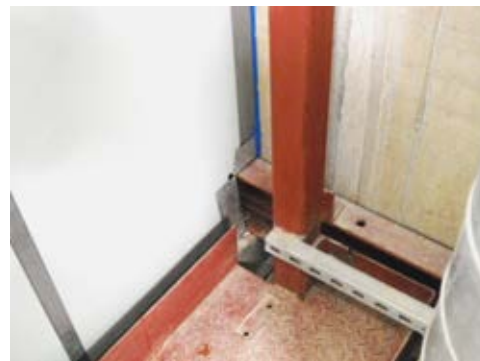
The fire rated partitions between the corridor and the Electrical Riser CCW-126 has incomplete fire stopping. The steelwork does not have intumescent paint. We asked Brookfield to confirm when this work has been completed. They have confirmed intumescent batt/firestopping was completed around the steelwork 26th Feb 2015. They are awaiting confirmation from the designers regarding requirements for intumescent paint. See Supervisor's Notification of Defect (CI 42.2) No 98.

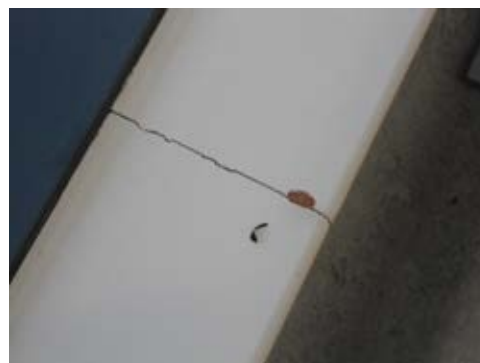
The joints at window cills are opening up. We asked Brookfield to confirm their remedial action to resolve this problem. They have confirmed that this defect is being investigated by their Package Managers and a further response to follow, when actions are completed. MSee Supervisor's Notification of Defect (CI 42.2) No 99.

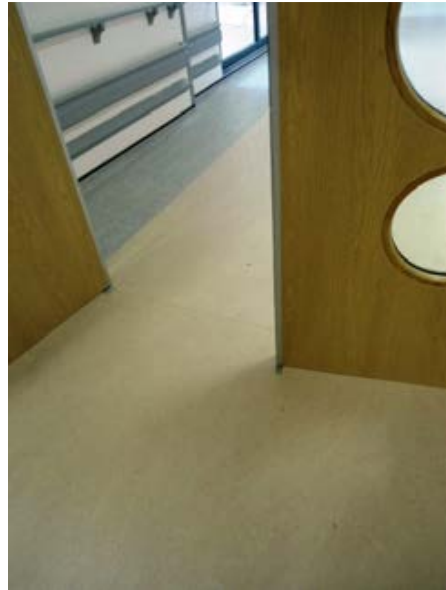
The fire door is sticking on the floor preventing the door to open and close in the corridor between CC1-032 and CC1-054. We asked Brookfield to confirm when this door is fully operational. They have confirmed that this defect has been issued to both TDSL (doors) and AC (Flooring) for them to resolve.

See Supervisor's Notification of Defect (CI 42.2) No 100.

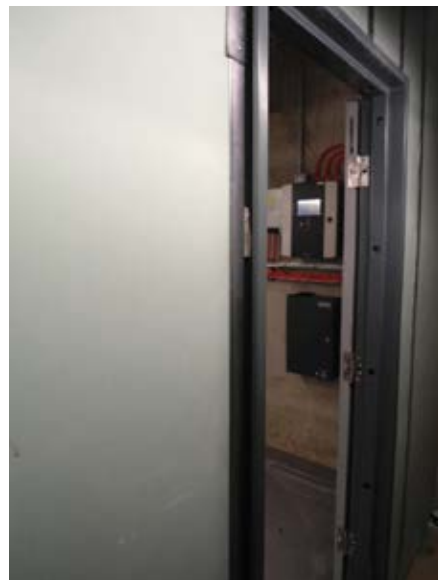
There is no fire stopping around the fire door on Level 12, Plantroom 121, Door M25-A. We asked Brookfield to confirm when the fire stopping has been completed. They have confirmed that this defect has been issued to TDSL to complete the fire stopping. They will confirm when completed. See Supervisor's Notification of Defect (CI 42.2) No 102.

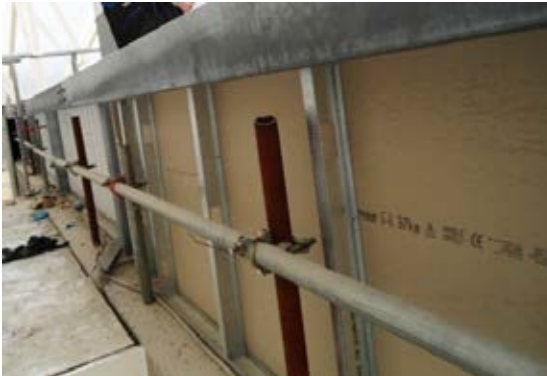
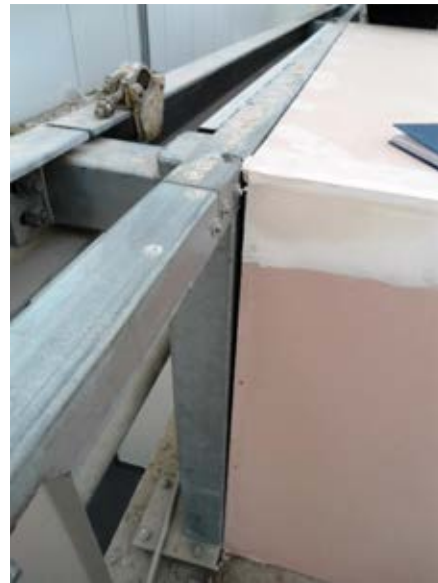
The fire stopping was incomplete to the Fire Enclosure in Core C above Level 12. We have inspected this with Brookfield and confirm that it is complete. Consequently Supervisor's Notification of Defect (CI 42.2) No 103 is closed out.

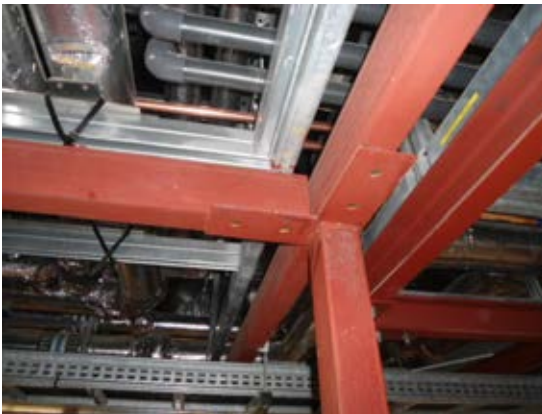
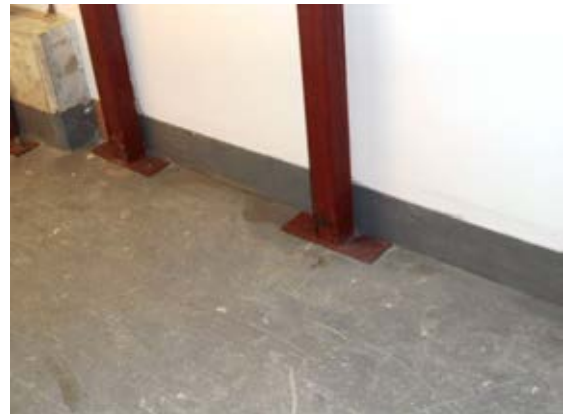
Vertical steel column to supporting services is not bolted to the horizontal member and not bolted to the floor. Confirm when this has been addressed. See Supervisor's Notification of Defect (CI 42.2) No 104.

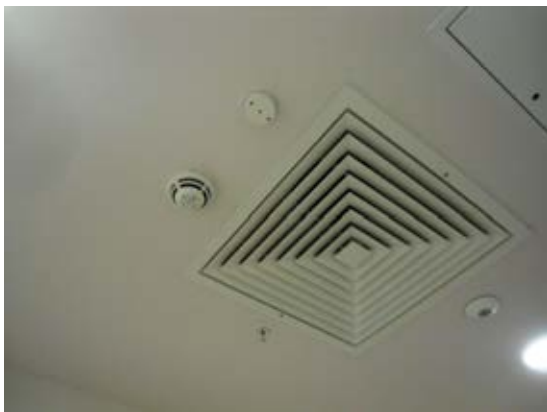
Smoke detector too close to air supply vent.

to address the defects. Generally the defects were of a minor nature. Below are the few that require some attention. See Supervisor's Notification of Defect (CI 42.2) No 106.

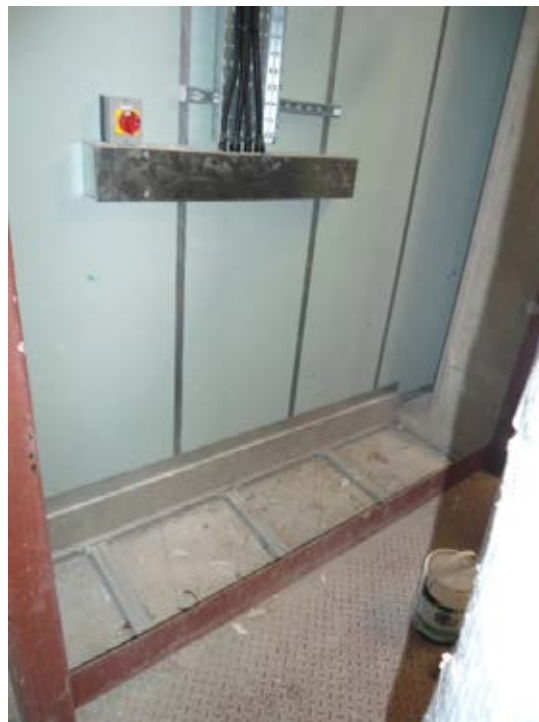
Gap between the metal deck and the wall with the floor comprising fire bats.

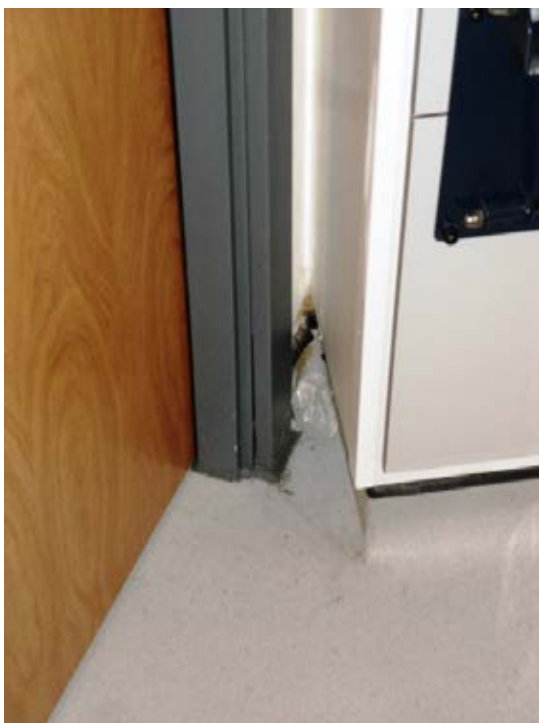
Poor vinyl detail at recess.

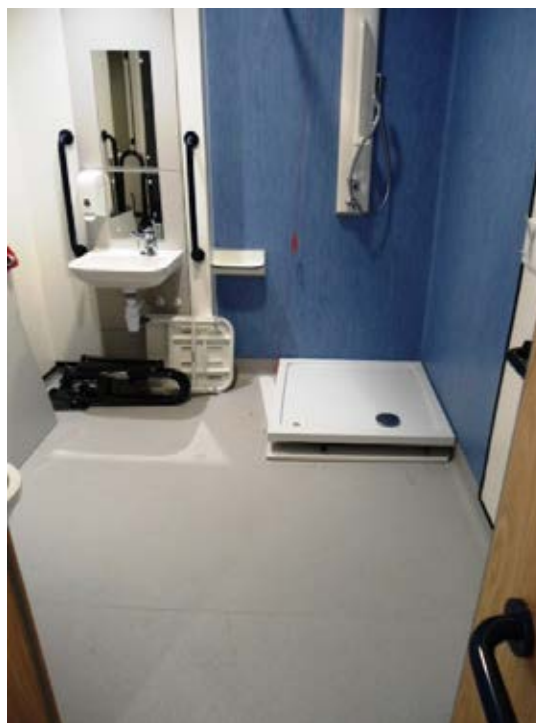
Incomplete work to surface shower unit

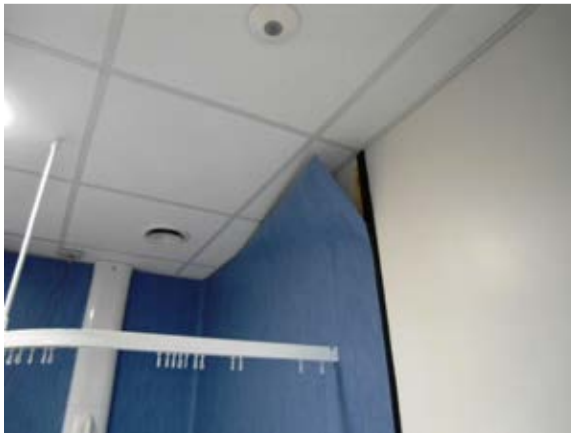
Peeling vinyl.

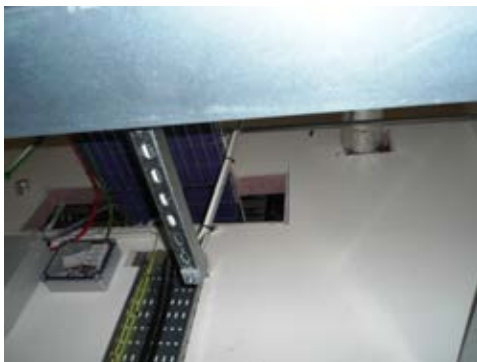
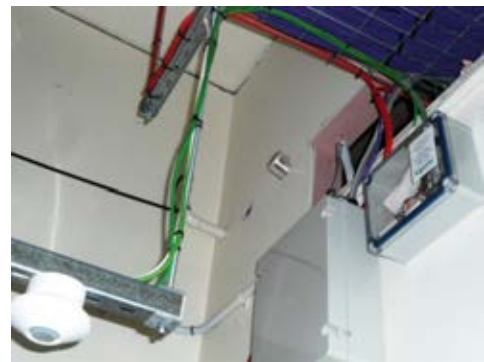
No fire stopping has been fitted around penetrations passing through the fire rated partition in the IT Hub Room FMC2-406 on Level 2. We asked Brookfield to confirm when these are addressed. Brookfield has provided us with further information which confirms that the room forms part of a cluster consequently no fire stopping is required. Supervisor's Notification of Defect (CI 42.2) No 111 is closed out.

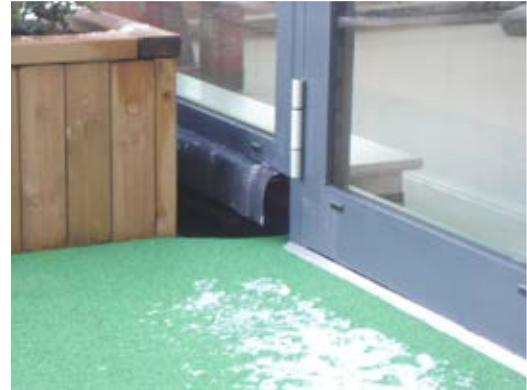
We asked Brookfield to confirm the finish below the glazed frame to prevent water penetrating adjacent to the door into corridor CC4-054. They have issued this to their Package manager who will liaise with the sub contractor to resolve and complete this detail. See Supervisor's Communication General Matters / Other Instructions (CI 13.1) No 240.

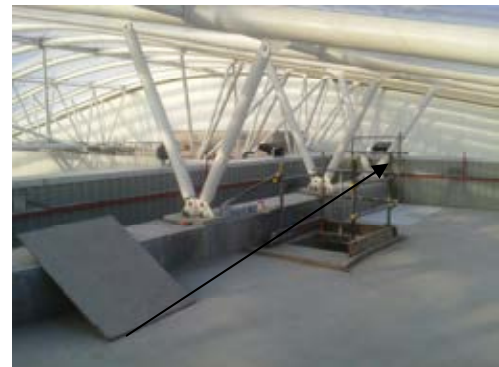
There is temporary scaffolding providing perimeter protection at concrete floor beams above the cores accessed from Level 12. We have asked Brookfield to confirm if permanent perimeter protection is to be fitted. See Supervisor's Communication General Matters / Other Instructions (CI 13.1) No 242.

Temporary scaffolding providing perimeter protection.

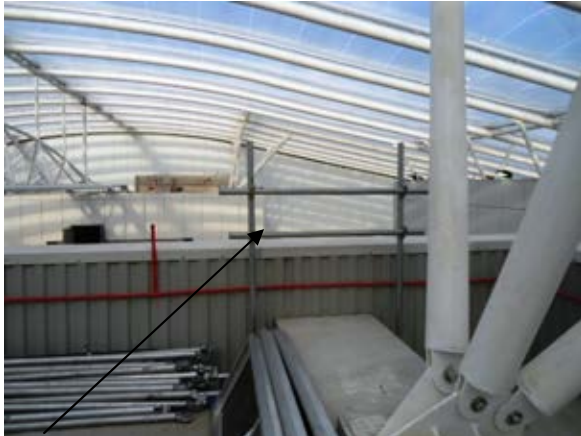
Temporary scaffolding providing perimeter protection.

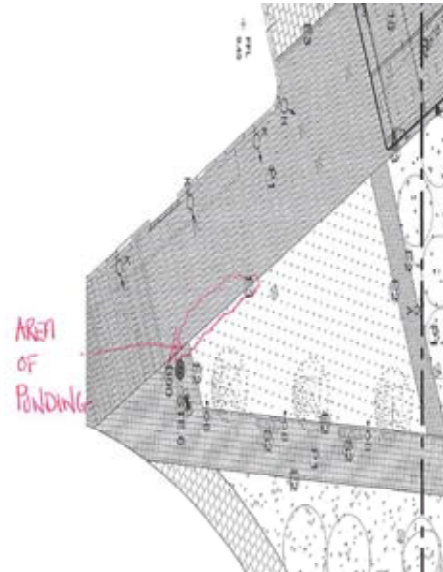
We noted water is ponding between the pavers and grassed area shown in the drawing opposite. We have asked Brookfield to confirm their remedial action to address this problem and confirm when the works are complete. See General Matters / Other Instructions (CI 13.1) No 248.

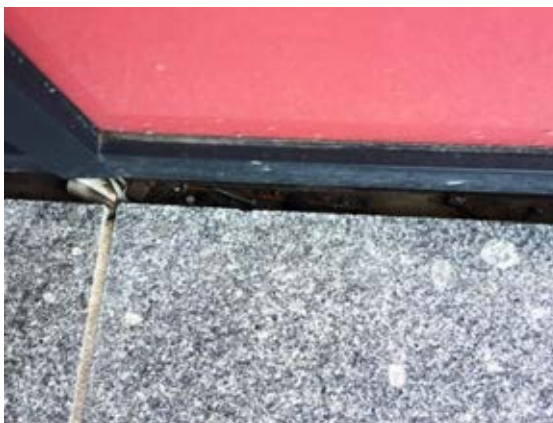
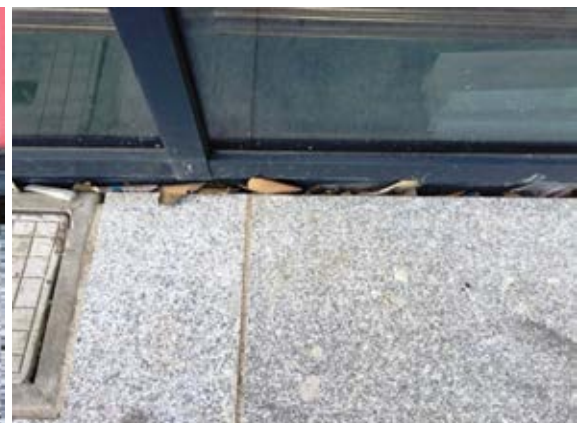
There are open joints between the granite and the building around the perimeter of the building. We have asked Brookfield to confirm their proposals to fill the gap to stop debris falling down. See General Matters / Other Instructions (CI 13.1) No 250.

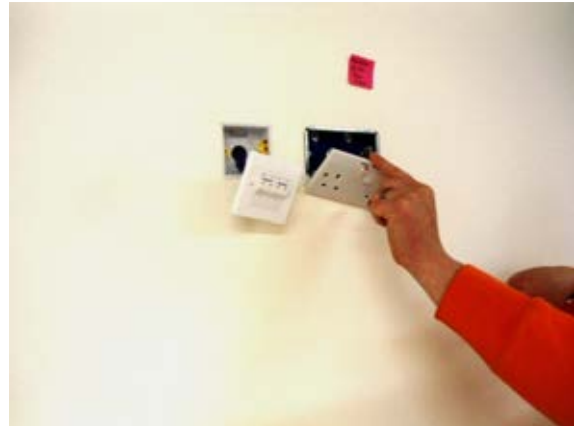
While undertaking inspections on Level 10 we note that a double socket was installed in a fire rated wall with a propriator putty pad, however the data point next to the socket did not have a putty pad placed in the back box. We asked Brookfield to confirm what type intumescent putty pads which will be used in the data point in this type of location and provide your marked up drawing or QA checks showing the location of sockets with intumescent putty pads installed in fire rated walls. Brookfield is investigating. See General Matters / Other Instructions (CI 13.1) No 251.

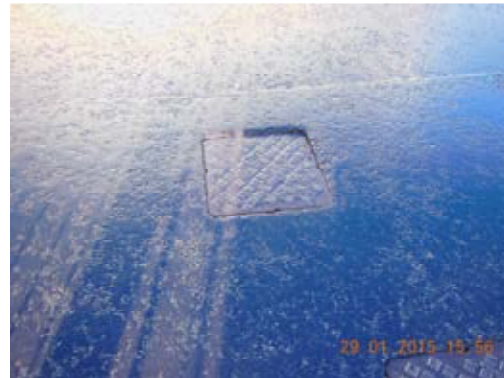
We reviewed Brookfield's NCR Tracker and noted the issues raised by the Package Managers. Brookfield confirmed that the tinting to the blockwork is complete to the pointing on the south and east elevations. An NCR has also been raised in relation to manholes which are below the level of the surrounding tar. (See photo opposite.)

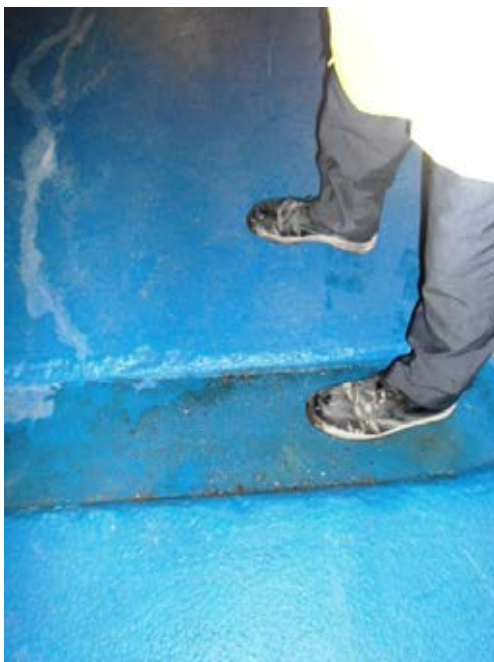
Level 5

The car park floors on levels 1, 2, 3, 4, and 5 adjacent to the stair on the east elevation have recessed channels which cross the pedestrian walkway similar to the potential trip hazards identified in Communication No 209. Brookfield has confirmed that IFT is to infill the channels with coloured screed on the walkways. This work is complete and we await a formal response. (See Supervisor's Communication General Matters / Other Instructions (CI 13.1) No 224).

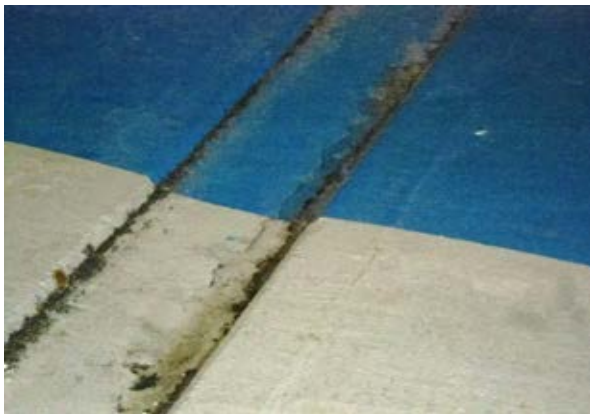
Level 3: Channel exceeds 30mm deep.

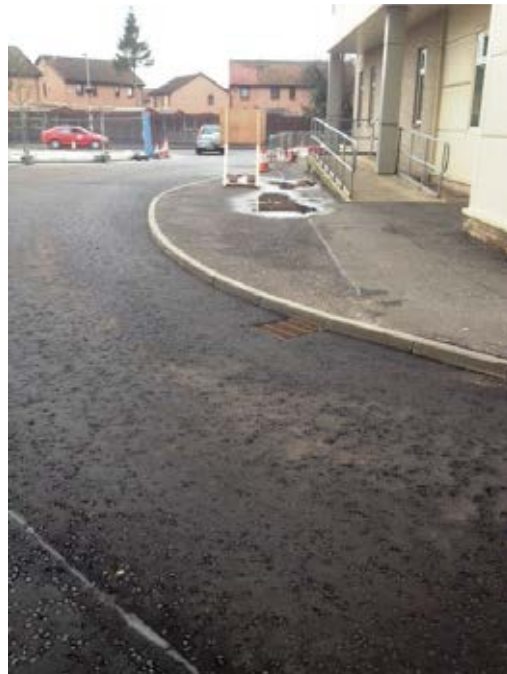
Footpath to the east side of the maternity unit.

We advised the Brookfield team on 16th December that ponding on the new extended footpath to the east side of the maternity unit has the potential to be a significant slip hazard in cold weather. We asked them to confirm their action to address this hazard. Brookfield has confirmed that Land Engineering have been instructed to lift the full width of tar and re-lay with a fall from the ramp to the new road kerb.

Ponding at the extended footpath area on the east side of the maternity unit, and potential specification non-compliance on sections of the footpath to the dual carriageway just north of the energy centre.

Brookfield had confirmed that work would commence week beginning 13th April. However they are awaiting an asphalt squad. (See Supervisor's Communication General Matters / Other Instructions (CI 13.1) No 237).

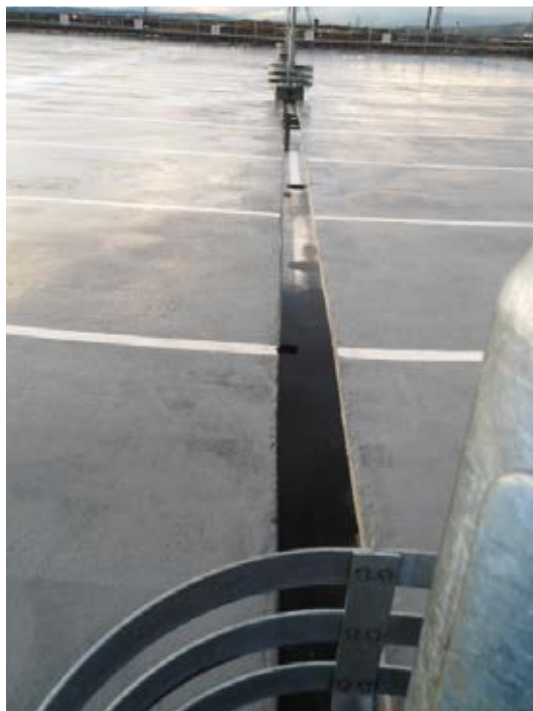
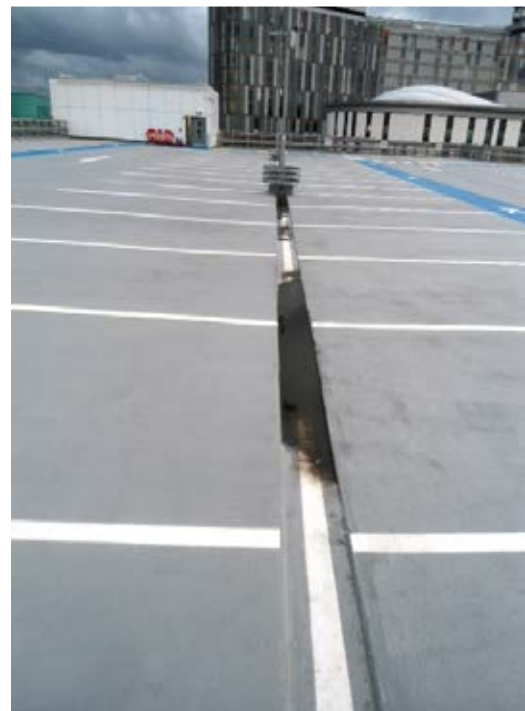
Some of the outlets taking the rainwater from the top level of the Car park are too high consequently water is ponding in the recessed channels.

We asked Brookfield to confirm what remedial work will be undertaken to resolve this issue and confirm when the work is complete. A further inspection was carried out with the client and it was agreed that due to the levels filling the channels would only cause the water to spread over a larger area. Consequently Supervisor's Notification of Defect (CI 42.2) No 83 is closed out.
