**Bundle of documents for Oral hearings
commencing from 13 May 2025 in relation
to the Queen Elizabeth University Hospital
and the Royal Hospital for Children,
Glasgow**

**Bundle 33
NEC3 Supervisor's Reports and Project
Supervisors Interface Action Notes**

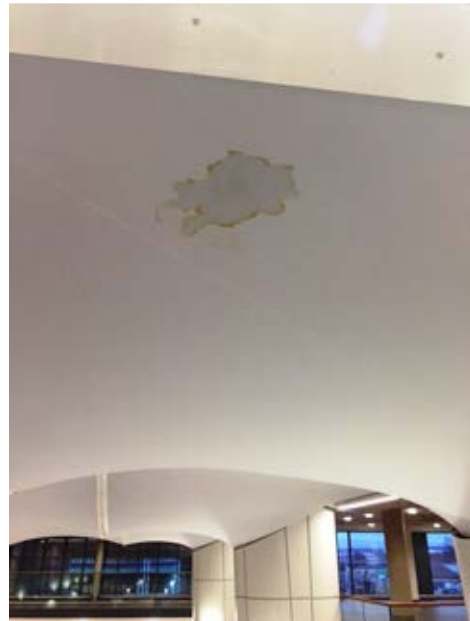
We asked Brookfield to confirm when they have located the source of the water ingress which caused a water stain on the fabric ceiling. We have also asked them to confirm their remedial action. They have confirmed that the issue has been resolved and we await a formal response. A response is awaited. See Supervisor's Notification of Defect (CI 42.2) No 95

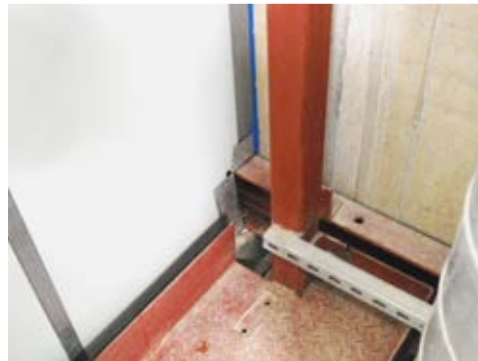
The fire rated partitions between the corridor and the Electrical Riser CCW-126 has incomplete fire stopping. The steelwork does not have intumescent paint. We asked Brookfield to confirm when this work has been completed. They have confirmed intumescent batt/firestopping was completed around the steelwork 26th Feb 2015. They are awaiting confirmation from the designers regarding requirements for intumescent paint. See Supervisor's Notification of Defect (CI 42.2) No 98.

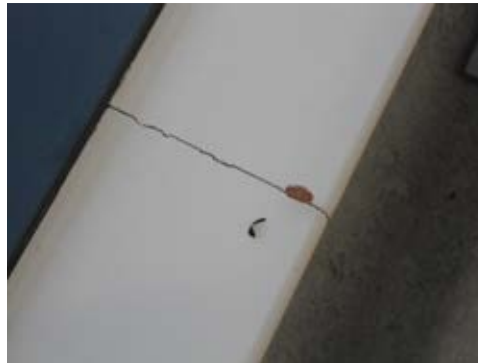
The joints at window cills are opening up. We asked Brookfield to confirm their remedial action to resolve this problem. They have confirmed that this defect is being investigated by their Package Managers and a further response to follow, when actions are completed. MSee Supervisor's Notification of Defect (CI 42.2) No 99.

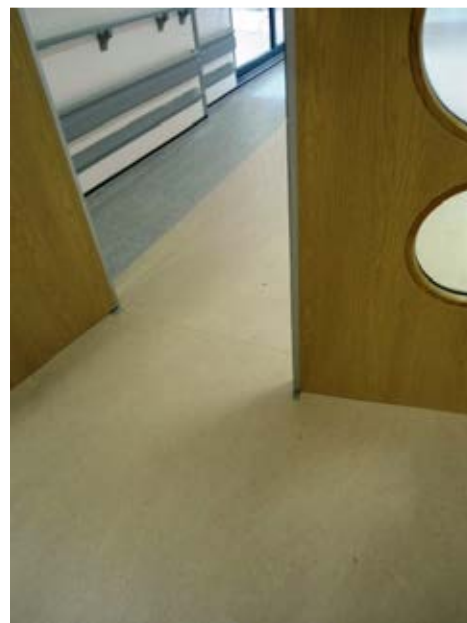
Brookfield has confirmed that the fire door which was sticking on the floor preventing the door to open and close in the corridor between CC1-032 and CC1-054 has been rectified. We await a formal response from Brookfield. See Supervisor's Notification of Defect (CI 42.2) No 100.

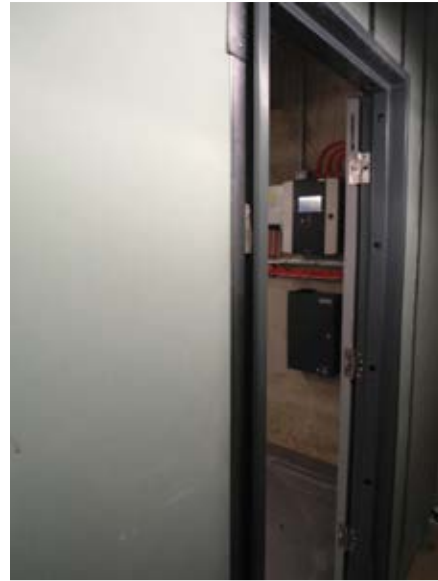
There was no fire stopping around the fire door on Level 12, Plantroom 121, Door M25-A. Brookfield has confirmed that the fire stopping has been completed. We await a formal response from Brookfield. See Supervisor's Notification of Defect (CI 42.2) No 102.

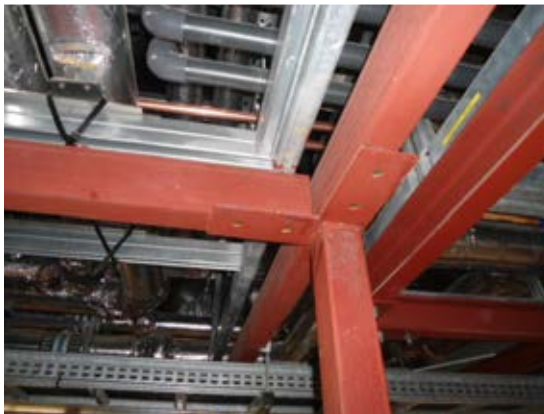
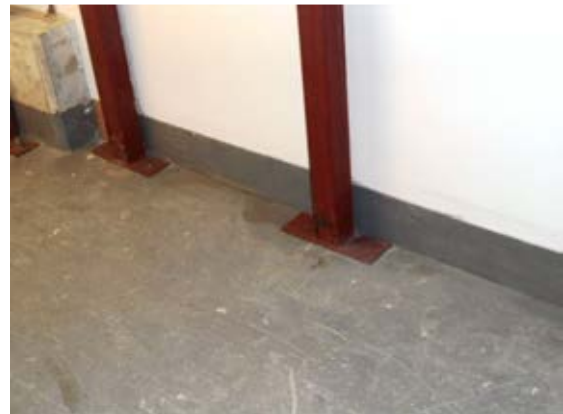
Vertical steel column to supporting services is not bolted to the horizontal member and not bolted to the floor. Brookfield confirmed that floor bolts have been fitted to horizontal members but the floors are not yet complete. Mercury will advise when completed. See Supervisor's Notification of Defect (CI 42.2) No 104.

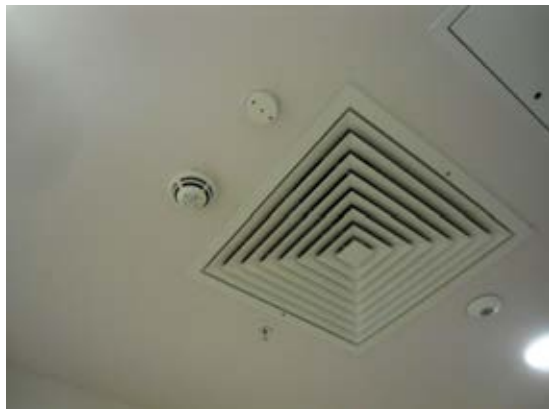
Smoke detector too close to air supply vent.

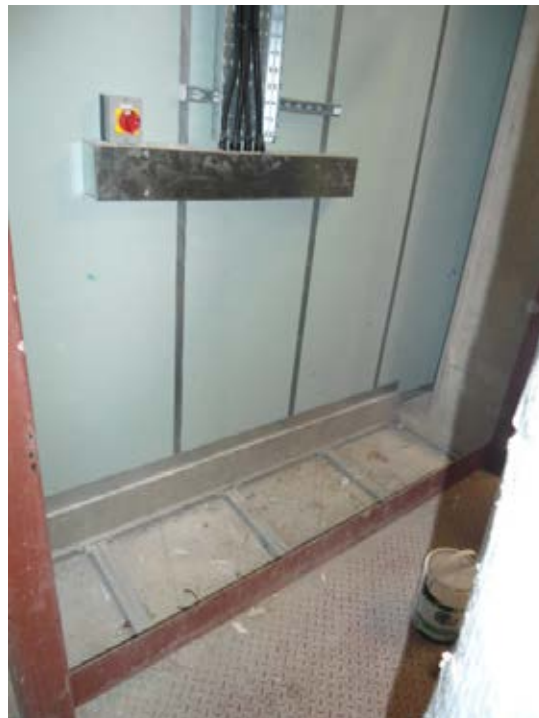
Gap between the metal deck and the wall with the floor comprising fire bats.

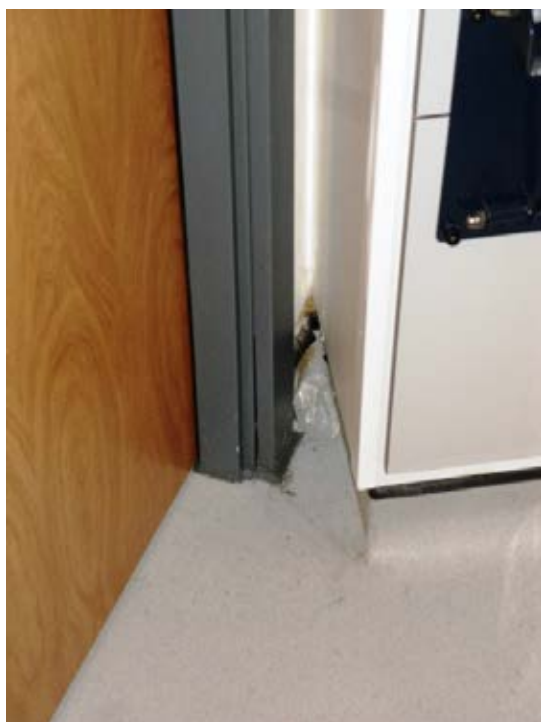
Poor vinyl detail at recess.

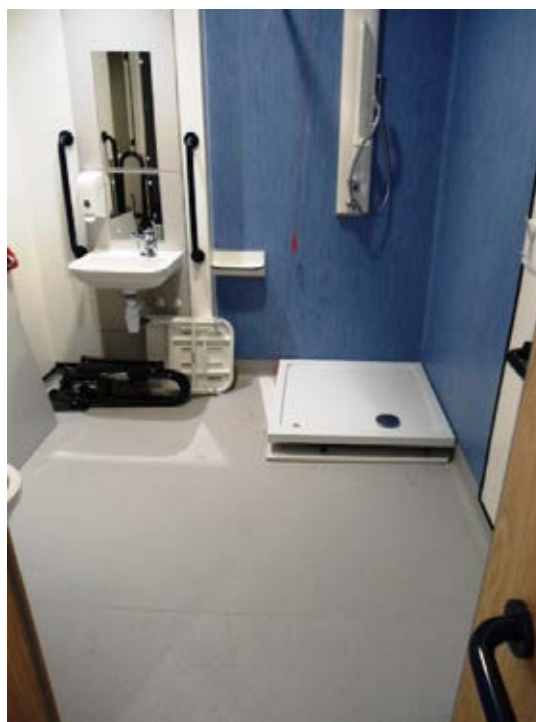
Incomplete work to surface shower unit

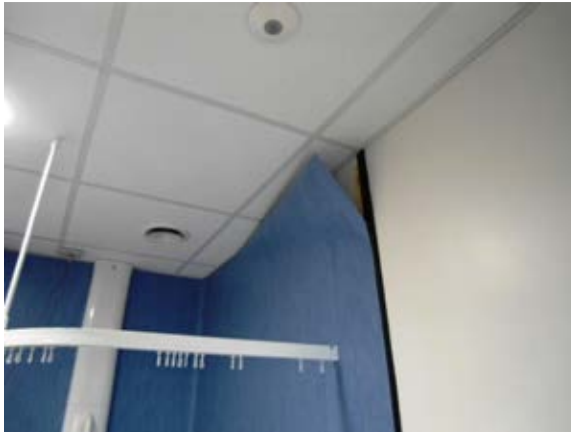
Peeling vinyl.

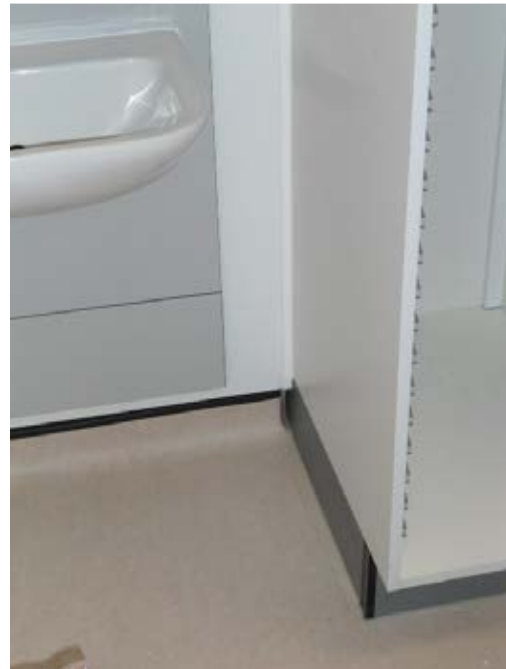
Following inspections of Levels 1, 6 and 7 we issued Defect No 107 covering all the defects found. Following our inspections with Brookfield they have issued the list attached to the Notification of Defect to all BMCE Managers to have the defects rectified. Generally the defects were of a minor nature. Below are the few that require some attention. See Supervisor's Notification of Defect (CI 42.2) No 107.

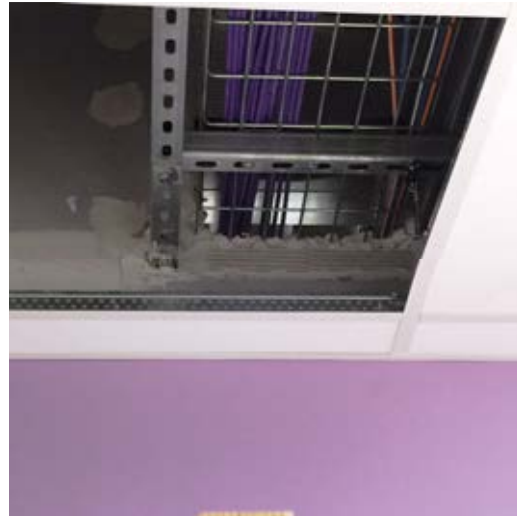
The intumescent pillows above the double doors between rooms GENW20-031 and GENW20-028 on Level 10 have been displaced. Brookfield has confirmed that this has now been addressed. Consequently Supervisor's Notification of Defect (CI 42.2) No 119 is closed out.

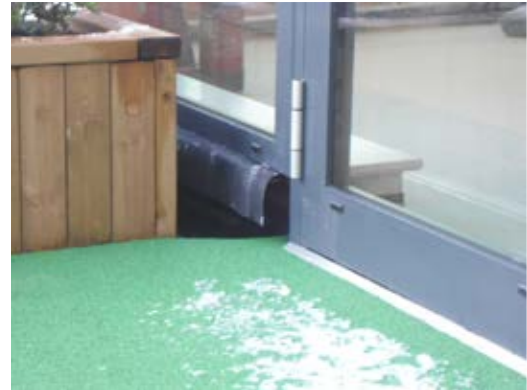
We asked Brookfield to confirm the finish below the glazed frame to prevent water penetrating adjacent to the door into corridor CC4-054. They have confirmed that the remedial action to fill the base of the frame has been completed. Supervisor's Communication General Matters / Other Instructions (CI 13.1) No 240 is closed out.

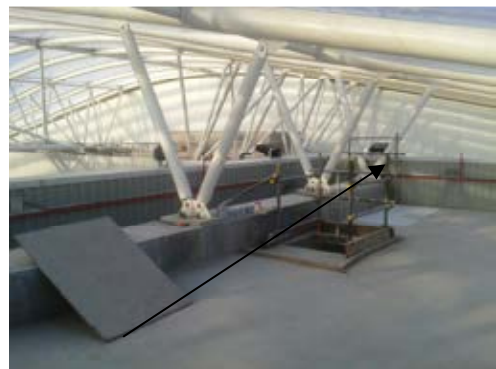
There is temporary scaffolding providing perimeter protection at concrete floor beams above the cores accessed from Level 12. We have asked Brookfield to confirm if permanent perimeter protection is to be fitted. See Supervisor's Communication General Matters / Other Instructions (CI 13.1) No 242.

Temporary scaffolding providing perimeter protection.

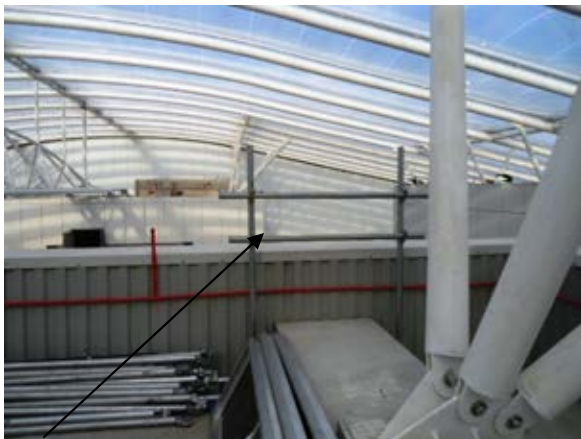
Temporary scaffolding providing perimeter protection.

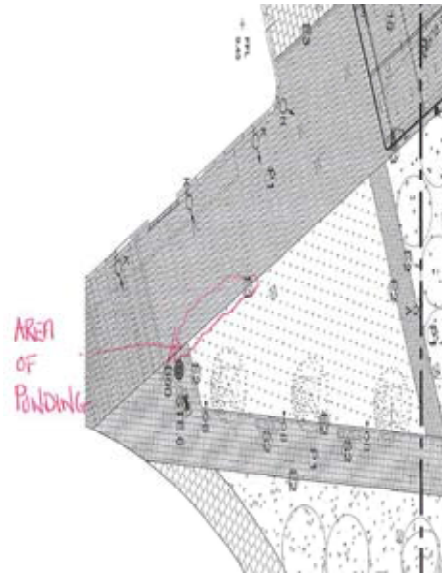
We noted water is ponding between the pavers and grassed area shown in the drawing opposite. We have asked Brookfield to confirm their remedial action to address this problem and confirm when the works are complete. They have intimated that this will be rectified in conjunction with the other area identified on Notification of Defect 133. General Matters / Other Instructions (CI 13.1) No 248.

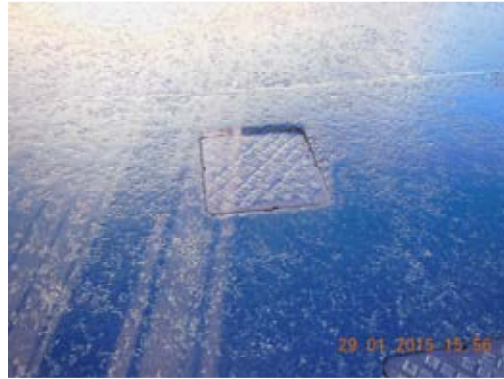
We reviewed Brookfield's NCR Tracker and noted the issues raised by the Package Managers. Brookfield confirmed that the tinting to the blockwork is complete to the pointing on the south and east elevations. An NCR has also been raised in relation to manholes which are below the level of the surrounding tar. (See photo opposite.)

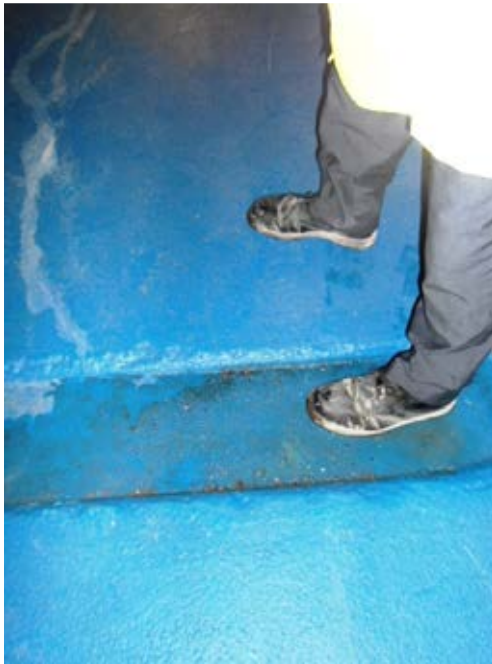
Level 4

The car park floors on levels 1, 2, 3, 4, and 5 adjacent to the stair on the east elevation have recessed channels which cross the pedestrian walkway similar to the potential trip hazards identified in Communication No 209. Brookfield has confirmed that all trip hazards have been infilled and coloured to match adjacent areas. Consequently Supervisor's Communication General Matters / Other Instructions (CI 13.1) No 224) is closed out.

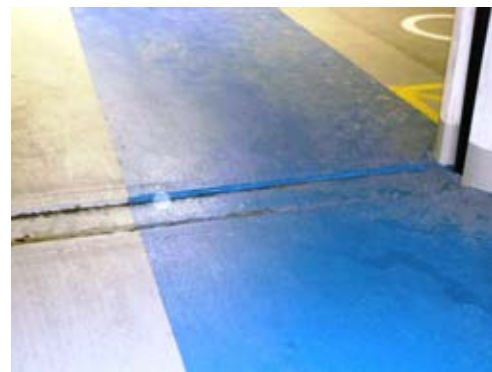
Level 3: Channel exceeds 30mm deep.

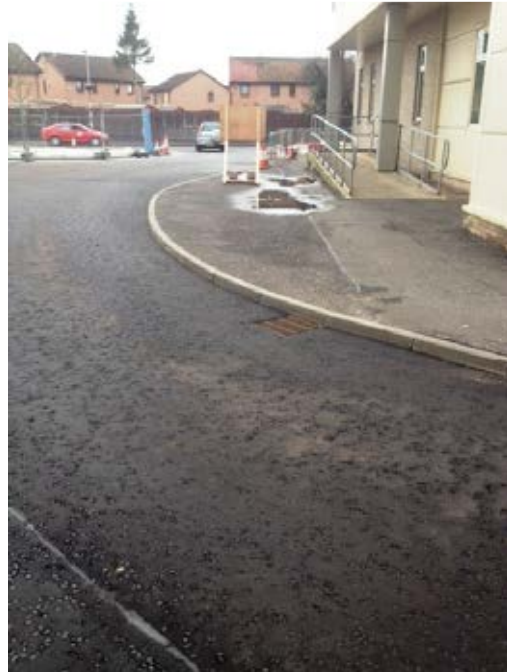
Footpath to the east side of the maternity unit.

We advised the Brookfield team on 16th December that ponding on the new extended footpath to the east side of the maternity unit has the potential to be a significant slip hazard in cold weather. We asked them to confirm their action to address this hazard. Brookfield has confirmed that Land Engineering have been instructed to lift the full width of tar and re-lay with a fall from the ramp to the new road kerb.

Ponding at the extended footpath area on the east side of the maternity unit, and potential specification non-compliance on sections of the footpath to the dual carriageway just north of the energy centre.

Brookfield had confirmed that work would commence week beginning 13th April. However they are awaiting an asphalt squad. (See Supervisor's Communication General Matters / Other Instructions (CI 13.1) No 237).

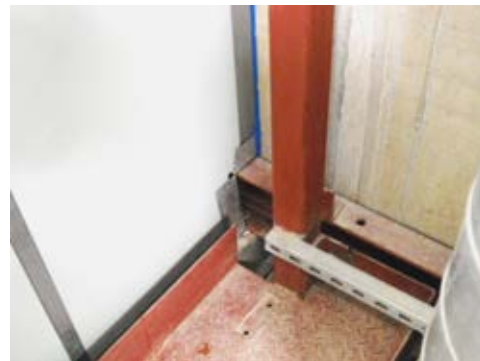
The fire rated partitions between the corridor and the Electrical Riser CCW-126 has incomplete fire stopping. The steelwork does not have intumescent paint. We asked Brookfield to confirm when this work has been completed. They have confirmed intumescent batt/firestopping was completed around the steelwork 26th Feb 2015. They are awaiting confirmation from the designers regarding requirements for intumescent paint. See Supervisor's Notification of Defect (CI 42.2) No 98.

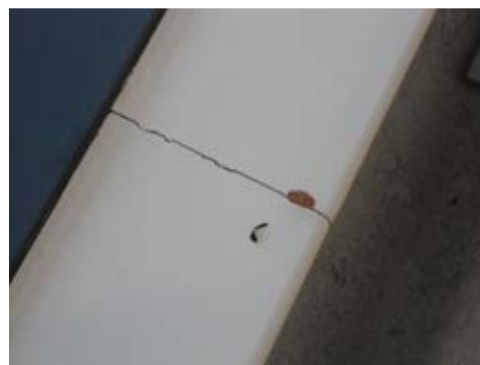
The joints at window cills are opening up. We asked Brookfield to confirm their remedial action to resolve this problem. They have confirmed that all joints have been filled and made good. Consequently Supervisor's Notification of Defect (CI 42.2) No 99 is complete.

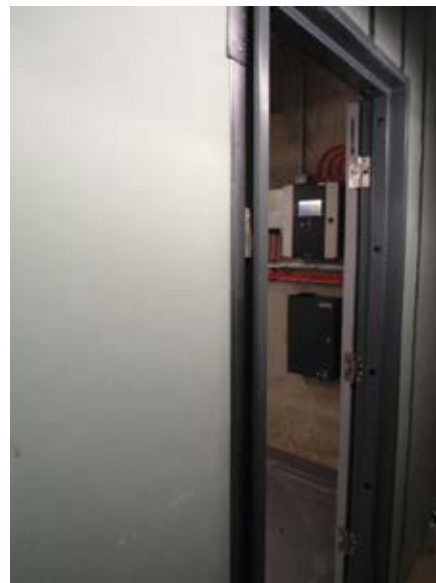
There was no fire stopping around the fire door on Level 12, Plantroom 121, Door M25-A. Brookfield has confirmed that the fire stopping has been completed. We await a formal response from Brookfield. See Supervisor's Notification of Defect (CI 42.2) No 102.

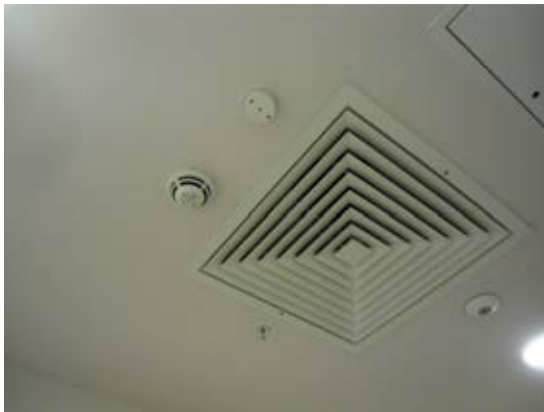
Smoke detector too close to air supply vent.

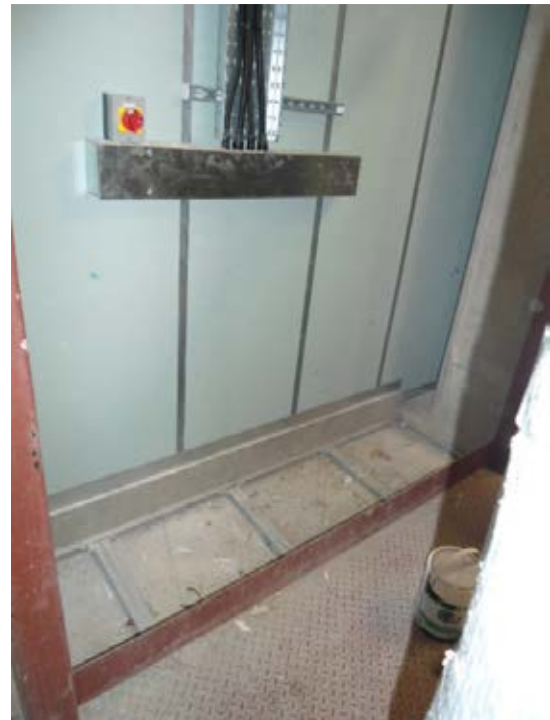
Gap between the metal deck and the wall with the floor comprising fire bats.

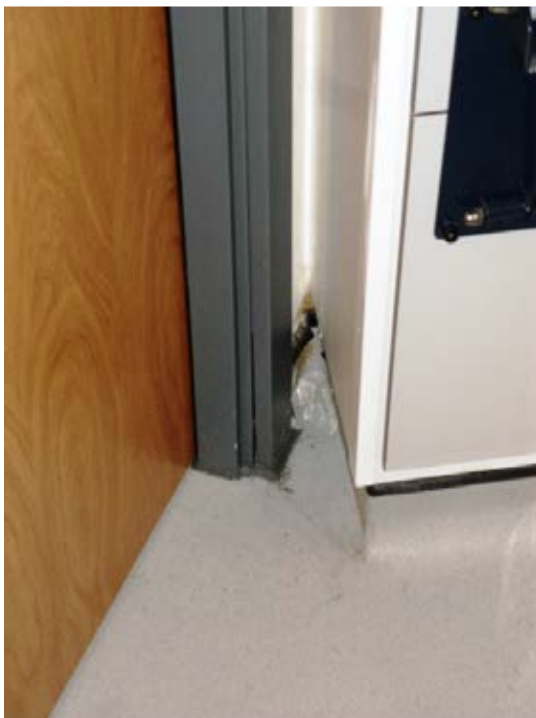
Poor vinyl detail at recess.

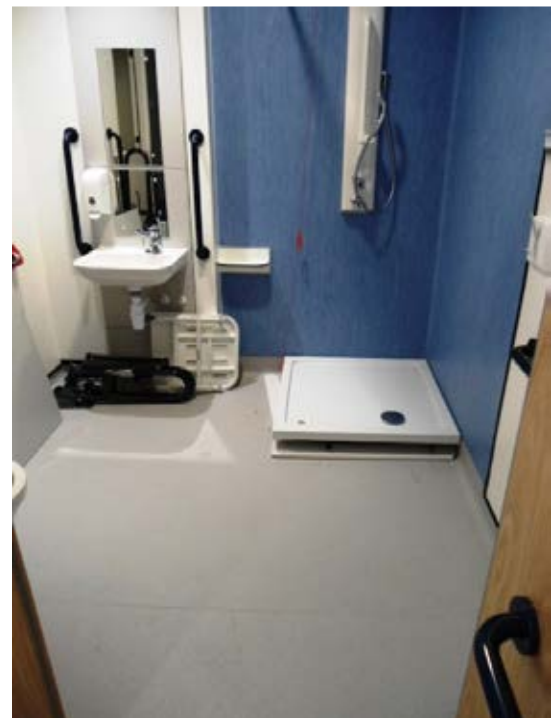
Incomplete work to surface shower unit

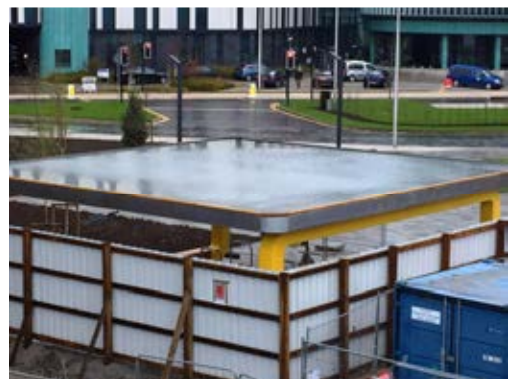
The Bicycle Shelter roof does not drain rainwater to the two corner outlets, consequently the rainwater is ponding. We asked Brookfield to confirm their proposed remedial action to resolve this defect. They have confirmed that following a meeting with the designer a level survey is required. The plan is to introduce a further outlet. See Supervisor's Notification of Defect (CI 42.2) No 129.

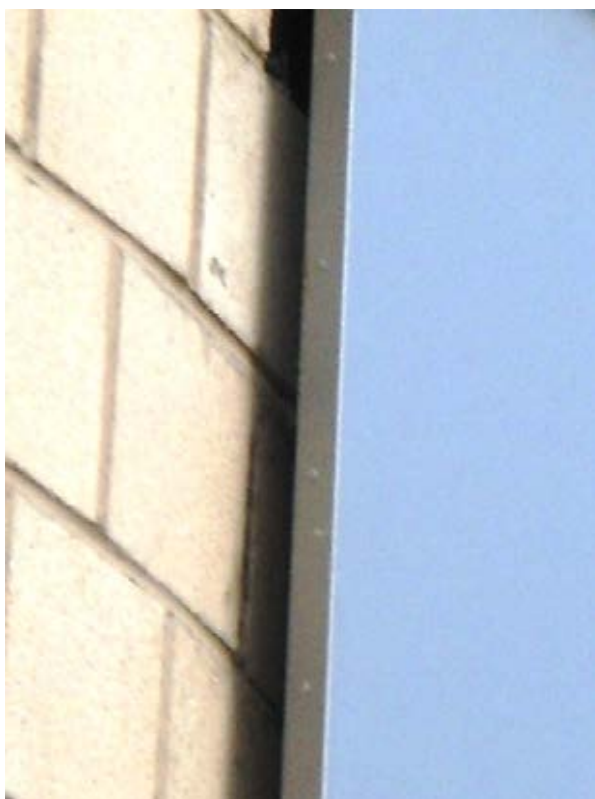
Gap between cladding and blockwork interface.

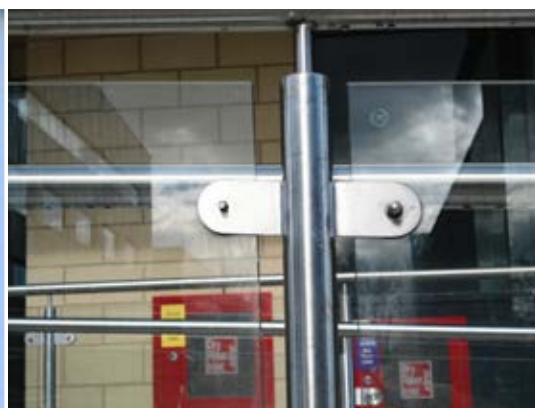
Nuts not fitted to glazed fixings to ramp.

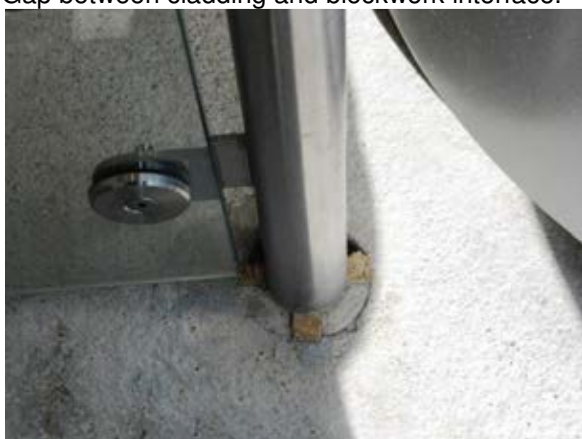
Timber wedges inappropriately used to support glazed panels.

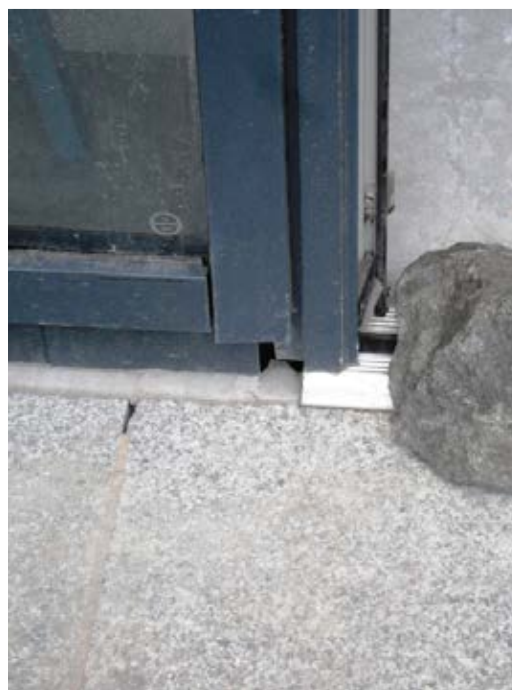
Excessive gap at the bottom of the door frame.

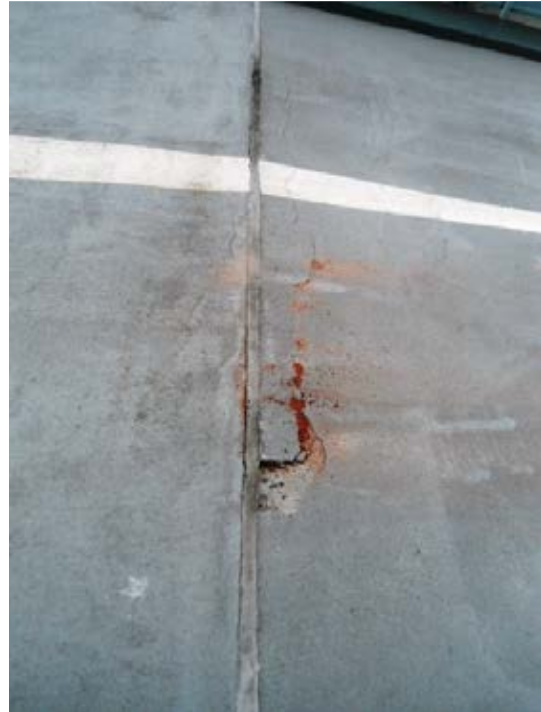
The concrete joint between the 6th floor and the down ramp is break up. We asked Brookfield to confirm the remedial measures to address this defect. They have instructed Dunne to carry out remedial works. See Supervisor's Notification of Defect (CI 42.2) No 132.

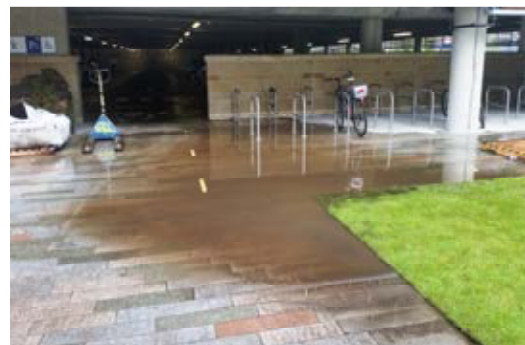
Water is ponding between the pavers and grassed areas at the main pedestrian access to the Car Park 1 opposite the hospital. We asked Brookfield to confirm their remedial action to address this problem and to confirm when the works are complete. They have intimated that the grass area was originally designed for soft landscaping but was later changed to turf. Their solution is to lift the turf and create a soakaway and re-lay the turf. See Supervisor's Notification of Defect (CI 42.2) No 133.

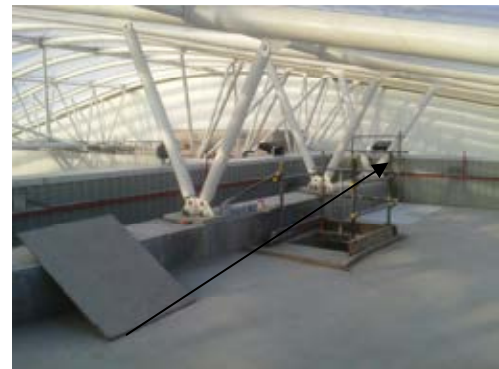
There is temporary scaffolding providing perimeter protection at concrete floor beams above the cores accessed from Level 12. The client intimated that protection is required. We have asked Brookfield to confirm when this will be undertaken. See Supervisor's Communication General Matters / Other Instructions (CI 13.1) No 242.

Temporary scaffolding providing perimeter protection.

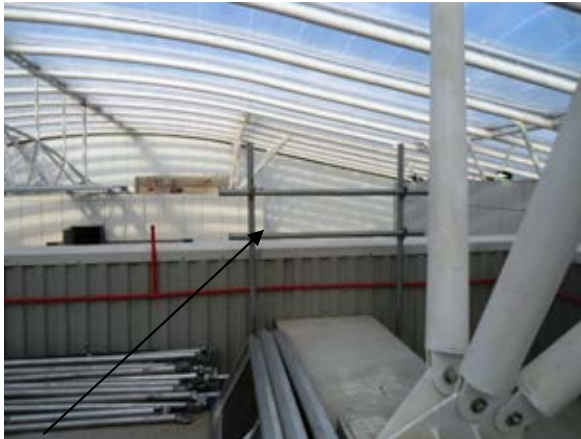
Temporary scaffolding providing perimeter protection.

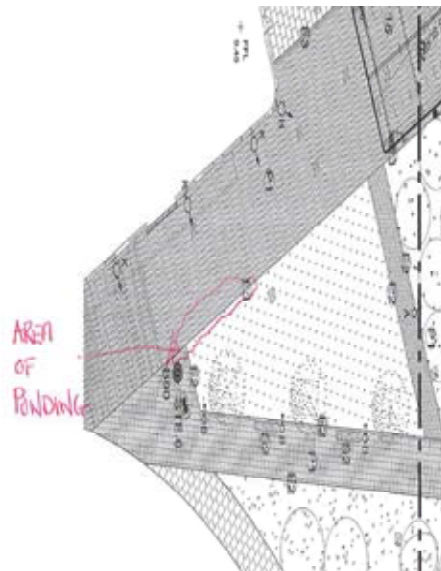
We noted water is ponding between the pavers and grassed area shown in the drawing opposite. Brookfield removed a section of turf and an additional section of gravel maintenance strip drain was laid. Consequently Communication General Matters / Other Instructions (CI 13.1) No 248 is closed out.

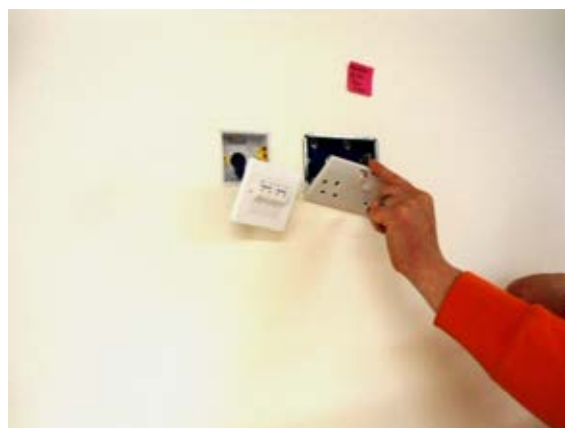
While undertaking inspections on Level 10 we noted that a double socket was installed in a fire rated wall with a proprietor putty pad, however the data point next to the socket did not have a putty pad placed in the back box. Brookfield confirmed that the putty pads missing from the data points have been inserted. We carried out a spot check with Brookfield and putty pads were present. Consequently General Matters / Other Instructions (CI 13.1) No 251 is closed out. However spot checks will be undertaken.

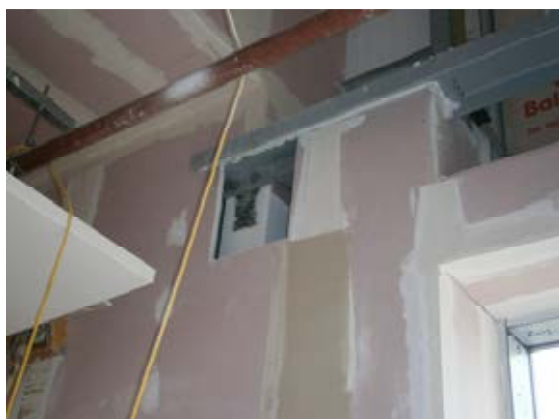
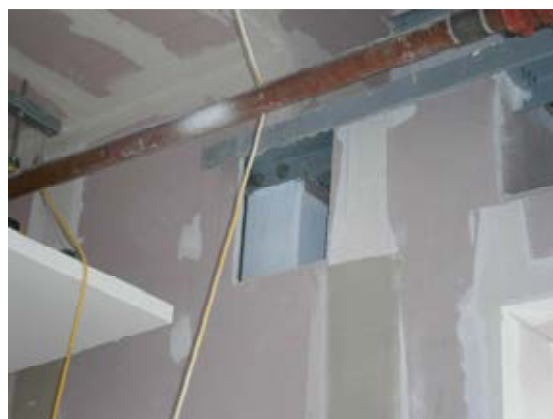
We carried out an inspection with Brookfield of part of the link corridor which will provide access between the Adult and Children's Hospital and Neurosurgery and the Teaching and Learning Centre. We noted that there was one area of incomplete intumescent coating to one columns and not two as previously reported. Brookfield confirmed that they have addressed the problem and provide photographic evidence of the completed work.

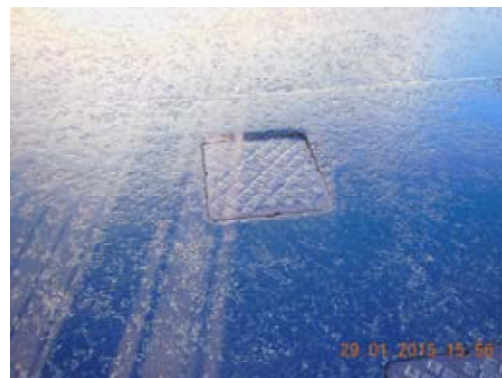
We reviewed Brookfield's NCR Tracker and noted the issues raised by the Package Managers. Brookfield confirmed that the tinting to the blockwork is complete to the pointing on the south and east elevations. An NCR has also been raised in relation to manholes which are below the level of the surrounding tar. (See photo opposite.)

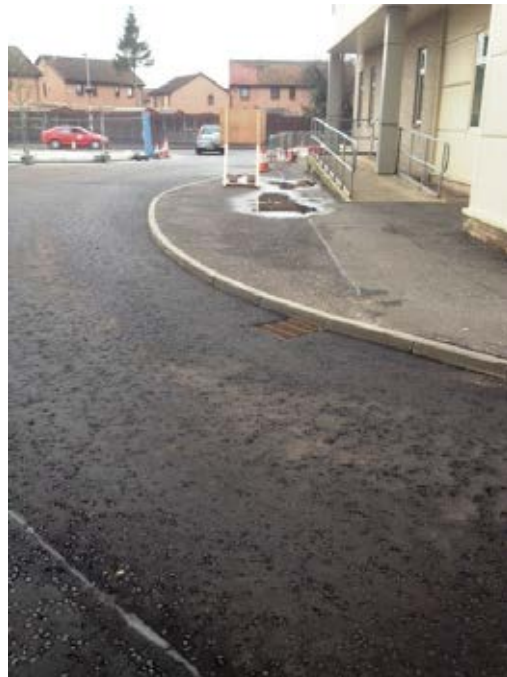
Footpath to the east side of the maternity unit.

We advised the Brookfield team on 16th December that ponding on the new extended footpath to the east side of the maternity unit has the potential to be a significant slip hazard in cold weather. We asked them to confirm their action to address this hazard. Brookfield has confirmed that Land Engineering have been instructed to lift the full width of tar and re-lay with a fall from the ramp to the new road kerb.

Ponding at the extended footpath area on the east side of the maternity unit, and potential specification non-compliance on sections of the footpath to the dual carriageway just north of the energy centre.

Brookfield had confirmed that work would commence week beginning 13th April. However they are awaiting an asphalt squad. (See Supervisor's Communication General Matters / Other Instructions (CI 13.1) No 237).

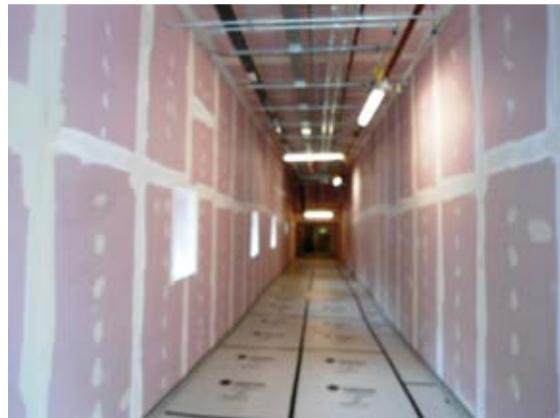
4.3.12 Neuro Link bridge

We have received a revised programme showing our inspection before handover on the 21st July 2015 and the completion of the works on the 23 July 2015. Work is progressing and the quality of the work is satisfactory.

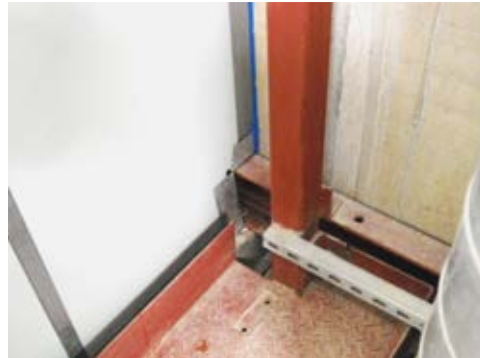
The fire rated partitions between the corridor and the Electrical Riser CCW-126 has incomplete fire stopping. The steelwork does not have intumescent paint. Brookfield has confirmed that this work has been completed. Consequently Supervisor's Notification of Defect (CI 42.2) No 98 is closed out.

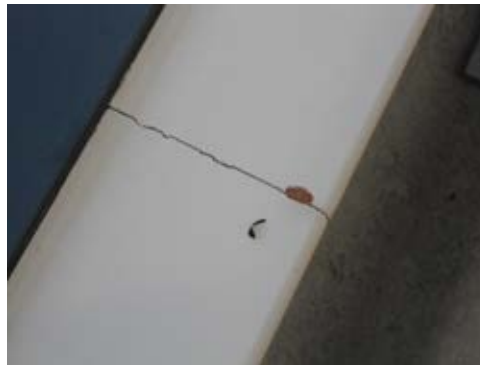
The joints at window cills are opening up. We asked Brookfield to confirm their remedial action to resolve this problem. We await their response. See Supervisor's Notification of Defect (CI 42.2) No 99

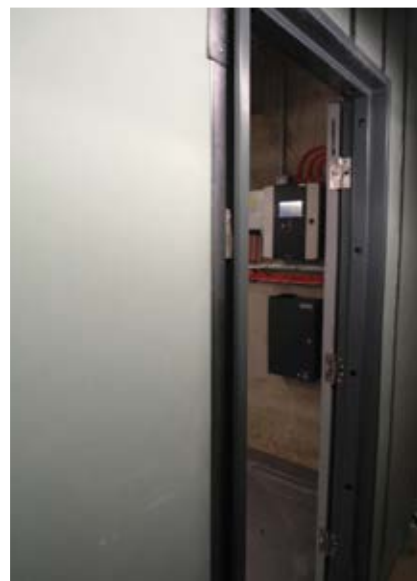
There was no fire stopping around the fire door on Level 12, Plantroom 121, Door M25-A. Brookfield has confirmed that the fire stopping has been completed. Consequently Supervisor's Notification of Defect (CI 42.2) No 102 is closed out.

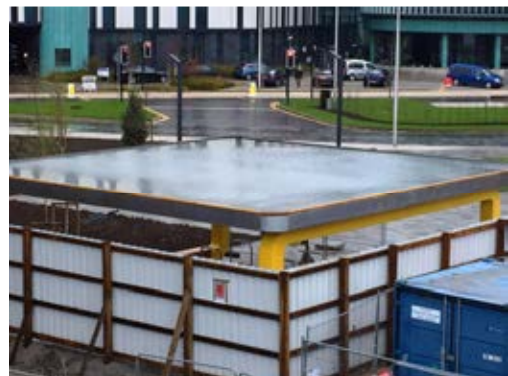
The Bicycle Shelter roof does not drain rainwater to the two corner outlets, consequently the rainwater is ponding. We asked Brookfield to confirm their proposed remedial action to resolve this defect. They have confirmed that following a meeting with the designer a level survey is required. The plan is to introduce a further outlet. See Supervisor's Notification of Defect (CI 42.2) No 129.

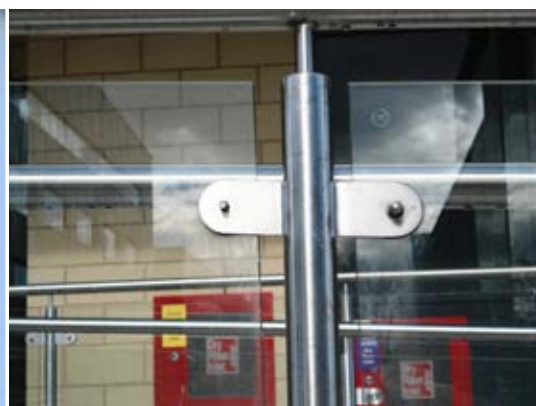
Nuts not fitted to glazed fixings to ramp.

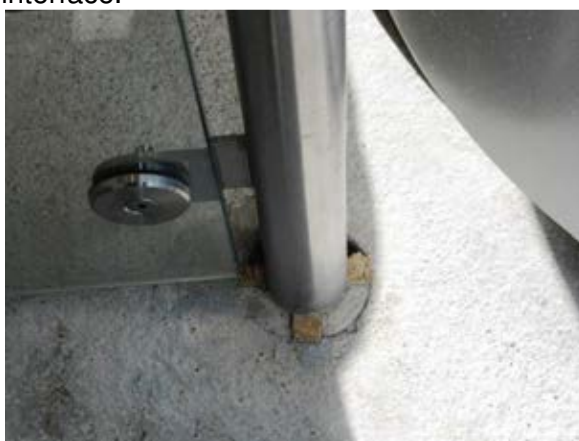
Timber wedges inappropriately used to support glazed panels.

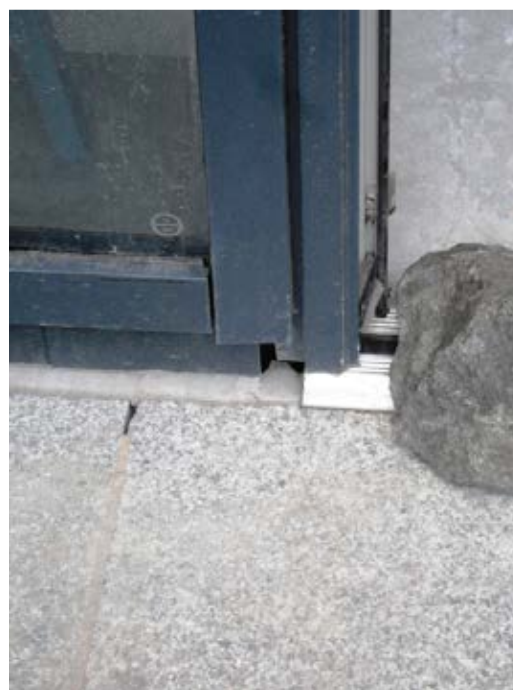
Excessive gap at the bottom of the door frame.

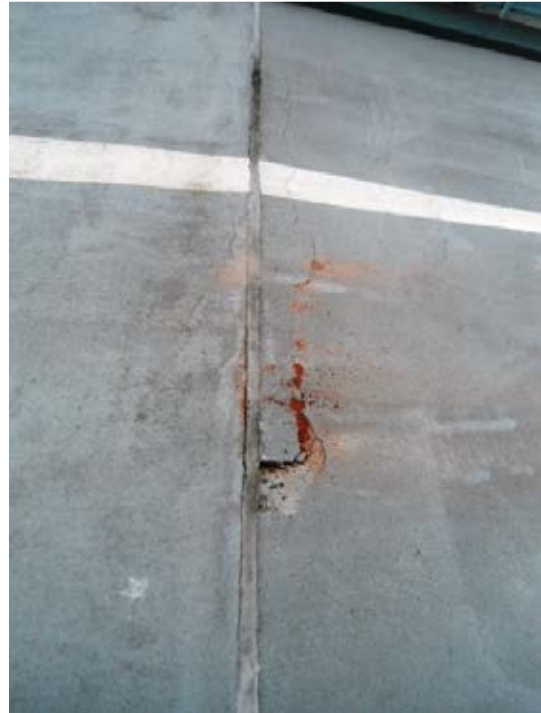
The concrete joint between the 6th floor and the down ramp is break up. We asked Brookfield to confirm the remedial measures to address this defect. They have instructed Dunne to carry out remedial works. See Supervisor's Notification of Defect (CI 42.2) No 132.

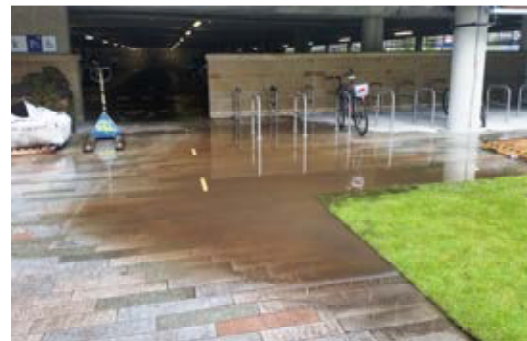
Water is ponding between the pavers and grassed areas at the main pedestrian access to the Car Park 1 opposite the hospital. Brookfield removed a section of turf and an additional section of gravel maintenance strip drain was laid. Consequently Supervisor's Notification of Defect (CI 42.2) No 133 is closed out.

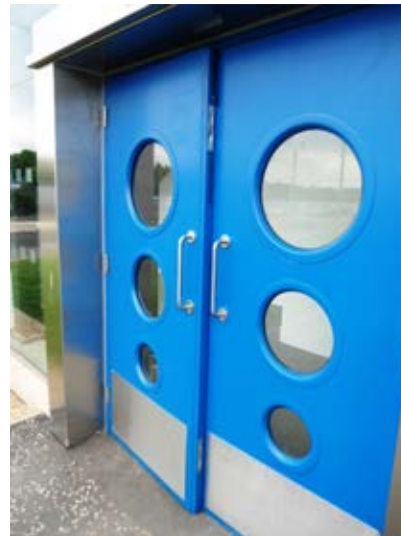
Entrance adjacent to Hardgate Road.

The door selector to the entrances adjacent to Hardgate Road did not allow the doors to close over properly. A joint inspection was carried out with Brookfield and the problem was rectified and the door closer operates properly. The doors are fitted as per the specification consequently Supervisor's Notification of Defect (CI 42.2) No 135 is closed out. However we observed that there is a design issue which allows the secondary doors to close before the primary door.

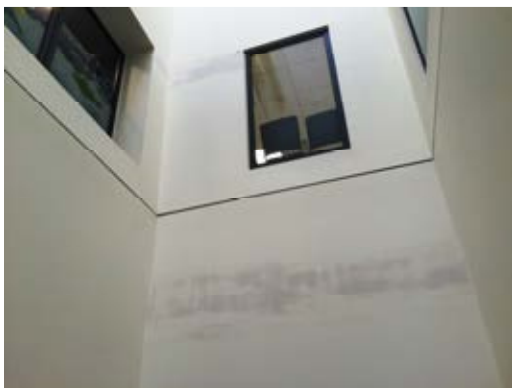
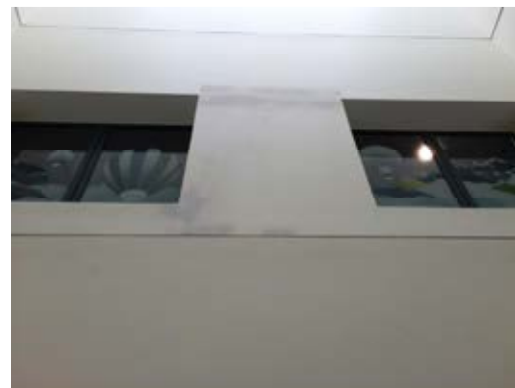
Following an inspection of the Lightwell adjacent to Hospital Street CC0-015 we identified incomplete decoration and grubby marks on walls within the Lightwell. There was also a damaged corner bead. Brookfield have arranged for their painting sub-contractor to return to site and rectify this defect until rectification. Supervisor's Notification of Defect (CI 42.2) No 136.

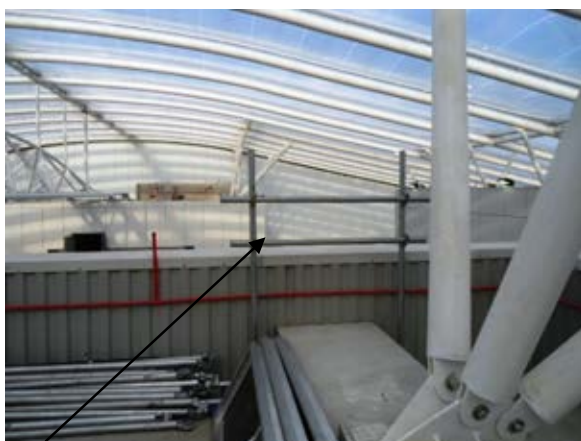
There is temporary scaffolding providing perimeter protection at concrete floor beams above the cores accessed from Level 12. The client intimated that protection is required. We have asked Brookfield to confirm when this will be undertaken. See Supervisor's Communication General Matters / Other Instructions (CI 13.1) No 242.

Temporary scaffolding providing perimeter protection.

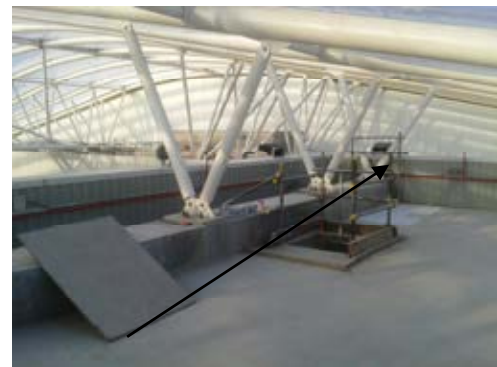
Temporary scaffolding providing perimeter protection.

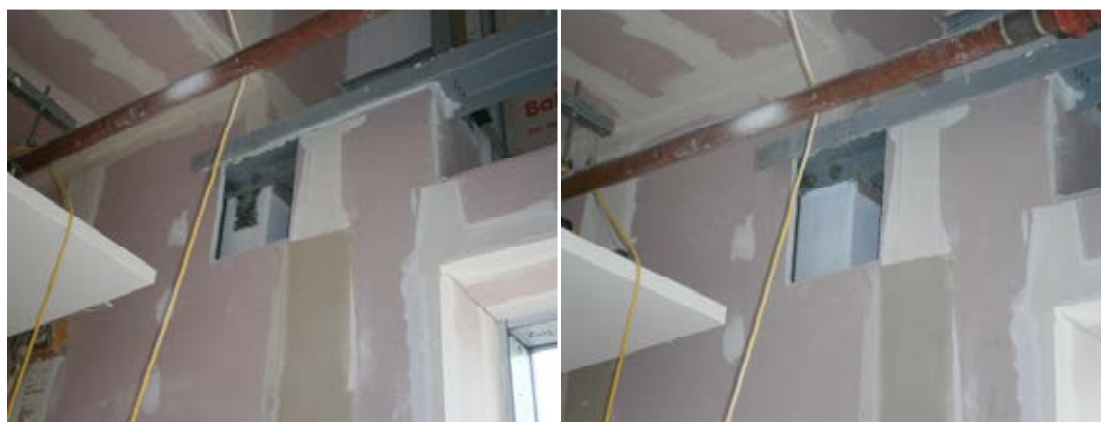
We carried out an inspection with Brookfield of part of the link corridor which will provide access between the Adult and Children's Hospital and Neurosurgery and the Teaching and Learning Centre. We noted that there was one area of incomplete intumescent coating to one column and not two as previously reported. Brookfield confirmed that they have addressed the problem and provide photographic evidence of the completed work.

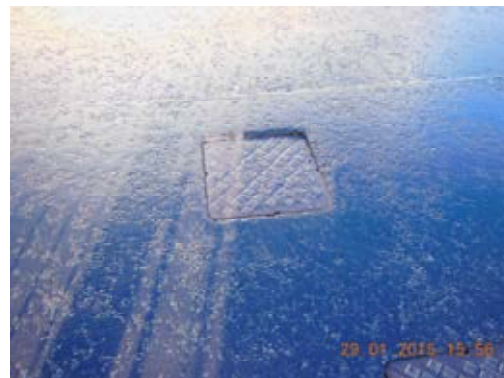
We reviewed Brookfield's NCR Tracker and noted the issues raised by the Package Managers. Brookfield confirmed that the tinting to the blockwork is complete to the pointing on the south and east elevations. An NCR has also been raised in relation to manholes which are below the level of the surrounding tar. (See photo opposite.)

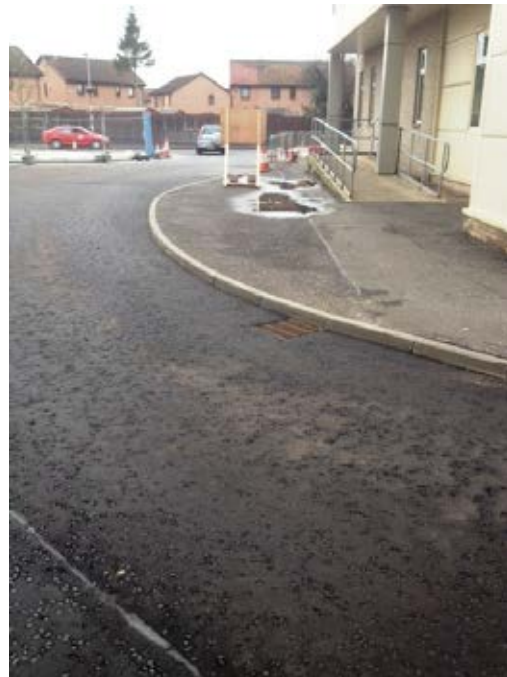
Footpath to the east side of the maternity unit.

We advised the Brookfield team on 16th December that ponding on the new extended footpath to the east side of the maternity unit has the potential to be a significant slip hazard in cold weather. We asked them to confirm their action to address this hazard. Brookfield has confirmed that Land Engineering have been instructed to lift the full width of tar and re-lay with a fall from the ramp to the new road kerb.

Ponding at the extended footpath area on the east side of the maternity unit, and potential specification non-compliance on sections of the footpath to the dual carriageway just north of the energy centre.

Brookfield had confirmed that work would commence week beginning 13th April. However they are awaiting an asphalt squad. (See Supervisor's Communication General Matters / Other Instructions (CI 13.1) No 237).

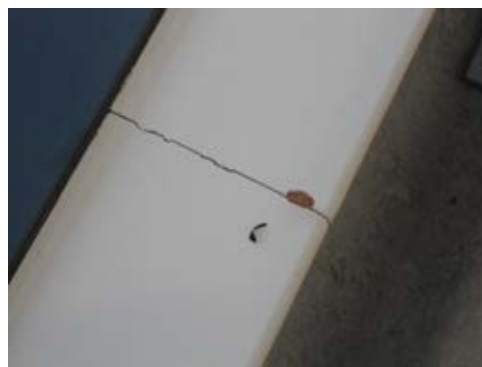
The joints at window cills are opening up. We asked Brookfield to confirm their remedial action to resolve this problem. They have filled and painted the joints but they have opened up again. They are sealing a joint with sealant to determine if this is a better solution. We await their response. See Supervisor's Notification of Defect (CI 42.2) No 99

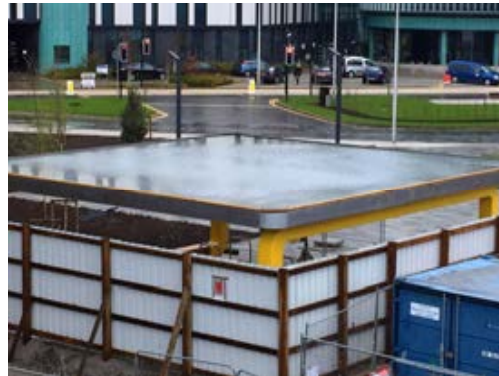
The Bicycle Shelter roof does not drain rainwater to the two corner outlets, consequently the rainwater is ponding. We asked Brookfield to confirm their proposed remedial action to resolve this defect. They have confirmed that following a meeting with the designer a level survey is required. The plan is to introduce a further outlet. See Supervisor's Notification of Defect (CI 42.2) No 129.

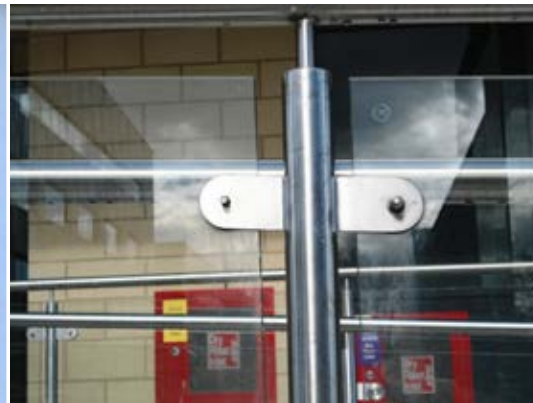
Nuts not fitted to glazed fixings to ramp.

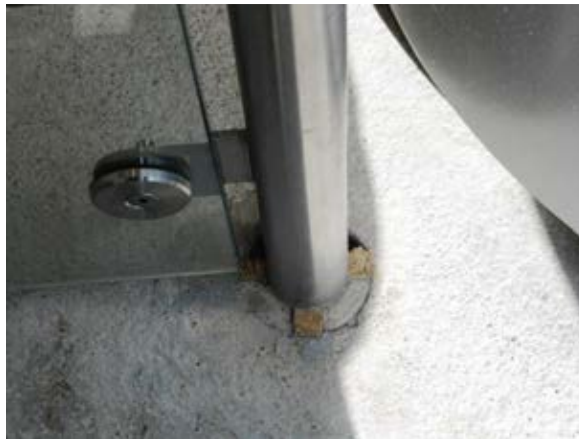
Timber wedges inappropriately used to support glazed panels.

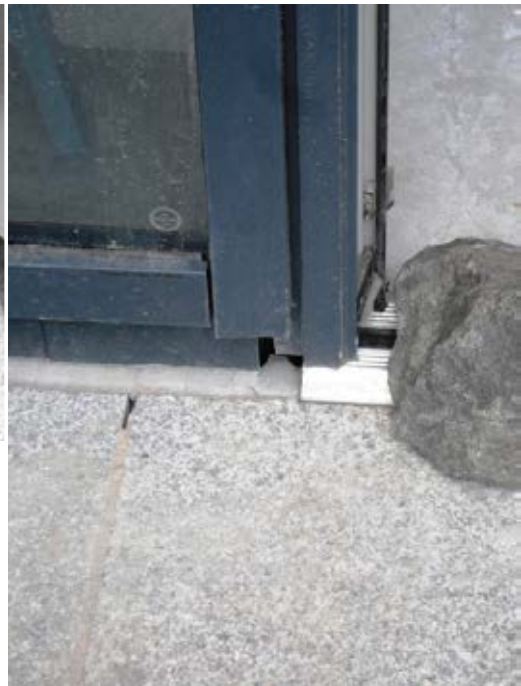
Excessive gap at the bottom of the door frame.

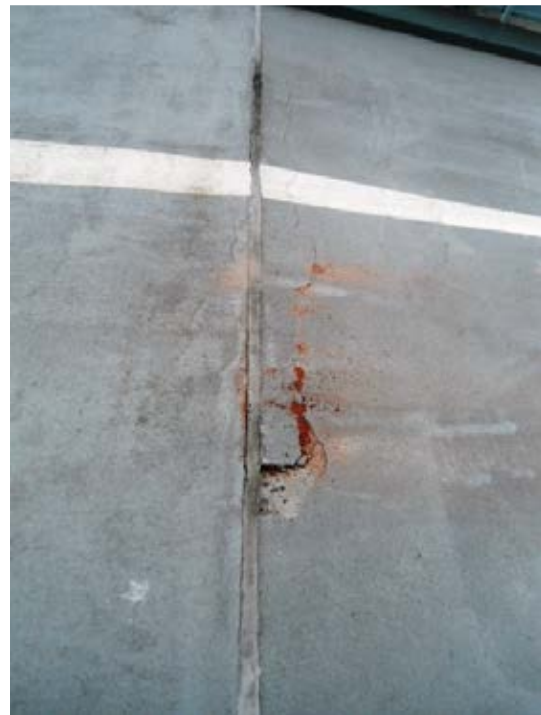
The concrete joint between the 6th floor and the down ramp is break up. We asked Brookfield to confirm the remedial measures to address this defect. They have instructed Dunne to carry out remedial works. See Supervisor's Notification of Defect (CI 42.2) No 132.
