**Bundle of documents for Oral hearings
commencing from 13 May 2025 in relation
to the Queen Elizabeth University Hospital
and the Royal Hospital for Children,
Glasgow**

**Bundle 33
NEC3 Supervisor's Reports and Project
Supervisors Interface Action Notes**

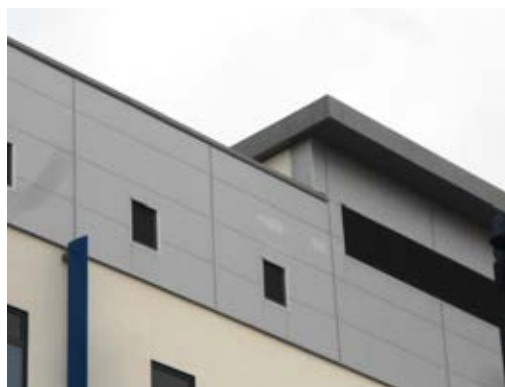
It appears that the cladding on the west facing elevation has been damaged and an unsuccessful attempt has been made to repair the damage. We asked Brookfield to confirm when this defect has been rectified. They have confirmed that this has been passed onto the sub-contractor Prater to rectify the unsuccessful attempt at the repair. See Supervisor's Notification of Defect (CI 42.2) No 137.

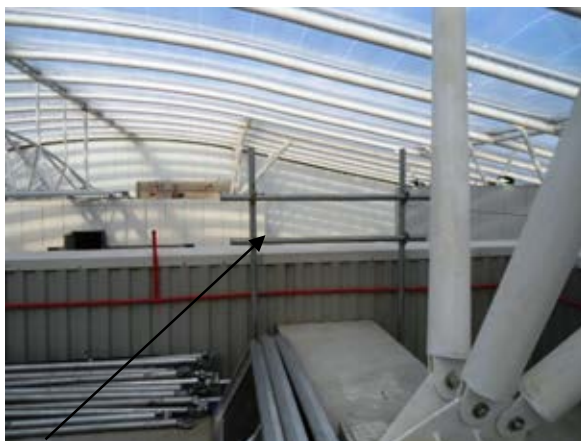
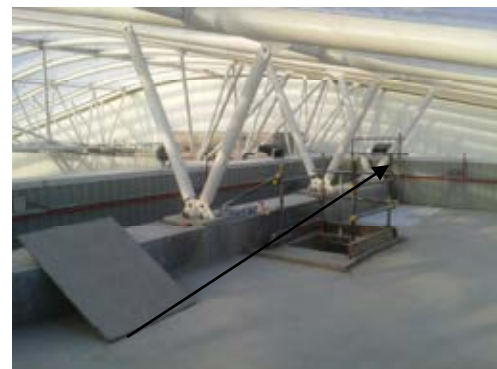
There is temporary scaffolding providing perimeter protection at concrete floor beams above the cores accessed from Level 12. The client intimated that protection is required. We have asked Brookfield to confirm when this will be undertaken. They are currently arranging for this work to be carried out. See Supervisor's Communication General Matters / Other Instructions (CI 13.1) No 242.

Temporary scaffolding providing perimeter protection.

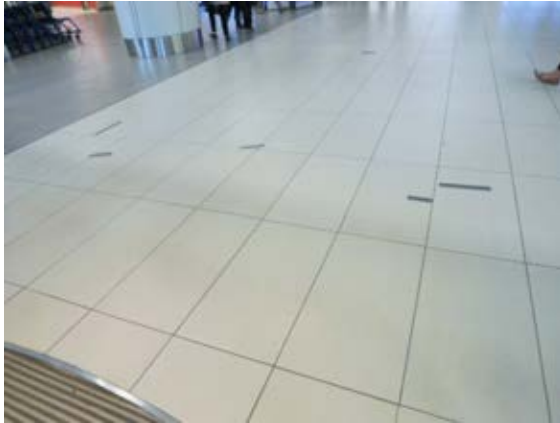
continue towards the third retail outlets in the main atrium. All of the damaged tiles were covered with protective tape. There were a few damaged tiles which had sustained impact damaged and these are shown below. Some of the damaged tiles which were inspected did not have a hollow sound when taped. Brookfield intend to carry out replacement to damaged tiles.

Damaged tiles at main entrance.

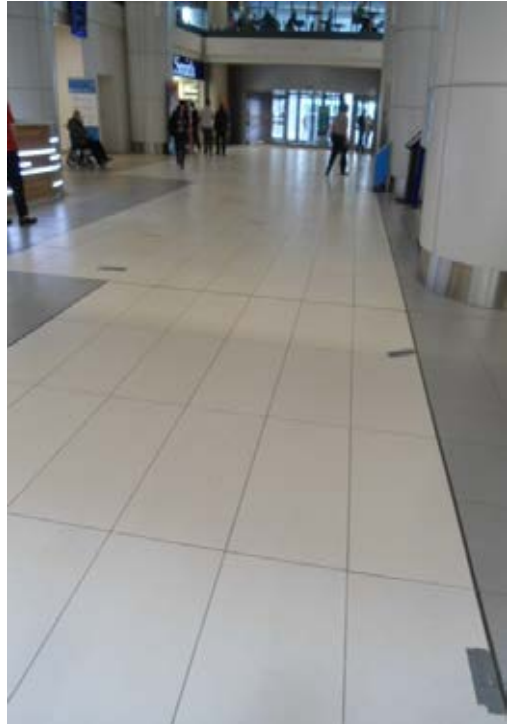
Damaged tiles leading from main entrance toward the retail outlet in the main atrium.

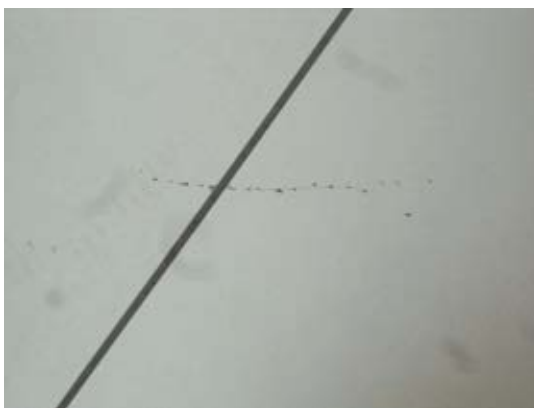
Two of the tiles has impact damage caused by what appears to be from an external source.

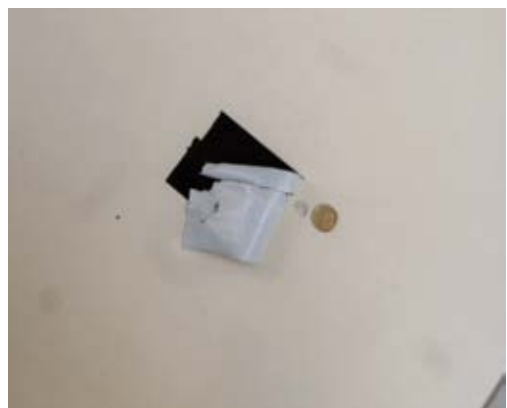
Tile in the Children's Hospital located opposite room CCO-047 has impact damage caused by what appears to be from an external source.

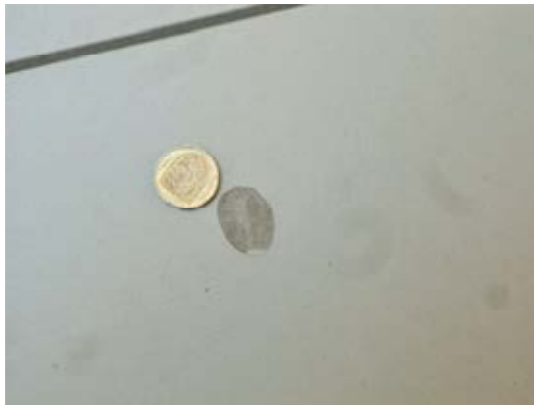
Tile in the Children's Hospital located in the waiting area in the atrium has impact damage caused by what appears to be from an external source.

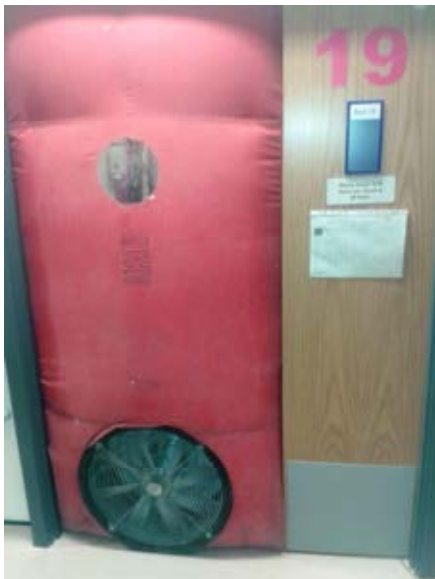
Brookfield has responded from the Defect Notice that they are in the process of carrying out test to these rooms and any necessary work to ensure that they comply. They have provided the test results and confirm works are ongoing to complete.

See Supervisor's Notification of Defect (C 42.2) No 139.

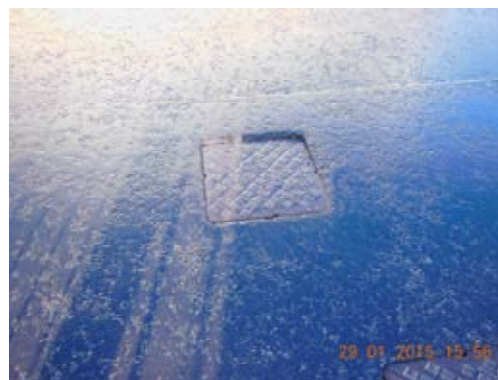
An NCR has also been raised in relation to manholes which are below the level of the surrounding tar. (See photo opposite.)

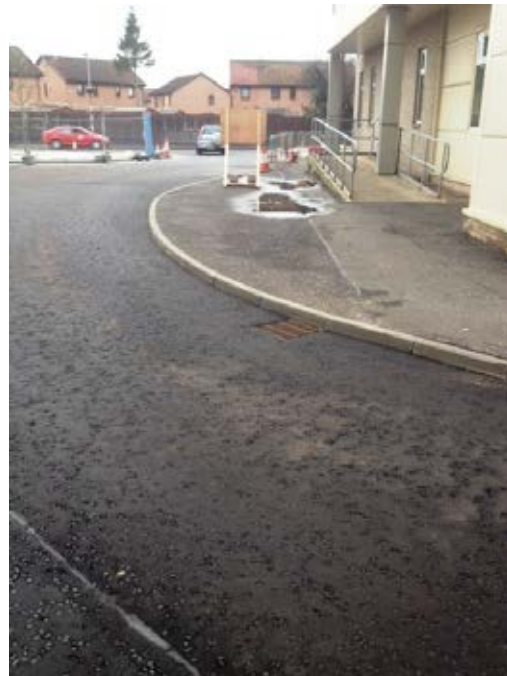
We advised the Brookfield team on 16th December that ponding on the new extended footpath to the east side of the maternity unit has the potential to be a significant slip hazard in cold weather. We asked them to confirm their action to address this hazard. Brookfield has confirmed that Land Engineering have been instructed to lift the full width of tar and re-lay with a fall from the ramp to the new road kerb.

Footpath to the east side of the maternity unit.

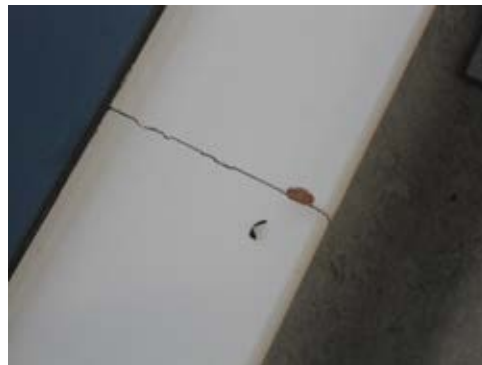
The joints at window cills are opening up. We asked Brookfield to confirm their remedial action to resolve this problem. They have filled and painted the joints but they have opened up again. They are sealing a joint with sealant to determine if this is a better solution. We await their response. See Supervisor's Notification of Defect (CI 42.2) No 99

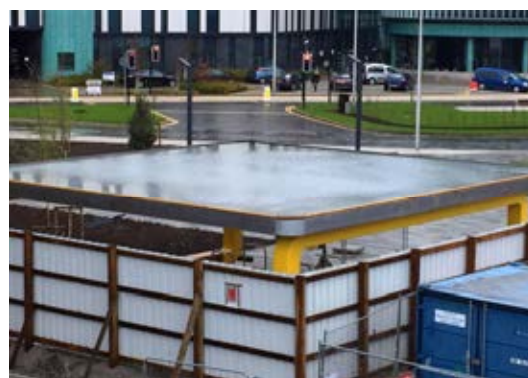
The Bicycle Shelter roof does not drain rainwater to the two corner outlets, consequently the rainwater is ponding. We asked Brookfield to confirm their proposed remedial action to resolve this defect. They have confirmed that following a meeting with the designer a level survey is required. The plan is to introduce a further outlet. See Supervisor's Notification of Defect (CI 42.2) No 129.

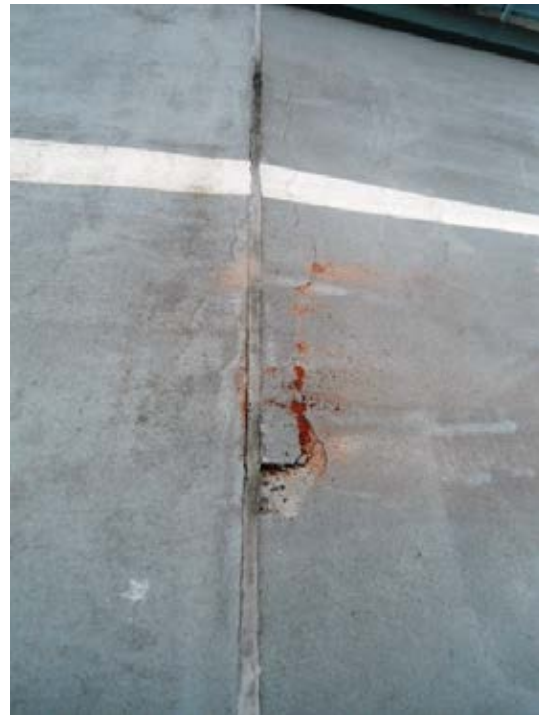
The concrete joint between the 6th floor and the down ramp is break up. We asked Brookfield to confirm the remedial measures to address this defect. They have instructed Dunne to carry out remedial works. See Supervisor's Notification of Defect (CI 42.2) No 132.

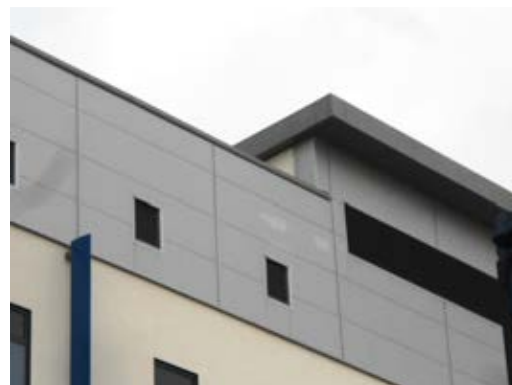
It appears that the cladding on the west facing elevation has been damaged and an unsuccessful attempt has been made to repair the damage. We asked Brookfield to confirm when this defect has been rectified. They have confirmed that this has been passed onto the sub-contractor Prater to rectify the unsuccessful attempt at the repair. See Supervisor's Notification of Defect (CI 42.2) No 137.

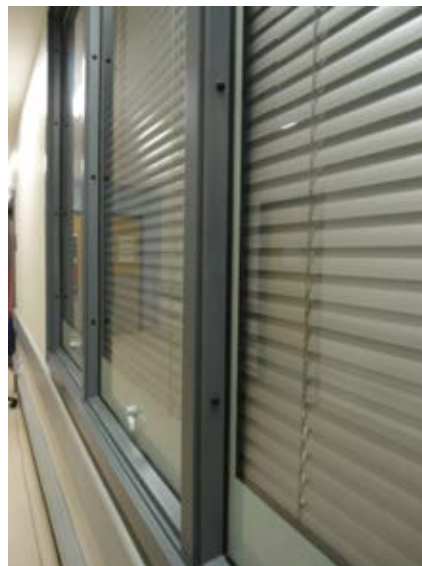
Following the discovery that Air Permeability Tests were not carried out within 36 isolation rooms in accordance with the Employer's Requirements NHS Guidance Documentations, document HBN 04-01. Brookfield is undertaken tests and remedial work to ensure the rooms are compliant.

During our inspection in the Hospital in September we were present during air permeability testing of room CCW-077 Bed 31. Additional work had to be carried out to the window beads by refitting them and fixing the screw heads with caps. Brookfield has been providing us with the test results for all rooms. There are currently 6 rooms requiring to be tested, 2 in Renal and 4 in Schiehallion. See Supervisor's Notification of Defect (C 42.2) No 138.

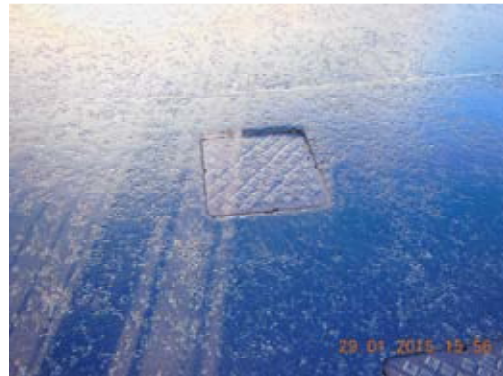
An NCR has also been raised in relation to manholes which are below the level of the surrounding tar. (See photo opposite.)

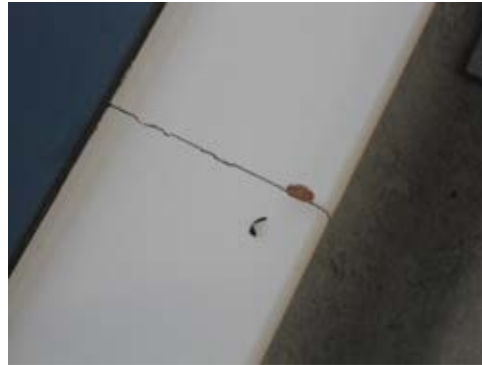
The joints at window cills are opening up. We asked Brookfield to confirm their remedial action to resolve this problem. They have filled and painted the joints but they have opened up again. They are sealing a joint with sealant to determine if this is a better solution. We await their response. See Supervisor's Notification of Defect (CI 42.2) No 99

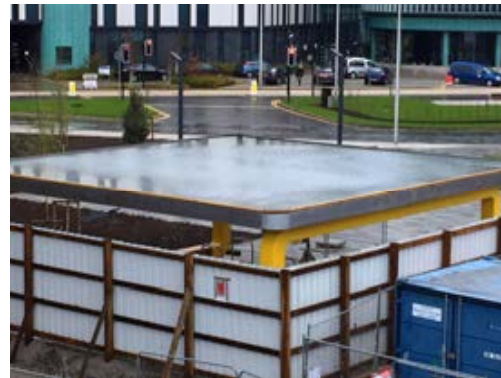
The Bicycle Shelter roof does not drain rainwater to the two corner outlets, consequently the rainwater is ponding. We asked Brookfield to confirm their proposed remedial action to resolve this defect. They have confirmed that following a meeting with the designer a level survey is required. The plan is to introduce a further outlet. See Supervisor's Notification of Defect (CI 42.2) No 129.

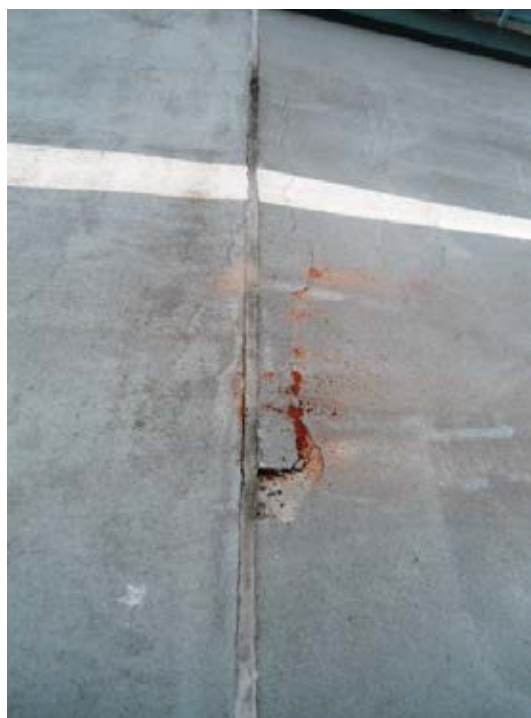
The concrete joint between the 6th floor and the down ramp is breaking up. We asked Brookfield to confirm the remedial measures to address this defect. They have instructed Dunne to carry out remedial works. See Supervisor's Notification of Defect (CI 42.2) No 132.

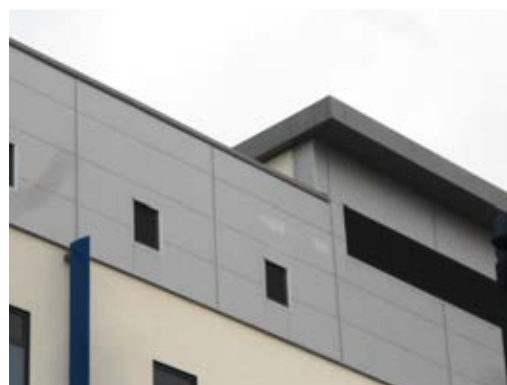
It appears that the cladding on the west facing elevation has been damaged and an unsuccessful attempt has been made to repair the damage. We asked Brookfield to confirm when this defect has been rectified. They have confirmed that this has been passed onto the sub-contractor Prater to rectify the unsuccessful attempt at the repair. See Supervisor's Notification of Defect (CI 42.2) No 137.

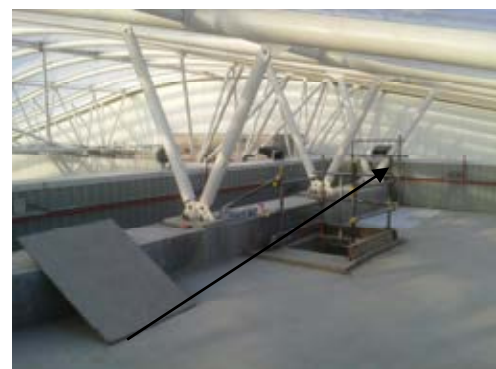
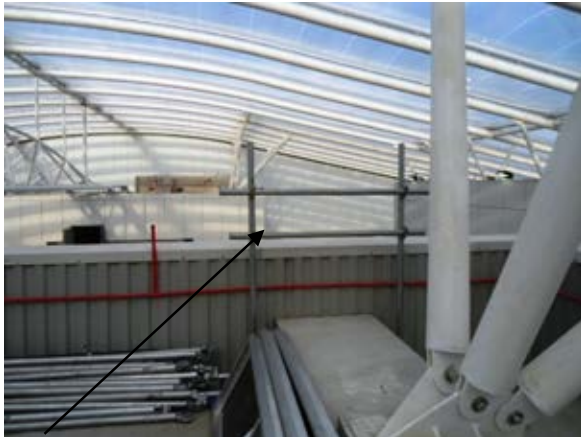
There is temporary scaffolding providing perimeter protection at concrete floor beams above the cores accessed from Level 12. The client intimated that protection is required. Brookfield has confirmed that M&S Engineering has taken site measurements and we await a date when the work will commence. See Supervisor's Communication General Matters / Other Instructions (CI 13.1) No 242.

Temporary scaffolding providing perimeter protection.

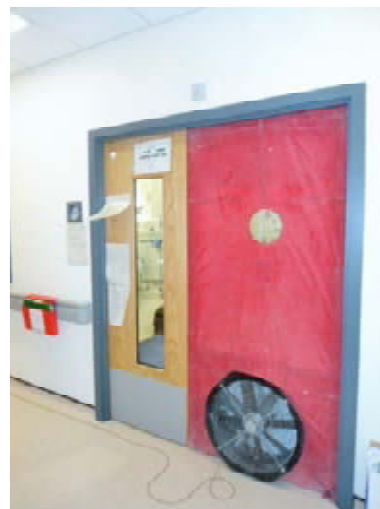
Following the discovery that Air Permeability Tests were not carried out within 36 isolation rooms in accordance with the Employer's Requirements NHS Guidance Documentations, document HBN 04-01. Brookfield is undertaken tests and remedial work to ensure the rooms are compliant.

During October we were in attendance during the successful air permeability test carried out in rooms A4 RENW-043 and A4 RENW-044. There are currently 2 in Schiehallion still to be tested. See Supervisor's Notification of Defect (C 42.2) No 139.

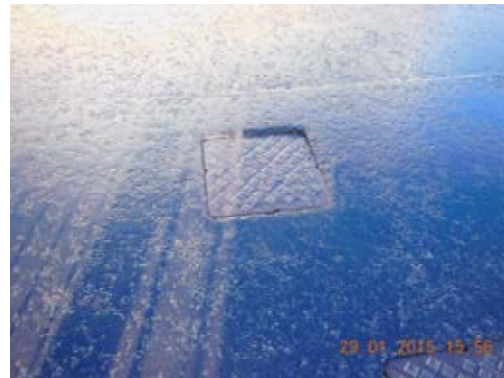
An NCR has also been raised in relation to manholes which are below the level of the surrounding tar. (See photo opposite.)

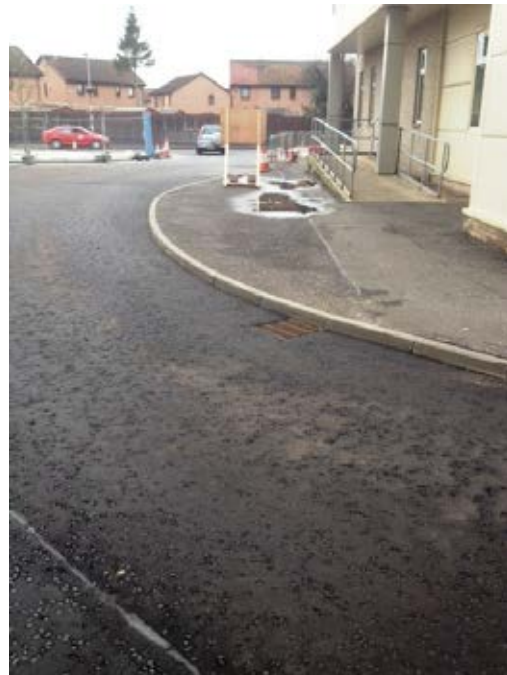
We advised the Brookfield team on 16th December that ponding on the new extended footpath to the east side of the maternity unit has the potential to be a significant slip hazard in cold weather. We asked them to confirm their action to address this hazard. Brookfield has confirmed that Land Engineering have been instructed to lift the full width of tar and re-lay with a fall from the ramp to the new road kerb.

Footpath to the east side of the maternity unit.

Brookfield had confirmed that work would commence week beginning 13th April. However they are awaiting an asphalt squad. (See Supervisor's Communication General Matters / Other Instructions (CI 13.1) No 237).

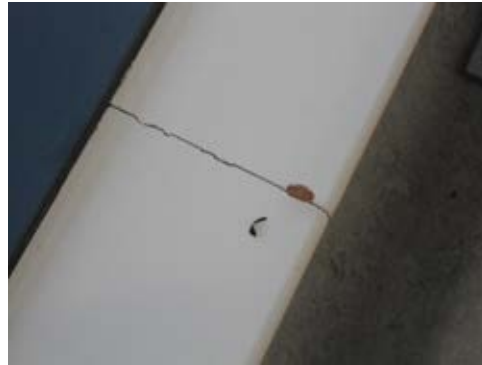
The joints at window cills are opening up. We asked Brookfield to confirm their remedial action to resolve this problem. They have filled and painted the joints but they have opened up again. They have sealed a joint with sealant to determine if this is a better solution. They intend to fill these cracks at the end of the defect liability period. See Supervisor's Notification of Defect (CI 42.2) No 99

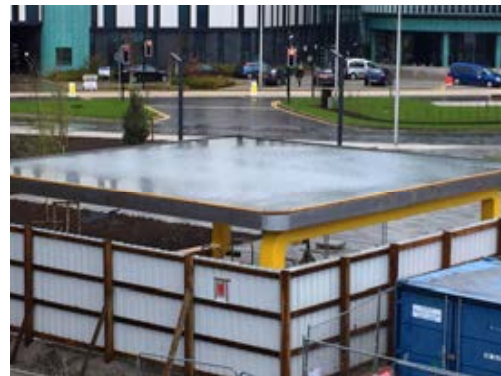
The Bicycle Shelter roof does not drain rainwater to the two corner outlets, consequently the rainwater is ponding. We asked Brookfield to confirm their proposed remedial action to resolve this defect. They have confirmed that following a meeting with the designer a level survey is required. The plan is to introduce a further outlet. See Supervisor's Notification of Defect (CI 42.2) No 129.

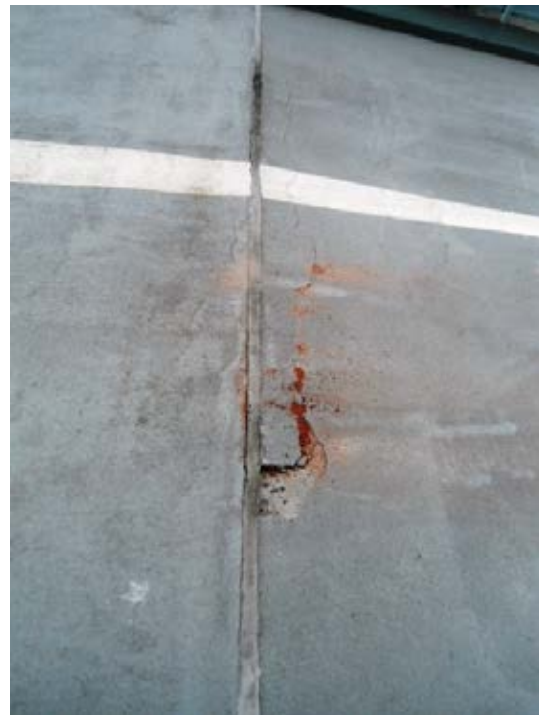
The concrete joint between the 6th floor and the down ramp is breaking up. We asked Brookfield to confirm the remedial measures to address this defect. They have instructed Dunne to carry out remedial works but await details from WSP. See Supervisor's Notification of Defect (CI 42.2) No 132.

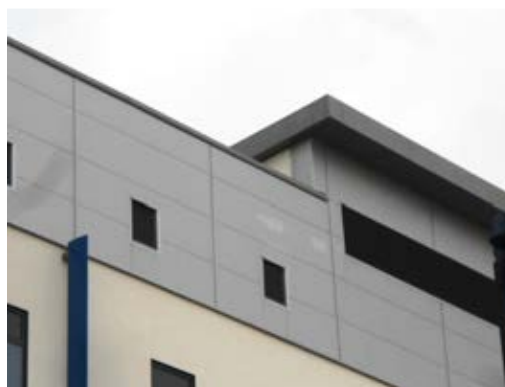
It appears that the cladding on the west facing elevation has been damaged and an unsuccessful attempt has been made to repair the damage. We asked Brookfield to confirm when this defect has been rectified. They have confirmed that this has been passed onto the sub-contractor Prater to rectify the unsuccessful attempt at the repair. See Supervisor's Notification of Defect (CI 42.2) No 137.

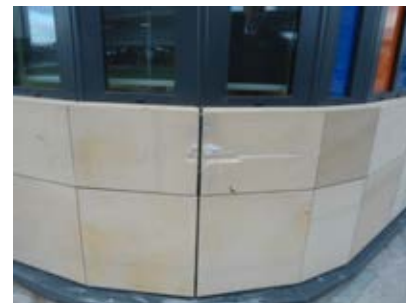
We noted that there is damage to the rain screen wall at the corner of the Royal Hospital for Children adjacent to the Children's Park. The rain screen sandstone cladding has sustained impact damage at ground floor level just below the windows. This may have been as a result of the adjacent works. We requested Brookfield to investigate the cause of the damage and advise on the proposed remedial action. We also asked them to confirm their proposals to prevent further incidents. Brookfield consequently investigated the damage and do not believe that this was caused by their works at the Children's play area. The type of plant that is working at that corner would have caused damage at a different height / location if it had come into contact with the building.

The only other activity within the area is the erection of the 20ft Christmas tree at the entrance of the Children's hospital. It is mounted in a concrete base which seems to have been sat in position by a forklift / Hiab, with the only access being round that corner. Following Brookfield's response, Supervisor's Communication General Matters / Other Instructions (CI 13.1) No 252 is now closed out.

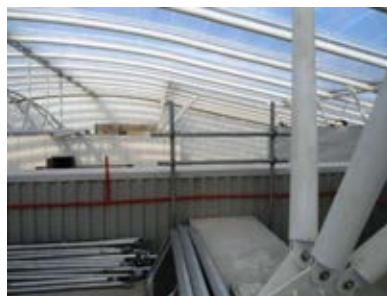
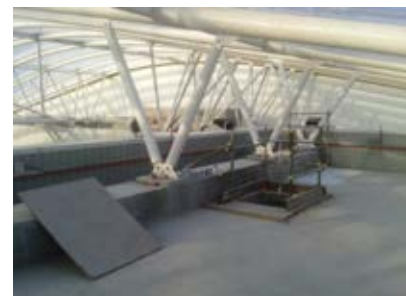
There is temporary scaffolding providing perimeter protection at concrete floor beams above the cores accessed from Level 12. The client intimated that protection is required. Brookfield has confirmed that M&S Engineering has taken site measurements and we await a date when the work will commence. See Supervisor's Communication General Matters / Other Instructions (CI 13.1) No 242.

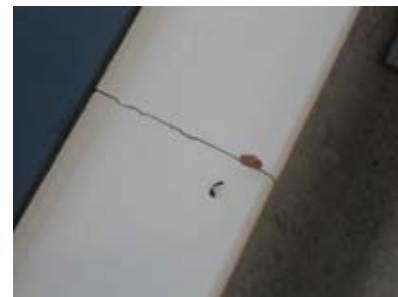
4.4.3 Supervisor's Notification of Defect (CI 42.2) No 99

The joints at window cills are opening up. We asked Brookfield to confirm their remedial action to resolve this problem. They have filled and painted the joints but they have opened up again. They have sealed a joint with sealant to determine if this is a better solution. They intend to fill these cracks at the end of the defect liability period.

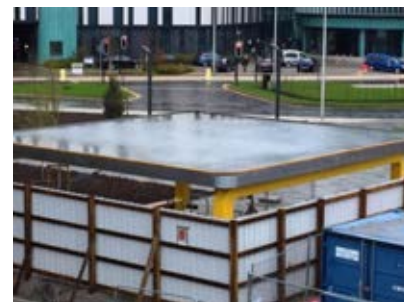
4.4.7 Supervisor's Notification of Defect (CI 42.2) No 129.

The Bicycle Shelter roof does not drain rainwater to the two corner outlets, consequently the rainwater is ponding. We asked Brookfield to confirm their proposed remedial action to resolve this defect. They have confirmed that following a meeting with the designer a level survey is required. The plan is to introduce a further outlet and be complete by the end of December.

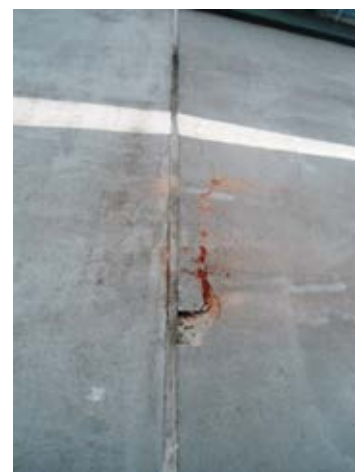
**4.4.8 Supervisor's Notification of Defect (CI 42.2) No 132**

The concrete joint between the 6th floor and the down ramp is breaking up. We asked Brookfield to confirm the remedial measures to address this defect. They have instructed Dunne to carry out remedial works but await details from WSP.

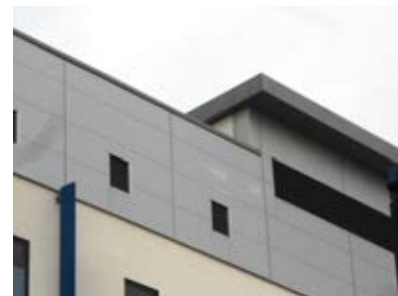
4.4.10 Supervisor's Notification of Defect (CI 42.2) No 137.

It appears that the cladding on the west facing elevation has been damaged and an unsuccessful attempt has been made to repair the damage. We asked Brookfield to confirm when this defect has been rectified. They have confirmed that this has been passed onto the sub-contractor Prater to rectify the unsuccessful attempt at the repair.

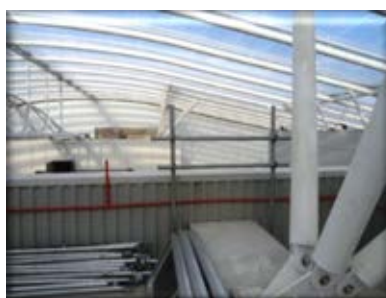
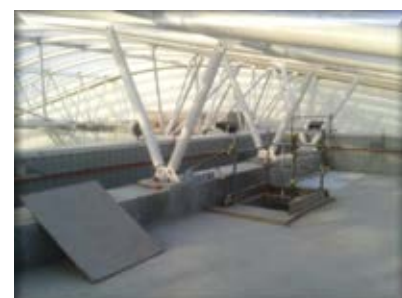
There is temporary scaffolding providing perimeter protection at concrete floor beams above the cores accessed from Level 12. The client intimated that protection is required. Brookfield has confirmed that M&S Engineering has taken site measurements and we await a date when the work will commence. See Supervisor's Communication General Matters / Other Instructions (CI 13.1) No 242.

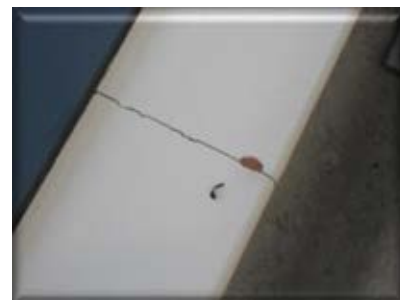
4.4.2 Supervisor's Notification of Defect (CI 42.2) No 99

The joints at window cills are opening up. We requested Brookfield to confirm the remedial action to resolve this problem. Brookfield has filled and painted the joints but they have opened up again. Thereafter Brookfield sealed a joint with sealant to determine if this resolved the defect. Accordingly, Brookfield intends to fill these cracks at the end of the defect liability period. We shall therefore retain this defect notification open.

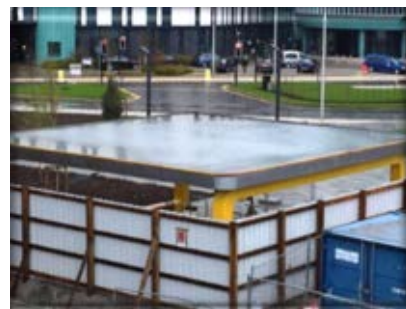
4.4.6 Supervisor's Notification of Defect (CI 42.2) No 129.

The Bicycle Shelter roof does not drain rainwater to the two corner outlets, consequently the rainwater is ponding. We requested Brookfield to confirm their proposed remedial action to resolve this defect. They have confirmed that following a meeting with the designer a level survey is required. The plan is to introduce a further outlet and be complete by the end of December. We request current status of resolution of this defect from Brookfield.

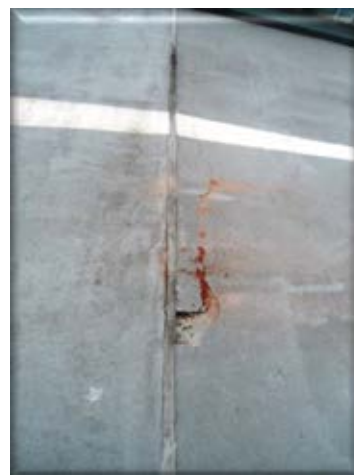
**4.4.7 Supervisor's Notification of Defect (CI 42.2) No 132**

The concrete joint between the 6th floor and the down ramp is breaking up. We asked Brookfield to confirm the remedial measures to address this defect. They have instructed Dunne to carry out remedial works but await details from WSP.

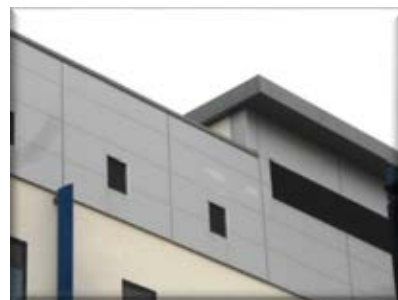
4.4.9 Supervisor's Notification of Defect (CI 42.2) No 137.

The cladding on the west facing elevation has been damaged and an unsuccessful attempt has been made to repair the damage. We requested Brookfield to advise when this defect is to be rectified. Brookfield has confirmed that this has been passed onto the relevant sub-contractor Prater to rectify the unsuccessful attempt at the repair.

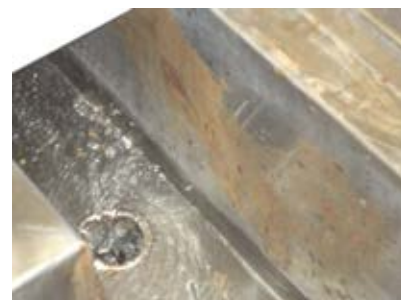
There is rust around the RHC Hydrotherapy pool surround, and on the handrails. The Department had a visit from Infection Control on 27th January 2016 and the rust was identified as sufficient a problem that the pool maybe put out of commission if the problem is not addressed. Brookfield to investigate this Defect and advise when this will be remedied.

4. Pool installers recommended cleaning regime for the pool is contained in "Zutec"
5. NHSGGH staff have received training on the operation and maintenance of the pool (now received from Brookfield)

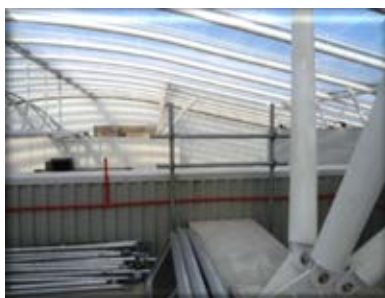
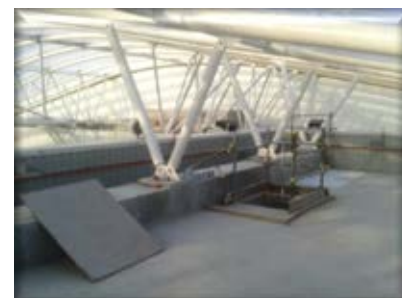
There is temporary scaffolding providing perimeter protection at concrete floor beams above the cores accessed from Level 12. The client intimated that protection is required. Brookfield has confirmed that M&S Engineering has taken site measurements and we await a date when the work will commence. See Supervisor's Communication General Matters / Other Instructions (CI 13.1) No 242.

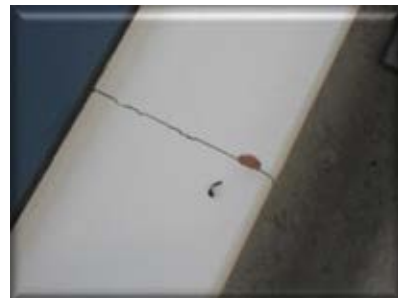
4.4.2 Supervisor's Notification of Defect (CI 42.2) No 99

The joints at window cills are opening up. We requested Brookfield to confirm the remedial action to resolve this problem. Brookfield has filled and painted the joints but they have opened up again. Thereafter Brookfield sealed a joint with sealant to determine if this resolved the defect.

Brookfield has advised that in general excessive shrinkage cracking in building elements of completed work will be addressed immediately prior to the end of defects period and that this defect falls into this category.

We shall therefore retain this defect notification open.

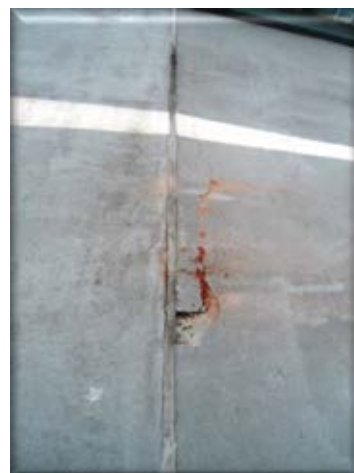
**4.4.7 Supervisor's Notification of Defect (CI 42.2) No 132**

The concrete joint between the 6th floor and the down ramp is breaking up. We asked Brookfield to confirm the remedial measures to address this defect. They have instructed Dunne to carry out remedial works but await details from WSP.

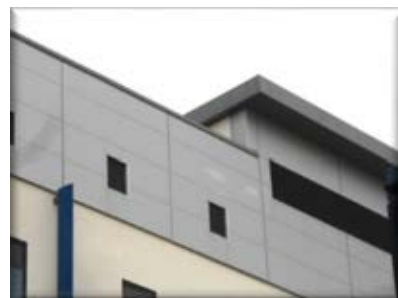
4.4.9 Supervisor's Notification of Defect (CI 42.2) No 137.

The cladding on the west facing elevation has been damaged and an unsuccessful attempt has been made to repair the damage. We requested Brookfield to advise when this defect is to be rectified. Brookfield has confirmed that this has been passed onto the relevant sub-contractor Prater to rectify the unsuccessful attempt at the repair.

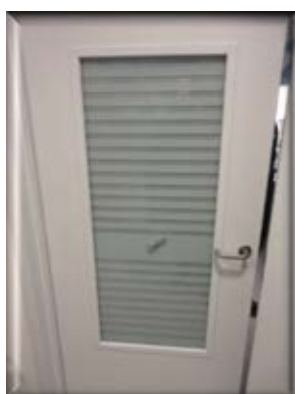
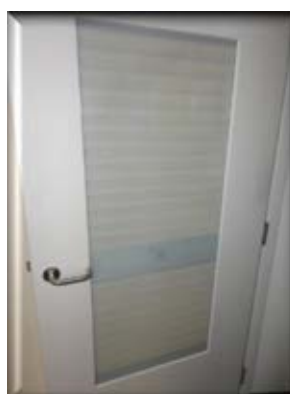
Photos below left show the retrofitted glazing bead to the outside face of the door (also facilitates maintenance future removal of the glazed unit) with photos below right showing the retention of the original detail on the internal face.

All in attendance agreed that this was an acceptable remedial solution and Infection Control is to be consulted for their acceptance.

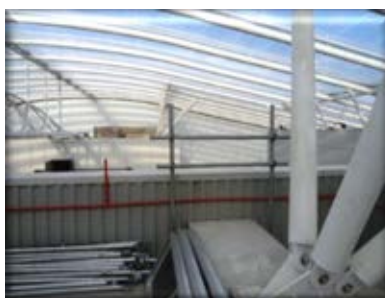
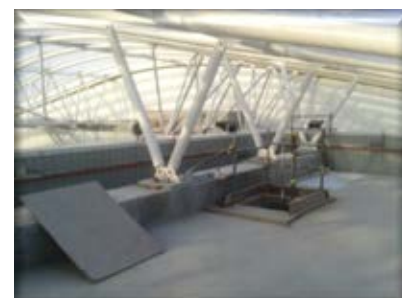
4.2.2 Supervisor's Communication General Matters / Other Instructions (CI 13.1) No 242.

There is temporary scaffolding providing perimeter protection at concrete floor beams above the cores accessed from Level 12. The client intimated that protection is required. Brookfield has confirmed that M&S Engineering has taken site measurements and we await a date when the work will commence. See Supervisor's Communication General Matters / Other Instructions (CI 13.1) No 242.

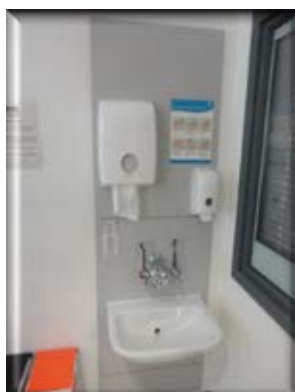
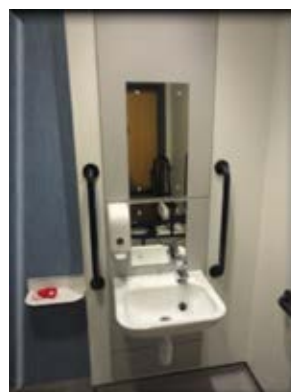
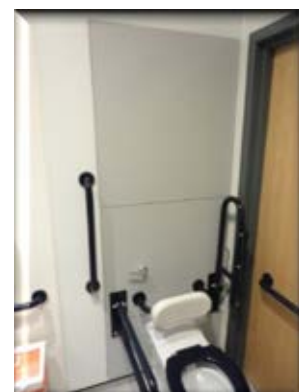
On Tuesday 5th April 2015 an inspection of several in-situ IPS examples was undertaken in Ward 5B with Project Team, Estates, Supervisor and Brookfield in attendance. NHS preference is to screw IPS panels (fitted with dispensers as photos below left) to the frame (Option 1.2C above) and Brookfield (caveated by their response to Communication 253) has offered to prepare proposals for NHS consideration to include provide: - fixing options; approximate quantity of rooms affected; approximate timescale for implementing proposals; approximate budget costs.

- A. Training for domestic staff.
- B. Signage on how to remove on all IPS mounted dispensers.
- C. Screw the IPS panel to the frame"

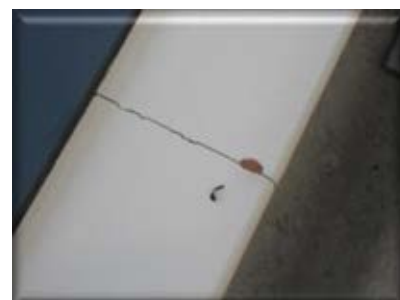
4.4.2 Supervisor's Notification of Defect (CI 42.2) No 99

The joints at window cills are opening up. We requested Brookfield to confirm the remedial action to resolve this problem. Brookfield has filled and painted the joints but they have opened up again. Thereafter Brookfield sealed a joint with sealant to determine if this resolved the defect. Brookfield has advised that in general excessive shrinkage cracking in building elements of completed work will be addressed immediately prior to the end of defects period and that this defect falls into this category. We shall therefore retain this defect notification open.

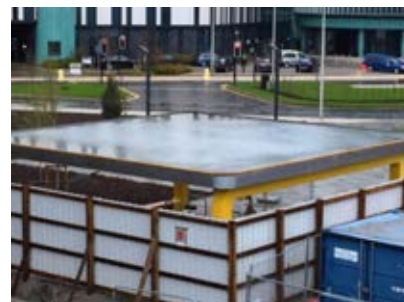
4.4.6 Supervisor's Notification of Defect (CI 42.2) No 129.

The Bicycle Shelter roof does not drain rainwater to the two corner outlets, consequently the rainwater is ponding. We requested Brookfield to confirm their proposed remedial action to resolve this defect. They have confirmed that following a meeting with the designer a level survey is required. The plan is to introduce a further outlet. Brookfield has advised that remedial works will be undertaken during April 2016.

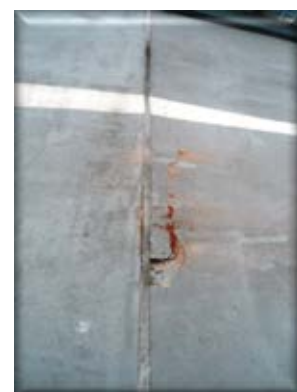
**4.4.7 Supervisor's Notification of Defect (CI 42.2) No 132**

The concrete joint between the 6th floor and the down ramp is breaking up. We asked Brookfield to confirm the remedial measures to address this defect. They have instructed Dunne to carry out remedial works but await details from WSP.

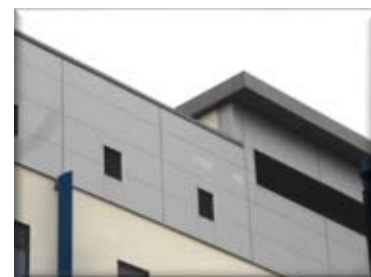
4.4.9 Supervisor's Notification of Defect (CI 42.2) No 137.

The cladding on the west facing elevation has been damaged and an unsuccessful attempt has been made to repair the damage. We requested Brookfield to advise when this defect is to be rectified. Brookfield has confirmed that this has been passed onto the relevant sub-contractor Prater to rectify the unsuccessful attempt at the repair.

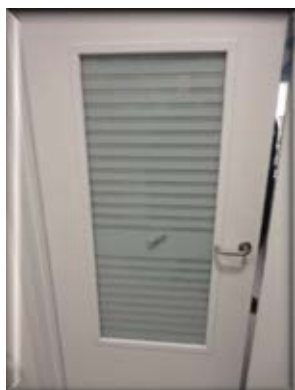
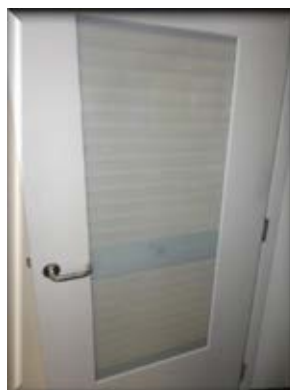
**4.4.10 Supervisor's Notification of Defect (CI 42.2) No 140.**

There are defective spindles to privacy visicom panels within timber doors and screens throughout the hospital. This is due to the nylon washer being reshaped by the spindle under the weight of the glass. This has led to the spindle being unable to move the washer as their shapes are incompatible. We requested Brookfield to advise when this defect will be addressed throughout the hospital and they have confirmed that the defect has been issued to their sub-contractor for action. All units will have new modified lifter installed; this is being reviewed by their sub-contractor. Once Brookfield has all relevant details from their sub-contractor they will issue us with a programme for rectification.

Photos below left show the retrofitted glazing bead to the outside face of the door (also facilitates maintenance future removal of the glazed unit) with photos below right showing the retention of the original detail on the internal face.

We attended a joint inspection of the sample retrofit glazing bead to the "plasform" doors at Room 20 in the Schiehallion ward (NCH – 2A) on Friday 26th February 2016. Represented were NHS Project Manager, NHS Estates and Brookfield. From a construction point of view, Ian Powrie from Estates accepted the sample, but would like to get Infection Control sign-off prior to Brookfield ordering materials. We believe that Infection Control has approved and we request confirmation of this. All in attendance agreed that this was an acceptable remedial solution and Infection Control is to be consulted for their acceptance.

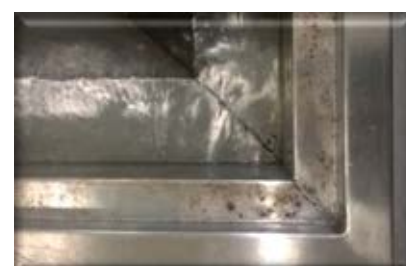
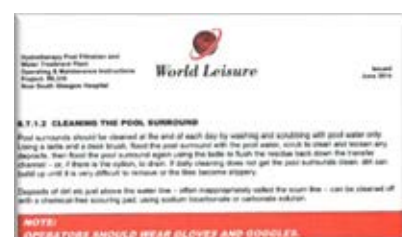
4.4.12 **Supervisor's Notification of Defect (CI 42.2) No 143**

There is rust around the RHC Hydrotherapy pool surround, and on the handrails. The Department had a visit from Infection Control on 27th January 2016 and the rust was identified as sufficient a problem that the pool maybe put out of commission if the problem is not addressed. Brookfield does not accept that the "rust" issue highlighted in defect notification no 143 is a defect. The following is an explanation from World Leisure:-

"The findings show that dirt is forming on the outside edge of the Channel (see picture). When wiped, this cleared. Our recommendation would be to introduce weekly cleaning procedures to the Pool Edge to prevent the dirt from forming. No chemical recommendation would be required at this stage as when wiped with a non-abrasive cloth, the dirt lifted and cleared."

World Leisure's recommended cleaning instructions for the pool surround are contained in pages 67 and 68 (extract right) of their document uploaded to Zutec. It would appear that the cleaning regime for the pool surrounds (pool surrounds should be cleaned at the start and end of each shift as a minimum) is not being carried out in accordance with these cleaning instructions and consequently the stainless steel is being coated in a residue. Once NHS Estates advises us that they have implemented the recommended cleaning regime and is satisfied that this resolves the problem, we will then close out this Defect.

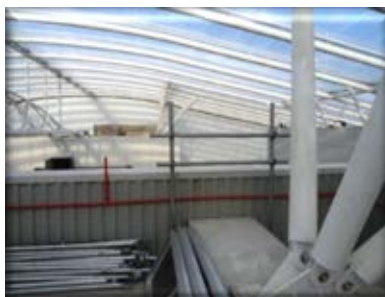
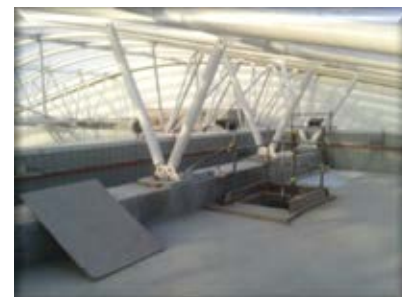
4.2.3 Supervisor's Communication General Matters / Other Instructions (CI 13.1) No 242.

There is temporary scaffolding providing perimeter protection at concrete floor beams above the cores accessed from Level 12. The client intimated that protection is required. Brookfield has confirmed that M&S Engineering has taken site measurements and we await a date when the work will commence. Brookfield has advised works will be undertaken late April 2016.

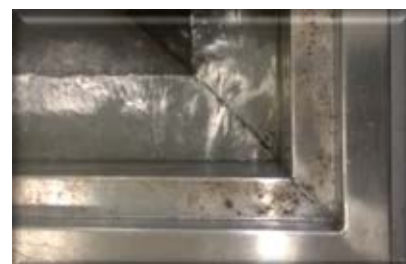
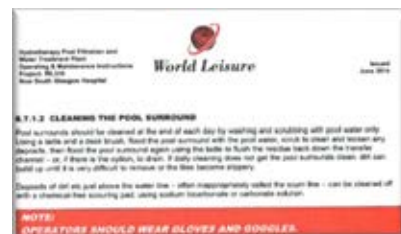
4.3.3 Supervisor's Notification of Defect (CI 42.2) No 143

There is rust around the RHC Hydrotherapy pool surround, and on the handrails. The Department had a visit from Infection Control on 27th January 2016 and the rust was identified as sufficient a problem that the pool maybe put out of commission if the problem is not addressed. Brookfield does not accept that the "rust" issue highlighted in defect notification no 143 is a defect. The following is an explanation from World Leisure:-

"The findings show that dirt is forming on the outside edge of the Channel (see picture). When wiped, this cleared. Our recommendation would be to introduce weekly cleaning procedures to the Pool Edge to prevent the dirt from forming. No chemical recommendation would be required at this stage as when wiped with a non-abrasive cloth, the dirt lifted and cleared."

World Leisure's recommended cleaning instructions for the pool surround are contained in pages 67 and 68 (extract right) of their document uploaded to Zutec. It would appear that the cleaning regime for the pool surrounds (pool surrounds should be cleaned at the start and end of each shift as a minimum) is not being carried out in accordance with these cleaning instructions and consequently the stainless steel is being coated in a residue. Once NHS Estates advises us that they have implemented the recommended cleaning regime and is satisfied that this resolves the problem, we will then close-out this Defect.

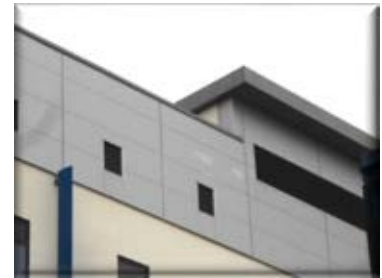
4.3.6 Supervisor's Notification of Defect (CI 42.2) No 137.

The cladding on the west facing elevation has been damaged and an unsuccessful attempt has been made to repair the damage. We requested Brookfield to advise when this defect is to be rectified. Brookfield has confirmed that this has been passed onto the relevant sub-contractor Prater to rectify the unsuccessful attempt at the repair.

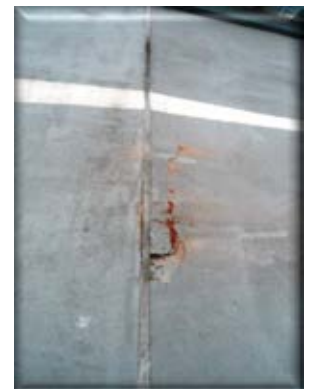
4.3.8 Supervisor's Notification of Defect (CI 42.2) No 132

The concrete joint between the 6th floor and the down ramp is breaking up. We asked Brookfield to confirm the remedial measures to address this defect. They have instructed Dunne to carry out remedial works but await details from WSP. Brookfield confirmed that Details have now been received from WSP.

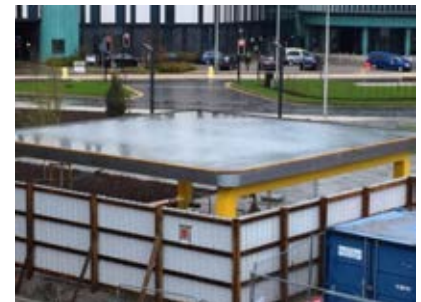
**4.3.9 Supervisor's Notification of Defect (CI 42.2) No 129.**

The Bicycle Shelter roof does not drain rainwater to the two corner outlets, consequently the rainwater is ponding. We requested Brookfield to confirm their proposed remedial action to resolve this defect. They have confirmed that following a meeting with the designer a level survey is required. The plan is to introduce a further outlet. Brookfield has advised that remedial works will be undertaken during May 2016.

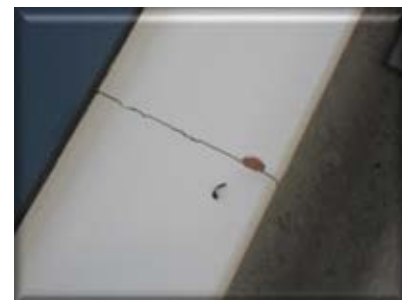
Brookfield has advised that in general excessive shrinkage cracking in building elements of completed work will be addressed immediately prior to the end of defects period and that this defect falls into this category.

We shall therefore retain this defect notification open.

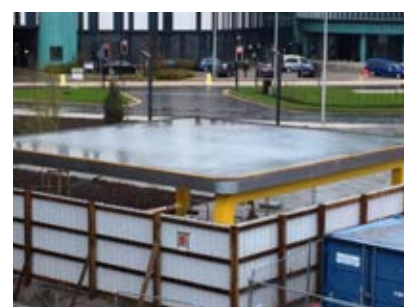
4.3.9 Supervisor's Notification of Defect (CI 42.2) No 129.

The Bicycle Shelter roof does not drain rainwater to the two corner outlets, consequently the rainwater is ponding. We requested Brookfield to confirm their proposed remedial action to resolve this defect. They have confirmed that following a meeting with the designer a level survey is required. The plan is to introduce a further outlet. Brookfield has advised that remedial works will be undertaken during May 2016.

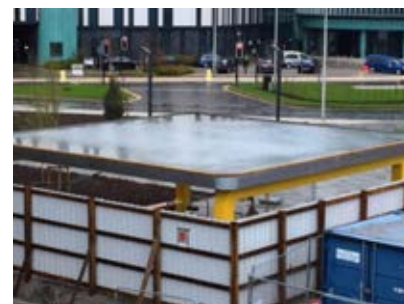
4.3.9 Supervisor's Notification of Defect (CI 42.2) No 129.

The Bicycle Shelter roof does not drain rainwater to the two corner outlets, consequently the rainwater is ponding. We requested Brookfield to confirm their proposed remedial action to resolve this defect. They have confirmed that following a meeting with the designer a level survey is required. The plan is to introduce a further outlet. Brookfield to advise when remedial works will be undertaken.

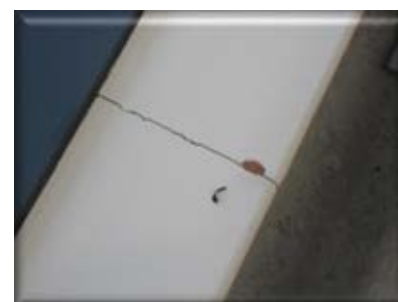
Brookfield has advised that in general excessive shrinkage cracking in building elements of completed work will be addressed immediately prior to the end of defects period and that this defect falls into this category.

We shall therefore retain this defect notification open.

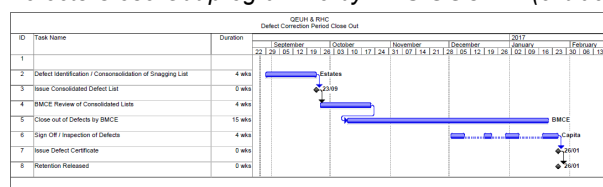
John McEwan and Dave Ramsay met with Ian Powrie and the FM/Estates Team (Cyril Dowson, Bob Geddes, David Bratney, Mark McKaig) on 11th October 2016 to discuss the FM First Summary Schedule (extract below right) as the consolidated list for defect matters raised by NHS GGC FM and Estates inclusive of any defects matters consequent to PPM. This meeting was consequent to NHS GGC liaison with Estates on Defects Close Out and the issue of the Defects Close Out programme by NHS GGC PM (extract below left).

First FM	Location	Room	Issue	Received	S/C	BMCE
160952580	A-03-FM3-051	FM Support	Plant Room 22-AHU-14 supply and extract duct work going down through the concrete floor does not have any fire stopping. This is a critical defect, Jordan has already seen this	13-Oct-16	MER	NH
160952608	C-00-OBW-002	Entrance	We have water leaking from hatch in ceiling in the resus corridor just at ambulance entrance to the children's hospital nearest tag is OBW002 - in between stage and C00. I will call estates also. Note added by MARK MCKAIG (07/09/2016 11:59:39) LOCATION EMC-066 NEXT TO LOBBY EMC-066	13-Oct-16	MER	NH
160952781	A-00-ENT-006	Concourse	ROOF LEAKING IN ATRIUM AT SOUP & JUICE	13-Oct-16	VEC	JM
160952786	C-00-OPD-037	Sub-reception	Roof in out-patient waiting - near Clinic 9 (Respiratory Function Lab) entrance door	13-Oct-16	VEC	JM
160952749			21-AHU-20 LEAKING ON SUPPLY AT JOINT BEFORE DROPPING TO LEVEL 2	13-Oct-16	MER	NH

160952835	Energy Centre		Aboriginal Centre & side shed for max heat 100°C this requires rectified	13-Oct-16	MER	NH
160952830	Energy Centre		all flexible fittings within a side shed CE marked requires to be rectified	13-Oct-16	MER	NH
160952835	Energy Centre		2 off lab block plate heat exchangers 115°C maximum rating and no CE marking	13-Oct-16	MER	NH
