Provisional Position Paper 11

**Potentially Deficient Features
of the water system
of the QEUH/RHC**

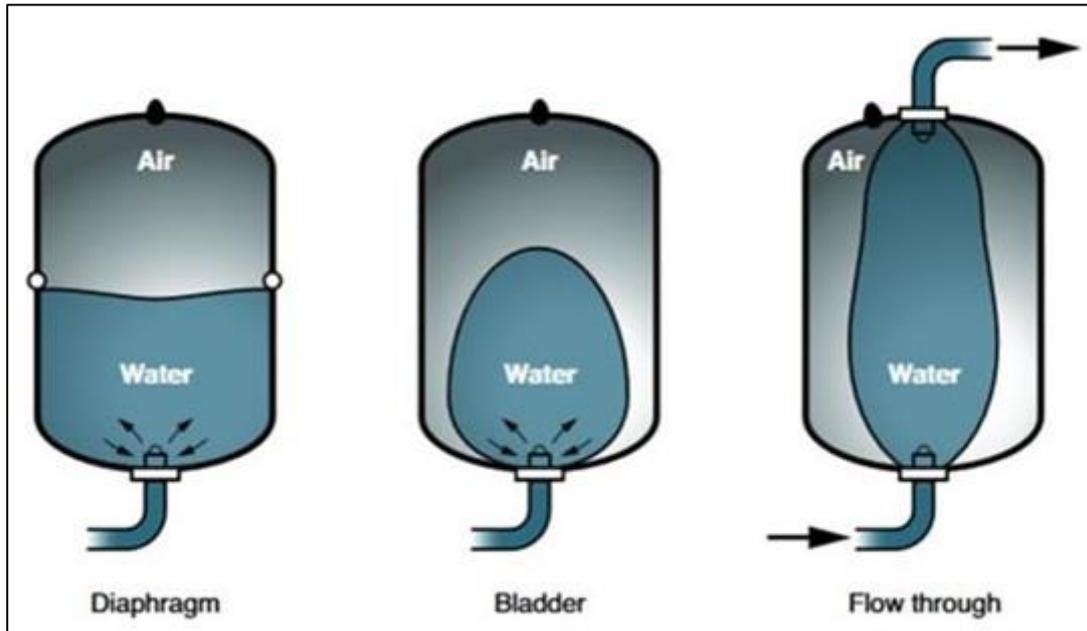
13.3. HSE guidance on Legionnaire’s Disease illustrates common designs for expansion vessels, including the directions of water flow, and describes further the risk of certain materials providing a surface location for contamination:

“...In pressurised systems, a means of accommodating water expansion (caused by the water heating) is required. This is often achieved with the use of an expansion vessel. However, these may not fill and empty where the system pressure and temperature remains steady....

13.4. These internal bladders are often made of synthetic rubber such as EPDM and may support the growth of microorganisms. Vessels with a ‘flow through’ design should provide less opportunity for water to stagnate and become contaminated (as in the latter design).¹⁹³

13.1. The expansion vessels were identified as a potentially deficient feature of the water system. A concern was raised regarding the design of them created a risk of them (or at least areas within them) acting as ‘deadlegs’ such that they were not being reliably flushed, with the result being a risk that contamination could accumulate.

“The expansion vessels attached to the calorifiers are not of a flow through design as recommended in HSG 274 Part 2 (info Box 2.1) and SHTM 04-01 Part A (Para 8.22) and they are not insulated as recommended in SHTM 04-01 Part A (Para 8.22). Estates advised that there is an intention to alter the pipework and vessels to accommodate flow through vessels in early 2019. Generally water flushed from drain on calorifiers and expansion vessels ran clear either instantly or after only a very short period of time (typically less than 10 seconds). No internal records of inspection for calorifiers were available”¹⁹⁵

Recommendation of 2017 DMA Risk Assessment (received in April 2018). The new design would be a flow through to remove the need for flushing the drains on the expansion vessels as this is deemed a dead leg”¹⁹⁶
